October 31, 2022

Tim Cottage | Project Manager  
Hilco Development Services  
1707 E 28<sup>th</sup> Street, Suite B  
Signal Hill, CA 90755

Re: 200 Baker – Due Diligence Survey  
200 E Baker St, Costa Mesa, CA 92626  
Review of Existing Structure and Site  
RSG Job #22-1-070.00

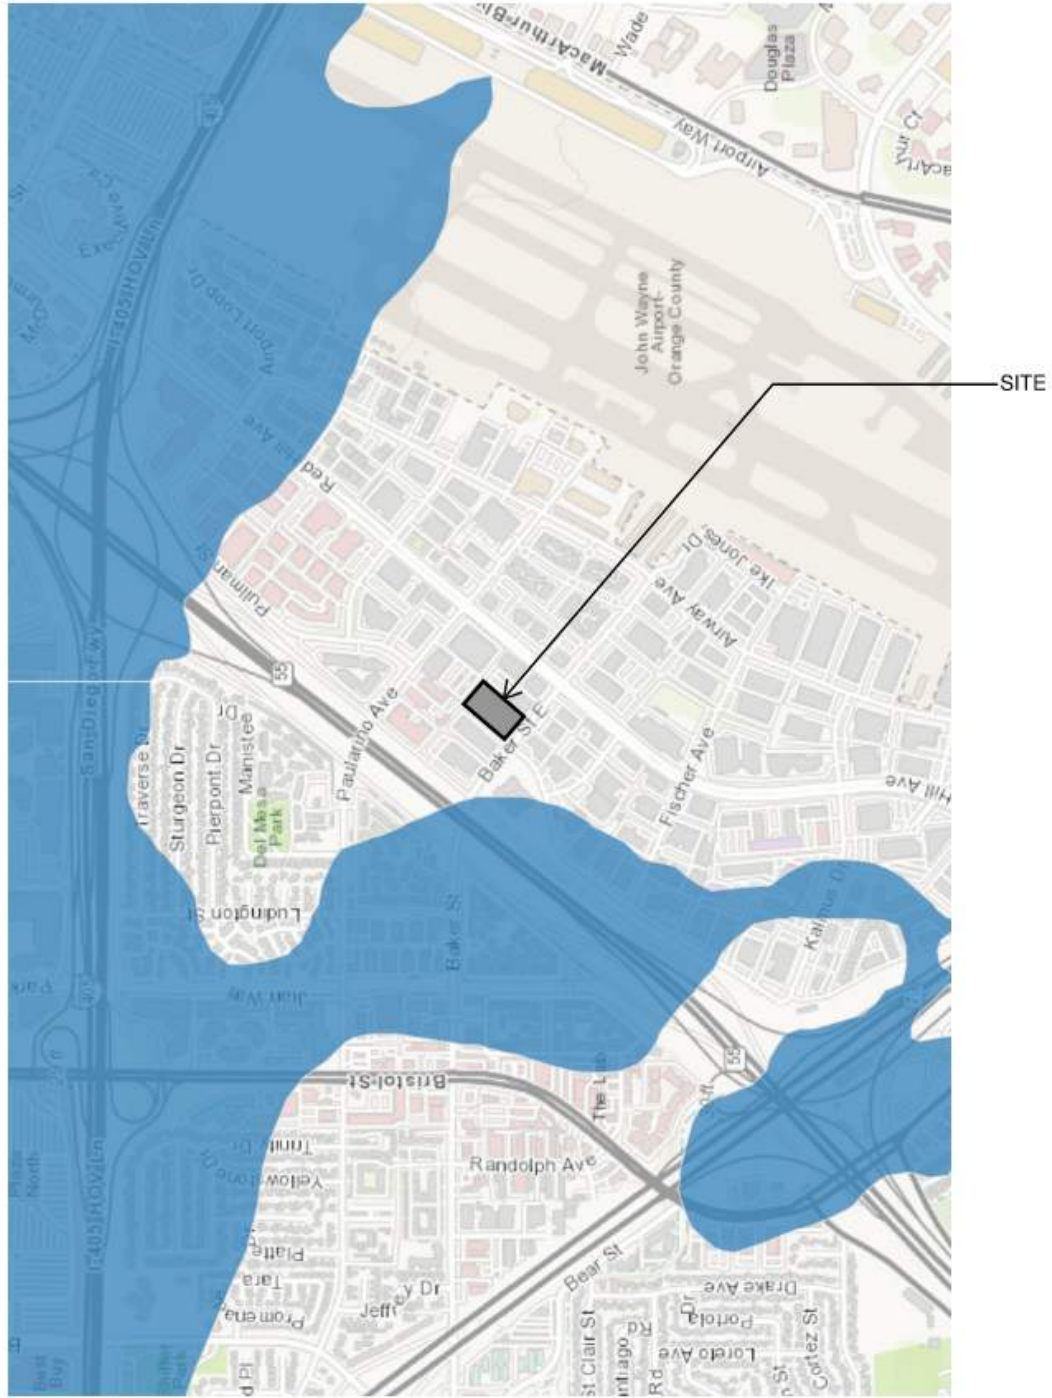
**Appendix A**  
**Liquefaction Map**

According to California GIS liquefaction maps, the site is near, but not directly located within a liquefaction zone (see Appendix A). For further soil investigations, as required, we recommend consulting a licensed geotechnical engineer.

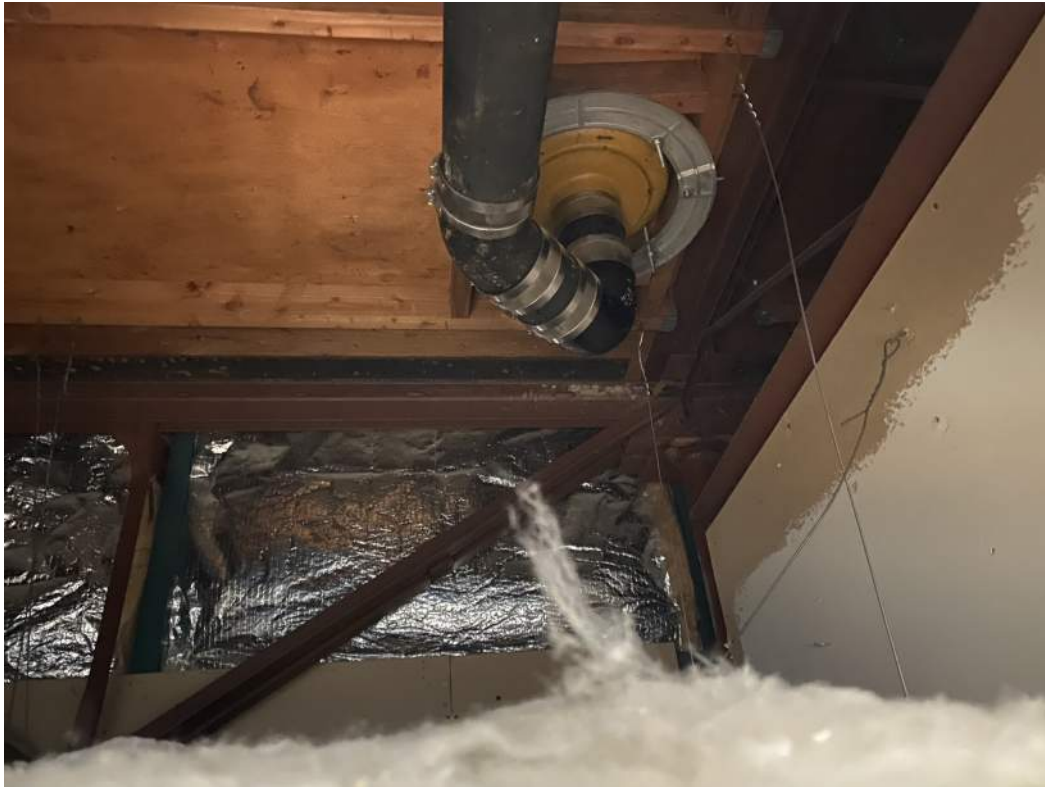
FIG 5: TYPICAL ROOF STRUCTURE - 2x4 SUBPURLINS, OWSJ, & OWSJ GIRDER W/  
ROOF DRAIN

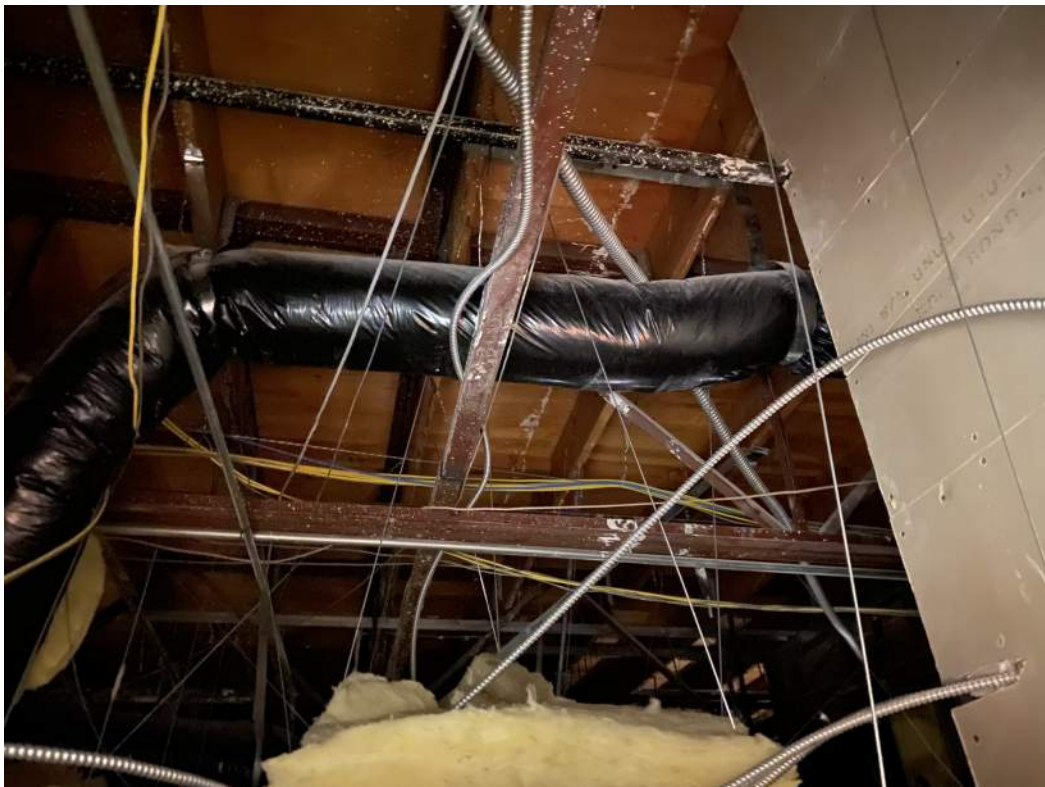
FIG 6: TYPICAL FLOOR STRUCTURE - 2x10 JOISTS, OWSJ, OWSJ GIRDER  
-12-

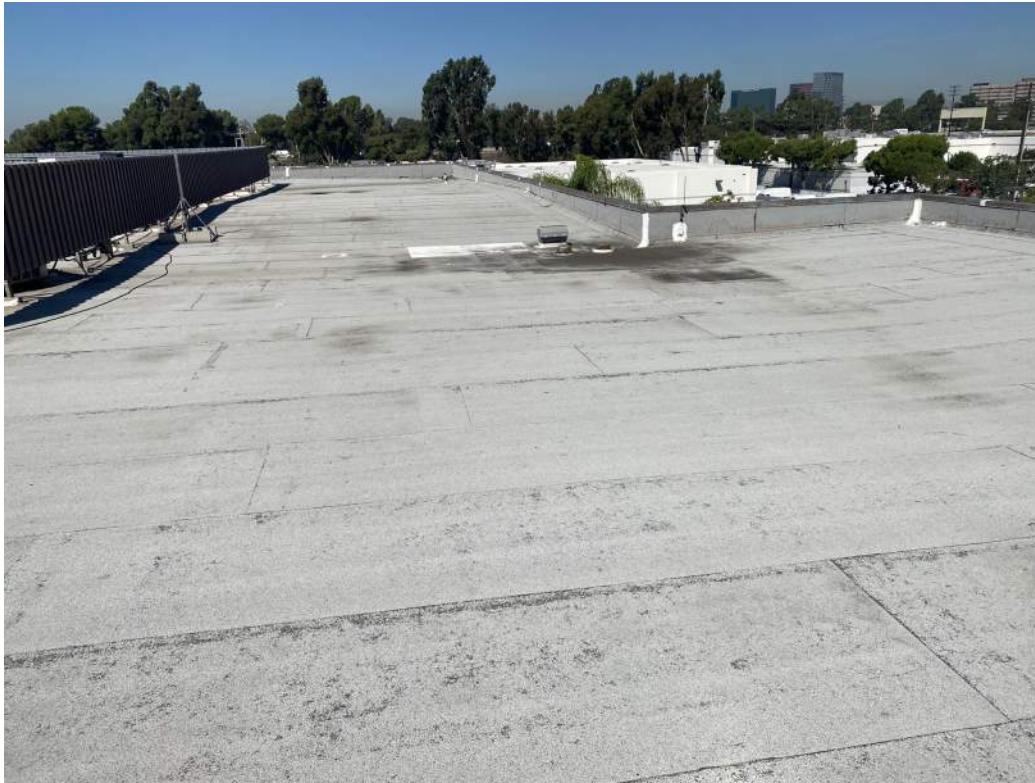
FIG 7: TYPICAL ROOF

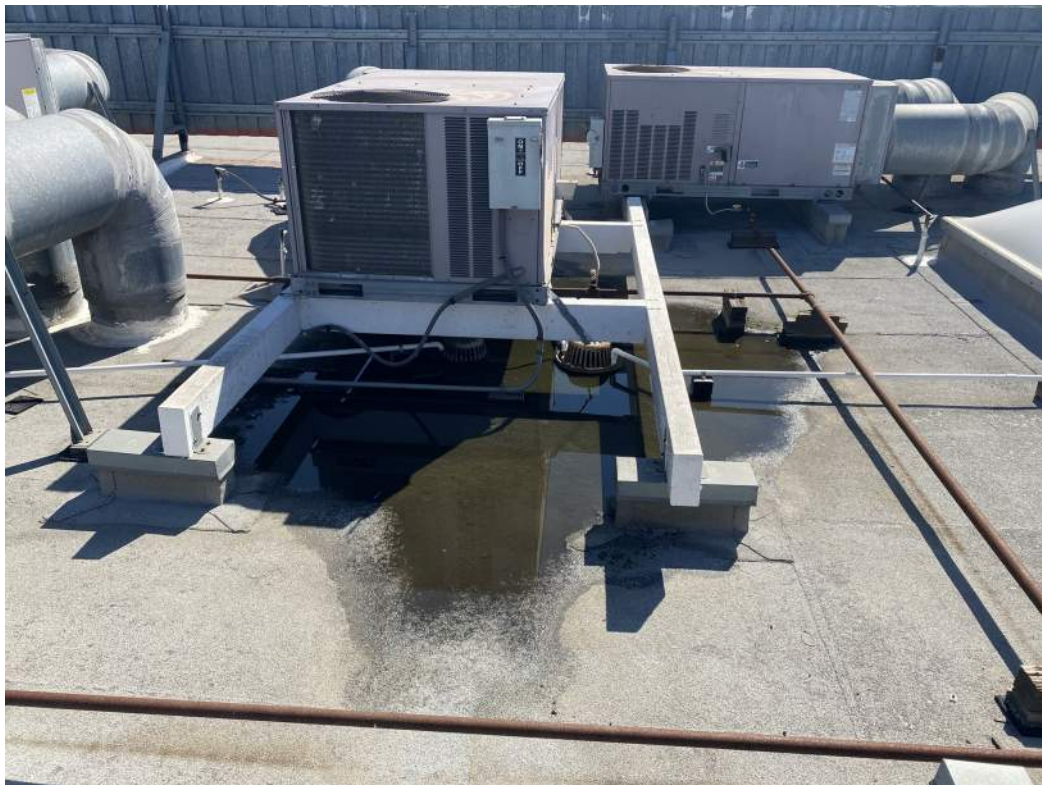
2. *Drainage Facilities:*  
While on site, we observed the existing roof. The existing roofing consists of asphalt rolled roofing and appeared to be adequately sloped to drain. We observed six (6) roof drains and back-up drains on the roof. Five (5) of the roof drains appeared to be free of debris and in good working condition. The roof drain located within the mechanical area had evidence of ponding surrounding it. The drain appeared to be clogged with moss and other debris. The area surrounding the ponding appeared to have additional moss which may indicate that this is a persistent issue. At the time of the survey, there was a moderate/heavy rainfall three days prior which may have contributed to this ponding. Additionally, a condensate line from a roof top mechanical unit was dripping adjacent to the drain which was unable to drain due to the clog. We recommend the drain be cleared of debris and the surrounding area cleaned of moss to allow the drain to function properly.

FIG 8: PONDING AT EXISTING ROOF DRAIN. CONDENSATE LINE CAN BE SEEN FROM LEFT EXACERBATING PONDING ISSUE.

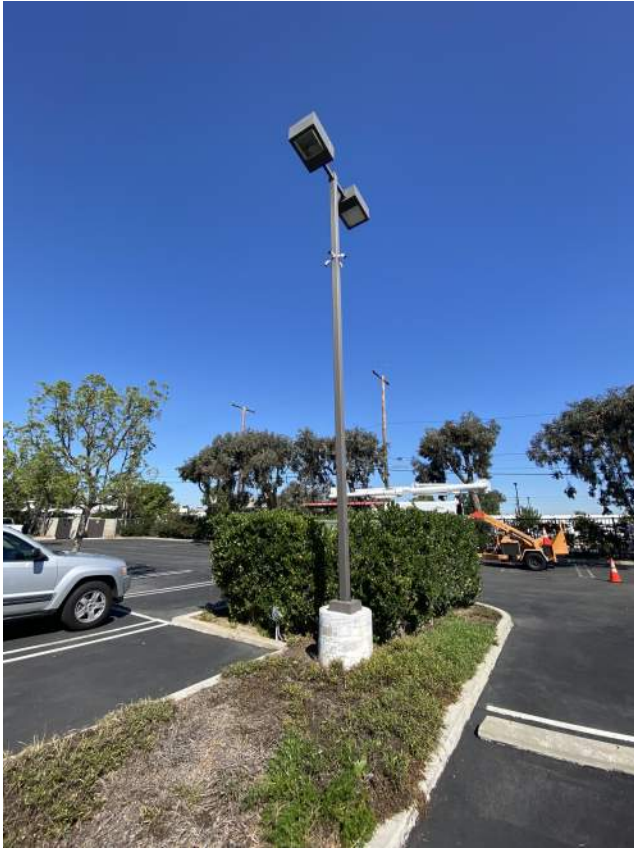
4. *Exterior Lighting:*  
Parking lot lighting consisted of 16-ft galvanized parking lot lighting poles. Lighting on the property line consisted of (1) light per pole and lights on the interior of the parking lot consisted of (2) lights per pole. Lighting poles were mounted to 24-inch diameter concrete piers. The piers in the parking lots and their supporting pier appeared to be in good condition. The site visit was performed during daylight hours however no noticeable defects were observed at the time of the visit. Therefore, it is assumed all lights are operational.

FIG 9: TYPICAL SITE LIGHTING

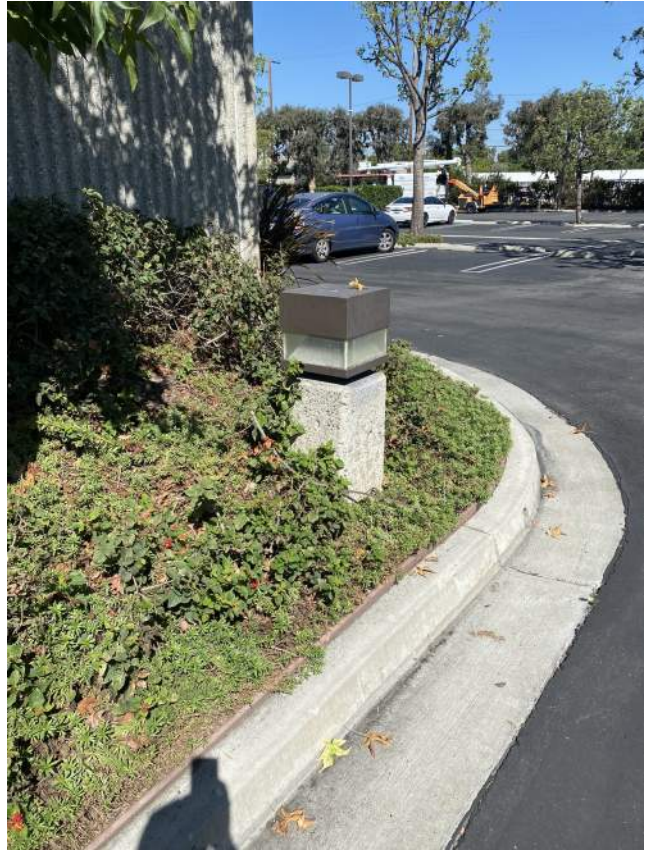
FIG 10: TYPICAL DRIVEWAY / WALKWAY LIGHTING

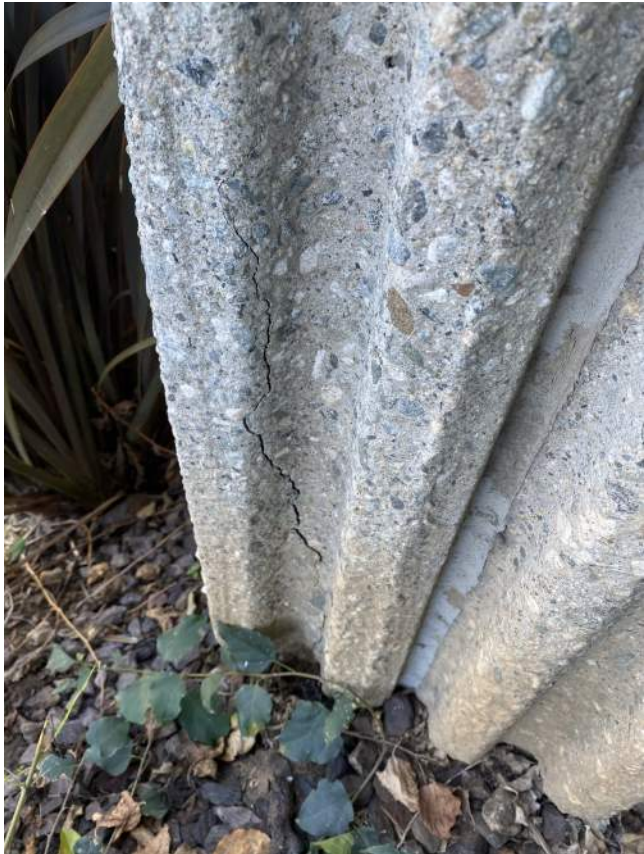
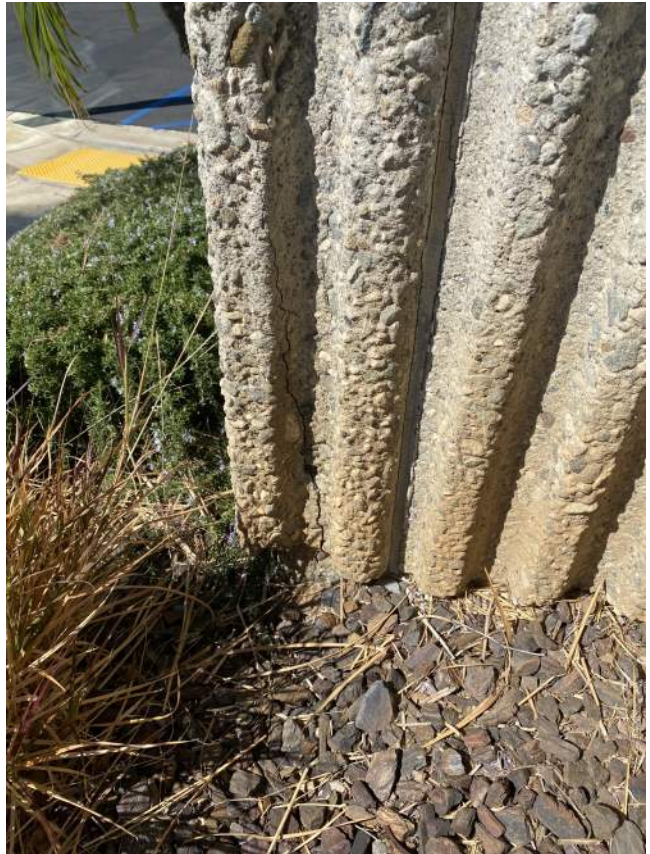
3. *Walls:*  
Exterior tilt-up walls appeared to be in good condition. Minimal cracking was observed in the walls. Cracking was observed in some locations at base near walls ends which is typical for areas where holdowns/tiedowns and areas of added reinforcing are present. Minor cracking was also observed where tilt-up concrete lintels bear on tilt-up bearing walls. We believe this to be a lack of trim-bar reinforcing in the wall and does not present an immediate cause for concern in the structure. Interior walls consisted of non-bearing metal stud partition walls. Partition walls at the offices were partial height and appeared to be adequately braced for lateral loading. Corridor walls and walls at the stairways were full height to maintain their fire rating. In general, the interior walls were in good condition.

FIG 11: MINOR CRACKING / SPAWLING IN EXISTING TILT-UP WALL

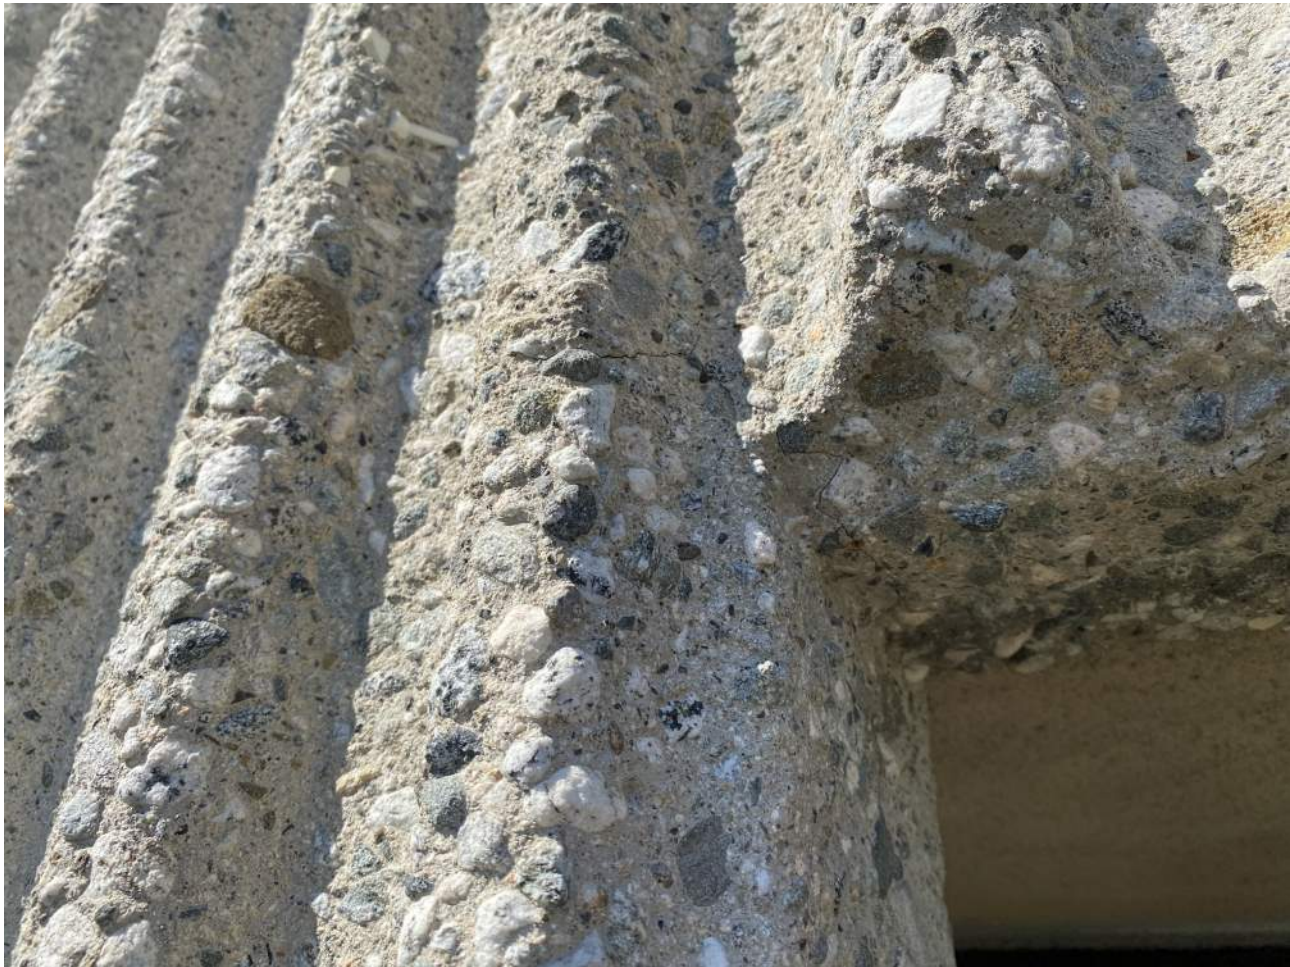
FIG 12: MINOR CRACKING IN CONCRETE TILT-UP LINTEL TO WALL

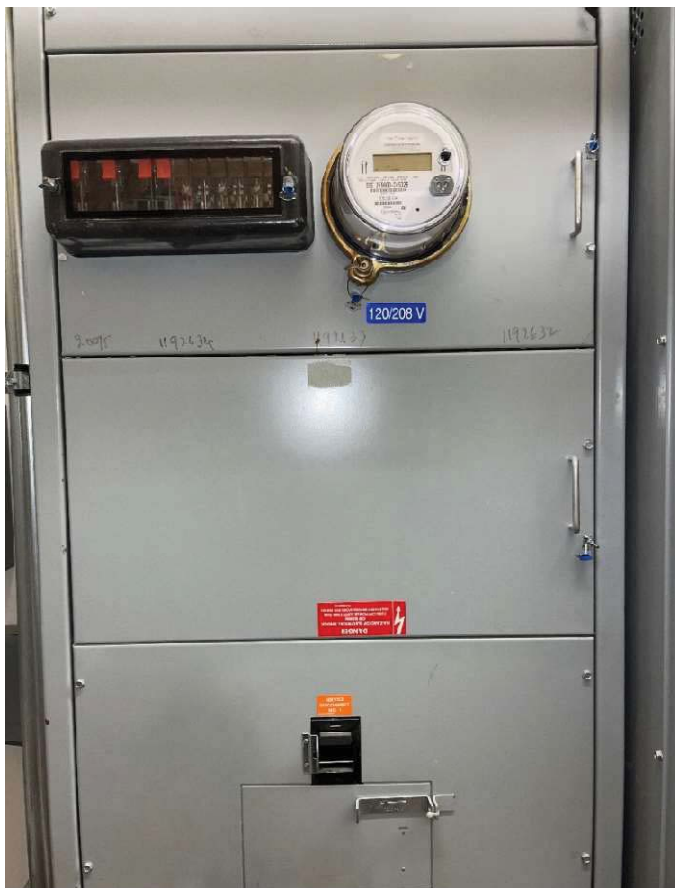
1) 400A 120/208V 3PH 4W 65k AIC with meter.

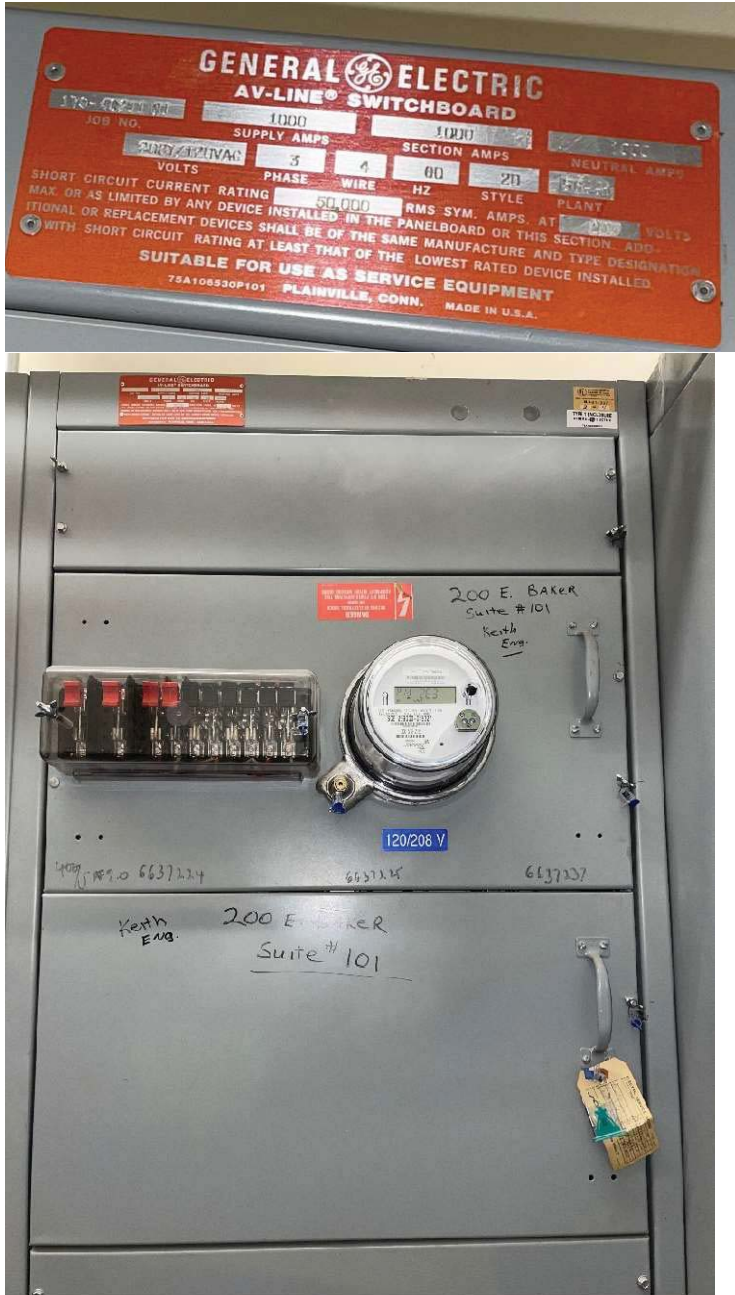
2) 1000A 120/208V 3PH 4W 50k AIC with meter.

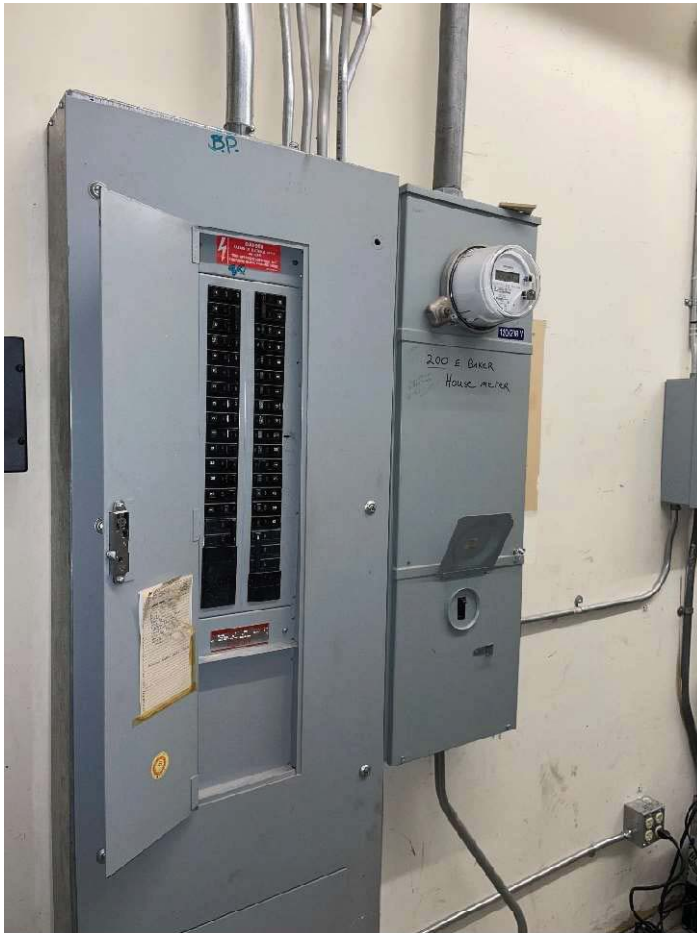
4) 225A 120/208V 3Ph 4W house panel "BP" with Meter

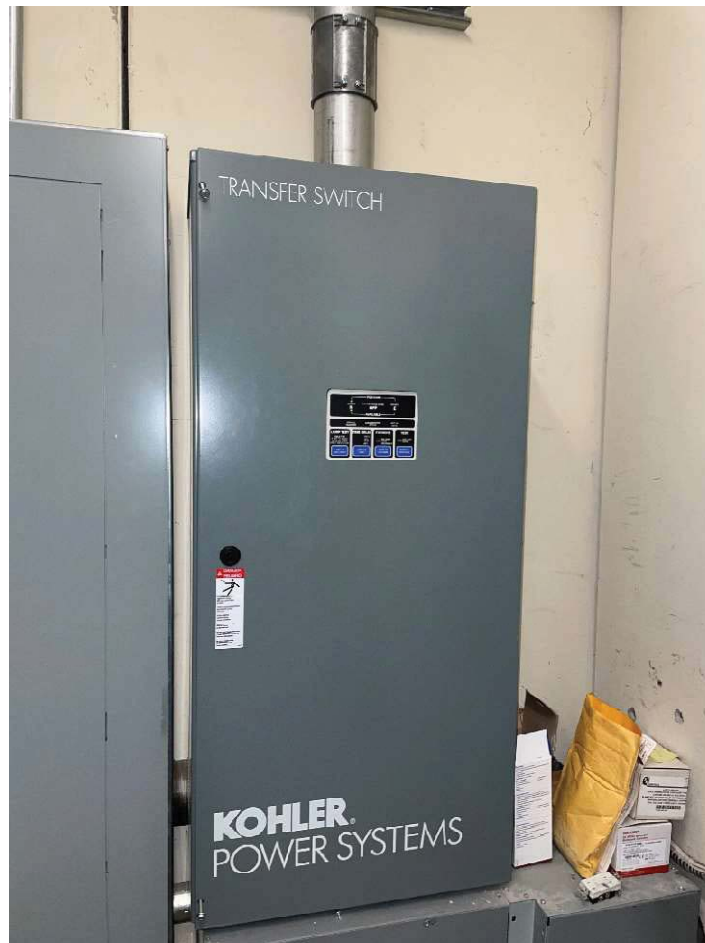
- 5) There is an existing transfer switch inside the first floor electrical room which is powering Panel Gen – 400A, 120/208V, 3PH 4W. Panel Gen is fed from the existing 1000A metering switchboard – Suite 101. Size of the backup generator is unknown. Q3 has not verified the size of the generator.

- a. Transfer switch – 400A, 120/208V, 3PH

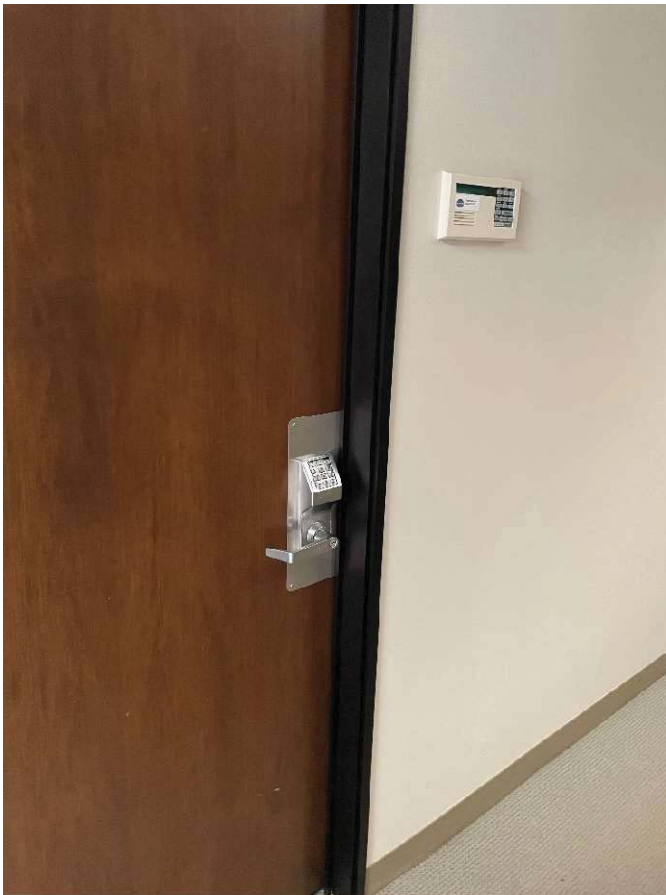
- 6) The electrical room on the 2<sup>nd</sup> floor was locked with passcodes, and Q3 could not gain access. At this point, we cannot verify if all the panels are in compliance with California Electrical Code.

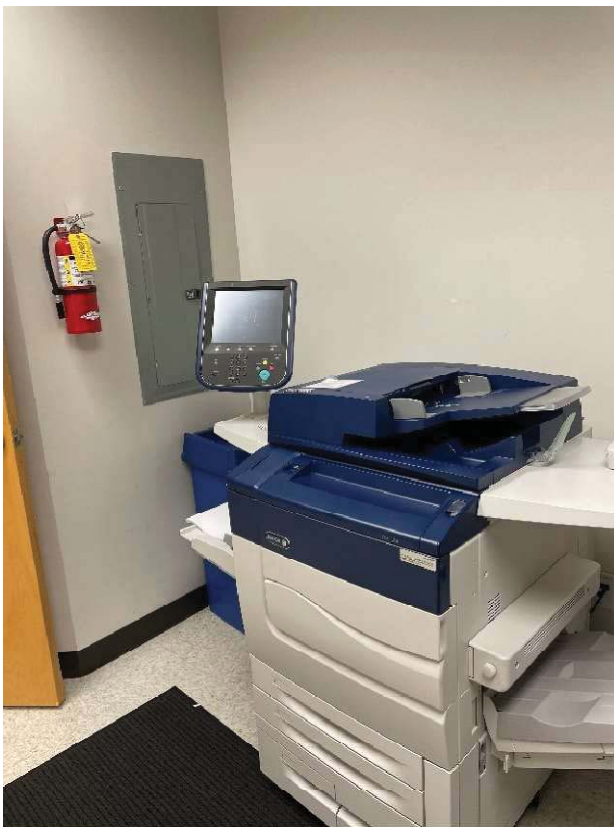
- 7) There is a 200A 120/208V 3Ph 4W panel “A” in the break room 215. The panel is in good condition. However, the panel needs minimum clearance 36” in front of the panel. Our recommendation is to relocate or shift the copy machine 36” away from the wall.

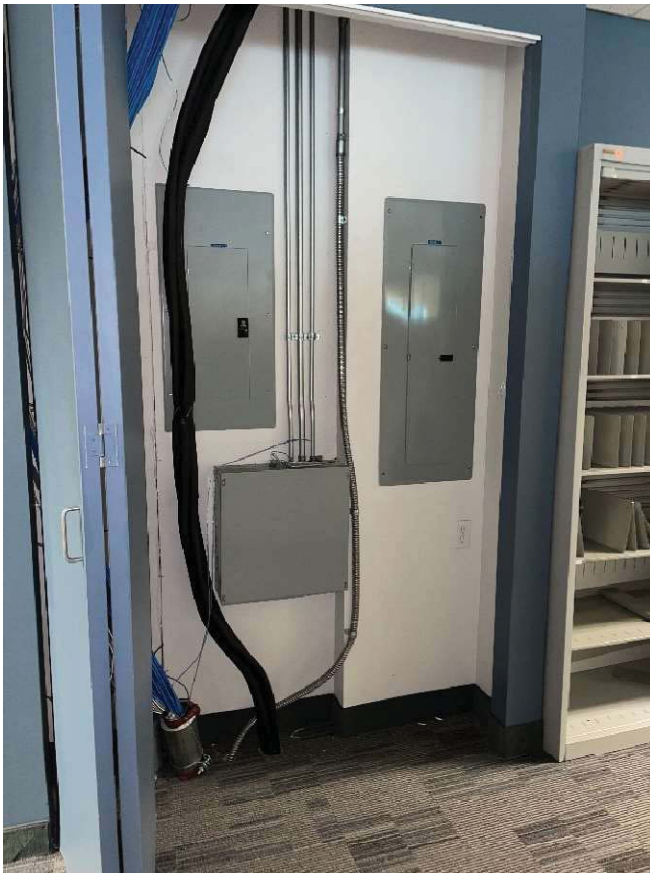
- 8) There are two electrical panels in the open office area of 2<sup>nd</sup> floor and they do comply with the 3ft clearance requirement. The panels seem to be in good condition.

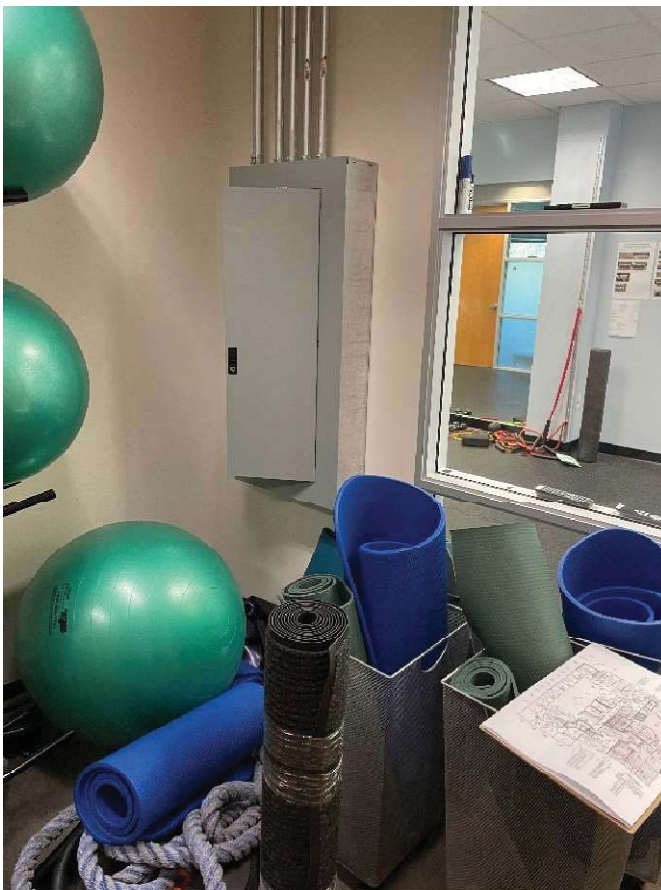
- 9) Panel "N" (225A 120/208V 3Ph 4W) located in the fitness room on the 2<sup>nd</sup> floor does not comply with the 3' clearance requirement. The panel appears to be in good condition. Our recommendaiton is to move all the items in front of the electrical panel to provide a 3' clearance.

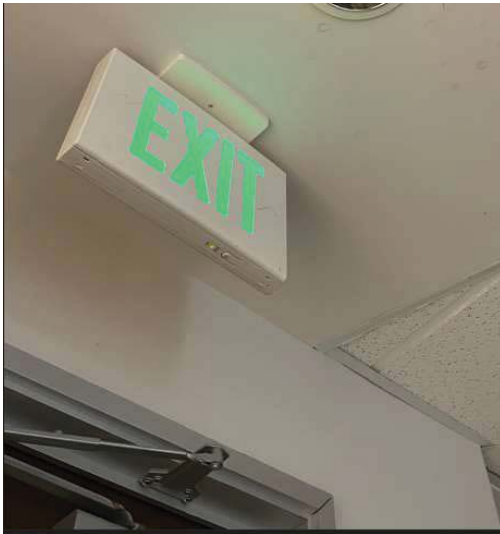
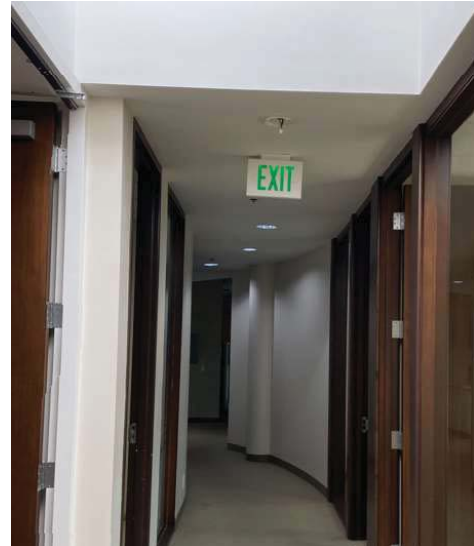
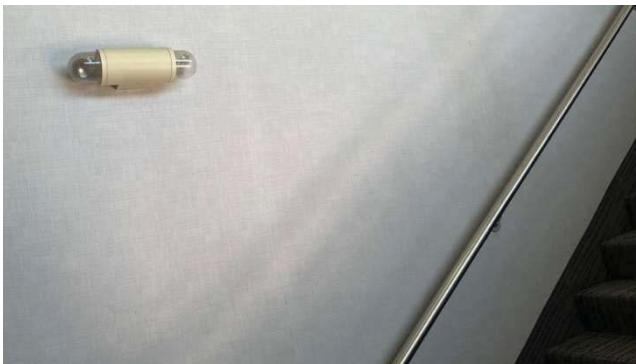
The building has exit signs at the exits and the hallways. There are bugeyes in the facility however we did not see many bugeyes in the facility. We believe the current light level along the path of egress will not comply with the current code requirement of 1 Footcandle. Our recommendation is to clearly define the path of egress and add additional bug eye light fixtures.

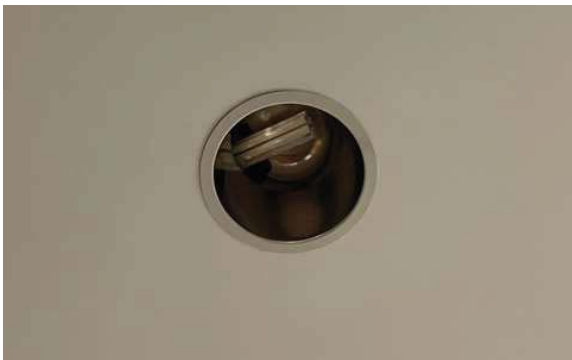
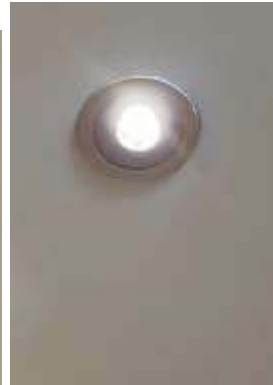
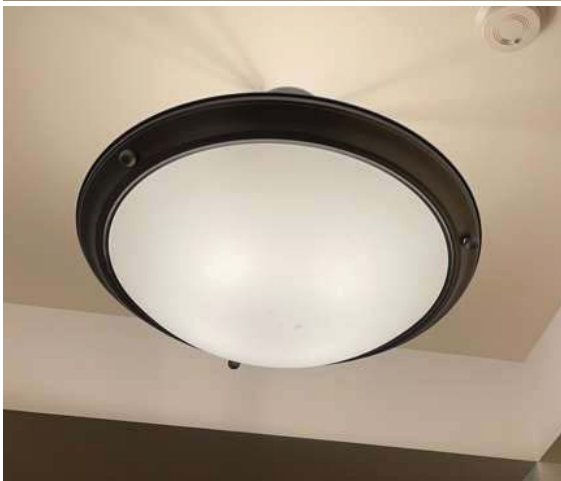
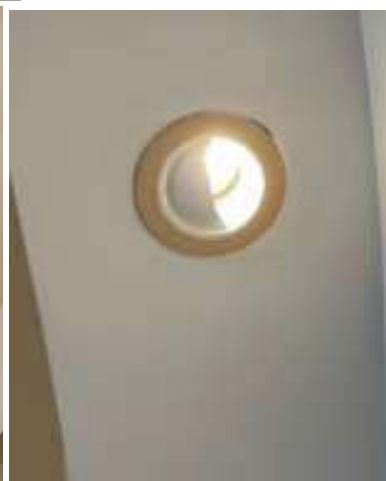
Compact fluorescent fixtures and MR16 can lights are installed in the lobby areas, conference rooms, and hallways. There are no partial-off vacancy sensor controls in the hallway. Our recommendation to bring this facility up to Title 24 Interior lighting compliance is to add in occupancy sensors for additional controls.

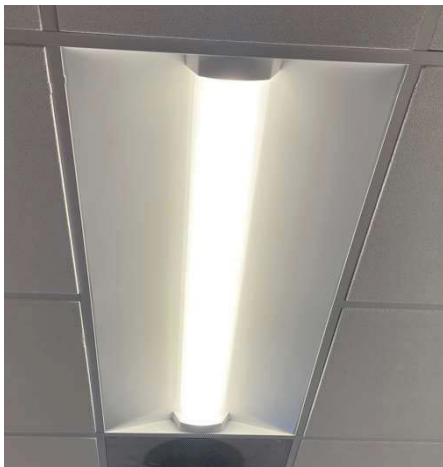
The kitchen area is equipped with 2x4 recessed LED fixtures.

Our recommendations for the interior office lighting are to replace all fluorescent lamp fixtures with new LED fixtures and to install proper controls using occupancy and photocell sensors

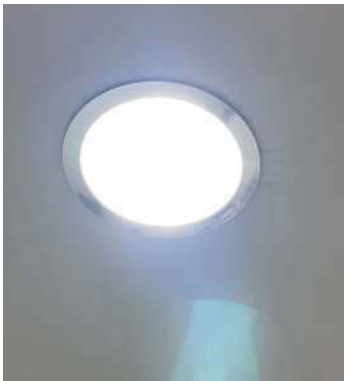
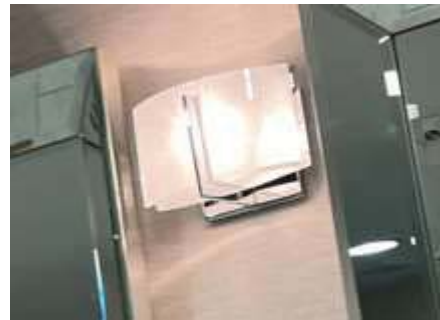
Compact fluorescent fixtures and wall sconces are used in the big restrooms in the middle of the floor.

Overall, most of the fixtures on the 1<sup>st</sup> floor are equipped with T8 and compact fluorescents lamps. Q3 recommends to upgrade to LED fixtures with daylighting and occupancy sensor controls.

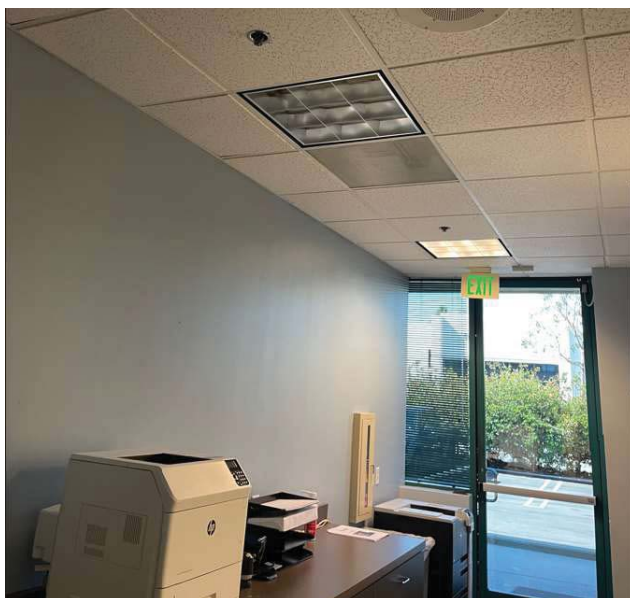
We also observed some non-operating fixtures in the building. Q3 recommends replacing these fixtures.

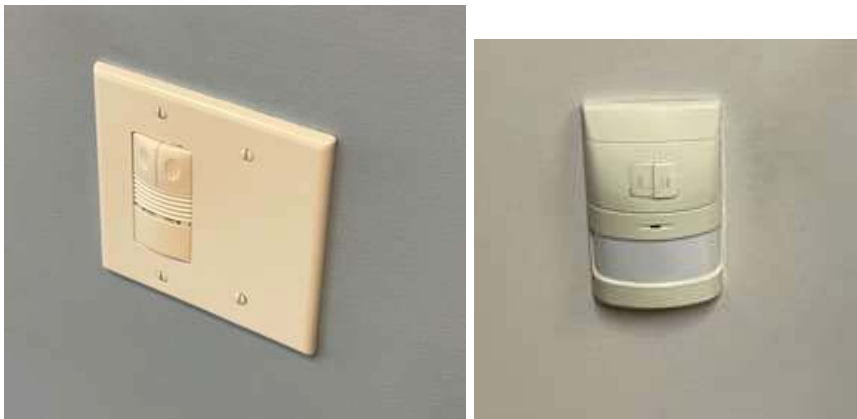
Some small offices are equipped with on/off switches with occupancy sensor and step dimmer. Step dimmer is set at 30/60/100% level. There are no daylighting controls. Q3 recommends installing photocell sensors to comply with current Title 24 Standards.

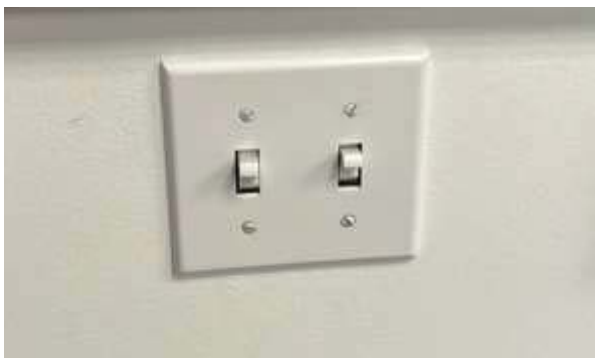
Some other areas such as the conference rooms are only equipped with on/off switches without occupancy sensor and dimmer. Q3 Recommends occupancy and photocell sensors to be installed in order to comply with current Title 24 Standards.

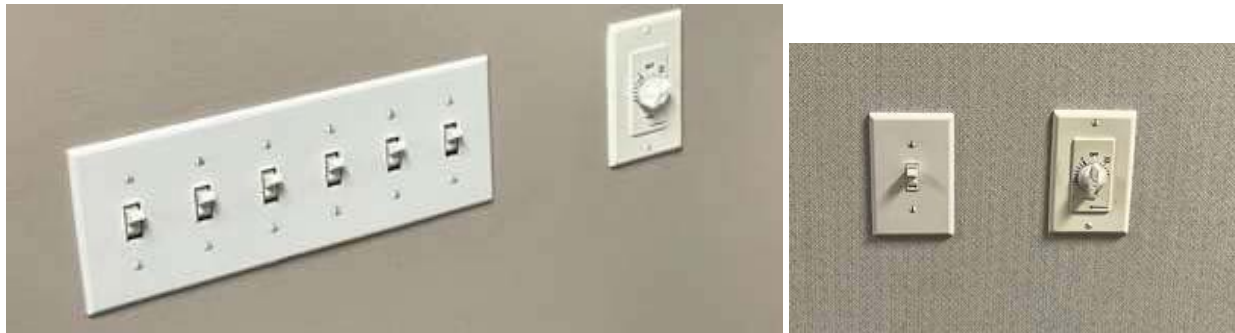
Open offices are equipped with time clock and on/off switches only. There are no daylighting controls. Q3 Recommends occupancy and photocell sensors to be installed in order to comply with current Title 24 Standards.

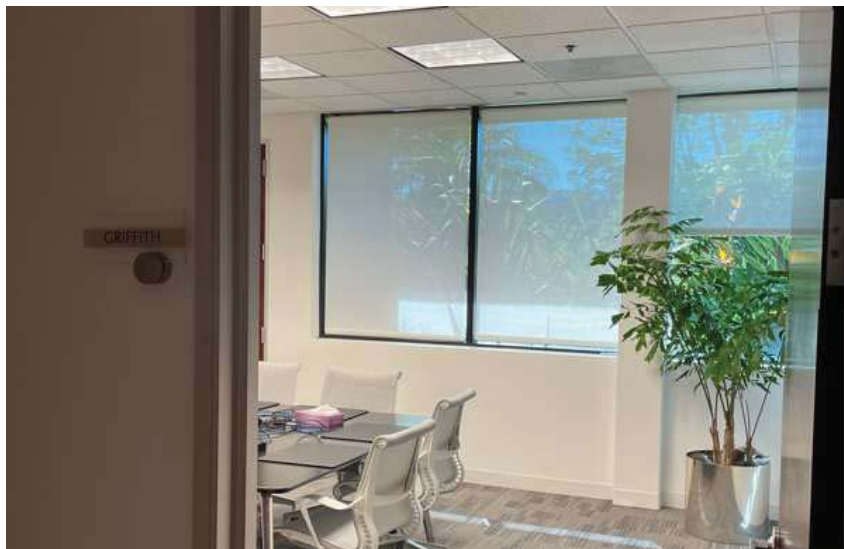
The building is surrounded by glass windows and there is no sign of any photocell sensors controls. Q3 recommends installing photocell sensors to comply with current Title 24 Standards.

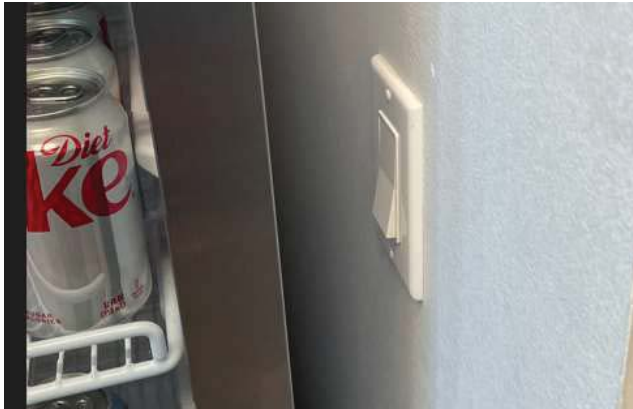
In the kitchen/break room area, recessed 2x4 LED fixtures are controlled by on/off switch. Q3 Recommends occupancy and photocell sensors to be installed in order to comply with current Title 24 Standards

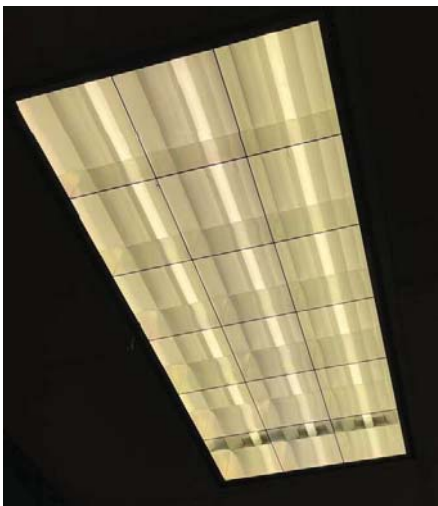
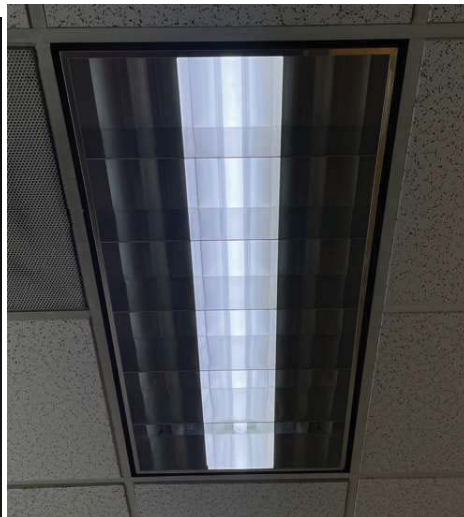
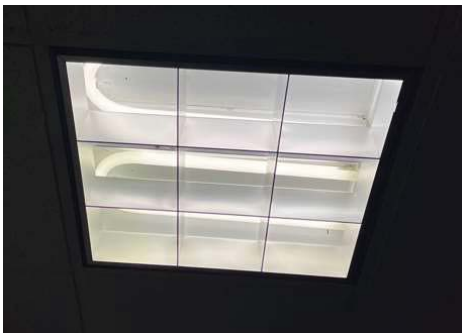
Fixtures with 3 – T8 lamps are typical for all the office areas. Some office areas have T12 lamps in addition to T8 Lamps. Q3 recommend to upgrade to LED fixtures since T8 and T12 wattages are high and will not comply with current Title 24 standards. Q3 also recommends occupancy and photocell sensors to be installed in order to comply with current Title 24 Standards.

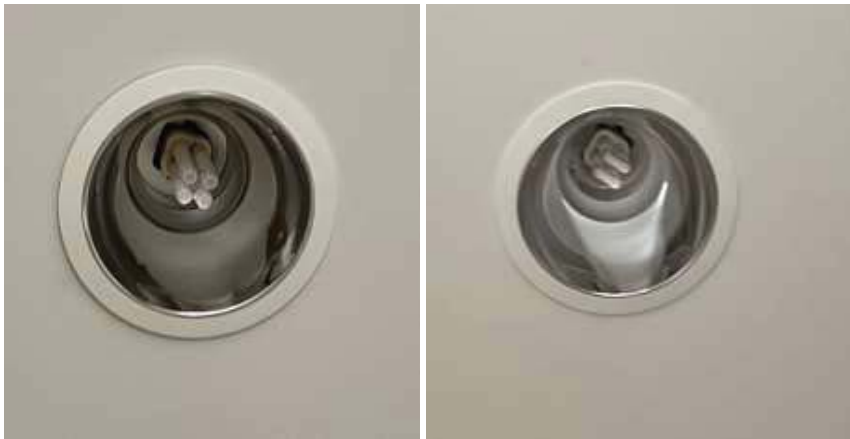
Compact fluorescent fixtures are used in some corridor and break room areas. There does not appear to be any daylighting controls. Q3 recommends installing photocell sensors to comply with current Title 24 Standards.

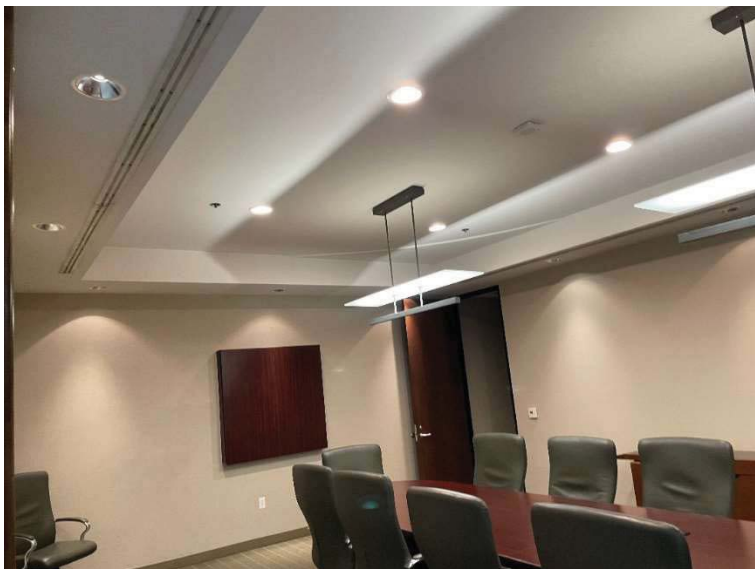
The conference room is equipped with some retrofit LED fixtures, MR16 can lights, and pendant indirect fixtures. There does not appear to be any occupancy sensor controls. Q3 recommends installing occupancy sensors to comply with current Title 24 Standards.

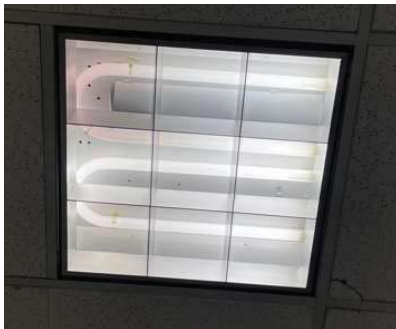
Q3 observed some fixtures with different color temperature lamps. Q3 recommends lamps of the same color temperature to be installed.

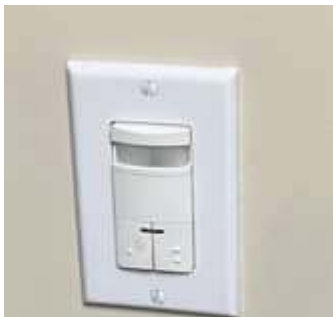
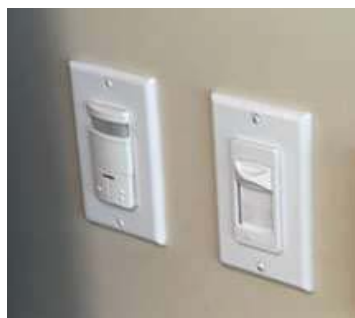
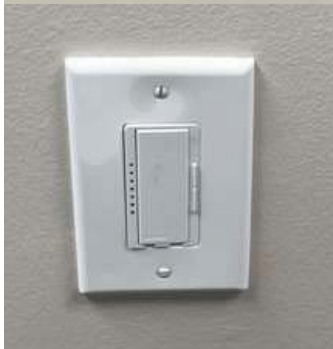
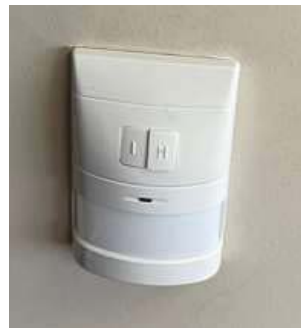
Most of the small offices are equipped with on/off switch with occupancy sensor and step dimmer. Step dimmer is set at 30/60/100%. 7-level step dimmer is found in some corridors. There are no partial-off vacancy sensor in all corridors. Some areas have continuous dimmers. Q3 recommends occupancy and photocell sensors to be installed in order to comply with current Title 24 Standards.

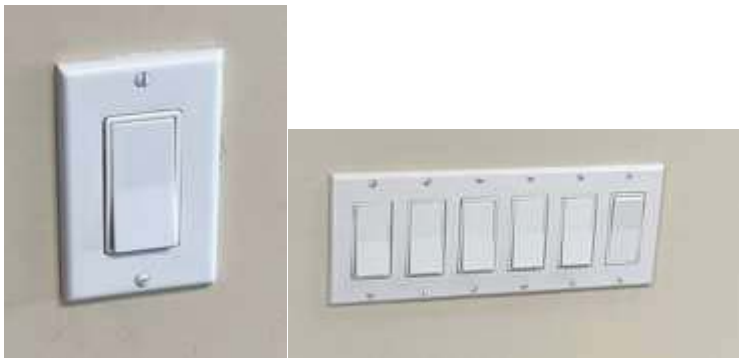
On/off switch only is used in some small rooms like storages or small offices. The big open office area in the middle of the 2<sup>nd</sup> floor is equipped with on/off switch only with no sensor/time clock. Q3 recommends occupancy sensors to be installed in order to comply with current Title 24 Standards.
