October 31, 2022

Tim Cottage | Project Manager  
Hilco Development Services  
1707 E 28<sup>th</sup> Street, Suite B  
Signal Hill, CA 90755

Re: 200 Baker – Due Diligence Survey  
200 E Baker St, Costa Mesa, CA 92626  
Review of Existing Structure and Site  
RSG Job #22-1-070.00

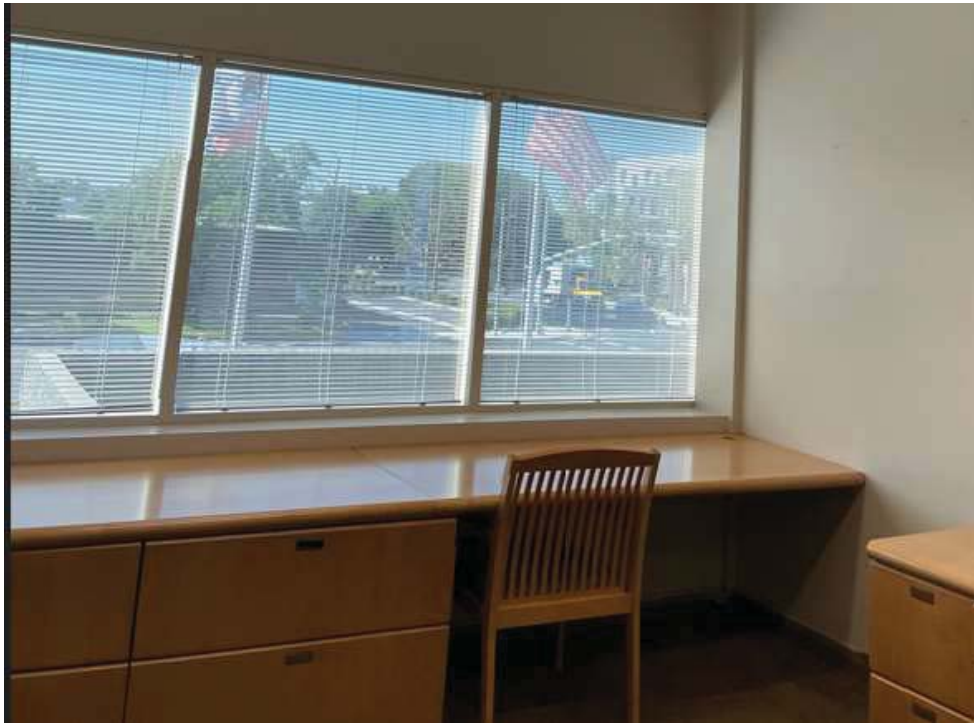
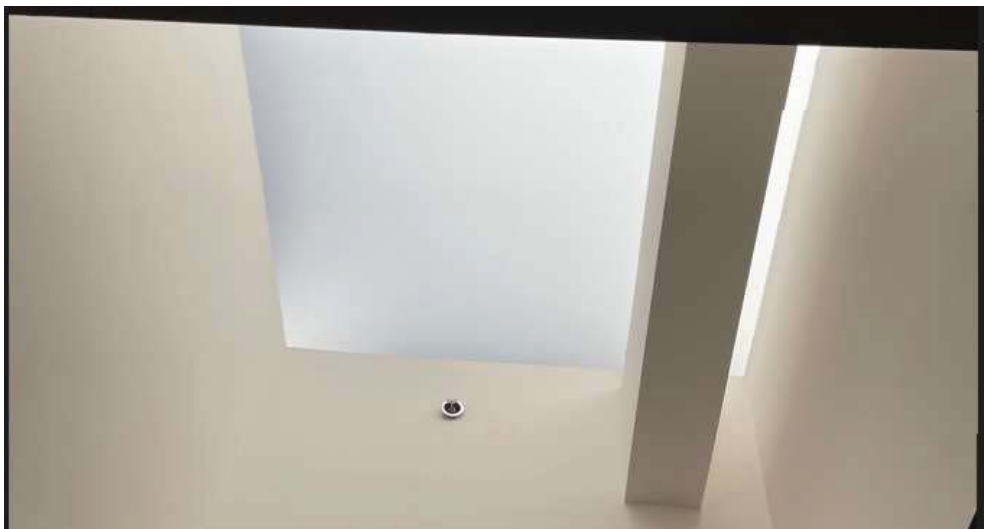
There are (3) skylights on the second floor, and most of rooms have windows. However, there is no photocell sensor for daylight zones. Q3 also recommends photocell sensors to be installed in order to comply with current Title 24 Standards.

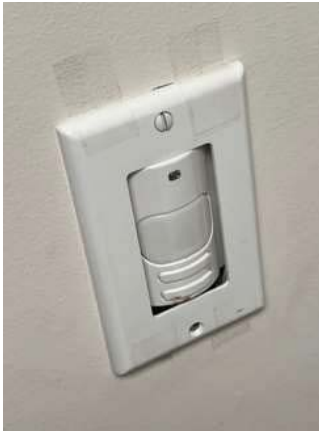
Q3 observed a few non-working occupancy sensor switches. The switches do work, however it appears the occupancy sensors are not working. We observed this condition in rooms 252, 255, 214, 206, 204, 203. Q3 recommends replacing these switches.

Some switch plates have tape on them. Q3 recommends replacing the switch plate.

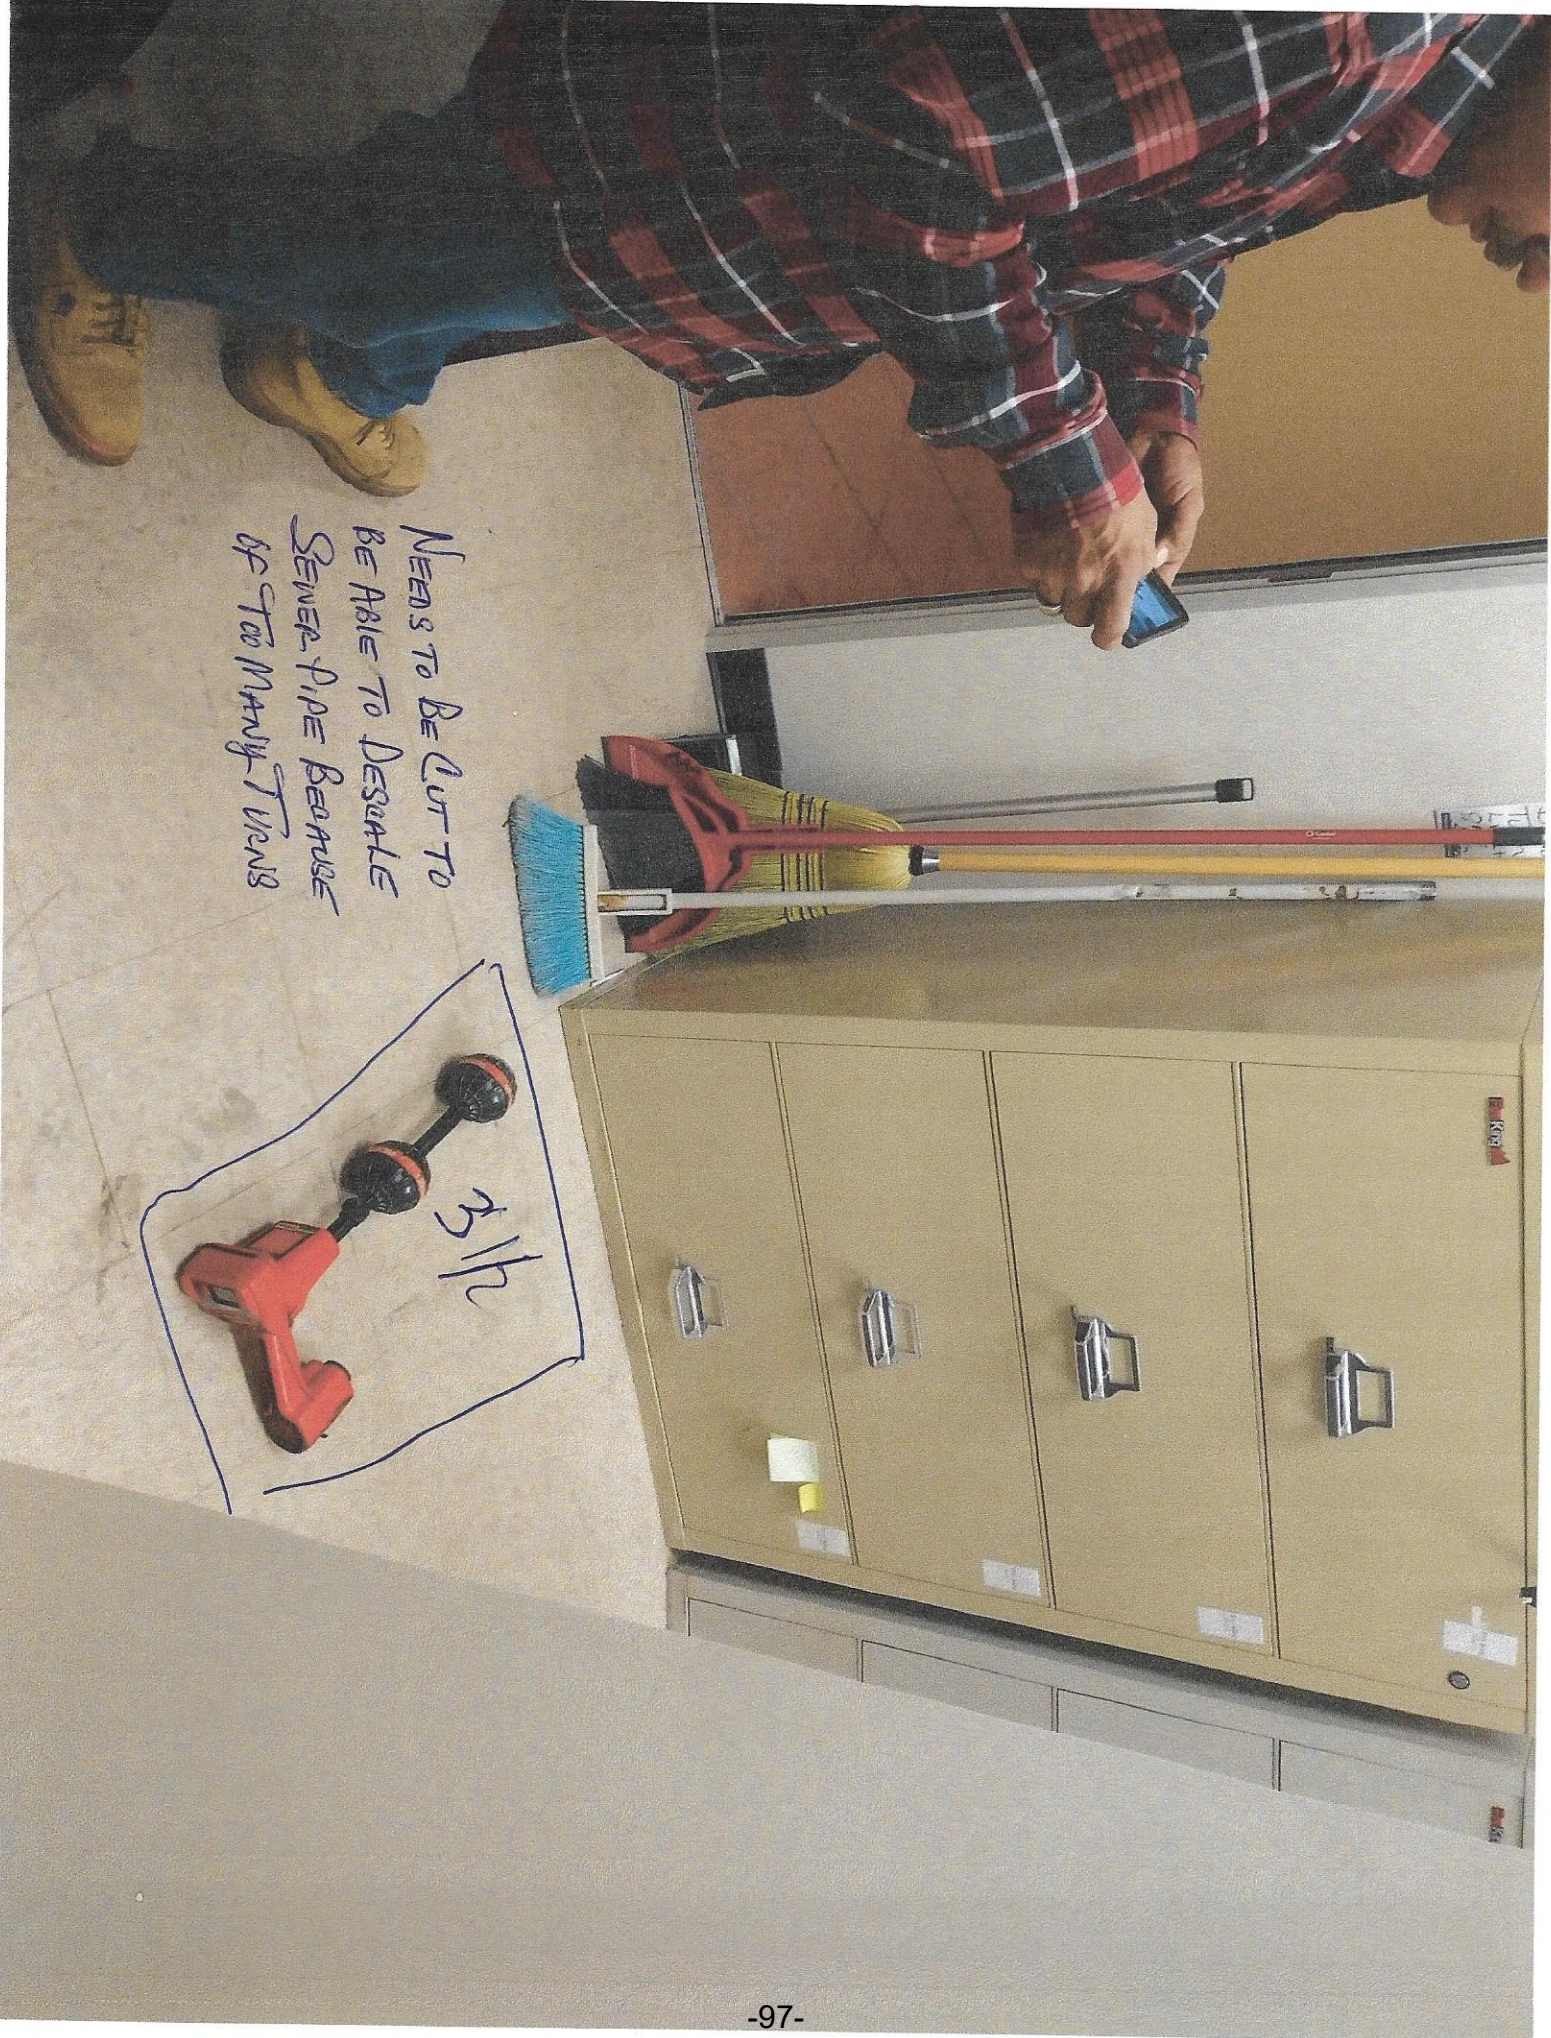
6' DEEP AREA 1 1/2" SHIFT  
SEWER MAIN

NEEDS TO BE CUT TO  
BE ABLE TO DESCALE  
SEWER PIPE BECAUSE  
OF TOO MANY TURNS
