CITY OF COSTA MESA
PARKS AND COMMUNITY SERVICES COMMISSION
Agenda

PARK ASSESSMENT

2025

Park Assessments were conducted at all public parks within the City of Costa Mesa and have been documented herein. The report identifies physical condition of amenities, structures, pathways, playgrounds, and existing program elements in each park. This parks assessment is essential for the City of Costa Mesa in identifying and prioritizing improvements, allowing for safe, functional and enjoyable spaces for the community to recreate and enjoy.

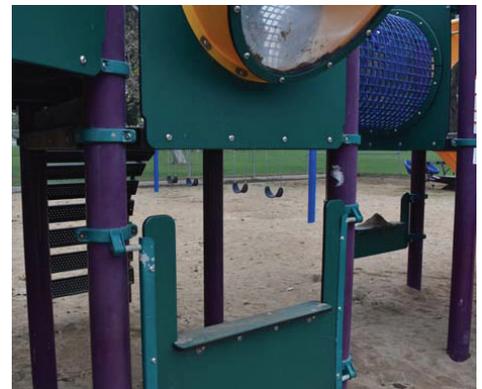
(Figure 1.06)

Figure 1.05, 1.06 - Dirt/mold growth on the slide. Powder coating is damaged and worn off on posts, caps, and components.
