Re: 200 Baker – Due Diligence Survey
200 E Baker St, Costa Mesa, CA 92626
Review of Existing Structure and Site
RSG Job #22-1-070.00

The purpose of this letter is to address our observations of the existing building and site located at 200 East Baker Street in Costa Mesa, CA. Regal Structural Group visited the site on October 18, 2022 and performed a non-destructive observation of the interiors, exteriors, and roof of the building and the site. As-built drawings were not available for our review.

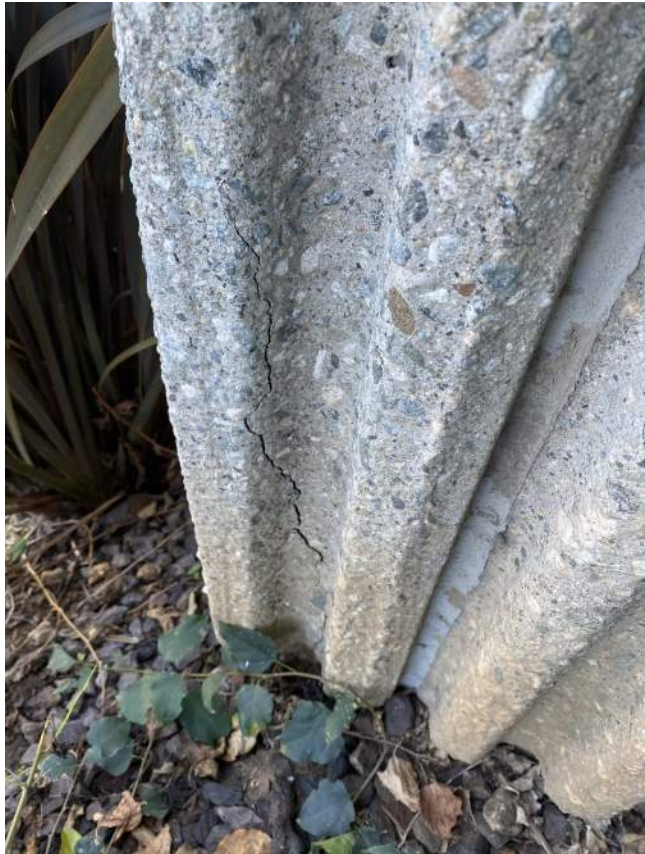
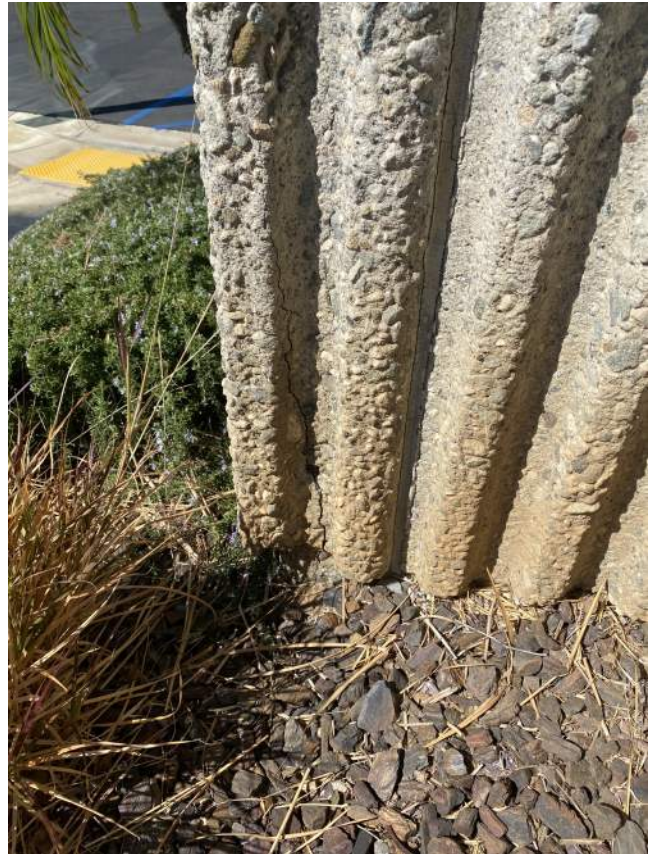
3. *Walls:*
Exterior tilt-up walls appeared to be in good condition. Minimal cracking was observed in the walls. Cracking was observed in some locations at base near walls ends which is typical for areas where holdowns/tiedowns and areas of added reinforcing are present. Minor cracking was also observed where tilt-up concrete lintels bear on tilt-up bearing walls. We believe this to be a lack of trim-bar reinforcing in the wall and does not present an immediate cause for concern in the structure. Interior walls consisted of non-bearing metal stud partition walls. Partition walls at the offices were partial height and appeared to be adequately braced for lateral loading. Corridor walls and walls at the stairways were full height to maintain their fire rating. In general, the interior walls were in good condition.

FIG 11: MINOR CRACKING / SPAWLING IN EXISTING TILT-UP WALL

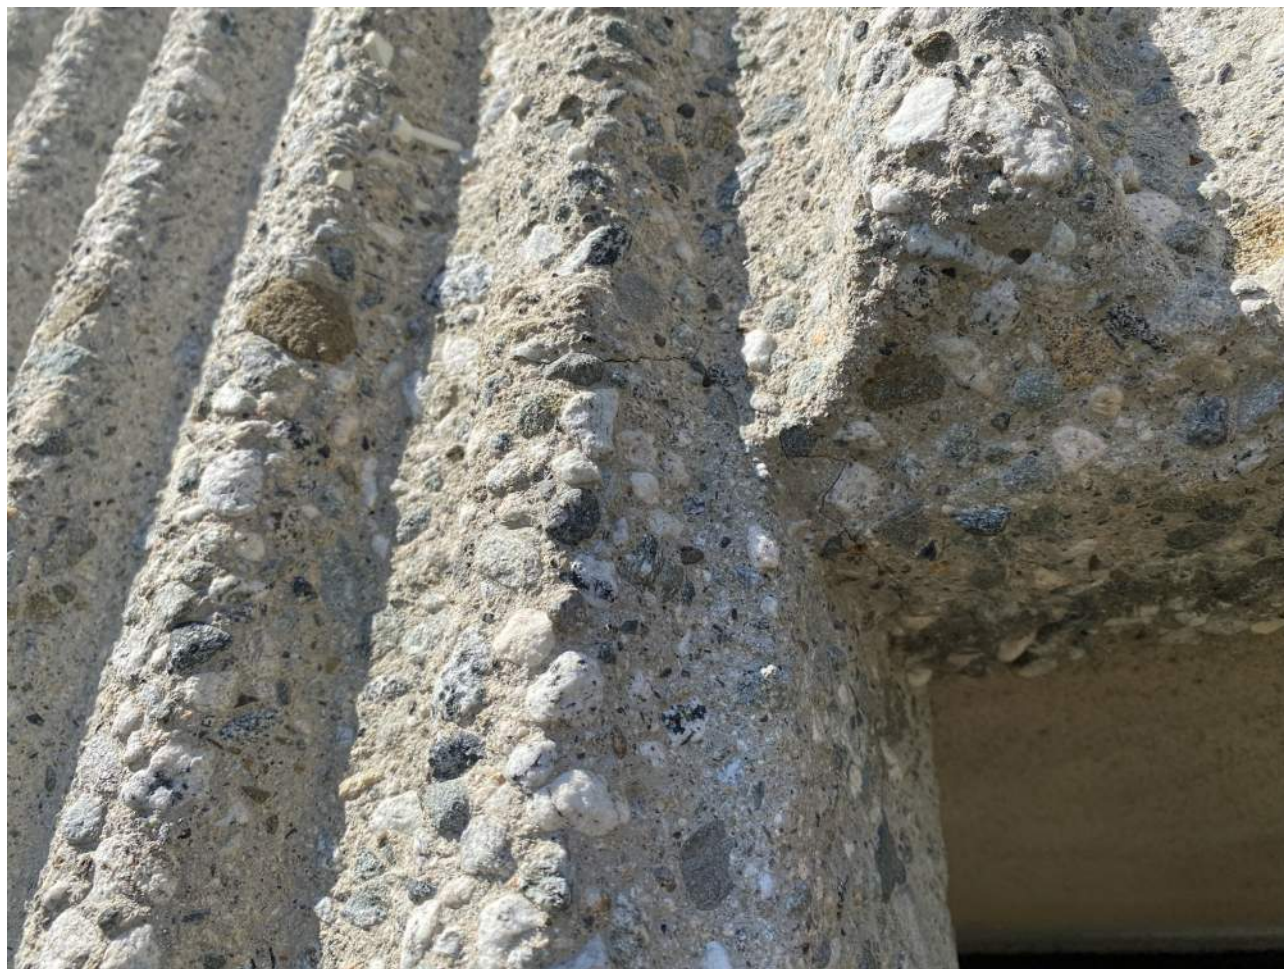
FIG 12: MINOR CRACKING IN CONCRETE TILT-UP LINTEL TO WALL

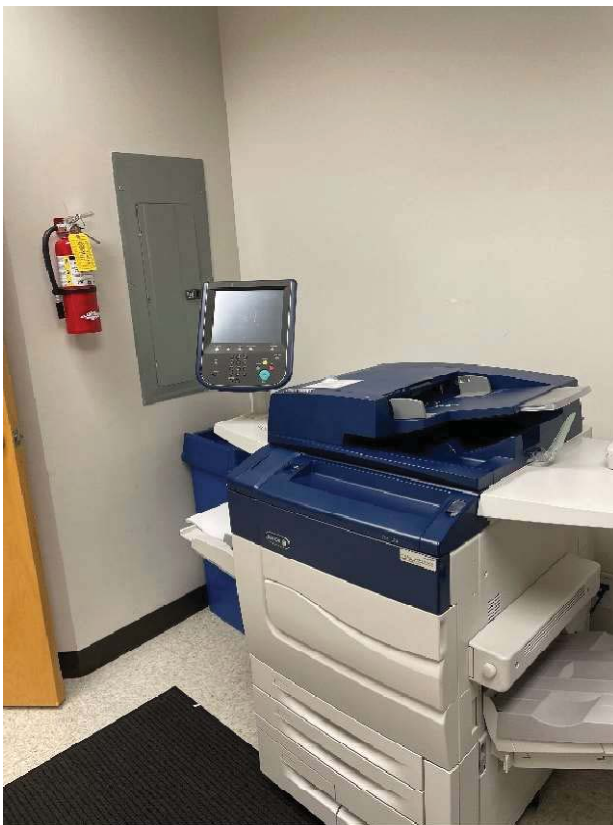
- 7) There is a 200A 120/208V 3Ph 4W panel "A" in the break room 215. The panel is in good condition. However, the panel needs minimum clearance 36" in front of the panel. Our recommendation is to relocate or shift the copy machine 36" away from the wall.

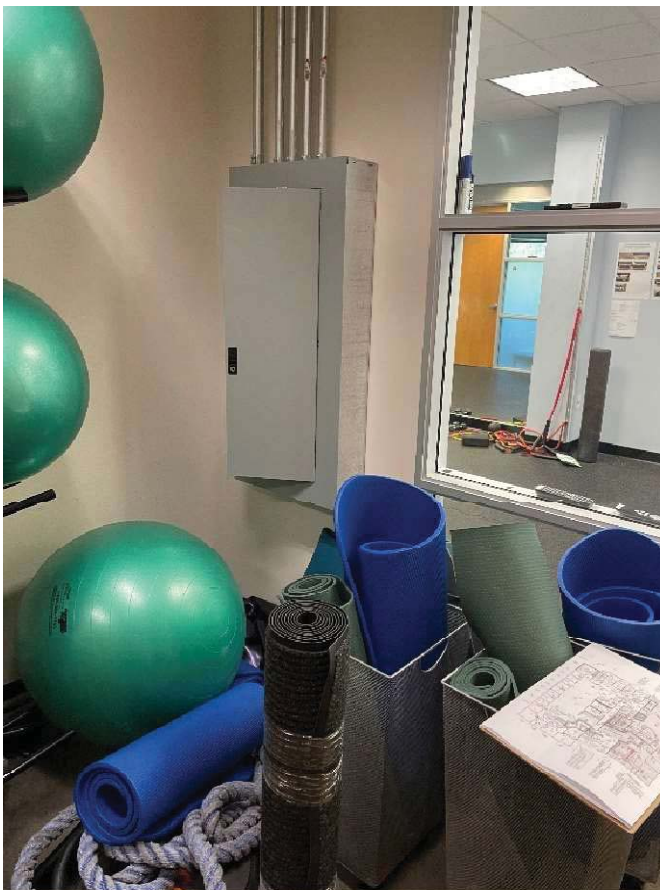
- 9) Panel "N" (225A 120/208V 3Ph 4W) located in the fitness room on the 2nd floor does not comply with the 3' clearance requirement. The panel appears to be in good condition. Our recommendation is to move all the items in front of the electrical panel to provide a 3' clearance.

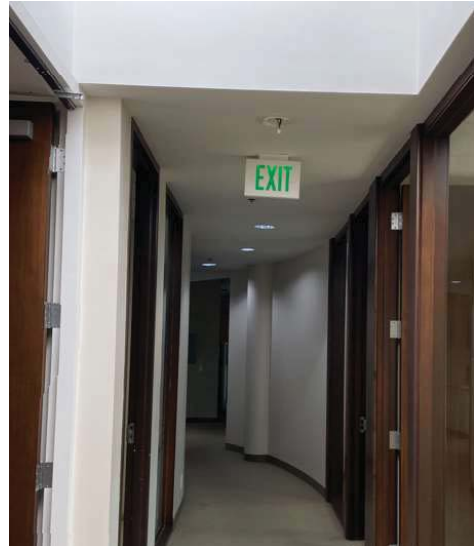
1. Exit signs/ Bugeyes (1st and 2nd Floors)

The building has exit signs at the exits and the hallways. There are bugeyes in the facility however we did not see many bugeyes in the facility. We believe the current light level along the path of egress will not comply with the current code requirement of 1 Footcandle. Our recommendation is to clearly define the path of egress and add additional bug eye light fixtures.

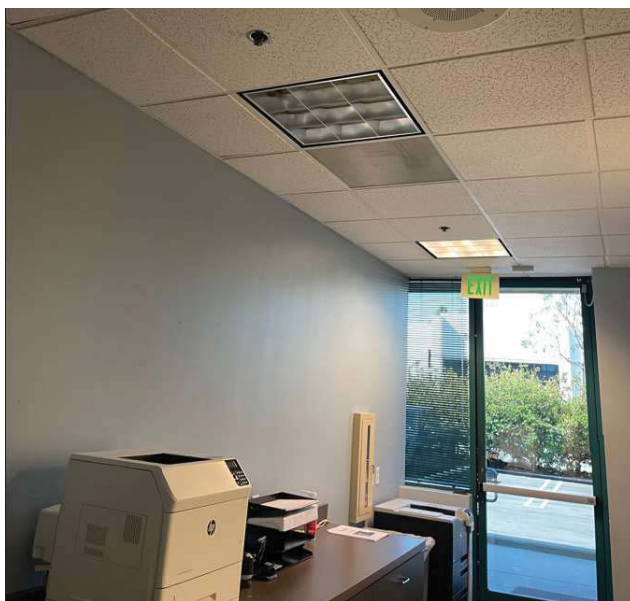
We also observed some non-operating fixtures in the building. Q3 recommends replacing these fixtures.

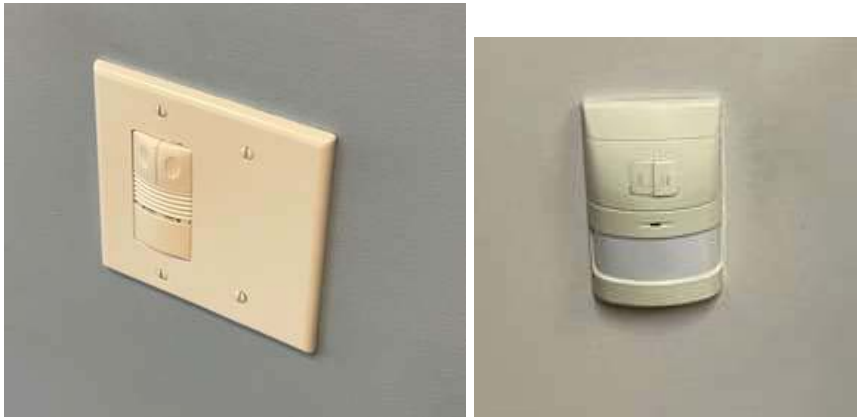
Some small offices are equipped with on/off switches with occupancy sensor and step dimmer. Step dimmer is set at 30/60/100% level. There are no daylighting controls. Q3 recommends installing photocell sensors to comply with current Title 24 Standards.

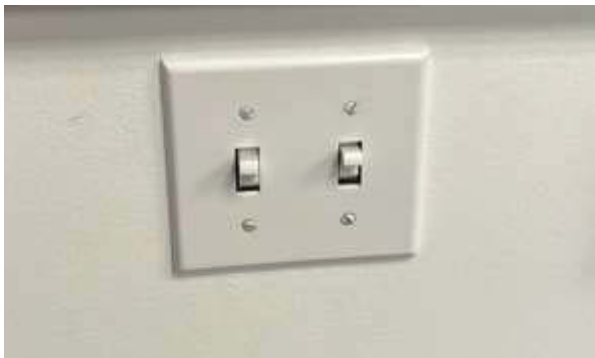
Some other areas such as the conference rooms are only equipped with on/off switches without occupancy sensor and dimmer. Q3 Recommends occupancy and photocell sensors to be installed in order to comply with current Title 24 Standards.

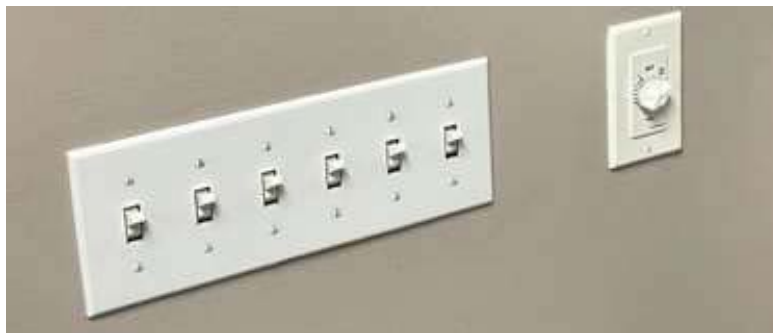
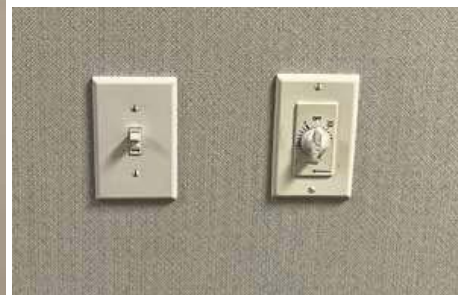
Open offices are equipped with time clock and on/off switches only. There are no daylighting controls. Q3 Recommends occupancy and photocell sensors to be installed in order to comply with current Title 24 Standards.

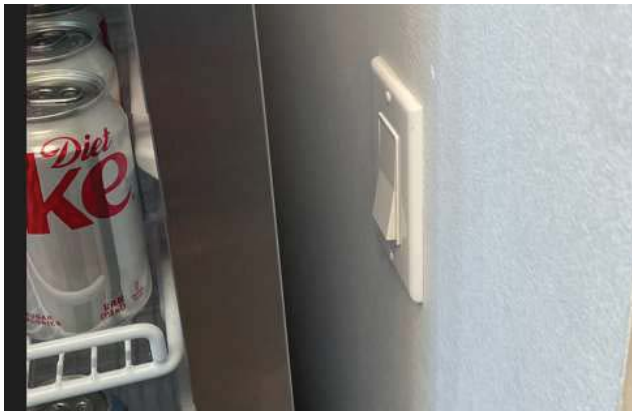
In the kitchen/break room area, recessed 2x4 LED fixtures are controlled by on/off switch. Q3 Recommends occupancy and photocell sensors to be installed in order to comply with current Title 24 Standards

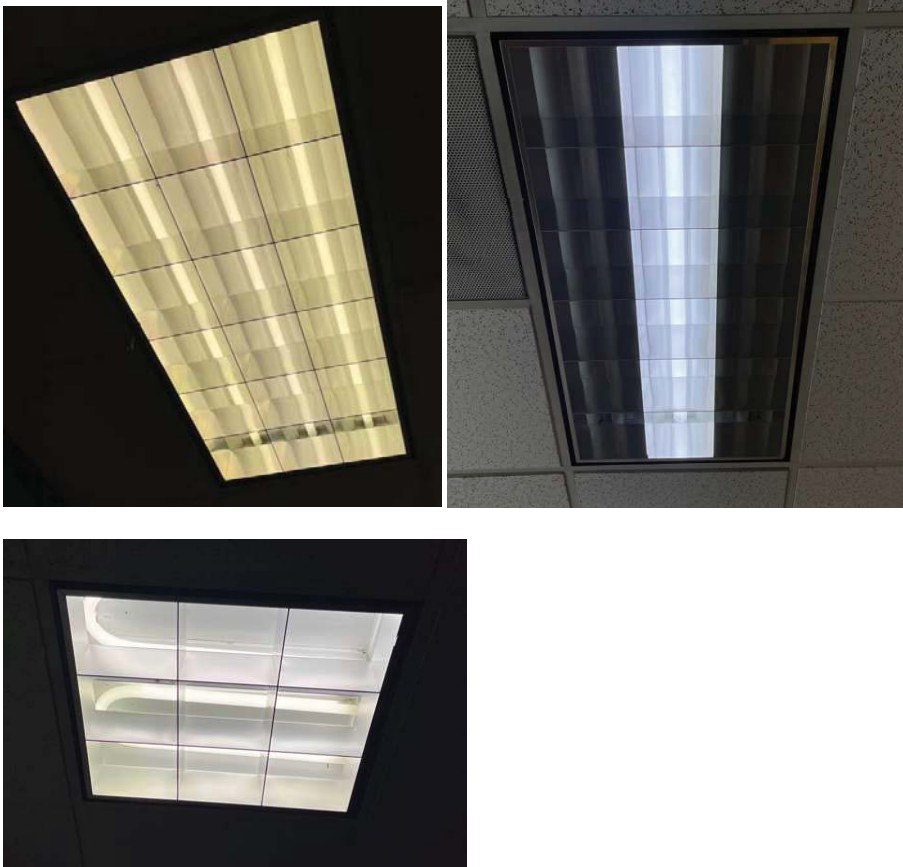
Fixtures with 3 – T8 lamps are typical for all the office areas. Some office areas have T12 lamps in addition to T8 Lamps. Q3 recommend to upgrade to LED fixtures since T8 and T12 wattages are high and will not comply with current Title 24 standards. Q3 also recommends occupancy and photocell sensors to be installed in order to comply with current Title 24 Standards.

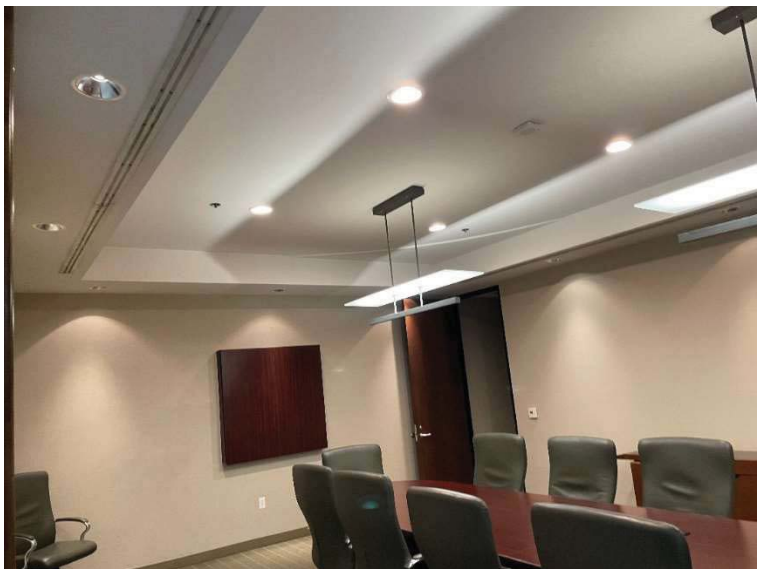
The conference room is equipped with some retrofit LED fixtures, MR16 can lights, and pendant indirect fixtures. There does not appear to be any occupancy sensor controls. Q3 recommends installing occupancy sensors to comply with current Title 24 Standards.

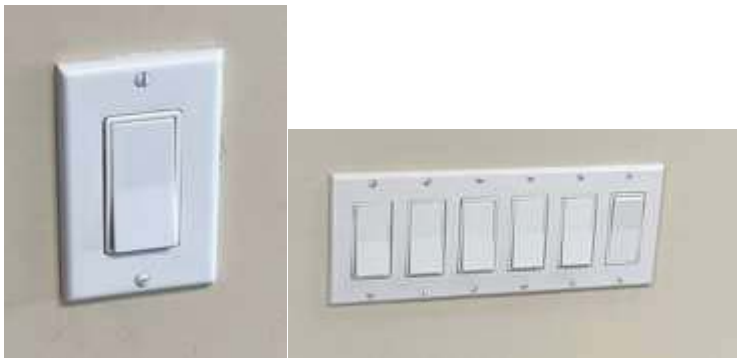
On/off switch only is used in some small rooms like storages or small offices. The big open office area in the middle of the 2nd floor is equipped with on/off switch only with no sensor/time clock. Q3 recommends occupancy sensors to be installed in order to comply with current Title 24 Standards.

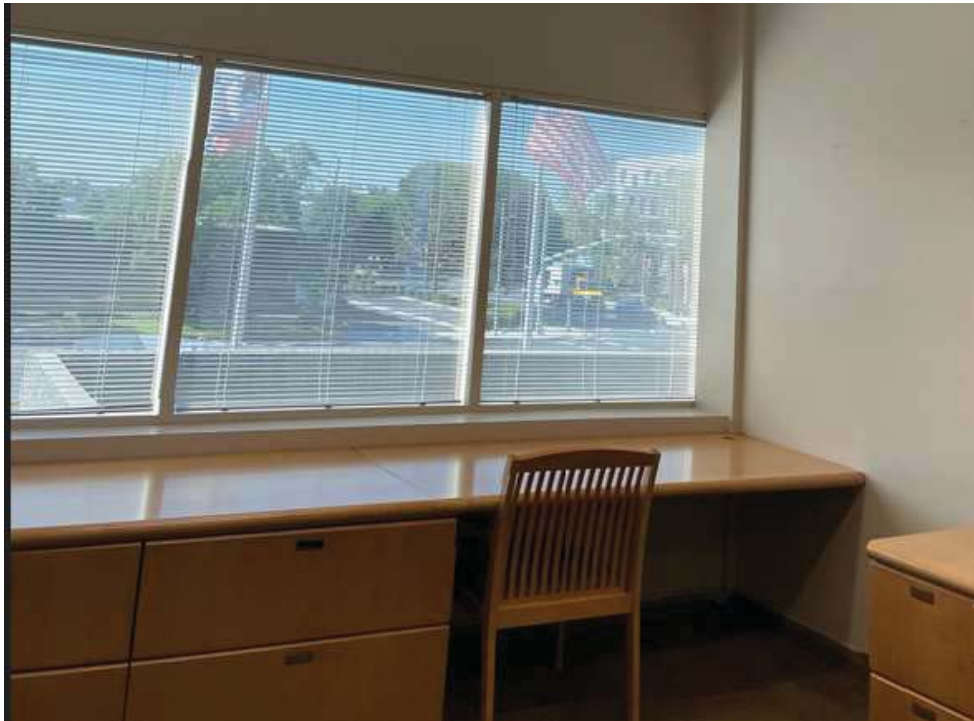
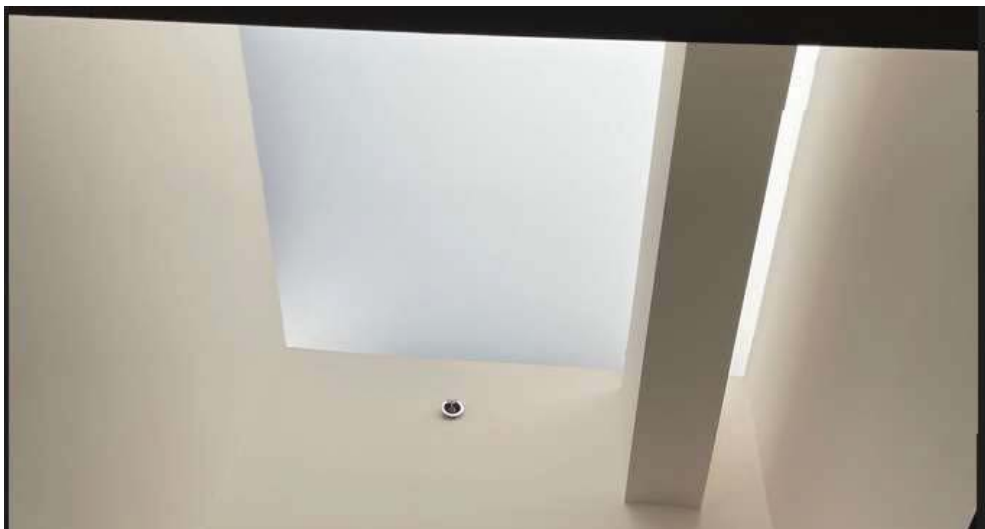
There are (3) skylights on the second floor, and most of rooms have windows. However, there is no photocell sensor for daylight zones. Q3 also recommends photocell sensors to be installed in order to comply with current Title 24 Standards.

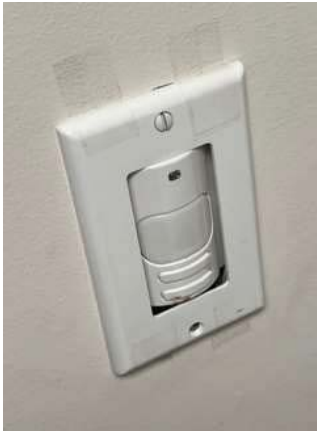
Some switch plates have tape on them. Q3 recommends replacing the switch plate.

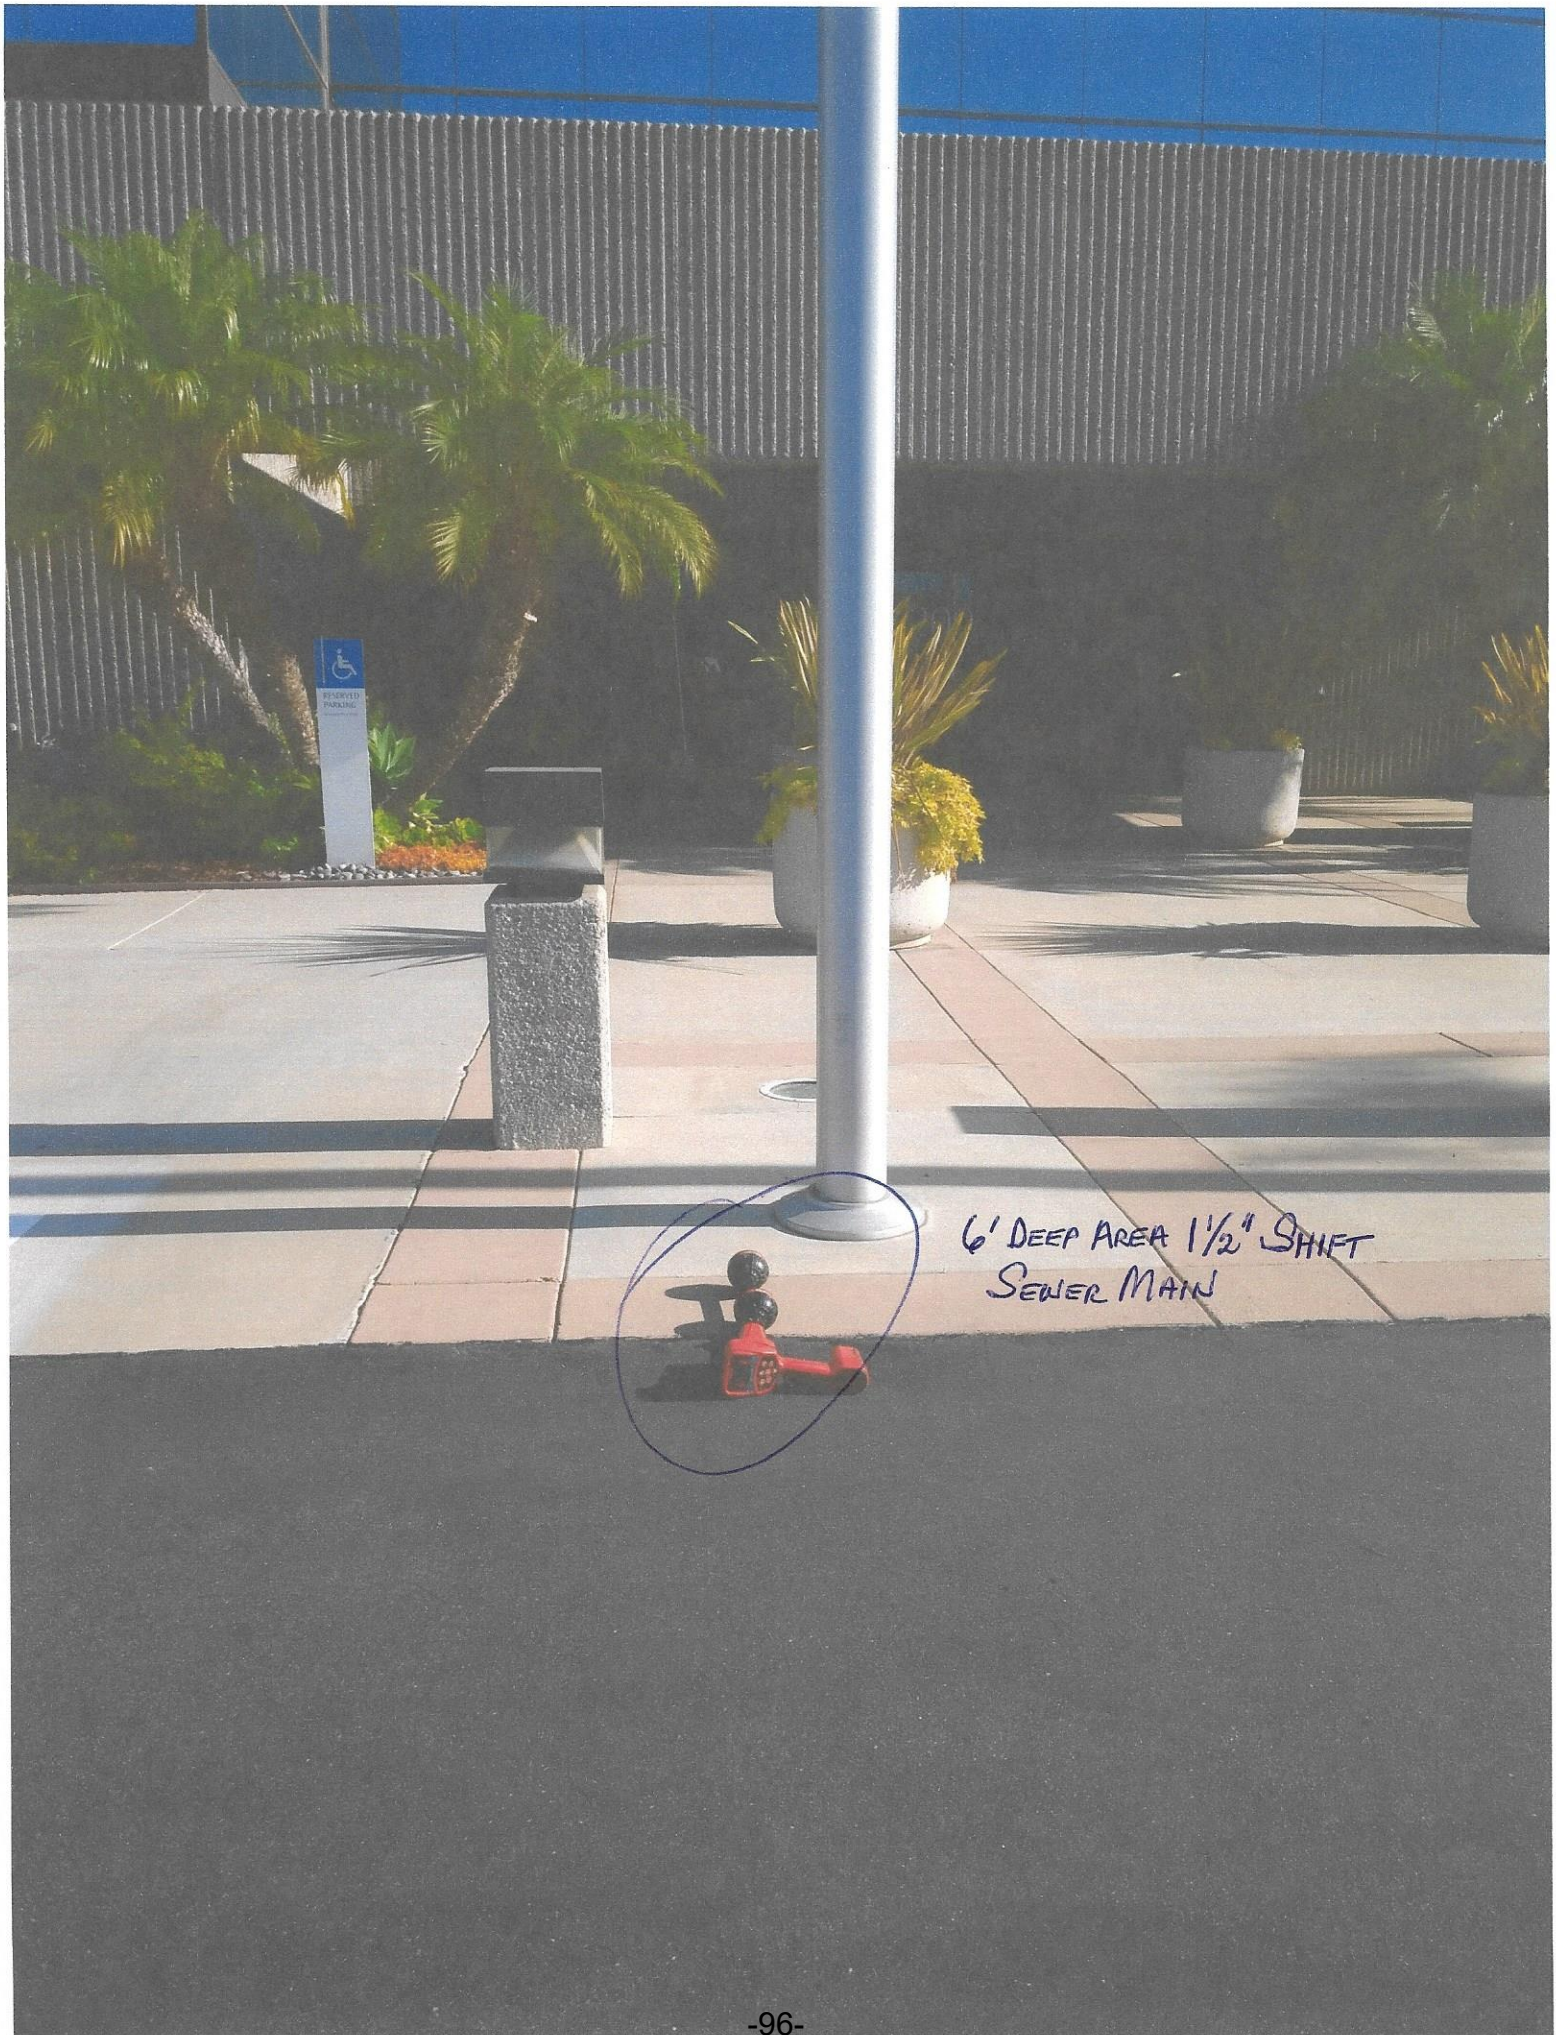
NEEDS TO BE CUT TO
BE ABLE TO DESCALE
SEWER PIPE BECAUSE
OF TOO MANY TURNS
