June 28, 2024

Re: 660 Baker St – Structural Due Diligence Survey  
660 Baker Street, Costa Mesa, CA 92626  
Review of Existing Structure and Site  
RSG Job #24-1-070.00

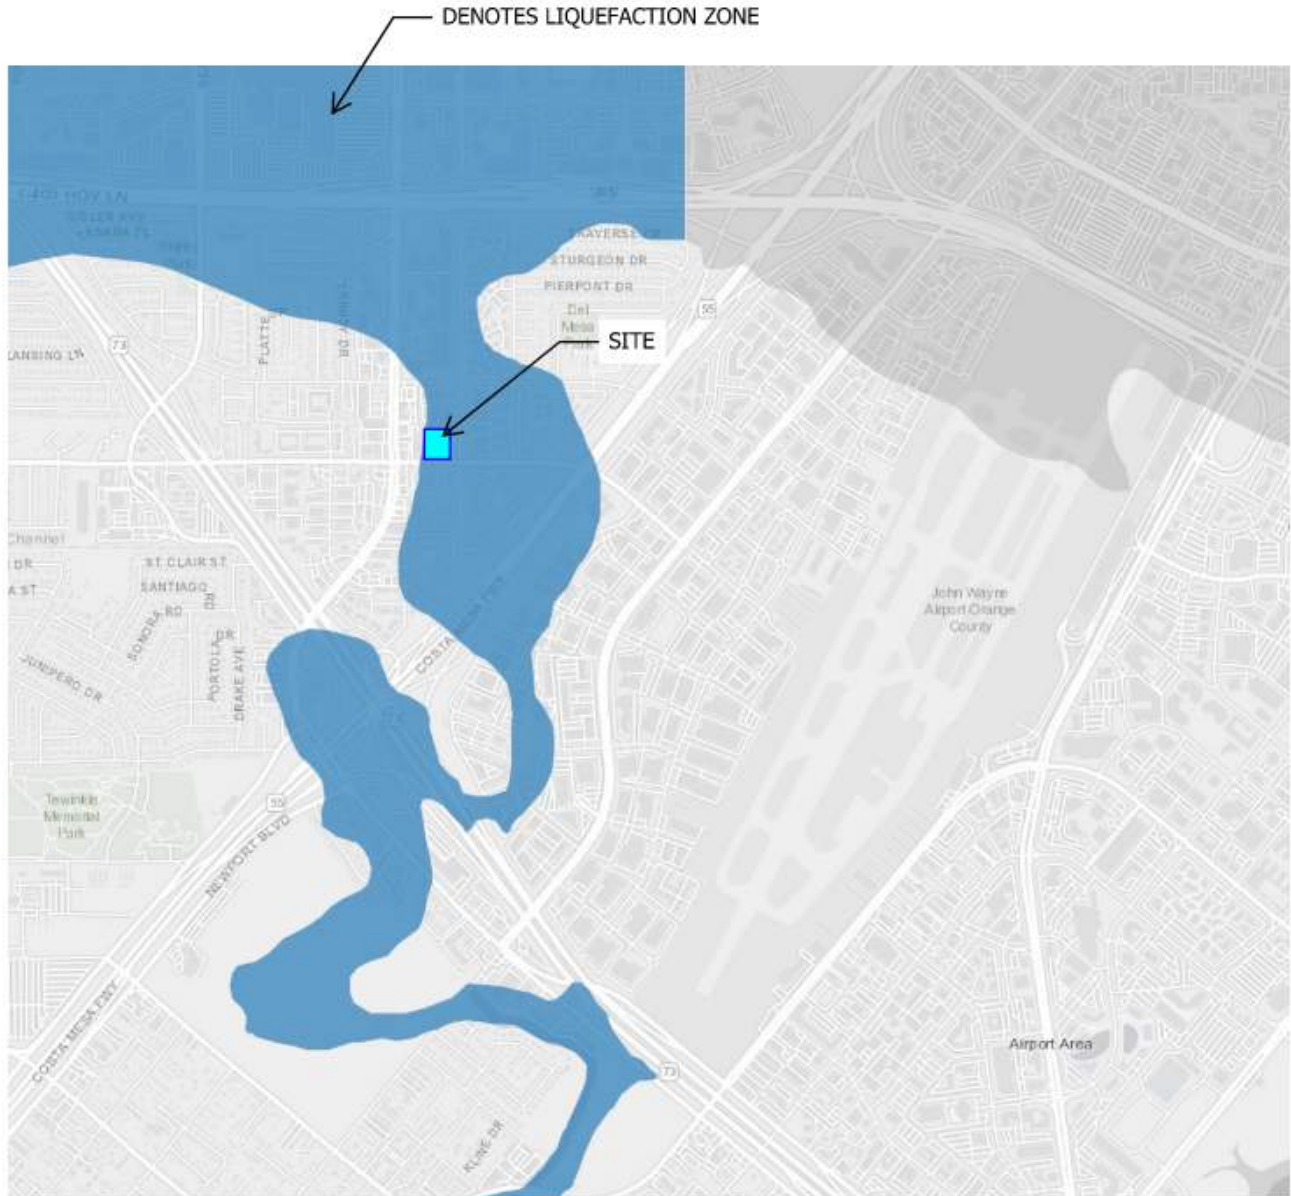
## APPENDIX B - LIQUEFACTION MAP

- b. According to California GIS liquefaction maps, the site is located within a liquefaction zone (see Appendix B). Should soil issues develop in the future, we recommend consulting a licensed geotechnical engineer to evaluate the potential for liquefaction. This is not a requirement currently.

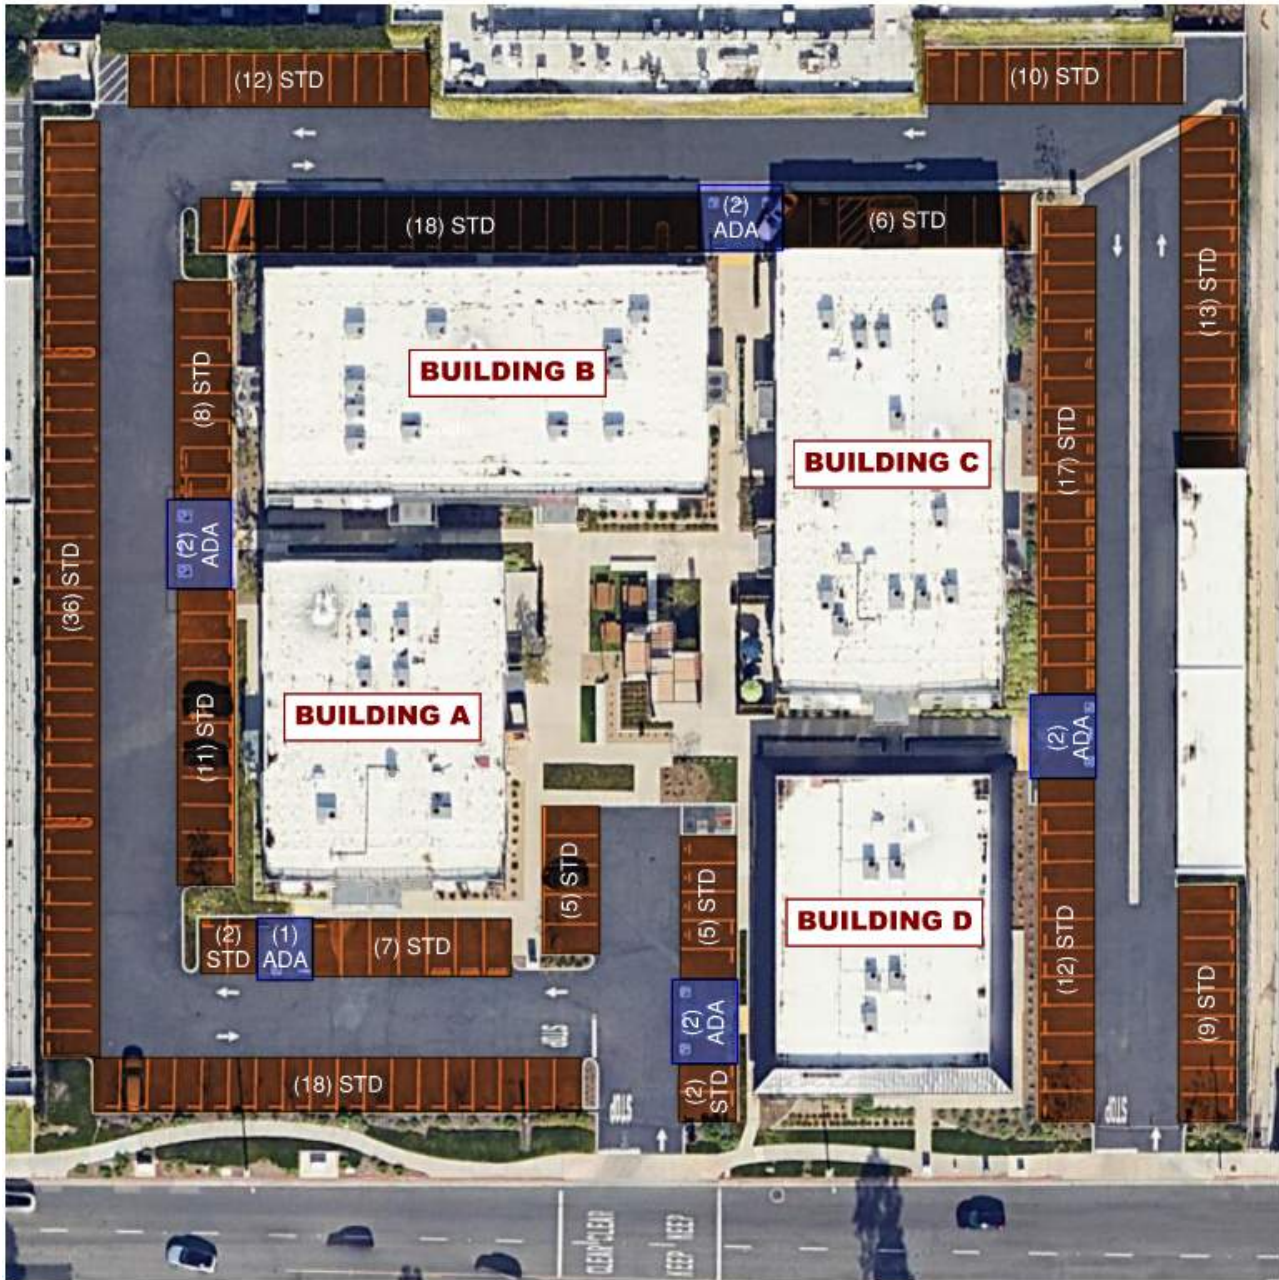
## APPENDIX C - PARKING FACILITIES

- (9) ACCESSIBLE PARKING
- (191) STANDARD PARKING

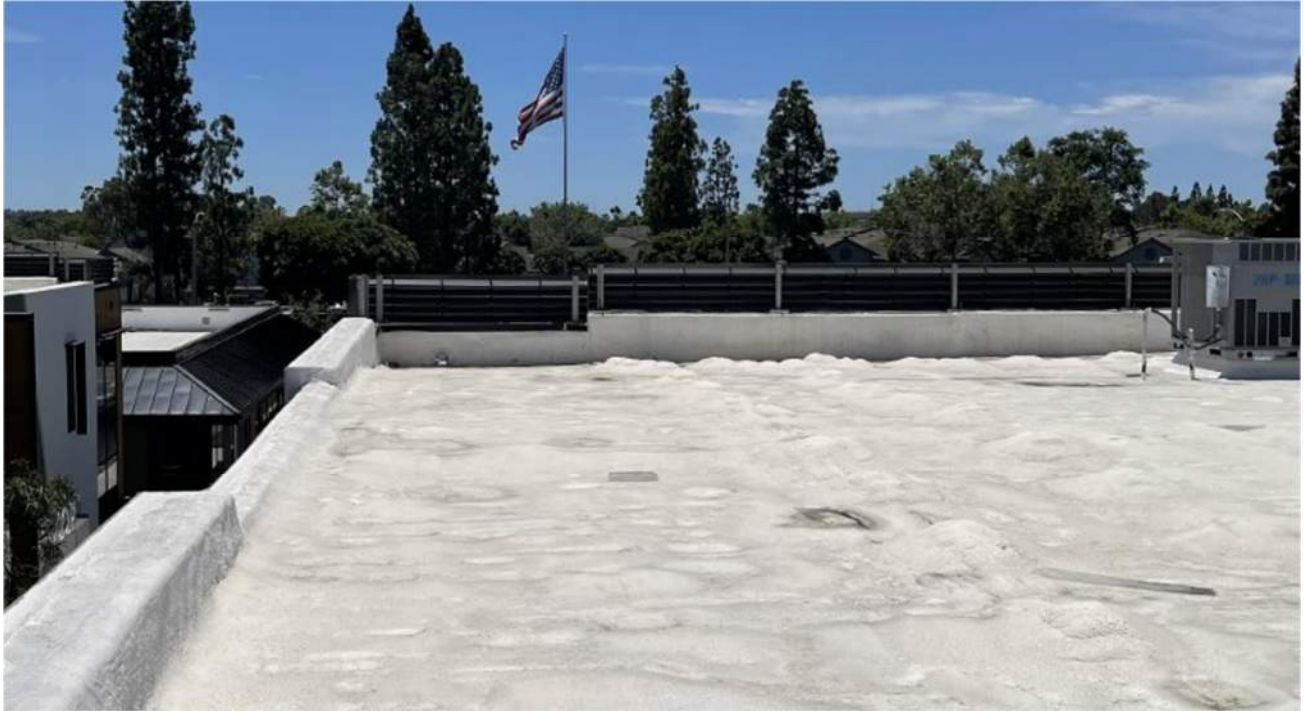
- h. *Drainage Facilities* – Each building was observed to have a built-up roof that appeared to be in good condition. Each roof was sloped to roof drains in the four corners of building which also had overflow scuppers through the exterior concrete walls. The roof drains internally to the buildings and is assumed to tie into the wastewater systems. We did not observe any standing water or other staining on the roof that would indicate any ponding issues. The exterior site surface is sloped to drain to the south and to the east. No issues were observed with the site slopes and all areas appeared to have adequate slopes to sheet flow water to the intended locations. Refer to Appendix D for an overview of the drainage facilities.

*Image 12 - Typical Roof Slope to Corner Drain and Scupper*

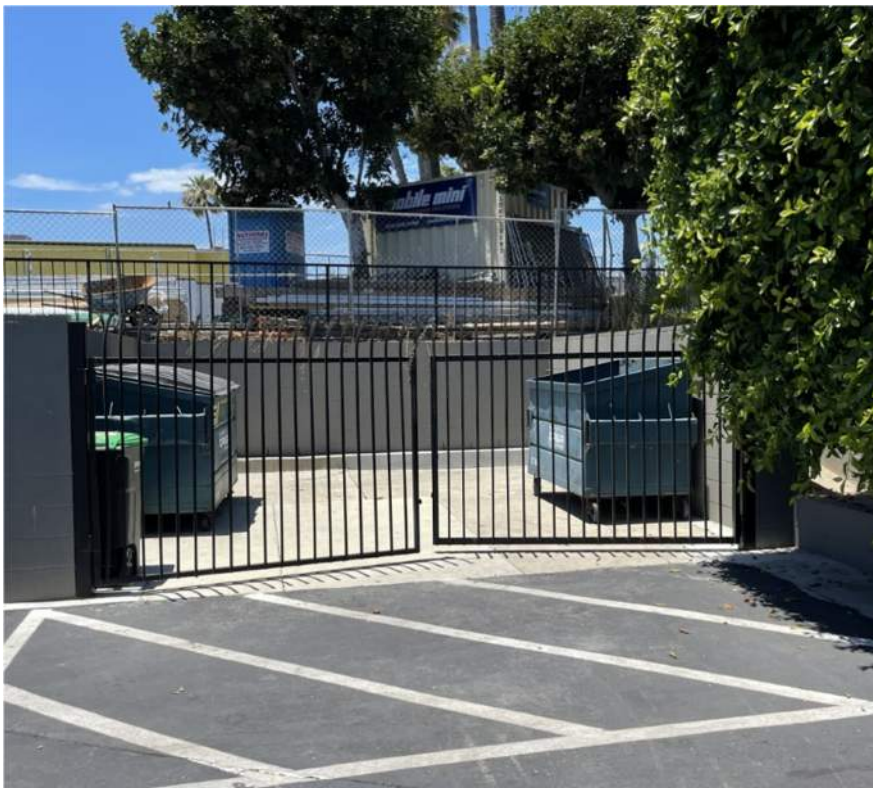
- units on three sides and has a double steel gate on the east side for access. The walls and door appeared to be in good condition. Refer to Appendix D for the location of the trash enclosure.
- j. *Exterior Lighting* – The site was lite by exterior lighting mounted to the surface of the exterior concrete walls. Pathway lighting was also present in the landscaping as well as the site walls next to ramps and steps. Although our site visit was performed during daylight hours, all exterior lighting appeared to be in good condition and operational.

*Image 13 - Trash Enclosure in North-West Corner*

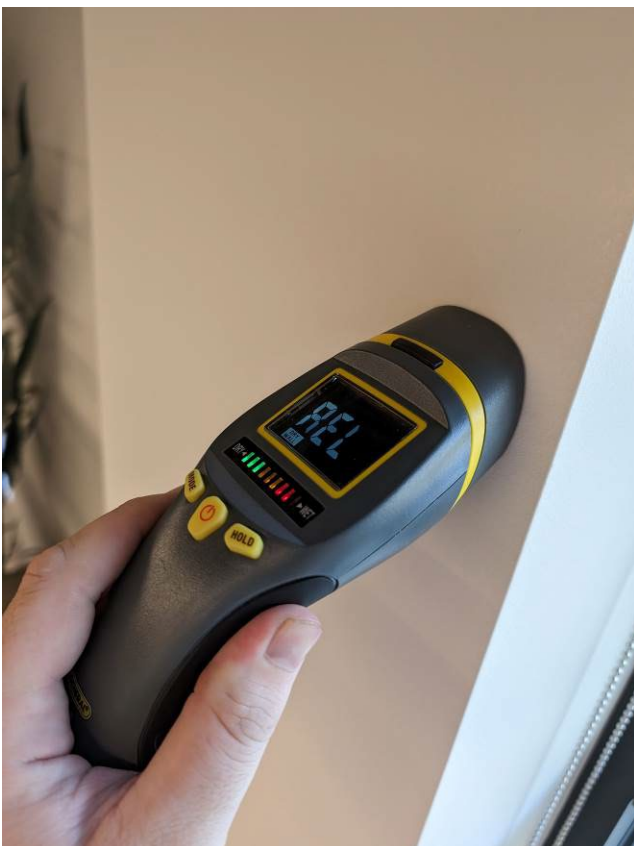
4. View showing elevated moisture reading of sheetrock near rear door of Unit-B101.

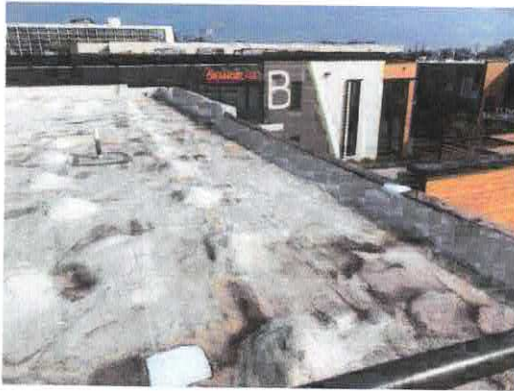
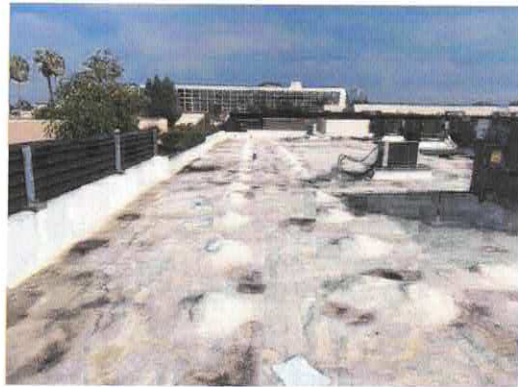
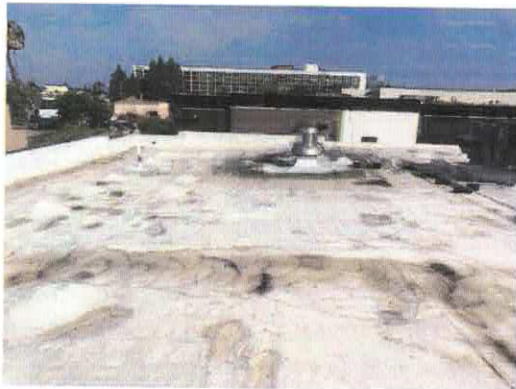
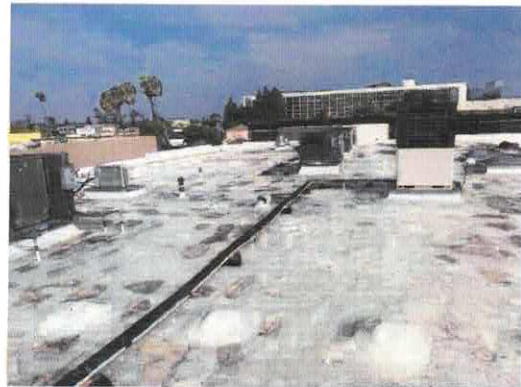
### Views of Building A

The A, B and C buildings are covered by SPF foam roofing installed over a preexisting BUR roof system. The foam is protected with a white acrylic coating. The roof membrane terminates at the top of the parapet wall. The roof system was resurfaced with an application of Western Colloid white acrylic in March of 2019. The system has been well maintained. This coating application has a manufacture warranty and life expectancy of 10 years from the time of application. At the end of the warranty period, the acrylic surfacing can be reapplied to extend the roof life and warranty. The roof deck is plywood.

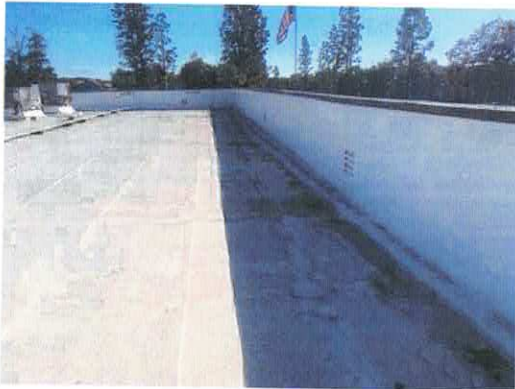
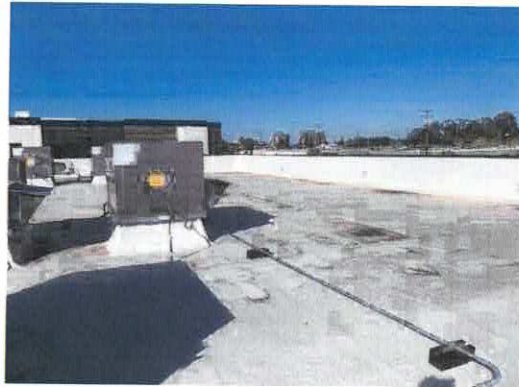
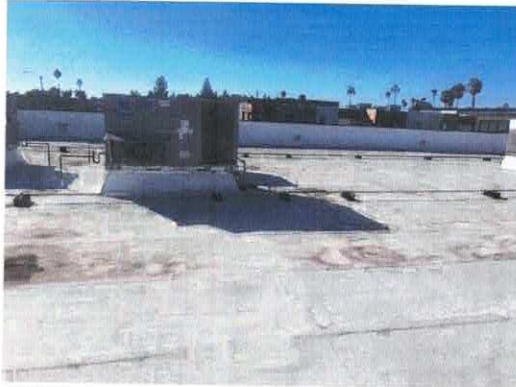
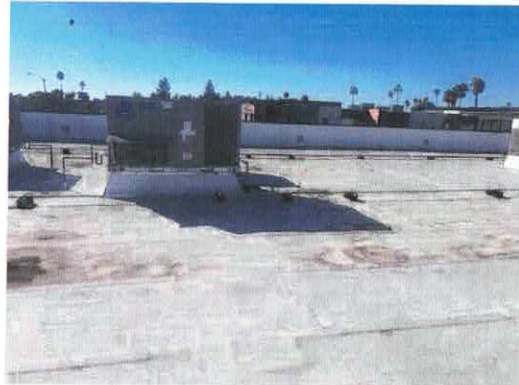
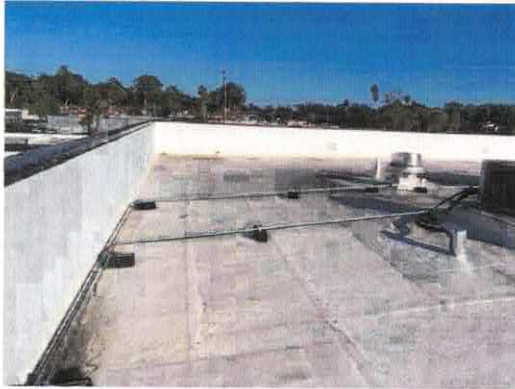
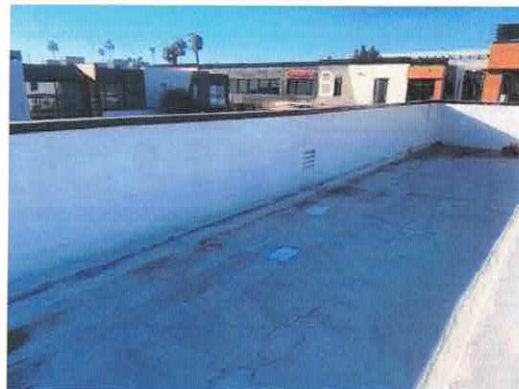
## Views of Building D

Building D is covered by a fully reinforced Western Colloid fluid applied roof restoration system installed over a preexisting BUR roof system. The fluid applied system is surfaced with white acrylic. The FARR system was installed in March of 2019. The system has been well maintained. This FARR system has a manufacture warranty and life expectancy of 10 years from the time of application. At the end of the warranty period, the acrylic surfacing can be reapplied to extend the roof life and warranty. The roof deck is plywood.

The fluid applied roof restoration systems on these buildings can be upgraded to 25-year systems with the installation of the Western Colloid SMAA-2P-8XE specification attached to this report.
