# PARK ASSESSMENT

2025

Prepared by  
DVD Creative

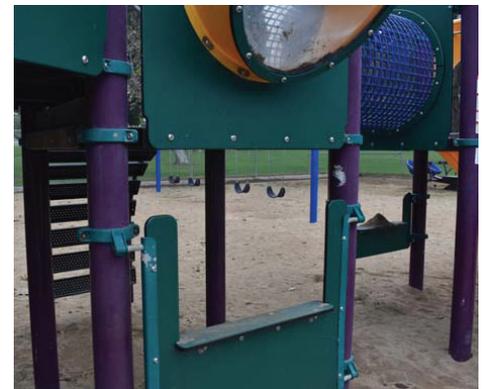
(Figure 1.06)

**Figure 1.05, 1.06** - Dirt/mold growth on the slide. Powder coating is damaged and worn off on posts, caps, and components.
