**City of Costa Mesa**

# **Facilities Master Plan Development**

City Council Study Session  
March 10, 2026

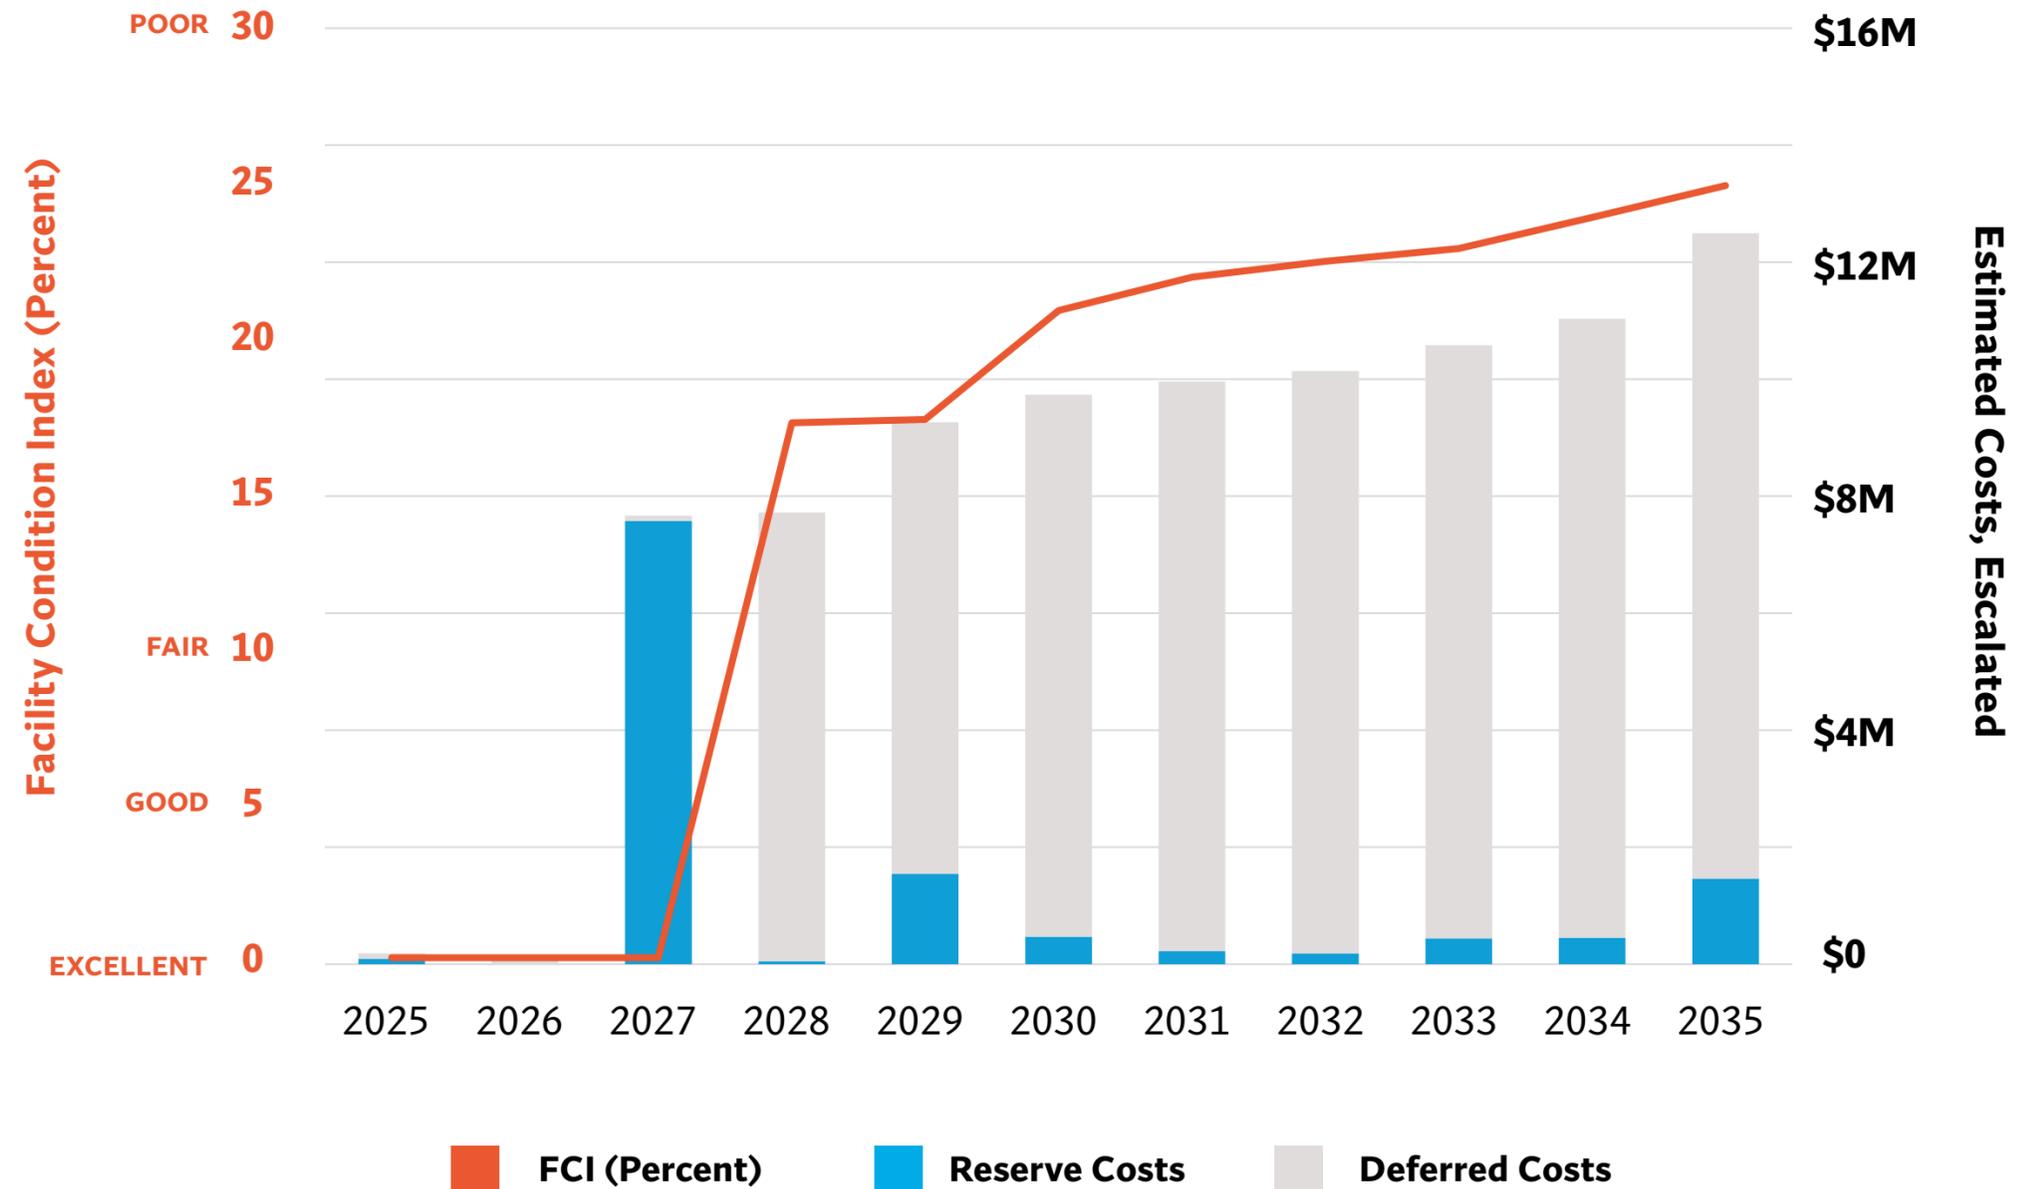
# Facility Condition Assessment City Hall

Needs by Year with Unaddressed FCI Over Time

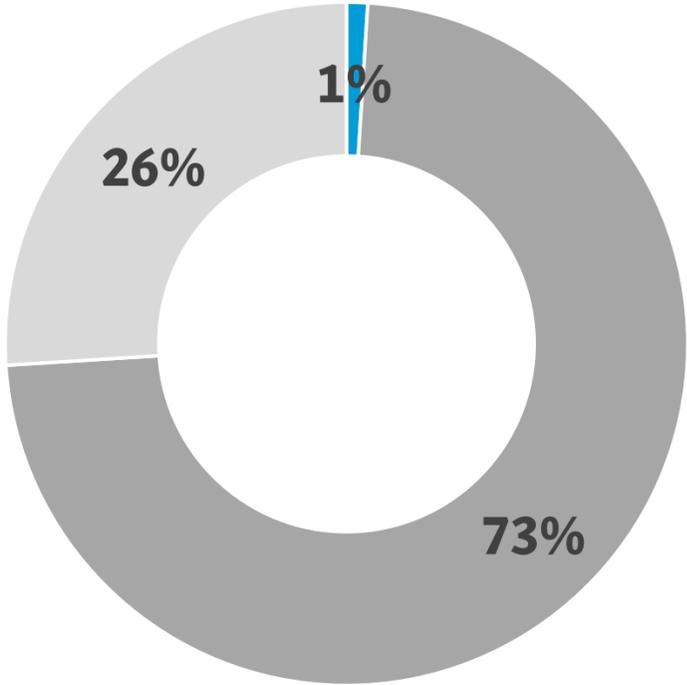
# Facility Condition Assessment City Hall

## System Expenditure Forecast

- Retrofit/Adaptation
- Aged But Functional
- Lifecycle/Renewal

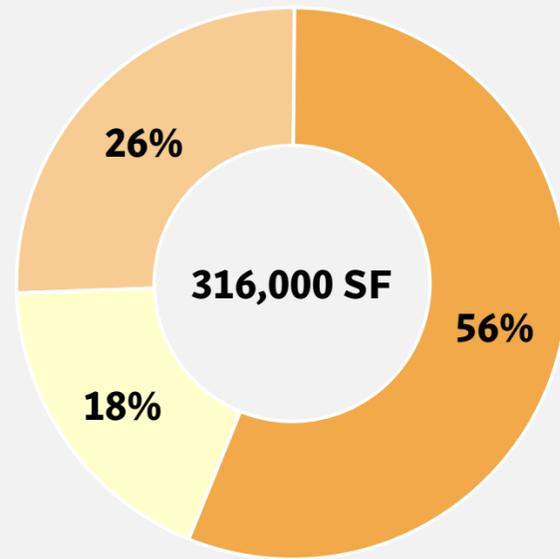
## Age of City Facilities

- Under 30 years old
- 30-50 years old
- Over 50 years old

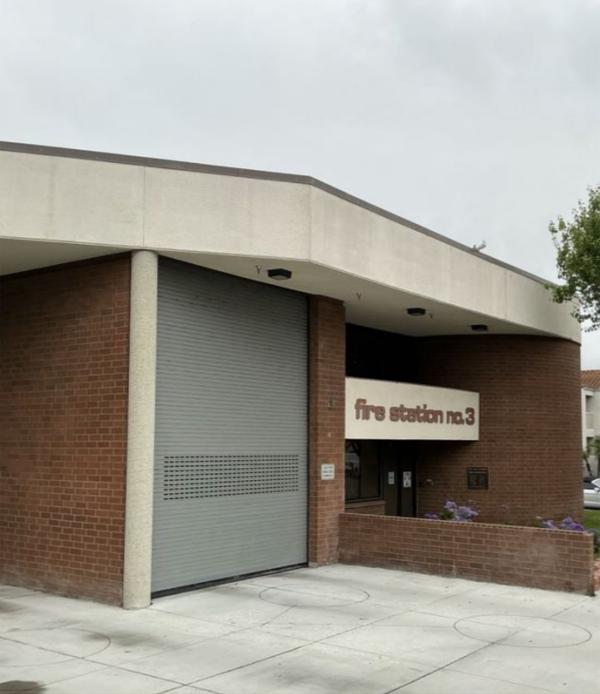
**Fire Station #3**

Many public safety facilities were constructed under prior code requirements and continue to be occupiable and fully functional today. Over the long term, updates through renovation or replacement need to be considered to align with current standards and support future service needs.

58	37.3%	Electrical, plumbing, low-voltage systems, and flooring are in poor condition.	Training functions are expanding; additional classroom and garage space is needed, subject to funding.	Building layout and systems do not meet current operational standards. Privacy, staff support spaces, and equipment accommodation are limited. Electrical capacity is outdated.	No location concerns identified.	Emergency generator installed in 2017.	Building is built to past code but no longer complies with modern code requirements.
Public Safety Facilities	Westside Substation	<b>1</b>	<b>2</b>		<b>1</b>	<b>1</b>	<b>3</b>	<b>1</b>	<b>Y</b>
		67	17.0%	Roof leaks and reported structural cracks; electrical and plumbing systems are in poor condition. HVAC and hot water are operational. Main entry experiences flooding.	Additional space could support specialty police functions (e.g., bunk rooms, training).	Building performance is poor; Most police operations have vacated the site.	Good location serving the Westside.	No sustainability measures or emergency power in place.	Building is built to past code but no longer complies with modern code requirements. Potential lead and asbestos in flooring and finishes

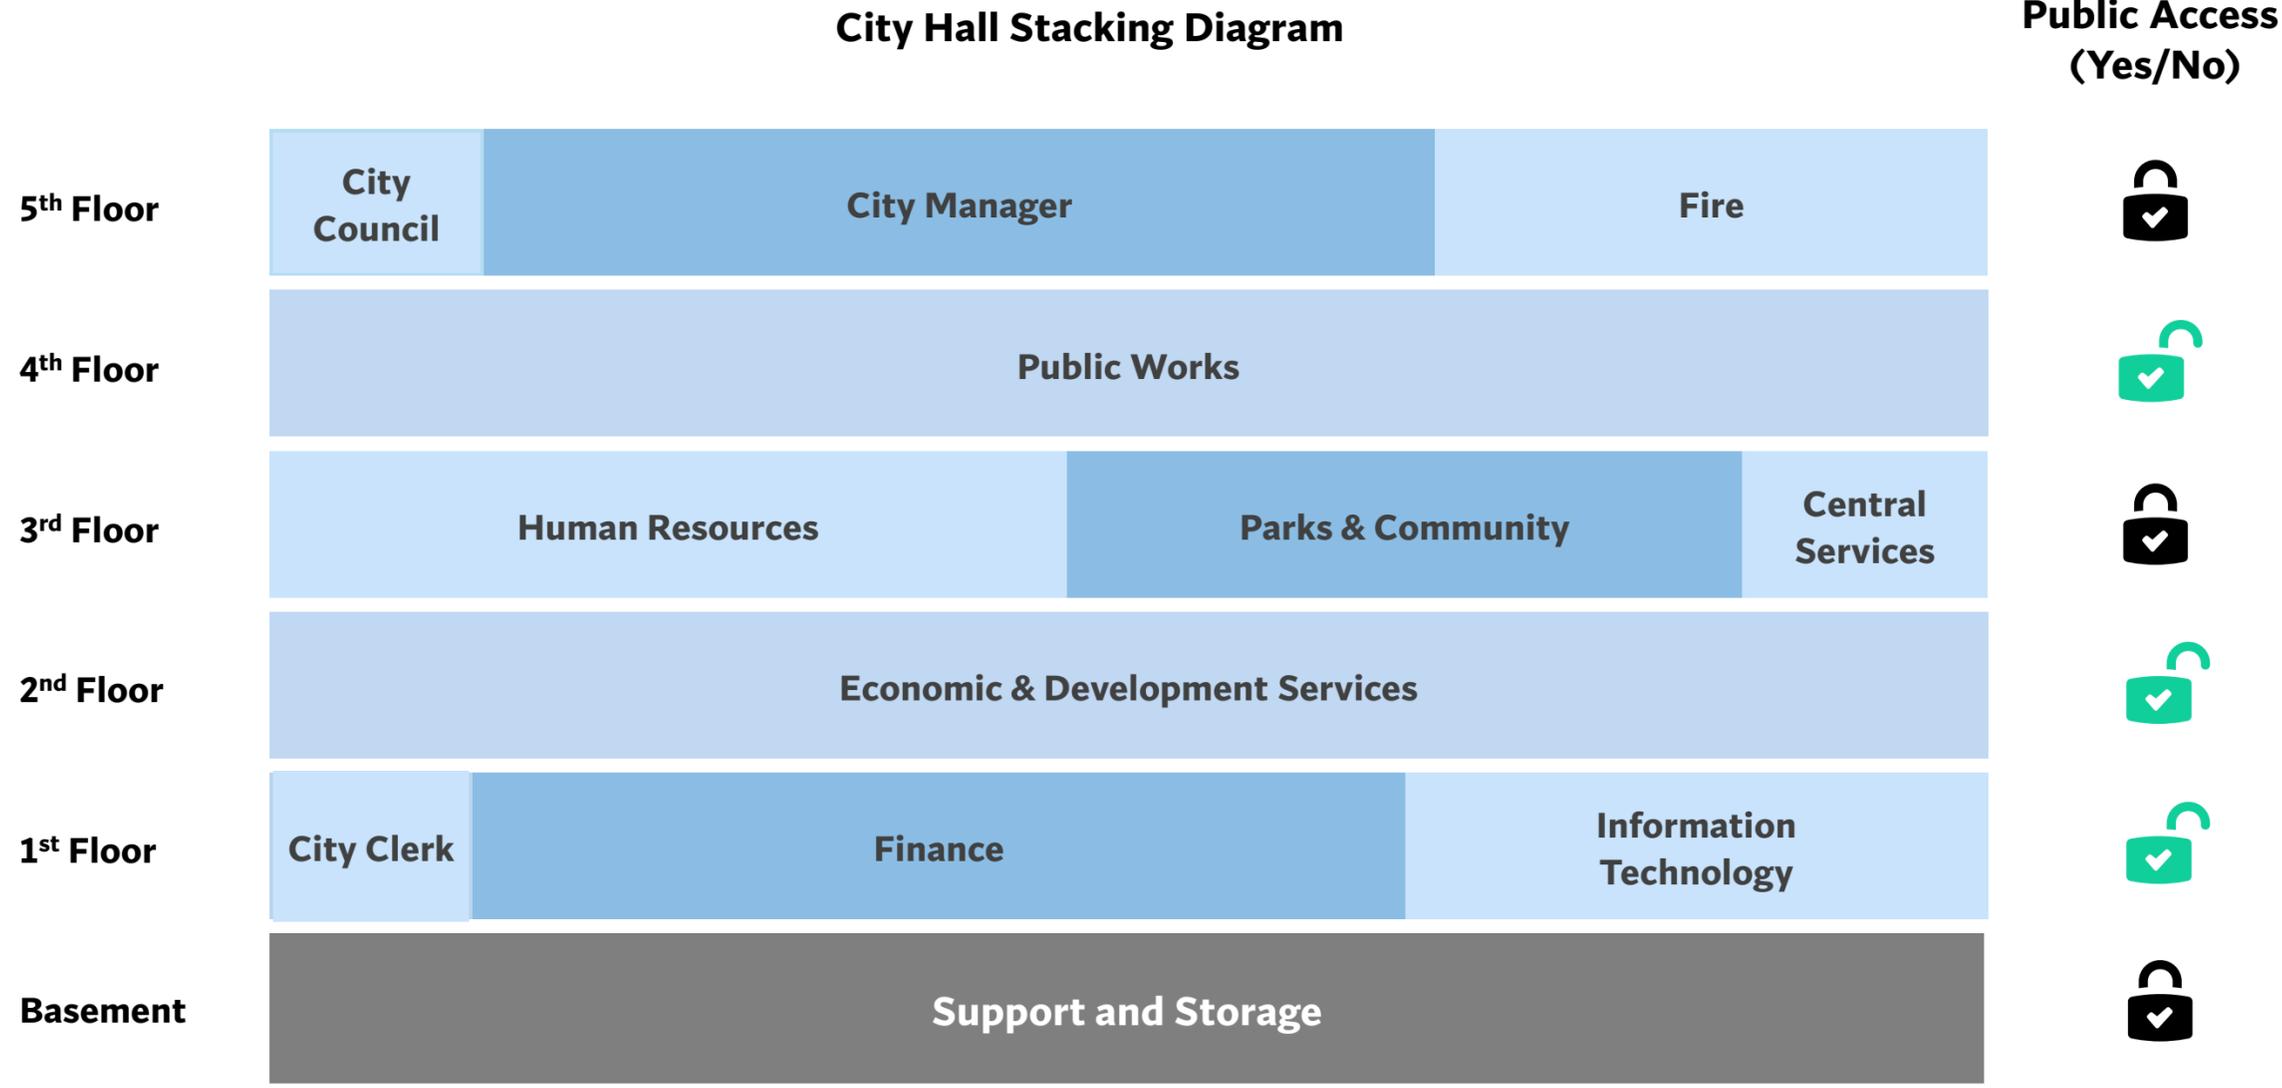
Public-facing services at City Hall are currently located across multiple floors with varying security access, while some internal-facing departments occupy the first floor. This presents an opportunity to better align space use with service delivery, enhancing wayfinding and creating a more intuitive and efficient layout for the public.

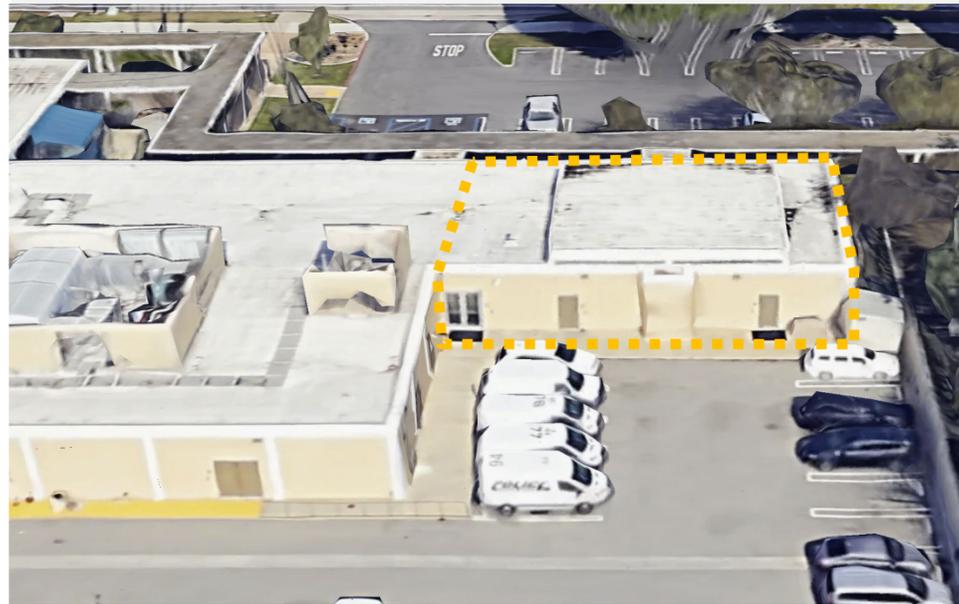
## Emergency Operations Center

- Current Emergency Operations Center (EOC) does not support long-term operations (e.g., outdated technology, limited space for storage and breakout rooms)
- No designated Continuity of Operations (COOP) site.

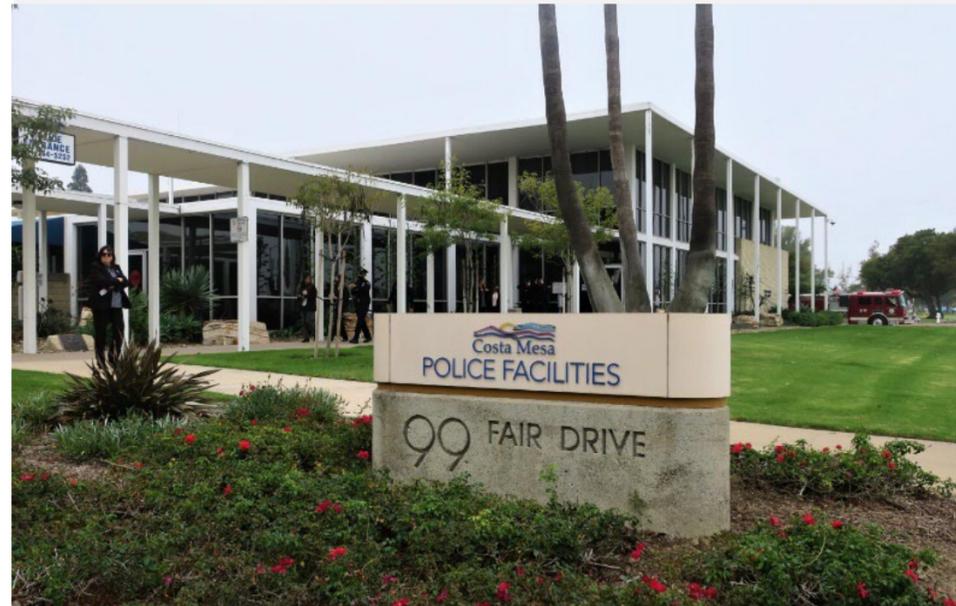
## Emergency Response & Public Safety Facilities

- Dispatch facility is outdated but upgrades are underway
- Police department lacks room for growth and space for modern services like real-time crime centers and drone operations

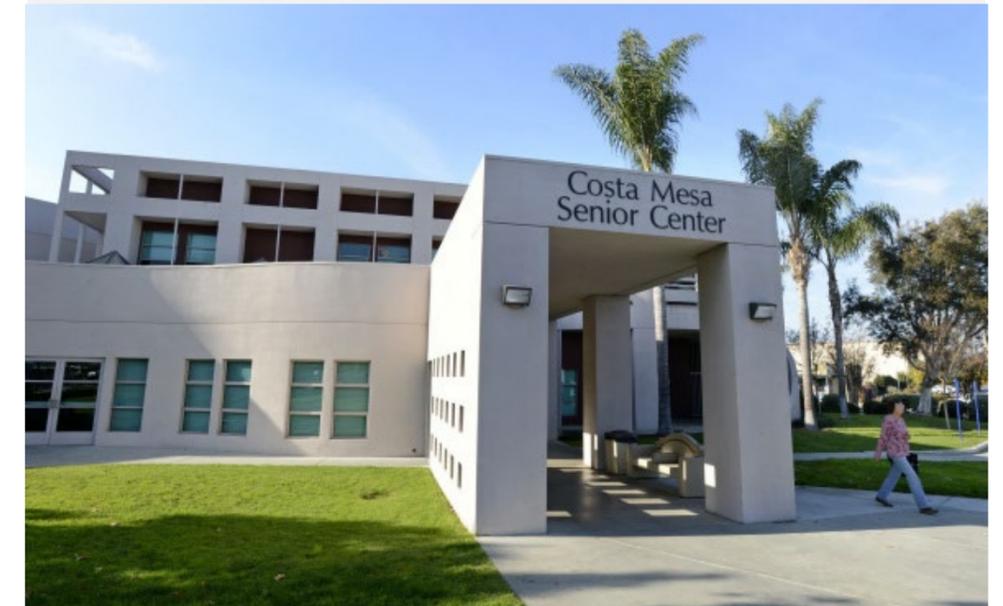
## Community Support & Shelter Facilities

- No facility is fully shelter-ready (e.g., ADA, kitchens, backup power).
- Senior Center has ADA access but is prone to flooding; DRC has showers but lacks a full kitchen; Balearic's lease status creates long-term uncertainty

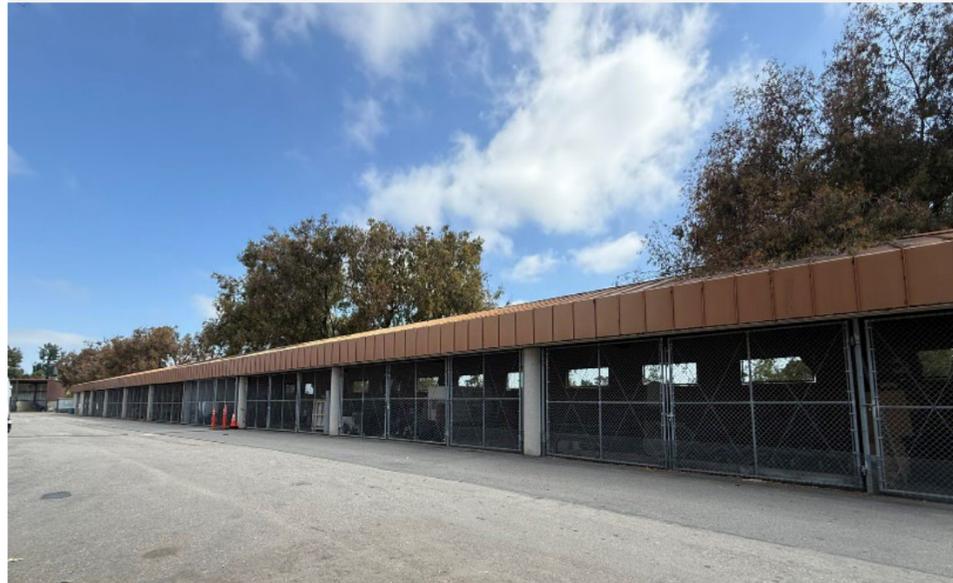
## Solar Infrastructure and EV Charging

- Not much solar infrastructure in place despite favorable conditions at the Corp Yard
- Future fleet will be all electric-based
- Consider shaded solar carports with EV charging

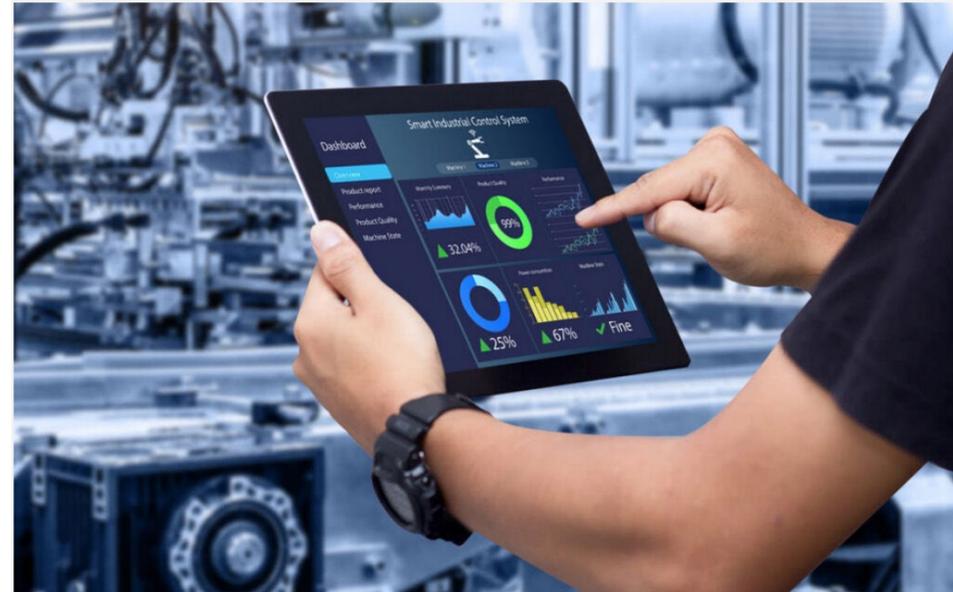
## Energy & Systems Modernization

- Facilities lack centralized HVAC or energy management systems
- Mechanical/plumbing assessments needed to identify critical infrastructure needs

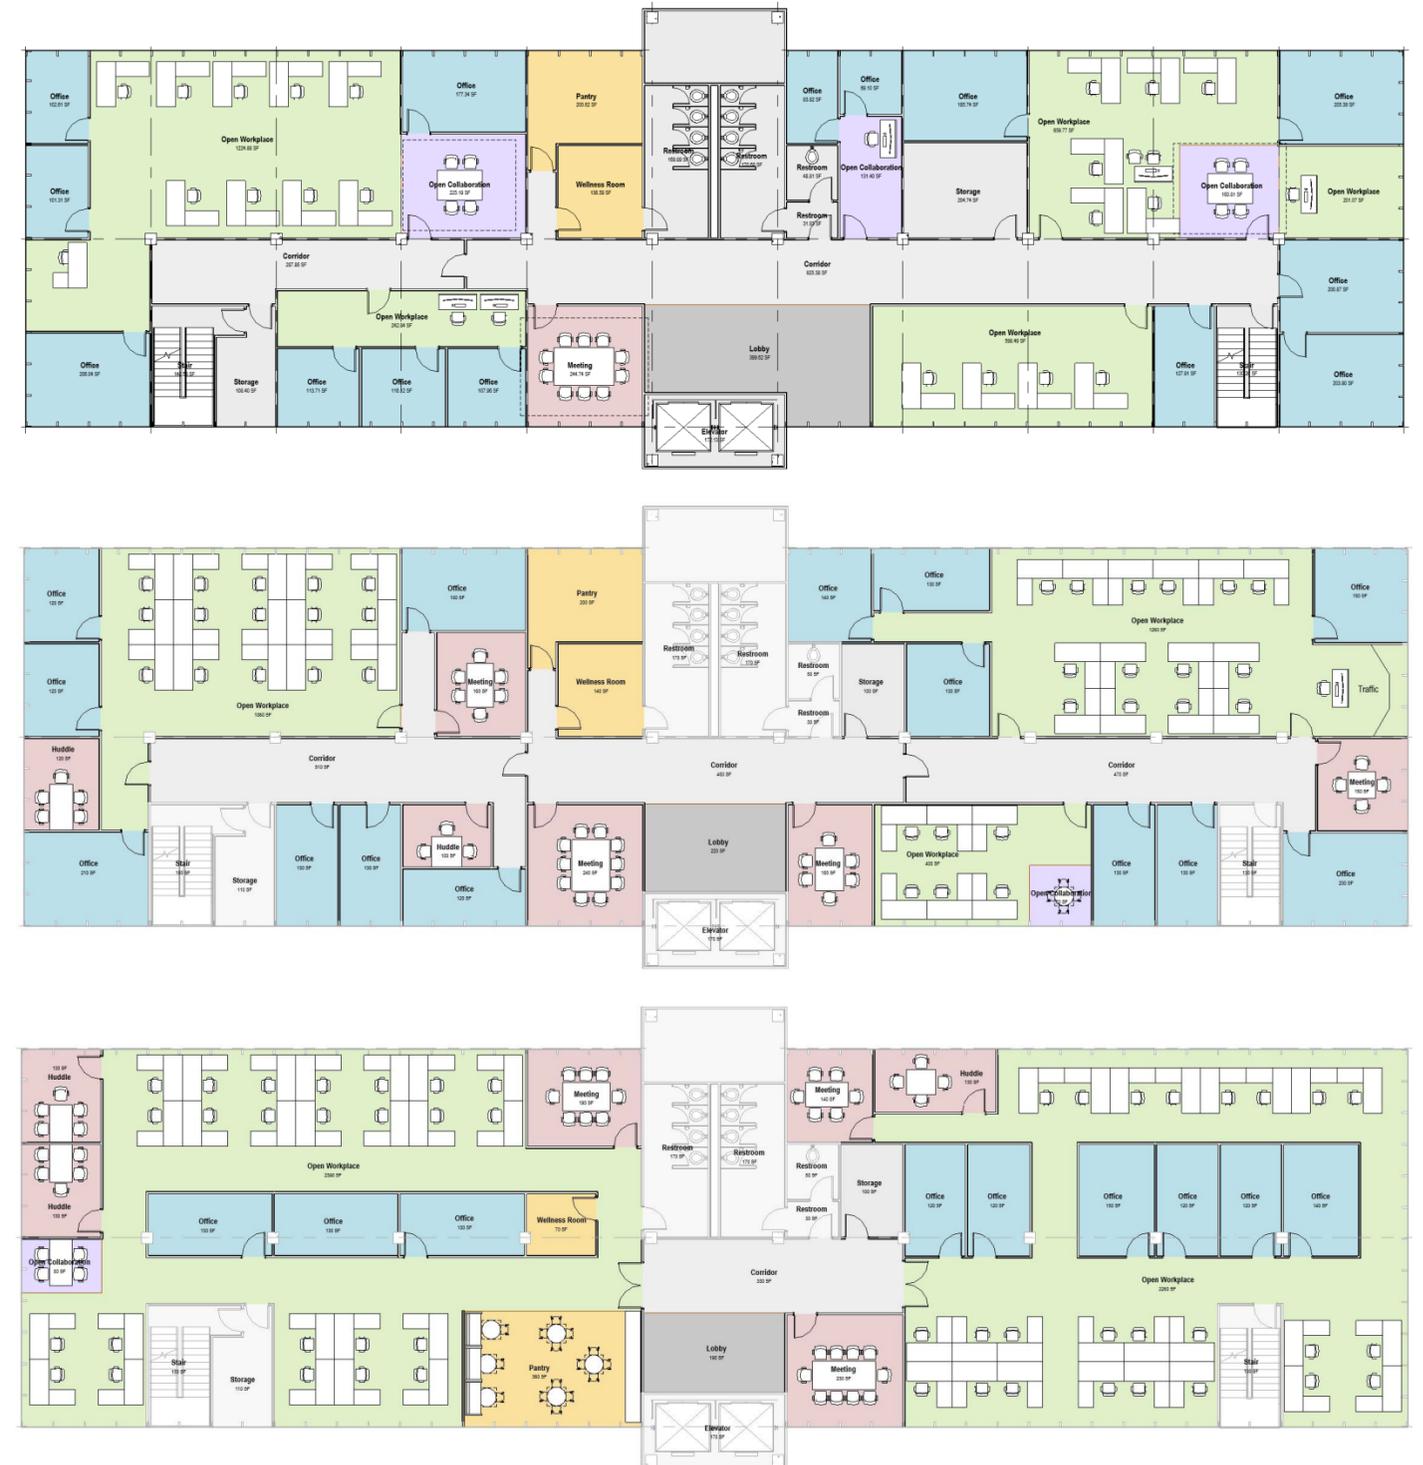
City Hall Level 4 Test Fits<sup>1</sup>

- **39** work seats on this floor, including 14 offices.
- Only one meeting room with some makeshift collaboration areas. Collab to work seats ratio is **1:2.05**.

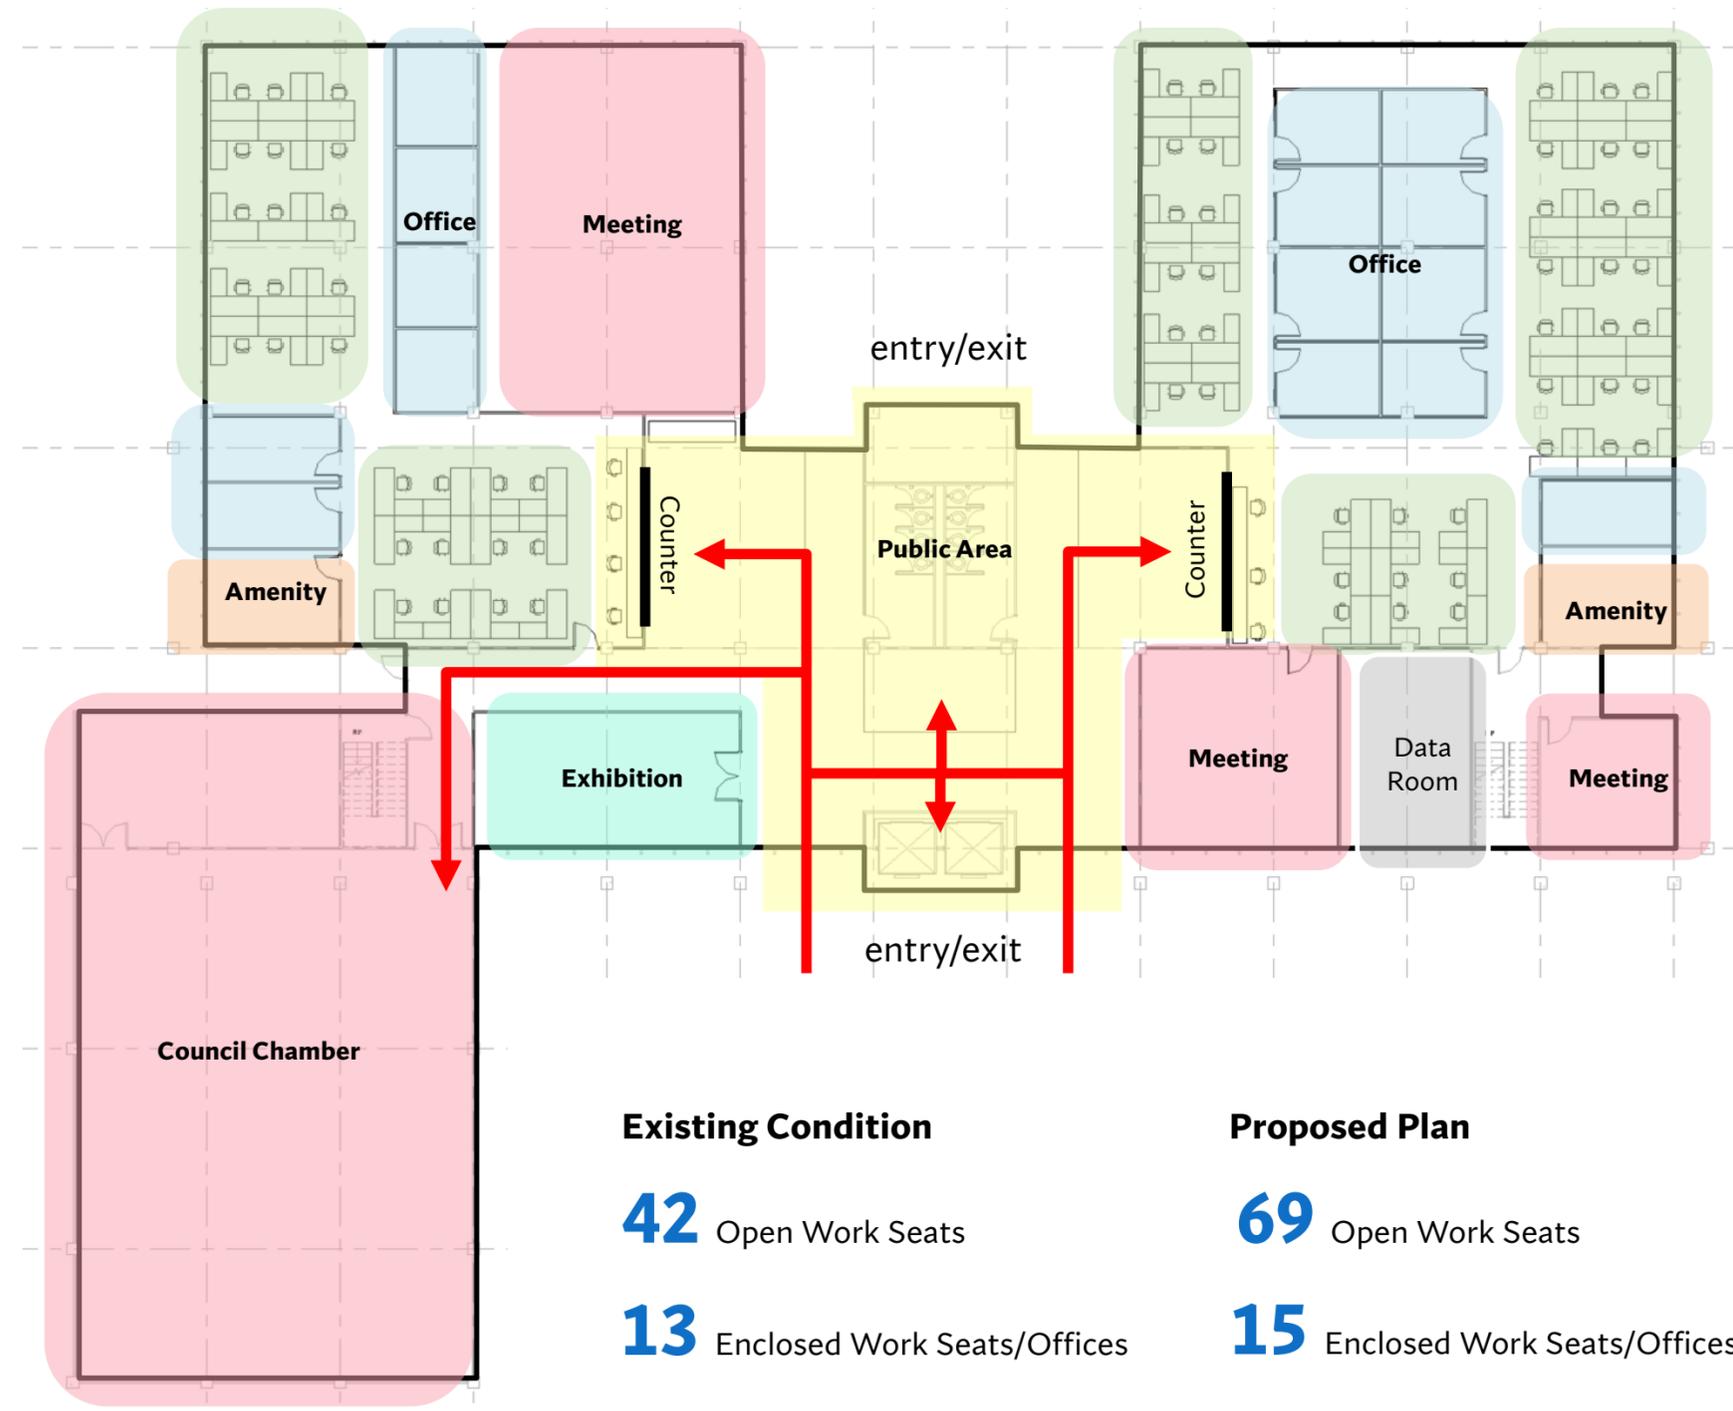
Reimagined City Hall First Floor Experience

**Existing Condition**

**42** Open Work Seats

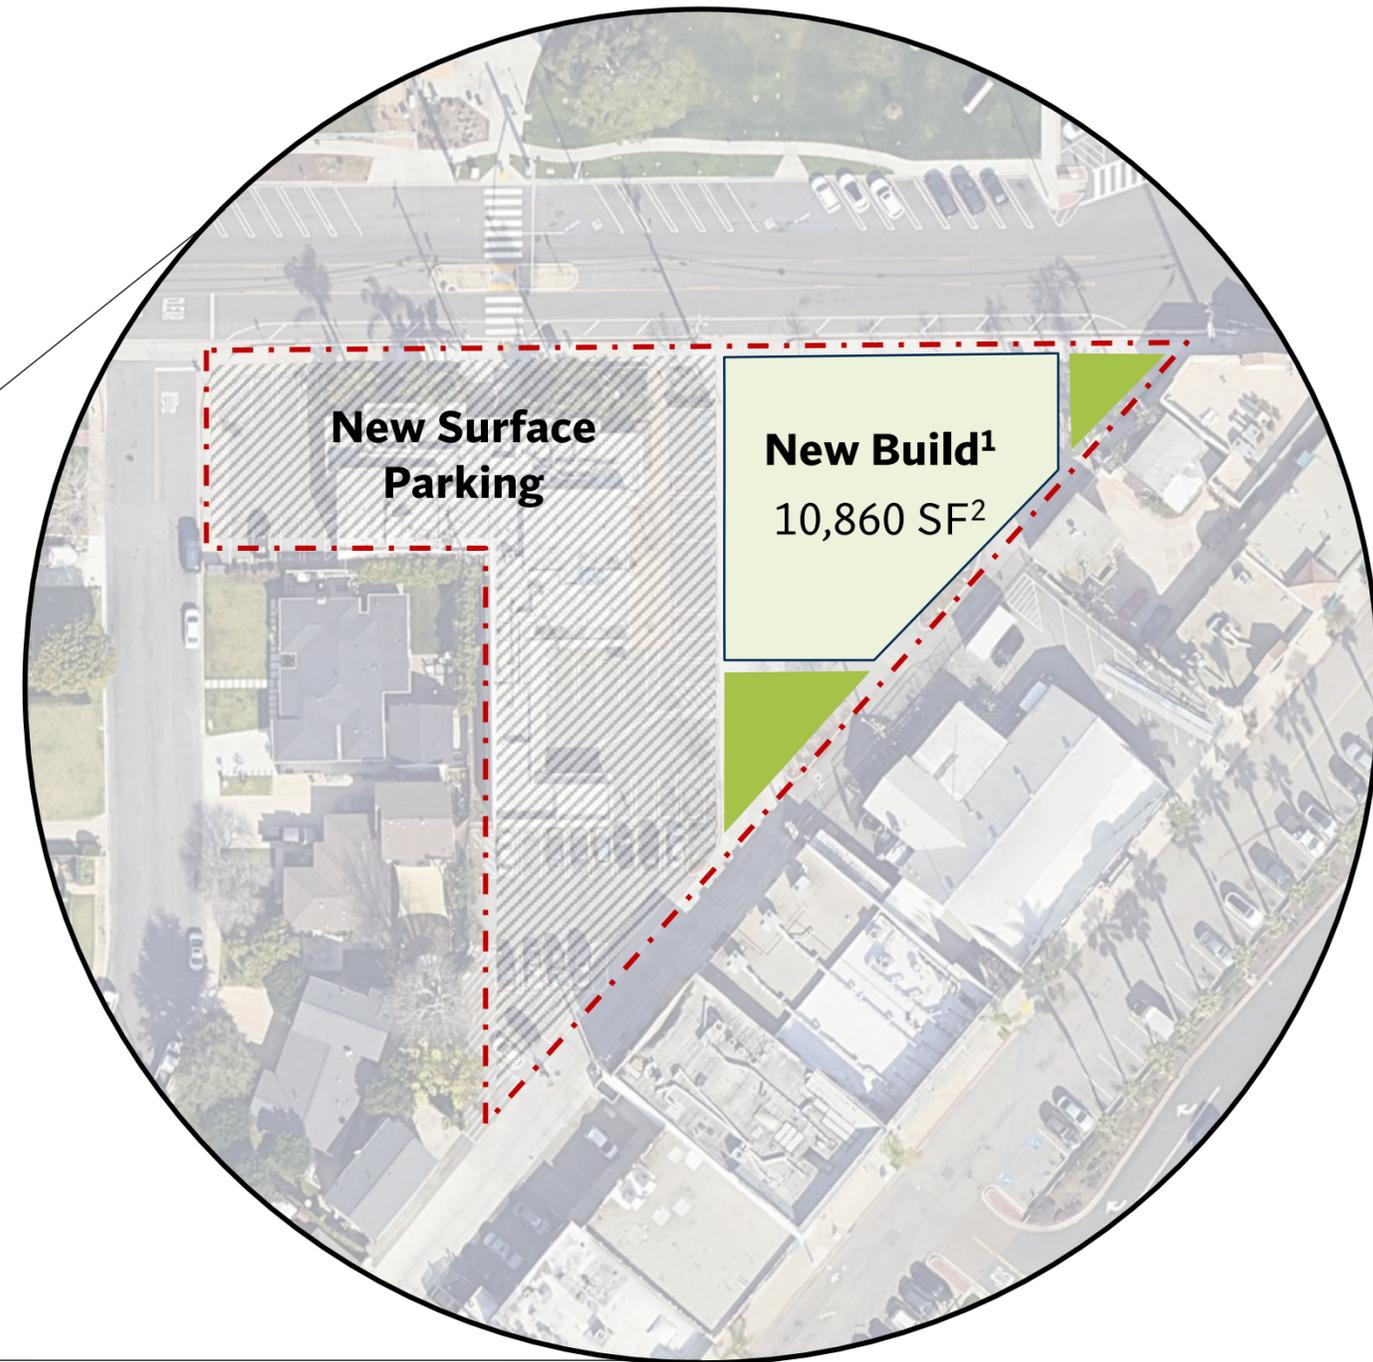
<sup>1</sup> New building location and massing are for illustration only.

<sup>2</sup> Note that this parcel is currently zoned as High Density Residential (R2-HD). It needs to be confirmed whether rezoning to Institutional & Recreational (I&R) is required. If rezoned to I&R, **the maximum building area allowed for the new Westside Service Center would be 10,860 square feet.** The existing Westside Substation is 8,640 square feet.

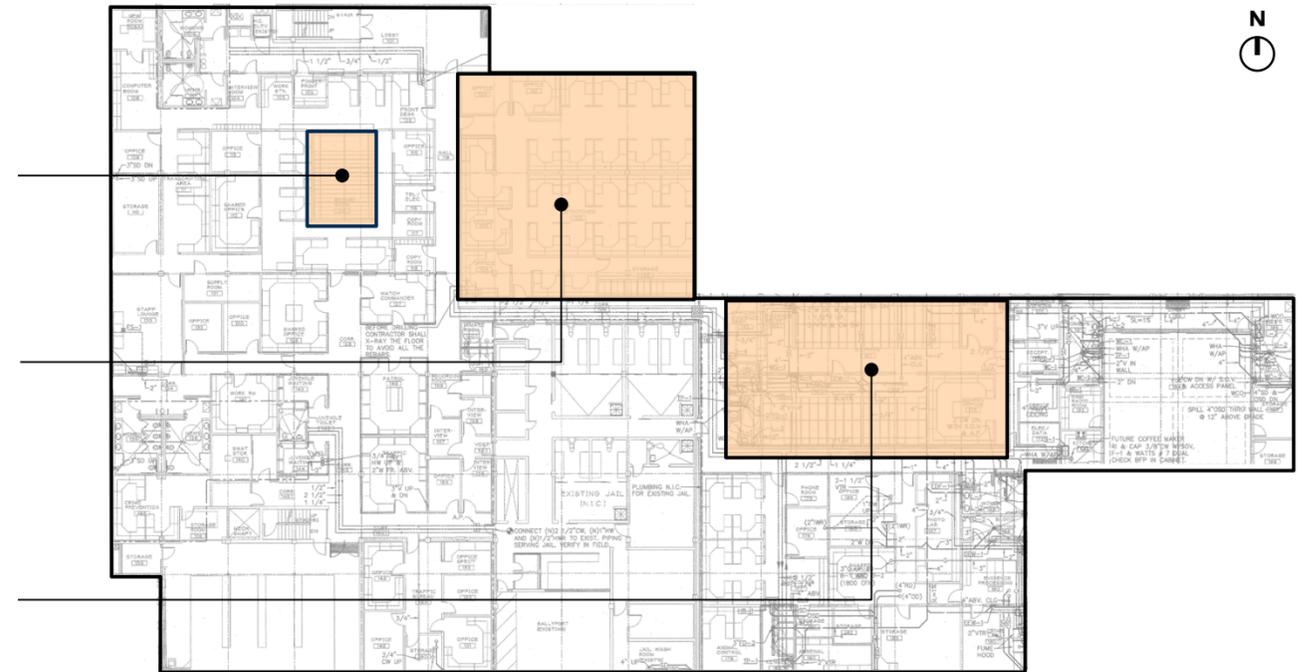
**Police Facility Level 2**

**Free up record storage**  
(approx. 400 SF)

**Modernize workspace**  
(approx. 3,400 SF)

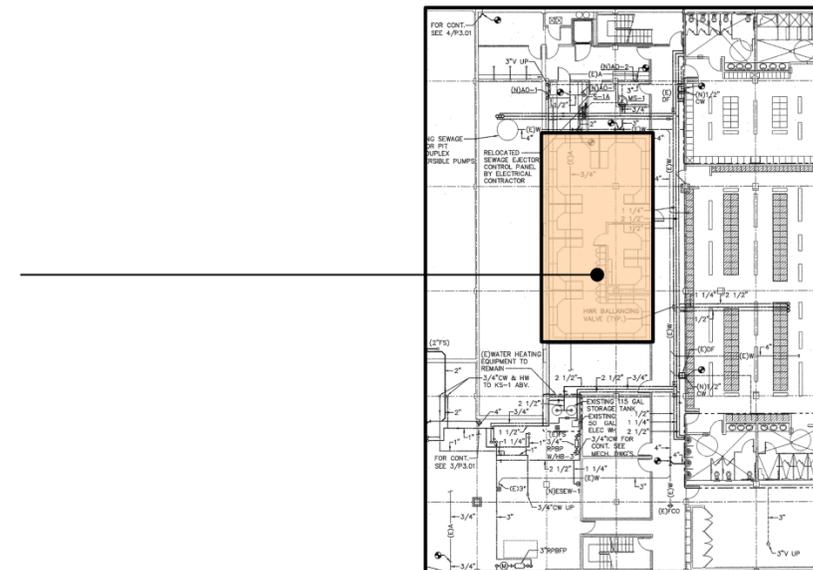
**Police Facility Basement**

**Remodel for gym/training space**  
(approx. 1,300 SF)

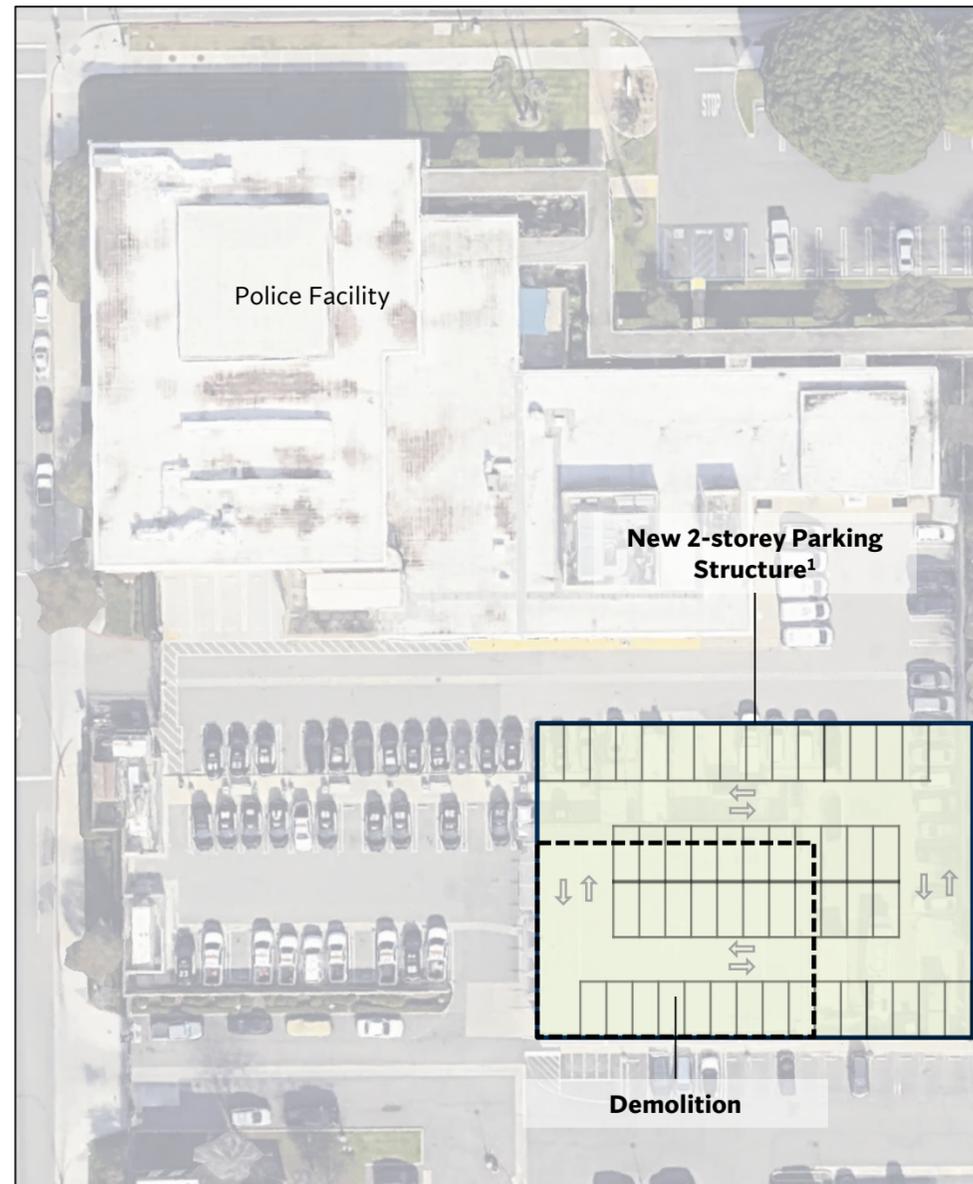
## Option 2

<sup>1</sup> Assumes a 125'x160' parking structure.

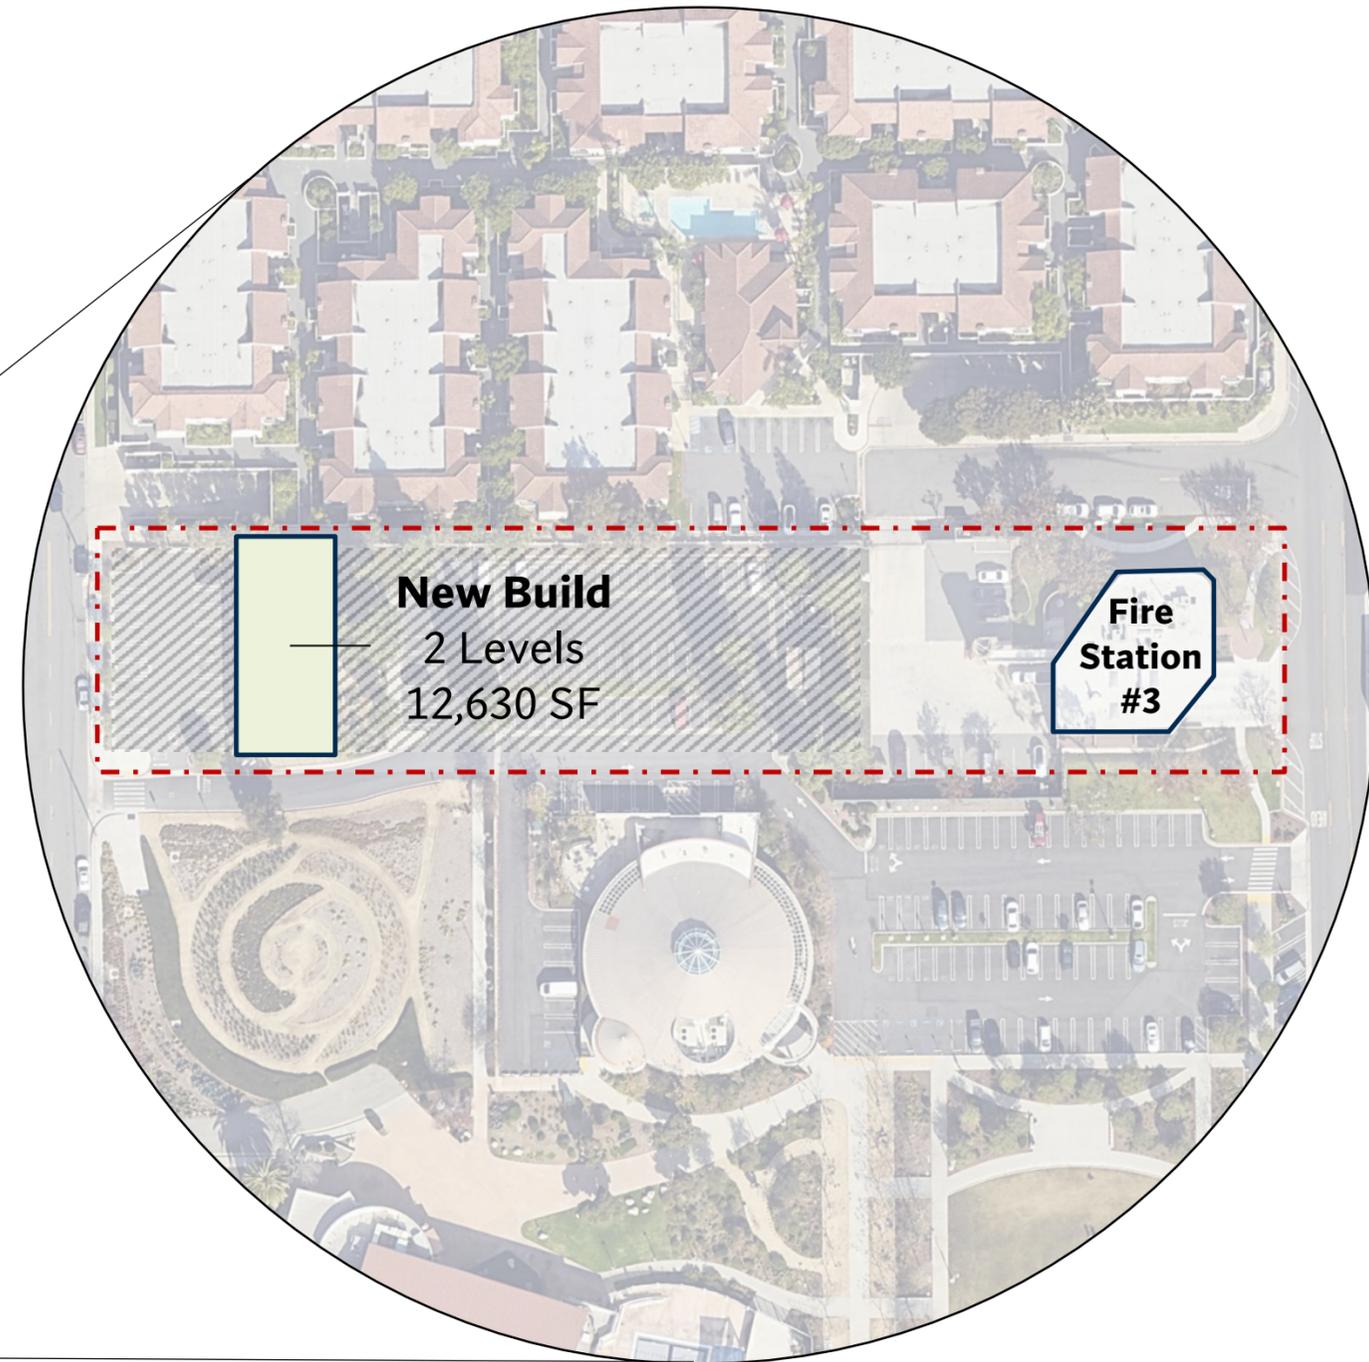
<sup>1</sup> New building location and massing are for illustration only.

<sup>2</sup> The Historic Society building and Fire Station #3 are located on the same parcel. The maximum allowable building area for that parcel is 19,120 square feet. Fire Station #3 occupies 6,490 square feet, so the **maximum allowable area for a new building replacing the Historic Society building would be 12,630 square feet.** The original Historic Society building is 4,000 square feet.
