October 31, 2022

Tim Cottage | Project Manager  
Hilco Development Services  
1707 E 28<sup>th</sup> Street, Suite B  
Signal Hill, CA 90755

Re: 200 Baker – Due Diligence Survey  
200 E Baker St, Costa Mesa, CA 92626  
Review of Existing Structure and Site  
RSG Job #22-1-070.00

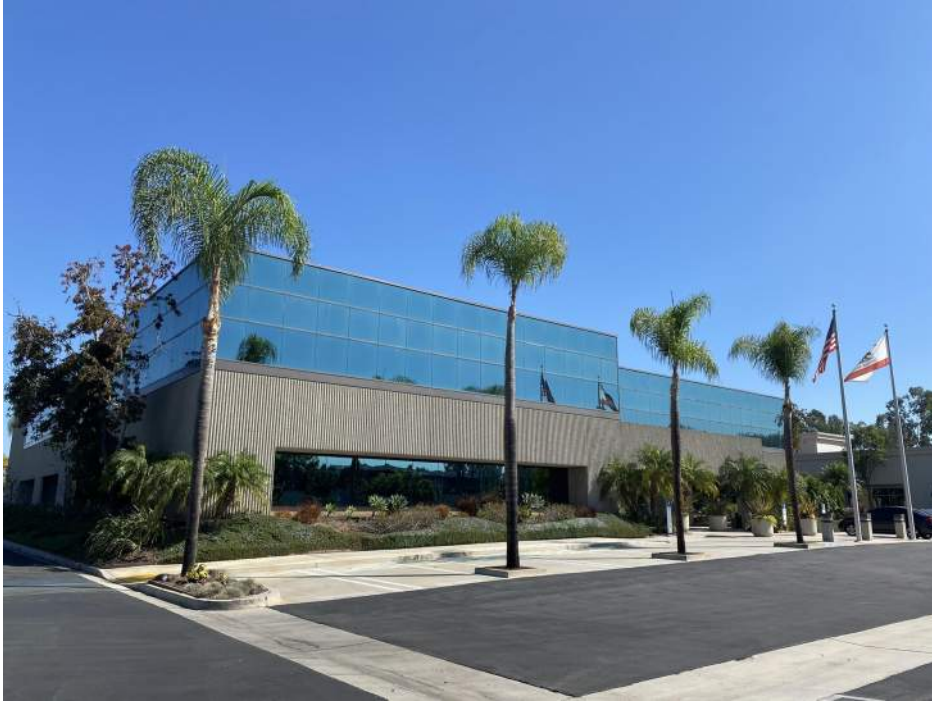
FIG 1: BUILDING EXTERIOR LOOKING FROM WEST

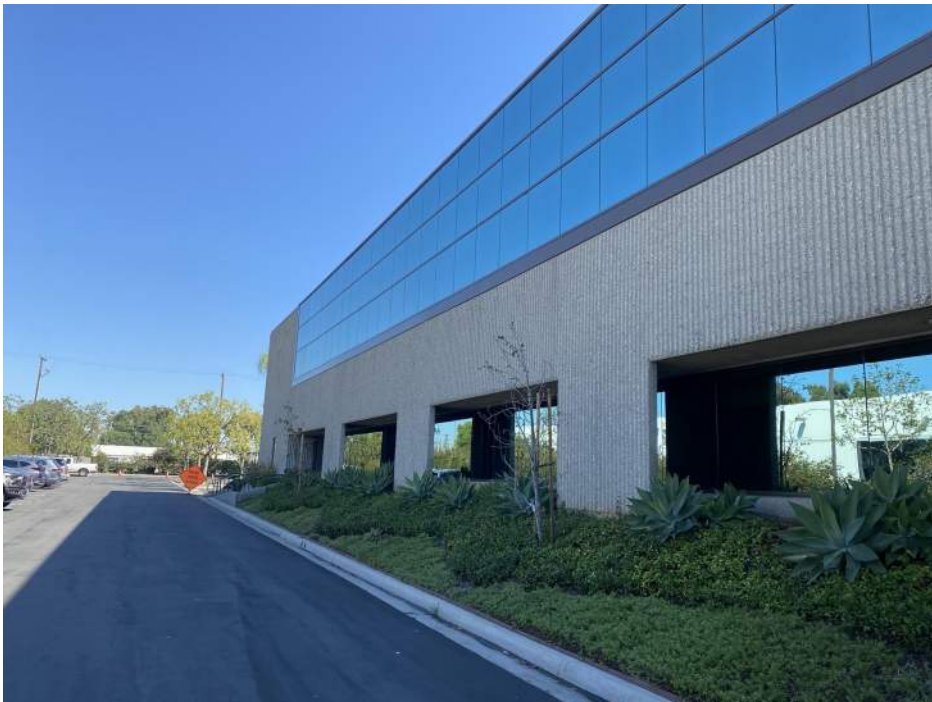
FIG 2: NORTHWEST ELEVATION OF BUILDING

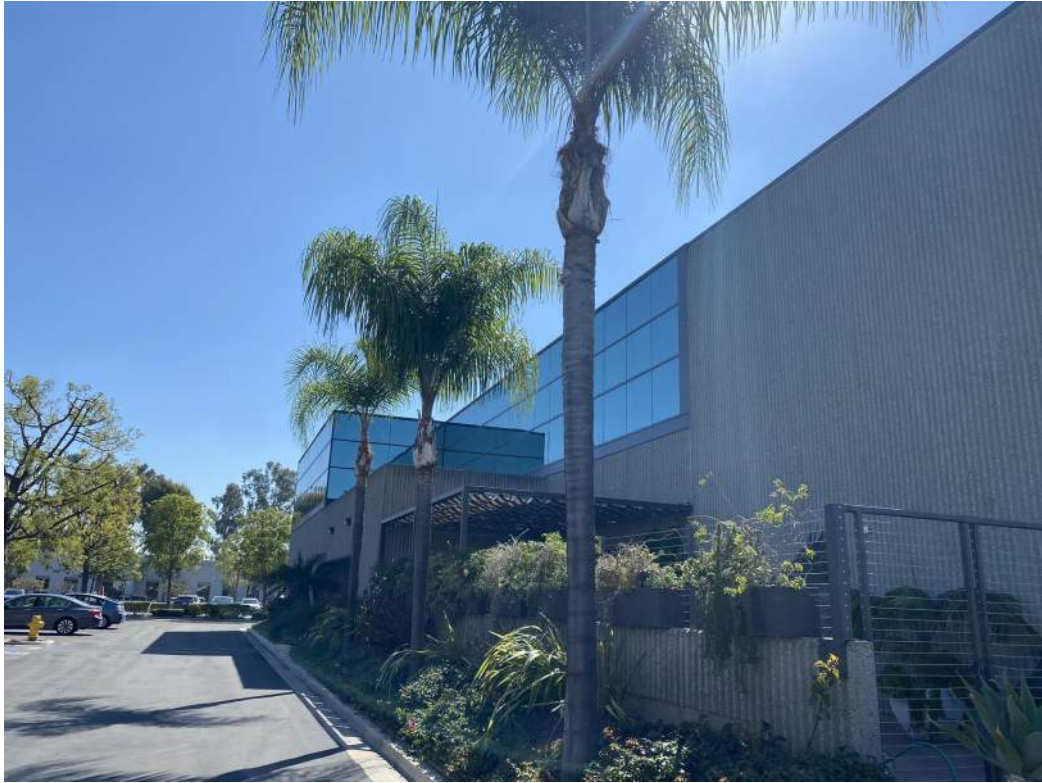
FIG 3: NORTHEAST ELEVATION OF BUILDING WITH EXTERIOR BACK PATIO

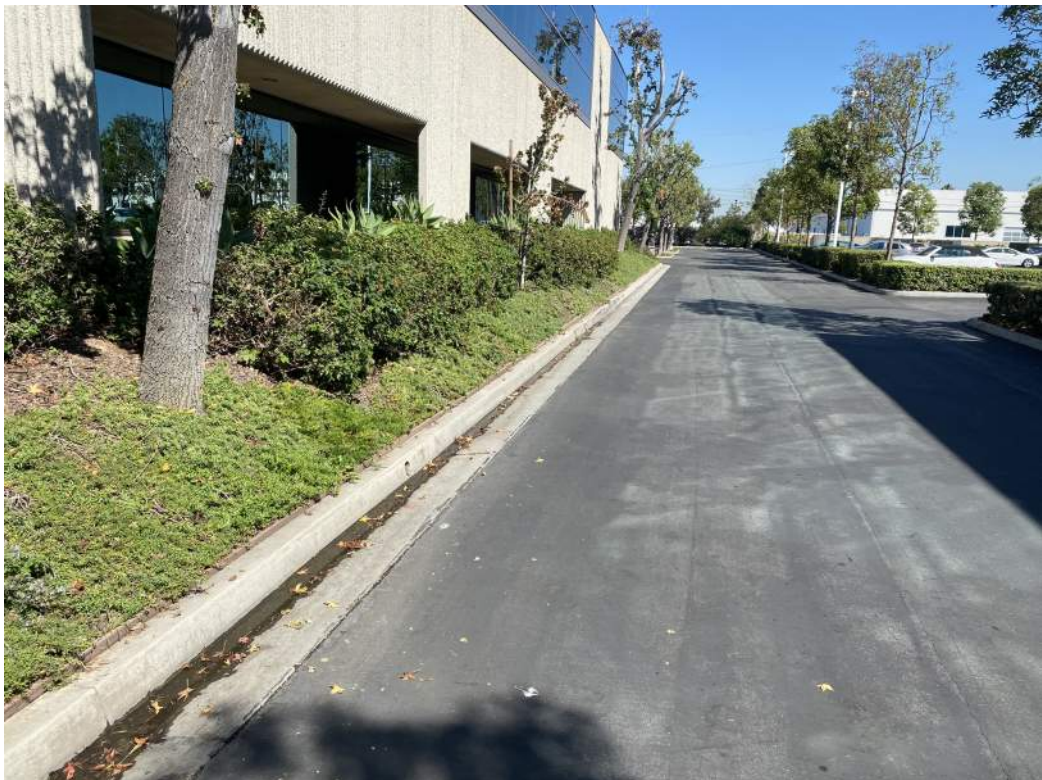
FIG 4: SOUTHEAST ELEVATION OF BUILDING WITH GUTTER
