CITY OF COSTA MESA
PARKS AND COMMUNITY SERVICES COMMISSION
Agenda

PARK ASSESSMENT

2025

Park Assessments were conducted at all public parks within the City of Costa Mesa and have been documented herein. The report identifies physical condition of amenities, structures, pathways, playgrounds, and existing program elements in each park. This parks assessment is essential for the City of Costa Mesa in identifying and prioritizing improvements, allowing for safe, functional and enjoyable spaces for the community to recreate and enjoy.

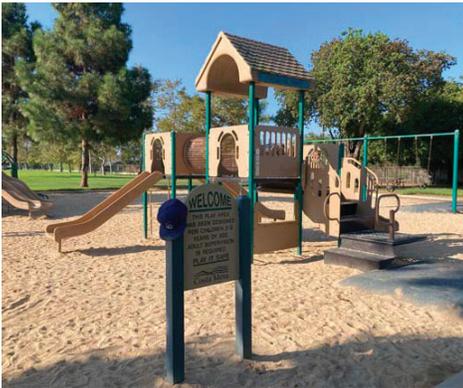
(Figure 1.1)

Figure 1.1 - The playground has a sand and rubber safety surfacing combination. The sand level covers the bottom of the rubber safety surfacing.

Suggested Action- Ensure sand level is at proper depth for fall safety requirements, as sand compacts over time. Additionally, maintain sand level to be within 2-3 inches to the top of the beveled edge of the rubber safety surfacing. Consider removing the sand and replace with rubber safety surfacing.

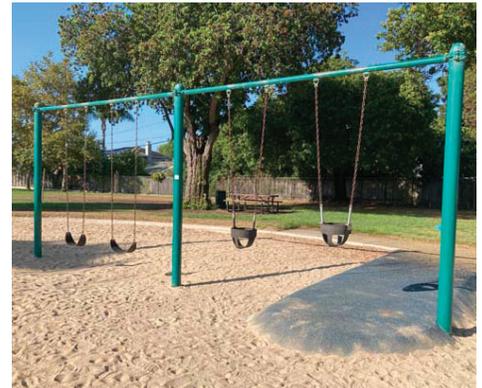
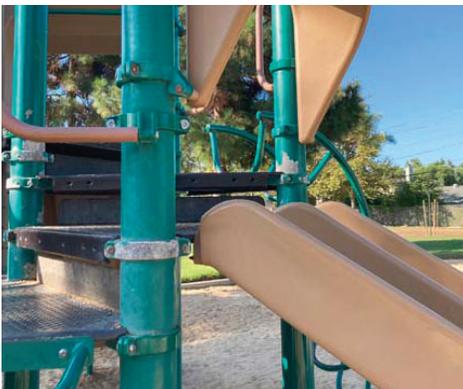
Figure 1.3, 1.4 - Powder coating is damaged and worn off on posts, caps, and components.

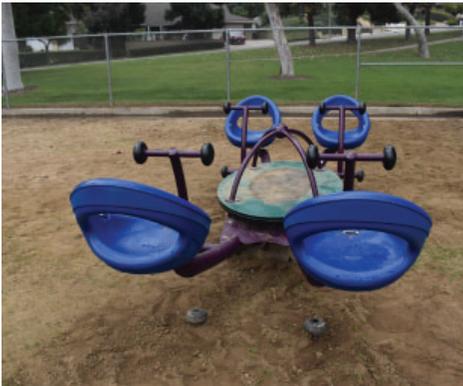
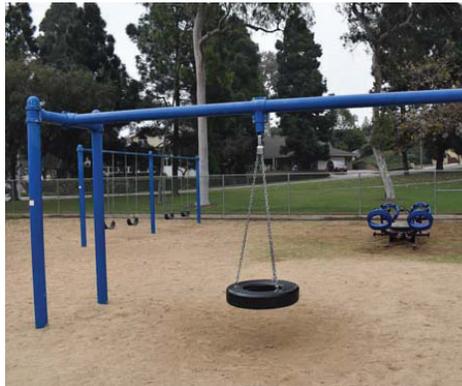
Figure 1.01, 1.02 - Play components are in good condition, parts are intact, color is bright.

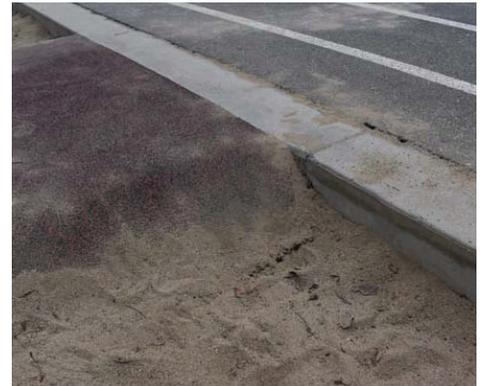
(Figure 1.03)

Figure 1.03 - The playground has a sand and rubber safety surfacing combination. The sand level is lower than the bottom of the rubber safety surfacing.

Suggested Action- Ensure sand level is at proper depth for fall safety requirements, as sand compacts over time. Additionally, maintain sand level to be within 2-3 inches to the top of the beveled edge of the rubber safety surfacing. Consider removing the sand and replace with rubber safety surfacing.

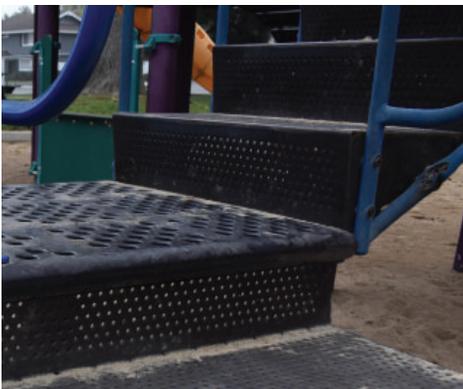
(Figure 1.04)

Figure 1.04 - Bottom rail of handrail is broken and rusting.

Suggested Action- Assess the damage and replace handrail when needed.

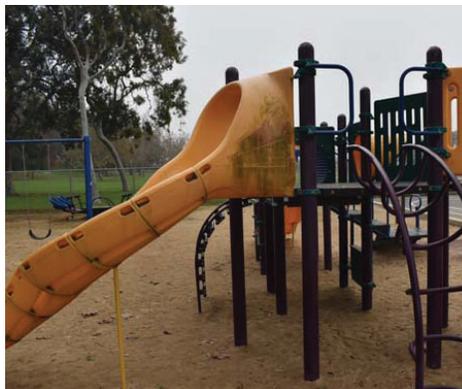
(Figure 1.05)

Figure 1.05, 1.06 - Dirt/mold growth on the slide. Powder coating is damaged and worn off on posts, caps, and components.

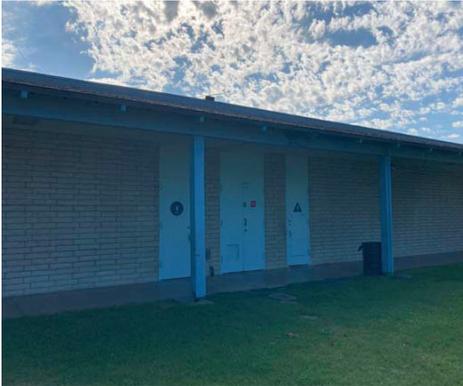
(Figure 2.1)

Figure 2.1 - The restrooms are located in the community center.

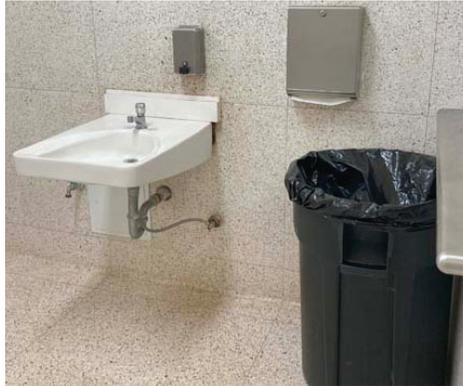
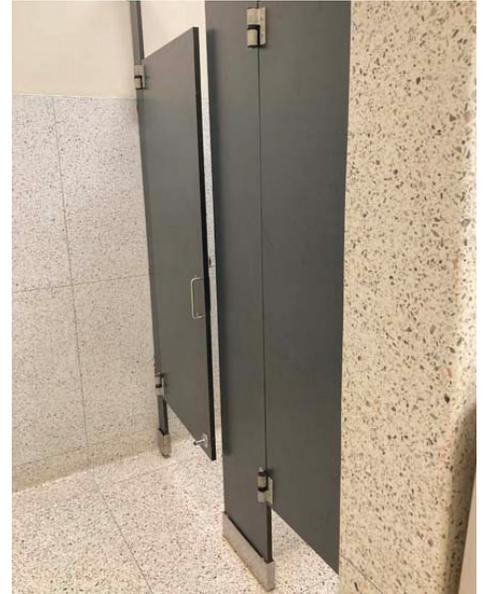
Figure 2.2, 2.3 - The interior of the restrooms are very clean.

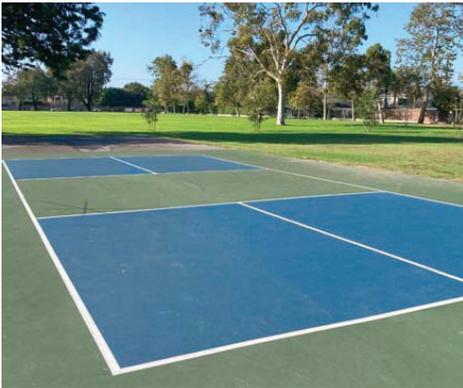
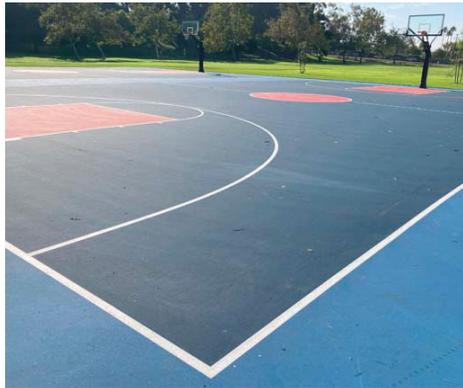
Figure 3.1, 3.2 - The pickleball courts and the basketball courts are in good condition. The color is vibrant, the lines are clear, and the pavement has no cracking.

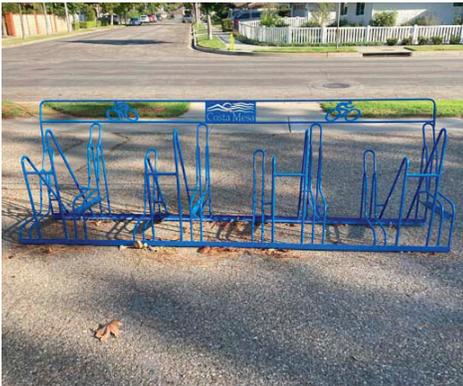
(Figure 4.1)

Figure 4.1 - Bike rack is in good condition. Color is bright, minor scratches or chipping of paint is observed. City logo is visible.

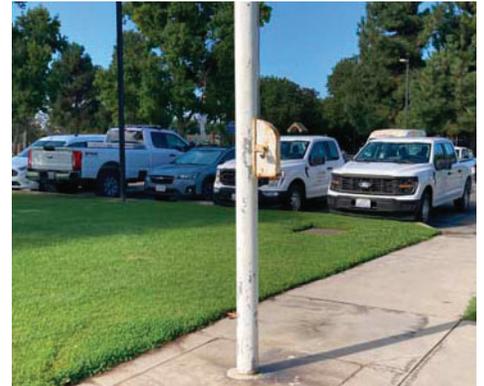
(Figure 4.3)

Figure 4.3 - Paint is chipping and rust forming on the flagpole.

Suggested action- Repaint the flagpole. Replace the winch component which has rusted.

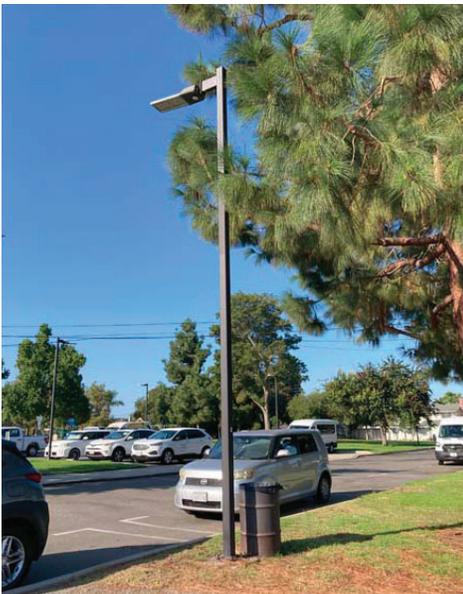
(Figure 4.4)

Figure 4.4 - Lighting was not assessed, but the fixtures appear to be energy efficient LED.

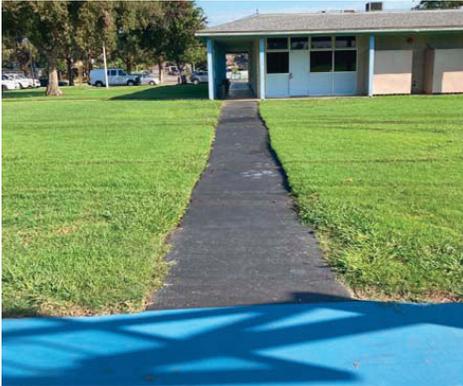
(Figure 5.1)

Figure 5.1 - Asphalt path connecting community center to basketball and pickleball courts has no edging to prevent turf overgrowing along the sides.

Suggested Action- Replace with concrete to ensure accessibility and ADA compliance.

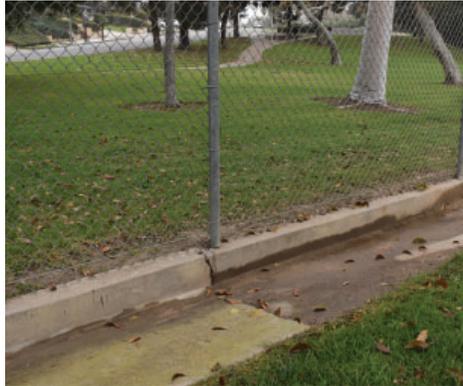
(Figure 5.2)

Figure 5.2 - Cracking in the retaining curb at the playground adjacent to the community center building.

Suggested Action- Replace or replace broken concrete.

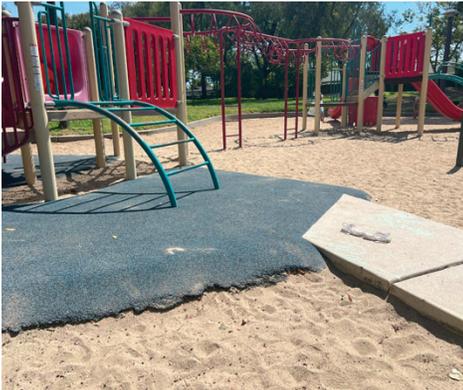
(Figure 1.1)

Figure 1.1 - Rubber safety surfacing edge is exposed above the level of sand.

Suggested Action- Ensure sand level is at proper depth for fall safety requirements, as sand compacts over time. Additionally, maintain sand level to be within 2-3 inches to the top of the beveled edge of the rubber safety surfacing. Consider removing the sand and replace with rubber safety surfacing.

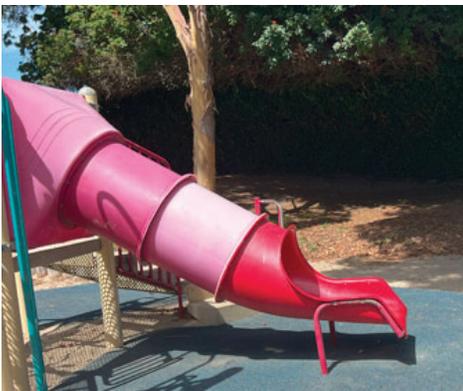
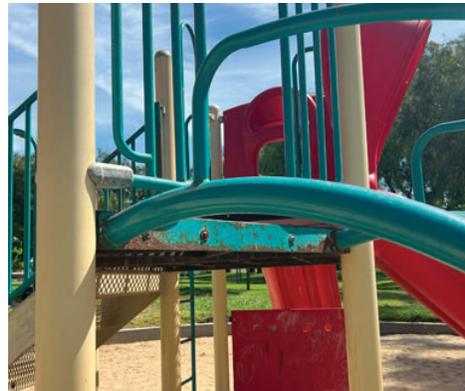
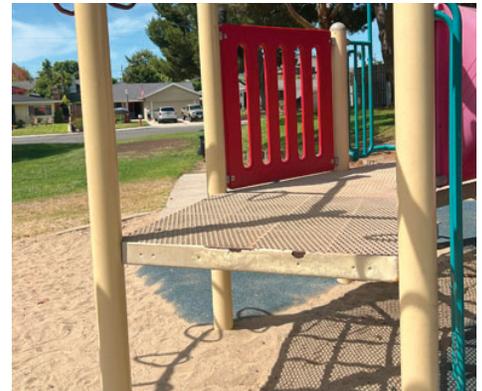
Figure 1.4, 1.5, 1.6 - The play structure has damaged or worn off powder coating on posts, caps, and components. The slide parts have varying degrees of sun damage and rusting at the attachments. Rust is observed on the metal bracket of the climbing ladder. The edge of the platform is breaking.

*(Play equipment is 30 years old in 2025,
replacement scheduled for 2025)

Suggested Action- Given the age of the play structure and the current condition of its parts, it is recommended to replace the play structure.*

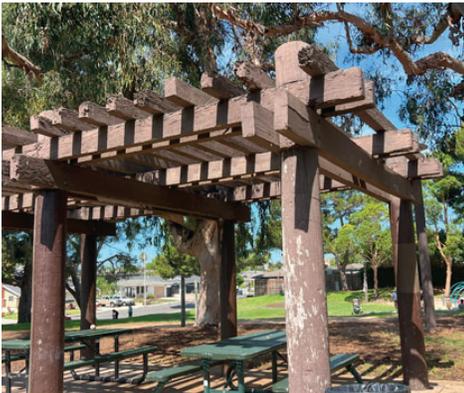
(Figure 2.1)

Figure 2.1 - Wood shade structure has termite damage and paint chipping.
Suggested Action- Replace the shade structure.

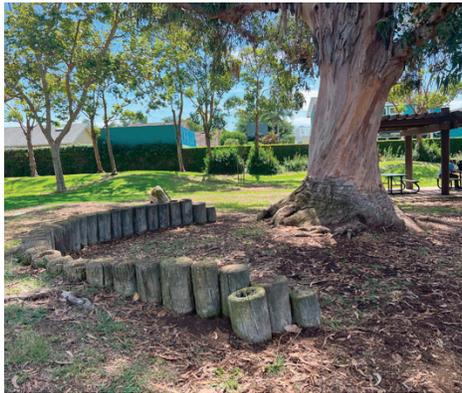
(Figure 2.2)

Figure 2.2 - Wood posts are rotted out in various areas.
Suggested Action- Replace or remove wood posts.

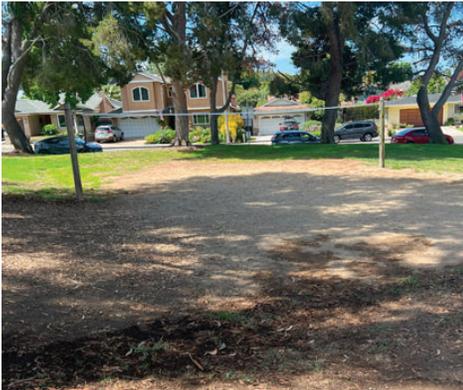
(Figure 3.1)

Figure 3.1 - There is no clear delineation where the sand volleyball court begins from the turf.

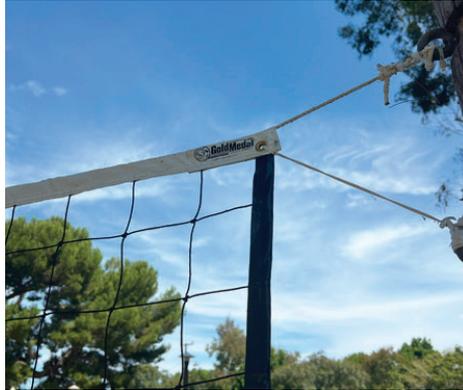
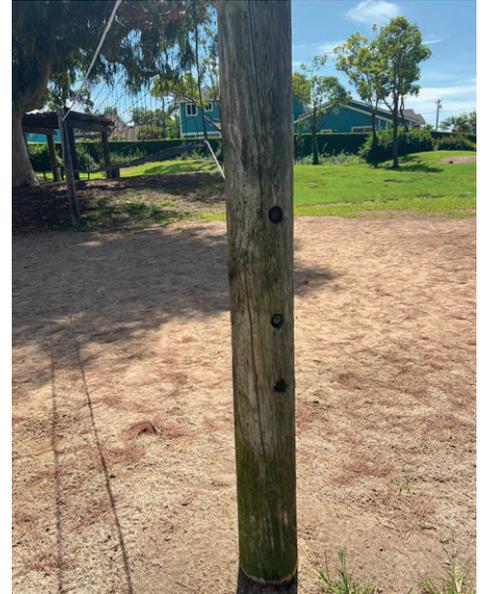
Figure 3.2, 3.3 - The volleyball net is securely tied to the post, but the wood post is splintering and shows signs of prolonged moisture.

Suggested Action- Replace volleyball posts.

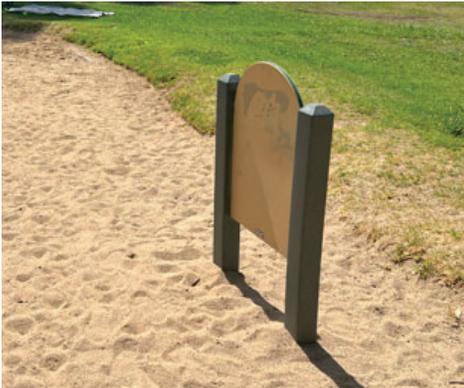
(Figure 5.1)

Figure 5.1- Concrete curb between playground sand area and turf is disappearing under the sand and turf.
Suggested Action- Replace concrete curb along playground area.

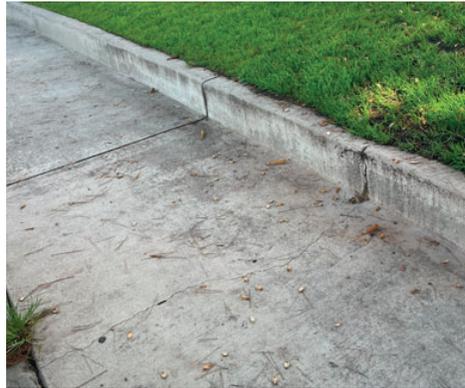
(Figure 5.2)

Figure 5.2- Multiple areas of cracking on the curb and sidewalk along the park boundary were observed.
Suggested Action- Replace with new concrete curb and sidewalk.

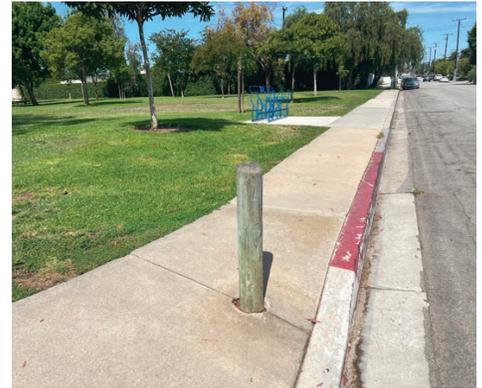
(Figure 5.3)

Figure 5.3- Gap in the concrete around the wooden bollard.
Suggested Action- Repair the broken concrete, and consider replacing the bollards (see Amenities section).

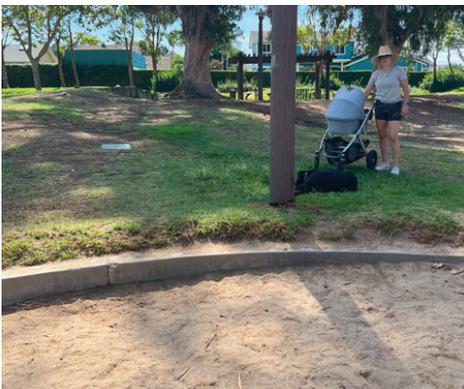
(Figure 5.4)

Figure 5.4- Concrete curb around playground is cracking.
Suggested Action- Replace with new concrete curb.

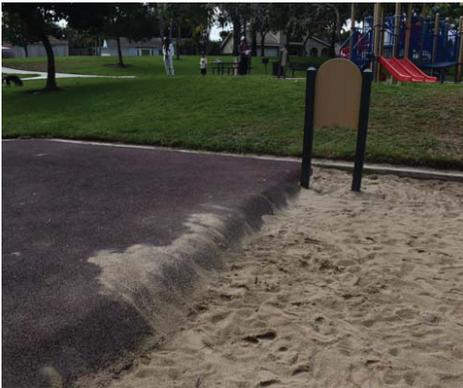
(Figure 1.1)

Figure 1.1 - Rubber safety surfacing edge is exposed above the level of sand.

Suggested Action- Ensure sand level is at proper depth for fall safety requirements, as sand compacts over time. Additionally, maintain sand level to be within 2-3 inches to the top of the beveled edge of the rubber safety surfacing. Consider removing the sand and replace with rubber safety surfacing.

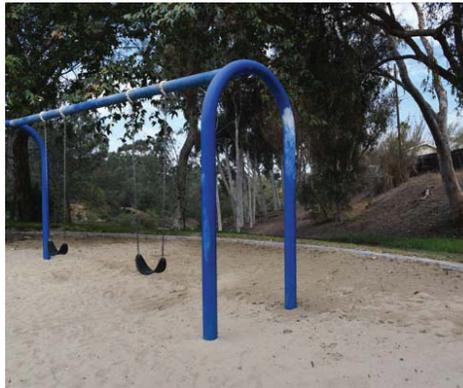
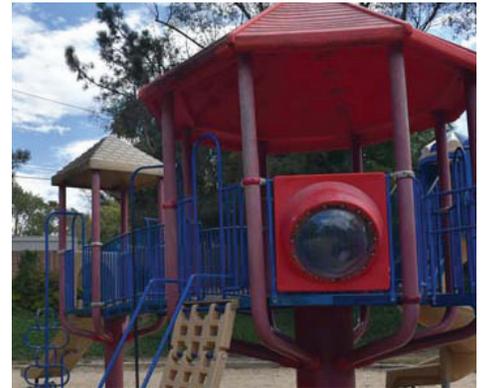
Figure 1.2, 1.3 - The play equipment has damaged or worn off powder coating on posts, caps, and components. The pyramid roofs on the play structure are blackened.

Manufacturer: Miracle Recreation
Year Installed: 1997
(Play equipment is 28 years old in 2025)

Suggested Action- Given the age of the play equipment and the current condition of its parts, it is recommended to replace the play structures.

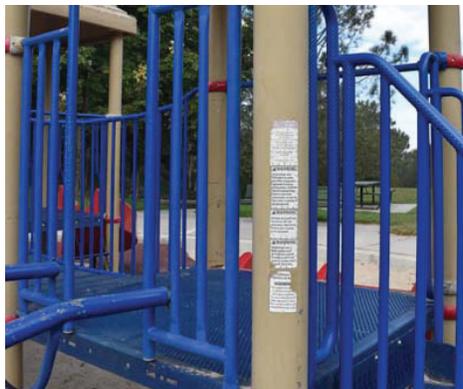
(Figure 1.5)

Figure 1.5 - Manufacturer's warning labels are deteriorating.

Suggested Action- Replace labels to be in compliance with industry standards.

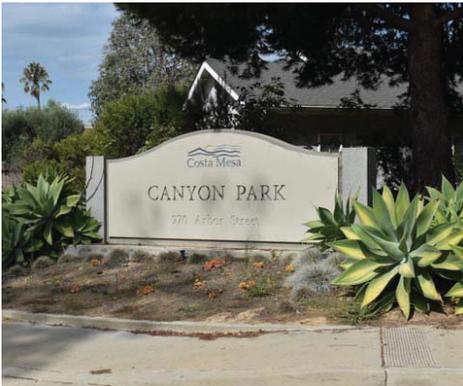
(Figure 4.1)

Figure 4.1 - Park monument sign is in good to excellent condition.

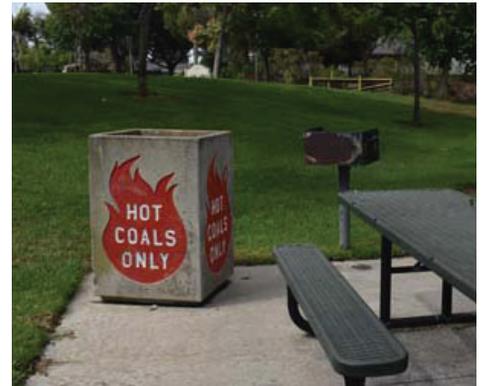
(Figure 4.3)

Figure 4.3 - BBQ grill shows extreme heat damage from repeated use over time. The picnic table has several small, broken spots.
Suggested Action- Replace with a new BBQ grill and picnic table.

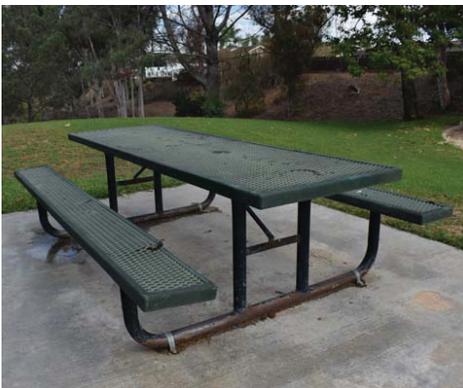
(Figure 4.4)

Figure 4.4 - Picnic table bench seat is torn and unsafe for sitting. The frame and table, bench surfaces are rusting.
Suggested Action- Replace with a new picnic table.

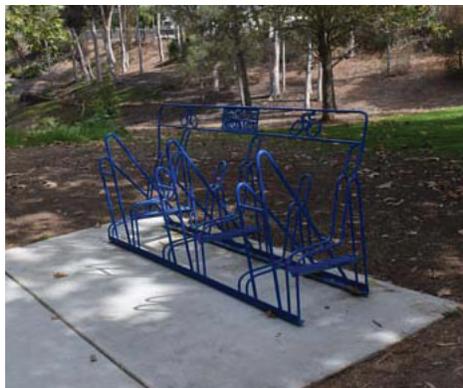
(Figure 4.5)

Figure 4.5 - Bike rack is in good condition, mounted securely to concrete, and well-located next to the road.

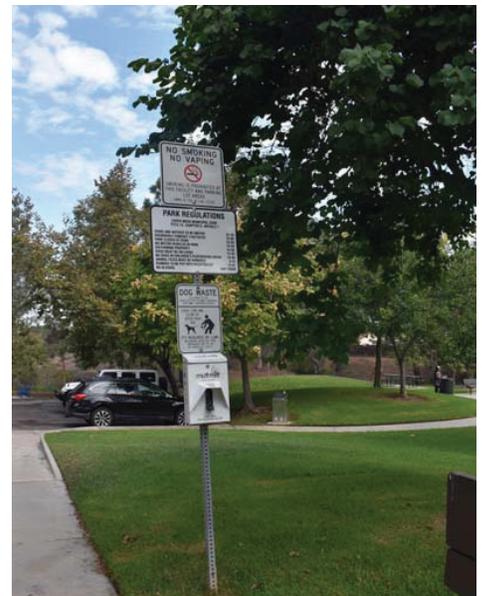
(Figure 4.6)

Figure 4.6 - Park signs and dog waste station are positioned at entrance of park and signs are legible.

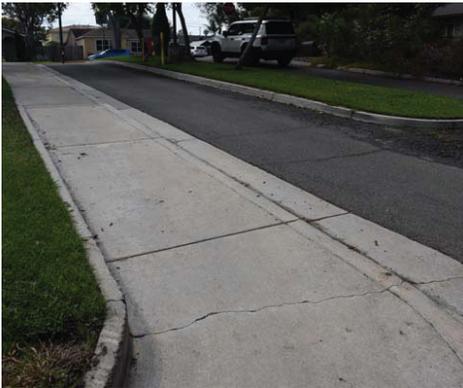
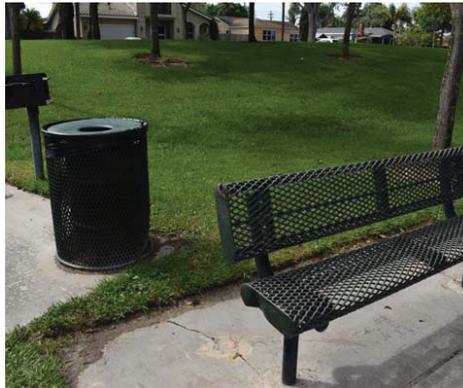
Figure 5.1, 5.2 - Cracks observed in the sidewalk, paved pathway and paved areas in the park.
Suggested Action- Replace areas of broken concrete.

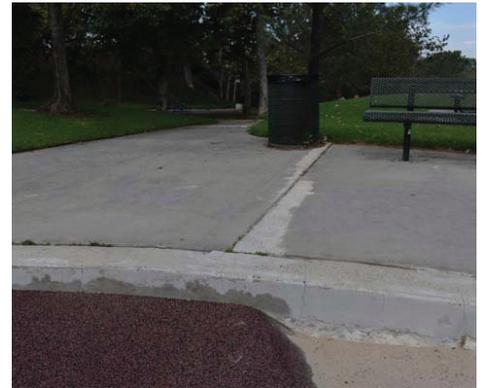
(Figure 5.3)

Figure 5.3 - Cracks observed in the concrete band at the playground.
Suggested Action- Replace concrete band.

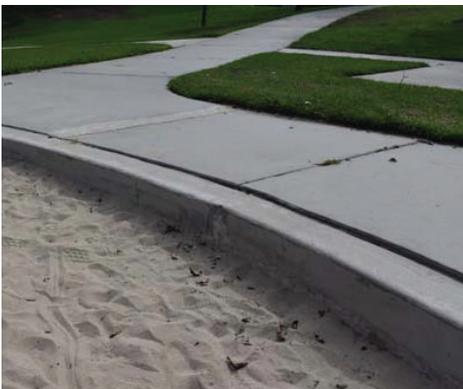
(Figure 5.4)

Figure 5.4 - Paved pathway is lifting from the concrete band at the playground.
Suggested Action- Monitor lifting and repair as needed.

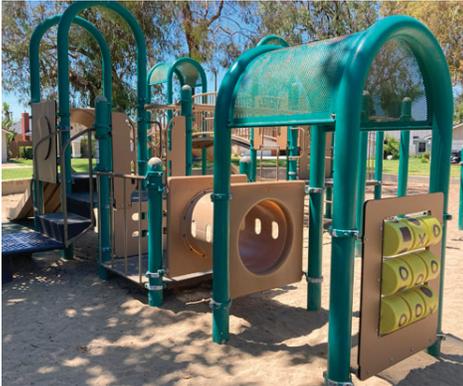
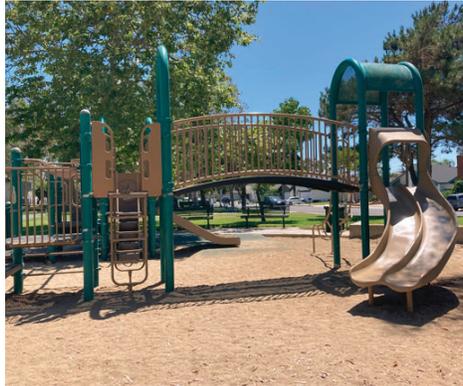
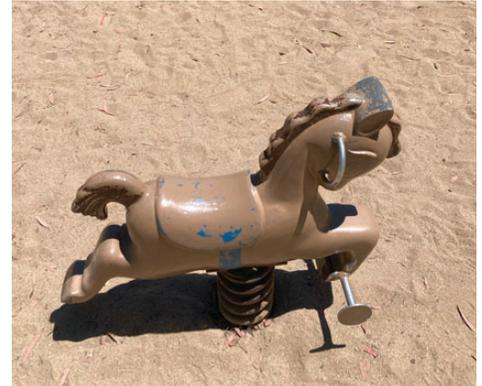
Figure 1.1, 1.2, 1.3 - The play structure has damaged or worn off powder coating on posts, caps, and components.
Suggested Action- Considering the age of the play equipment exceeds 15 years, it is suggested to assess feasibility of replacing the play equipment.

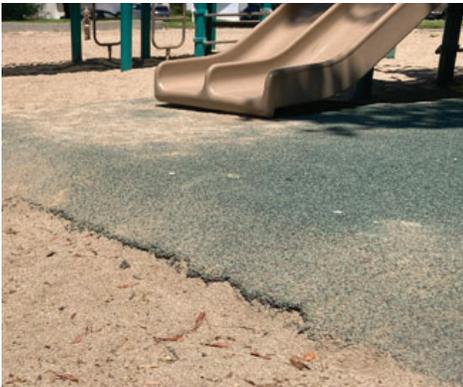
(Figure 1.4)

Figure 1.4 - Rubber safety surfacing edging is exposed above the level of sand.
Suggested Action- Ensure sand level is at proper depth for fall safety requirements, as sand compacts over time. Additionally, maintain sand level to be within 2-3 inches to the top of the beveled edge of the rubber safety surfacing. Consider removing the sand and replace with rubber safety surfacing.

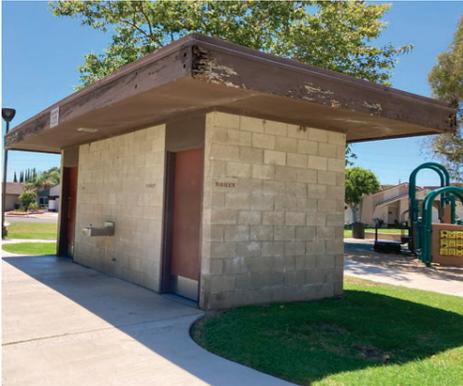
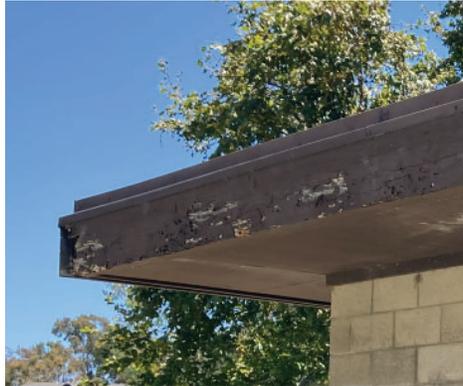
Figure 2.1, 2.2 - The restroom structure has termite damage in the wood on the roof.
Suggested Action- Replace the wood roof.

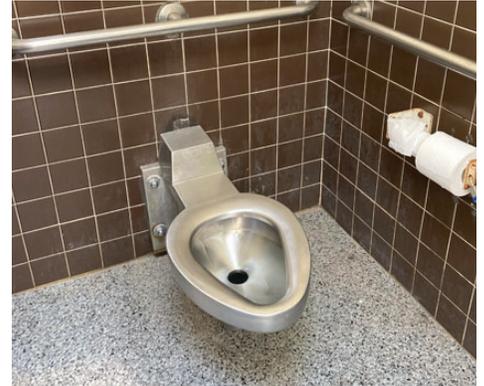
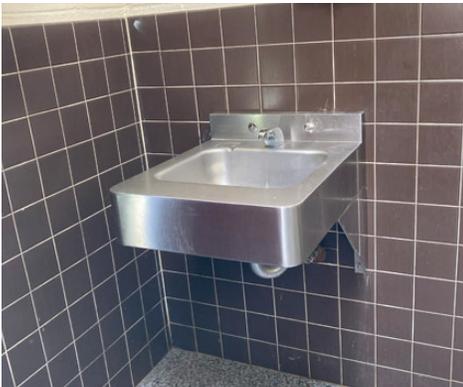
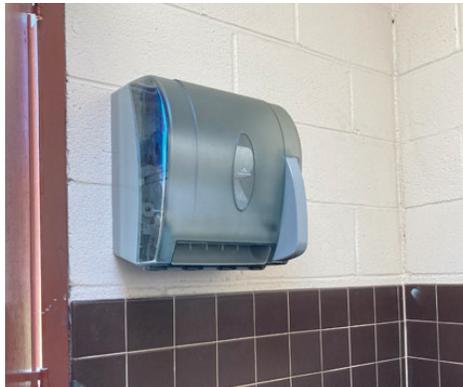
Figure 2.3, 2.4, 2.5 - Existing restroom interior is clean and is in good condition.

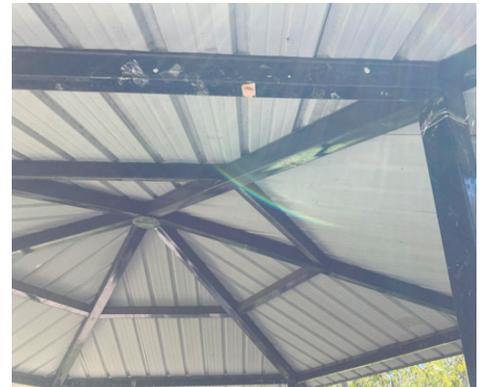
(Figure 2.6)

Figure 2.6 - The shade structure over the picnic area is in good condition, but has remnants of decorations accumulating on the beams and posts.

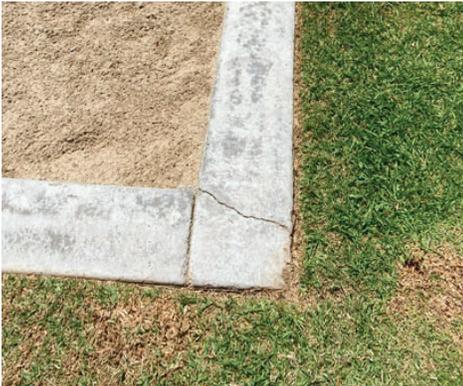
(Figure 3.1)

Figure 3.1 - The concrete band around the sand volleyball court is showing cracks in some areas.

Suggested Action- Consider replacement of the concrete band.

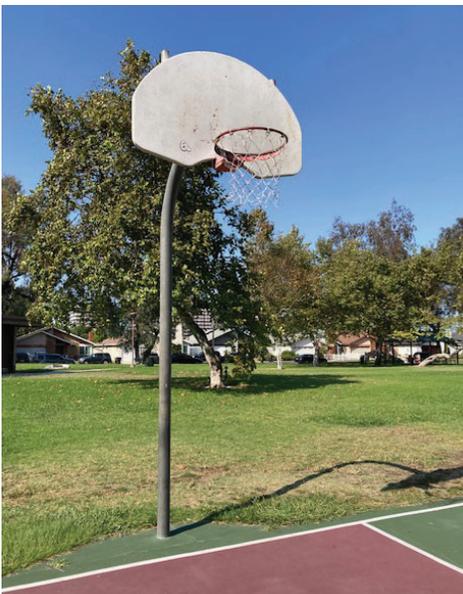
(Figure 3.4)

Figure 3.4 - The basketball hoop and net are in fair condition.

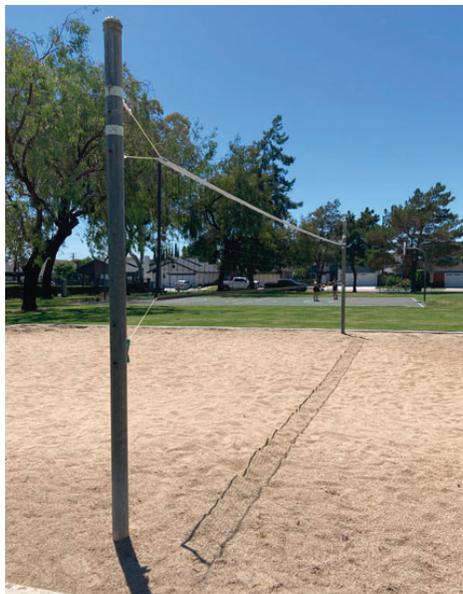
(Figure 3.5)

Figure 3.5 - The volleyball posts and net are in fair condition.

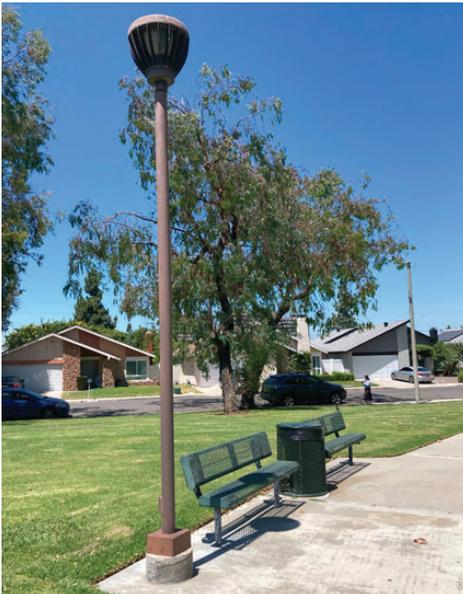
(Figure 4.1)

Figure 4.1 - Lighting was not assessed. The fixtures are an older style.
Suggested Action- Replace lights with energy efficient LED if not already done.

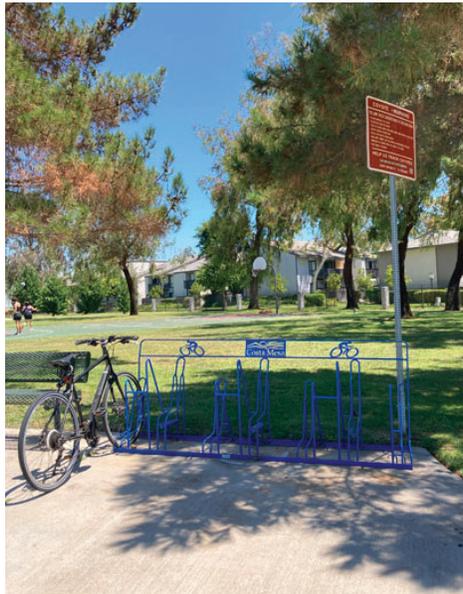
(Figure 4.2)

Figure 4.2 - Bike rack is in good condition. The color is bright, the city logo is visible. Minimal signs of wear and tear.

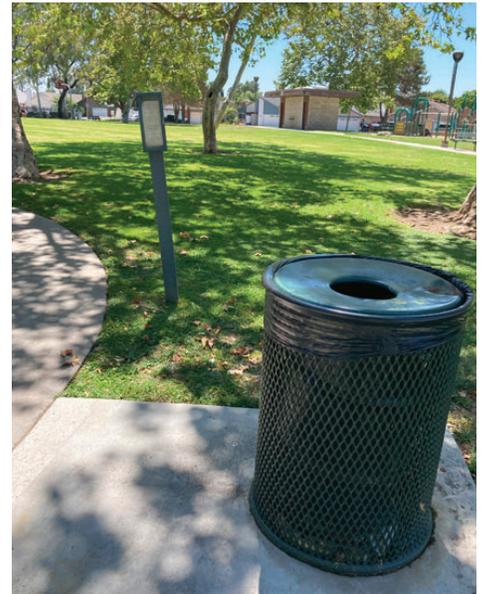
(Figure 4.3)

Figure 4.3 - Waste receptacles located throughout the park. No staining on the concrete underneath. Minimal damage to the lid on the waste receptacle pictured.
Suggested Action- Consider replacing with waste/recycling combination receptacles at the picnic shelter area.

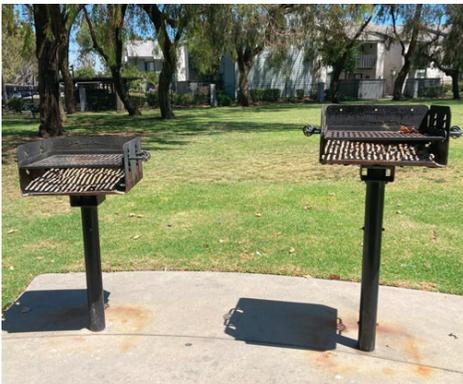
(Figure 4.4)

Figure 4.4 - BBQ grills are in fair condition. Signs of rusting and flaking observed on the surface.

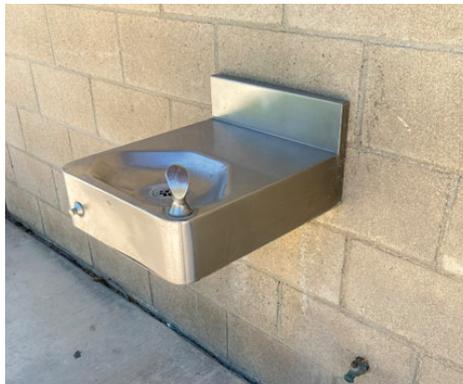
(Figure 4.5)

Figure 4.5 - The drinking fountain (located on the restroom building exterior) is clean and in excellent condition.

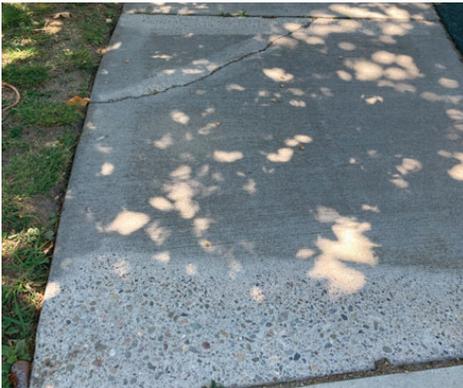
(Figure 5.1)

Figure 5.1 - Cracks observed in the concrete walkway.

Suggested Action- Replace areas of broken concrete.

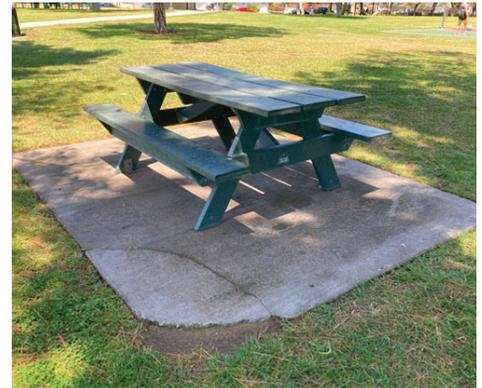
(Figure 5.3)

Figure 5.3 - Cracks in the concrete pads under the picnic tables.

Suggested Action- Replace concrete pads.

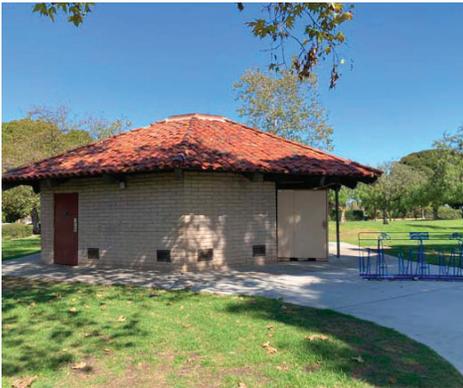
(Figure 2.1)

Figure 2.1 - The restroom building walls and roof match the look of the nearby historic Diego Sepulveda Adobe. The building is in fair to good condition. The roof has some missing tiles. The walls show areas that have been patched (around the doors and the base of the wall) and painted over.

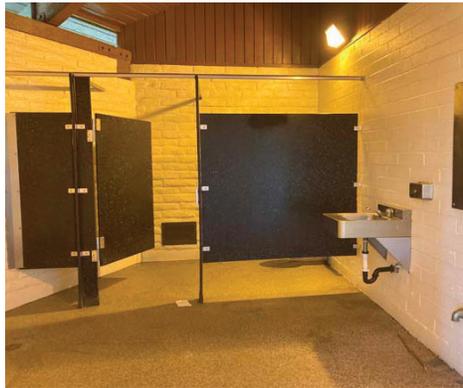
(Figure 2.2)

Figure 2.2 - The interior of the restroom is clean, has lighting, and is in fair to good condition.

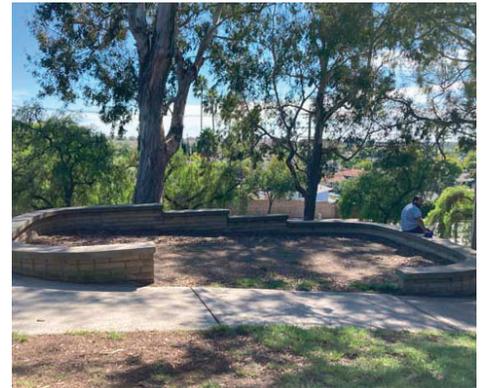
(Figure 2.3)

Figure 2.3 - The seatwall at an entrance to the Hillside Pathway is in poor to fair condition. There are some cracks and discoloration.

Suggested Action- Repair or replace the seatwall.

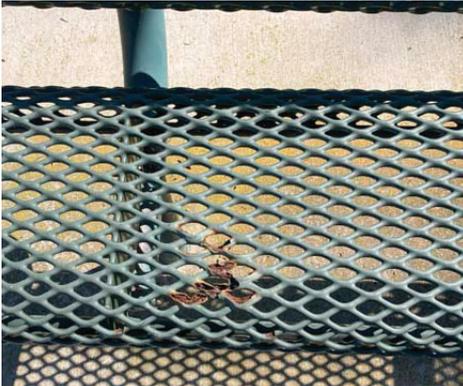
(Figure 4.1)

Figure 4.1 - Bench has a broken spot that is rusting.
Suggested Action- Replace the bench.

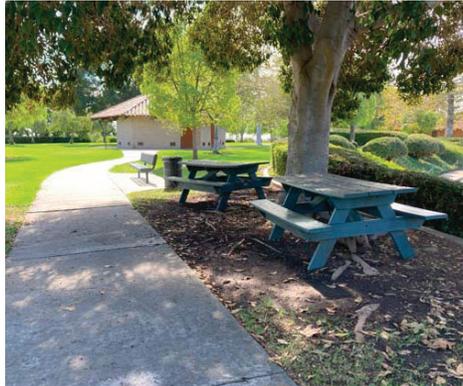
(Figure 4.2)

Figure 4.2 - Picnic tables are placed in turf area; turf will struggle to grow where there is soil compaction from frequent foot traffic.
Suggested Action- Relocate picnic tables and repair the damaged turf areas.

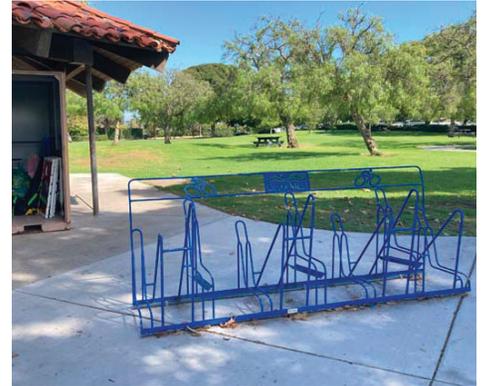
(Figure 4.3)

Figure 4.3 - Bike rack is in good condition. Color is bright, no scratches or chipping of paint is observed. City logo is visible.

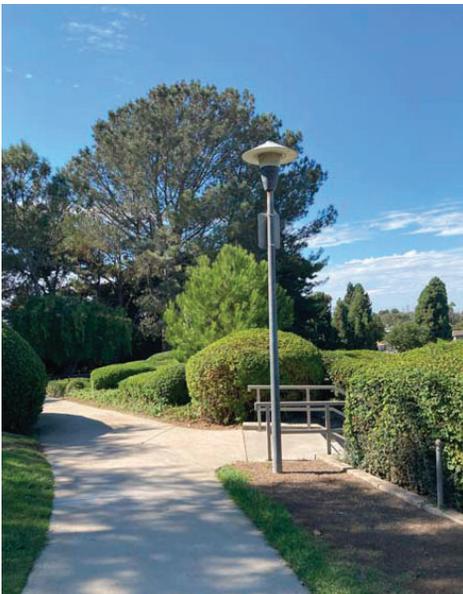
(Figure 4.4)

Figure 4.4 - Lighting was not assessed. The fixtures are an older style. The paint has worn off on the pole.
Suggested Action- Replace lights with energy efficient LED if not already done. Consider replacing the light poles.

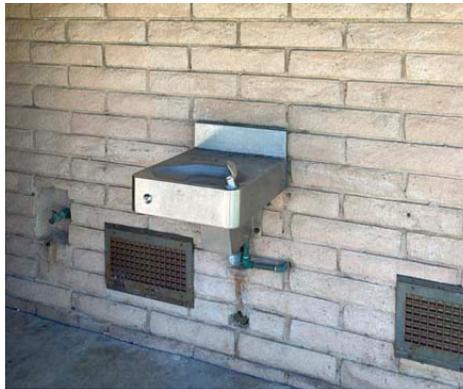
(Figure 4.5)

Figure 4.5 - The drinking fountain is located on the restroom building exterior and is in fair condition. There is some water staining on the walls from the piping.

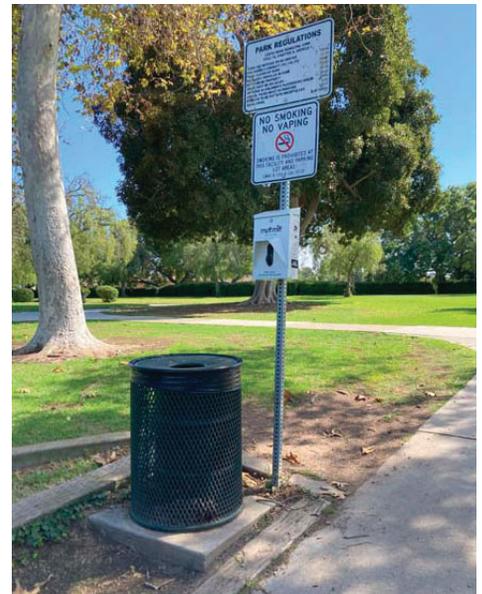
(Figure 4.6)

Figure 4.6 - The sign has bird droppings on it, making it difficult to read.
Suggested Action- Add bird deterrents to the tops of signs and/or posts.

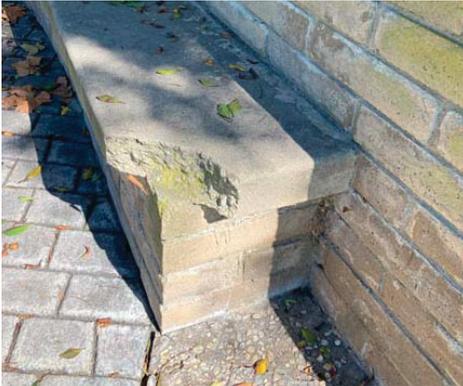
(Figure 4.7)

Figure 4.7 - Concrete bench is broken, and is in very poor to poor condition (this is part of the Hillside Pathway).

Suggested Action- The broken bench which is attached to the wall and the pathway are all showing signs of age and noticeable wear and tear (see Hardscape and Structures sections). Consider the redesign of the hillside hardscapes area (the paved pathway, stairs, retaining walls and benches).

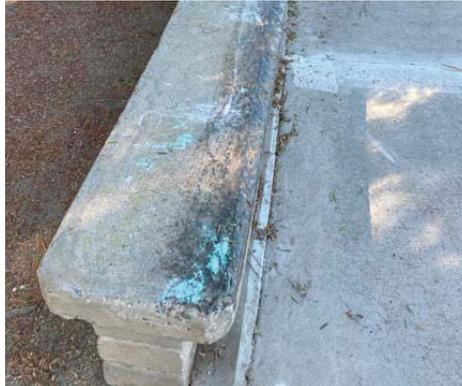
(Figure 4.8)

Figure 4.8 - Concrete bench is scraped and is in poor condition (this is part of the Hillside Pathway).

Suggested Action- Replace bench and install anti-skateboarding guards on the new bench.

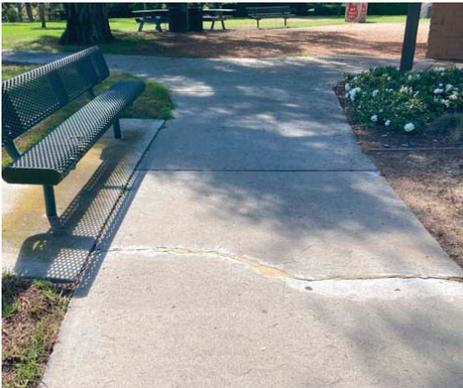
(Figure 5.1)

Figure 5.1 - Cracks observed in the concrete walkway.

Suggested Action- Replace areas of broken concrete.

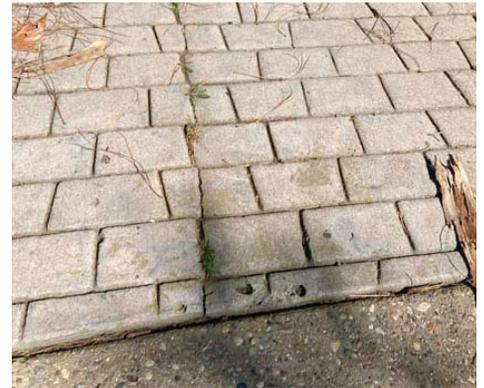
(Figure 5.3)

Figure 5.3 - Stamped concrete is old, cracking (this is part of the Hillside Pathway).

Suggested Action- Replace areas of broken concrete.

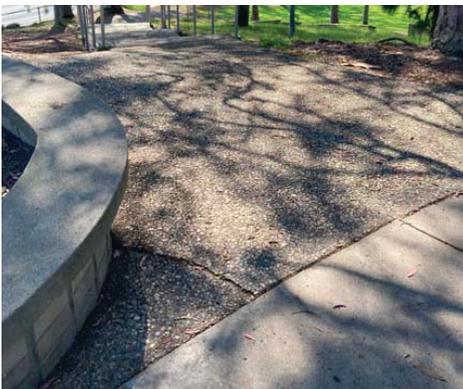
(Figure 5.4)

Figure 5.4 - Exposed aggregate path is cracking and sloping downward (this is part of the Hillside Pathway).

Suggested Action- Replace areas of broken concrete.

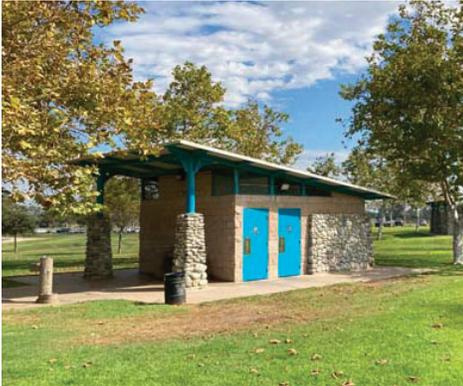
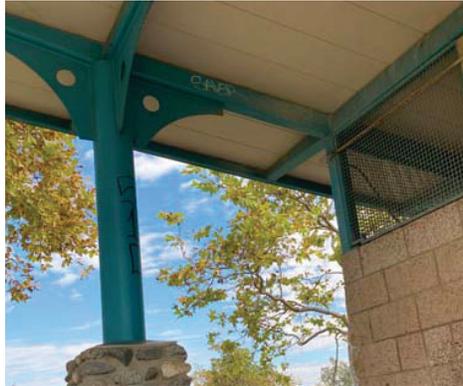
Figure 2.1, 2.2 - The restroom building is in fair to good condition. The stonework is whole and intact. The paint color is slightly patchy with a mix of differing shades, but similar enough to not notice from a distance. The paint is cracking and chipping in some areas.

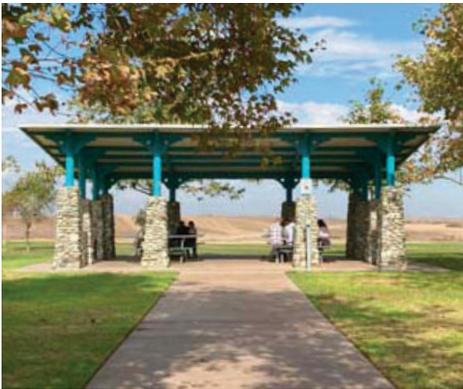
(Figure 2.4)

Figure 2.4 - The picnic area shelter is in good condition. The stonework is whole and intact. The concrete paving is whole and intact. There is an accessible paved pathway connecting the shelter to the parking lot. However, there is no paved pathway connecting the picnic area to the restroom.

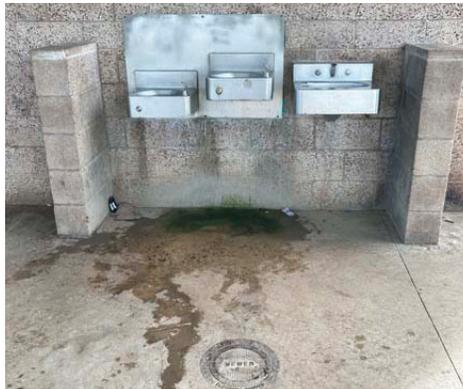
(Figure 4.5)

Figure 4.5 - The wall-mounted drinking fountains on the exterior of the restroom building have water accumulating on the floor underneath. There appears to be algae growing.
Suggested Action- Clean the area under the drinking fountains and assess the drinking fountains for leaks.

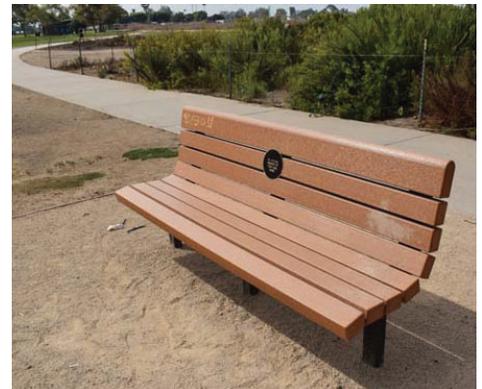
(Figure 4.6)

Figure 4.6 - The bench is in excellent condition.

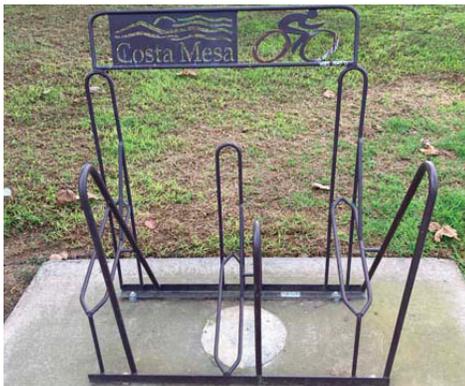
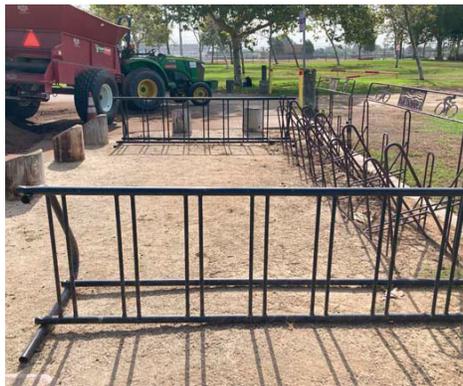
Figure 4.7, 4.8 - Bike racks are in good condition. There are multiple bike trails within the park, and the Santa Ana River Bike Trail and Talbert Nature Reserve Trail are accessible from this park.

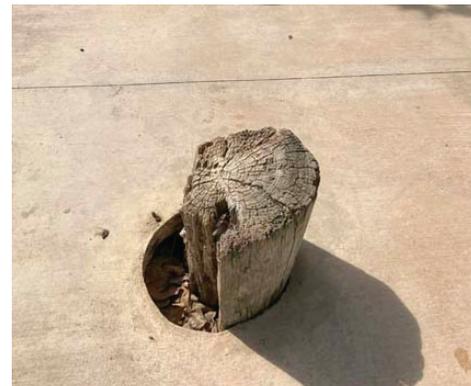
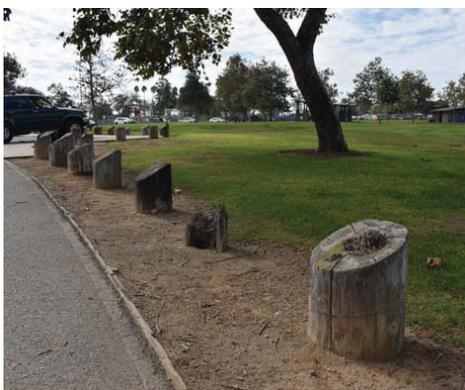
Figure 4.9, 4.10 - The wood bollards around the parking lot are in decline. Some are placed in bare earth and some are located in the paved pathway.

Suggested Action- Remove wood bollards and replace with more durable material. Consider small boulders, which are already placed in a few places in the line of bollards.

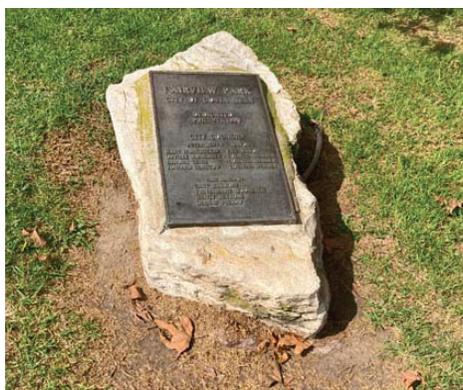
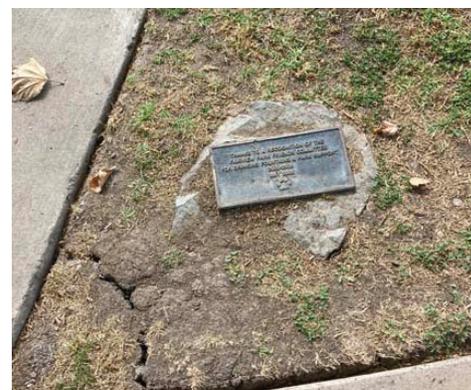
Figure 4.11, 4.12 - Boulders in turf create challenges in mowing and maintenance. One boulder with plaque is small and partially buried (near the drinking fountain) and should be reset.

Suggested Action- Maintenance could be simplified by keeping the turf away from the base of the boulders.

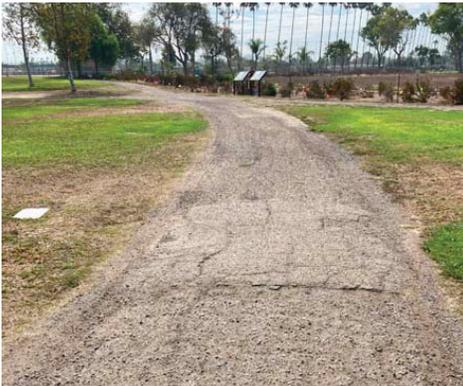
(Figure 5.1)

Figure 5.1 - Asphalt pathway is cracking and surface is uneven.

Suggested Action- Consider replacement with a paved pathway that ensures accessibility and ADA compliance.

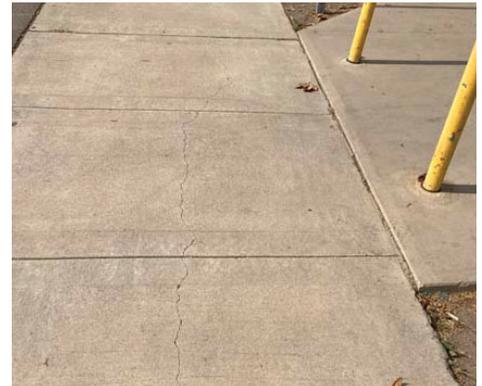
(Figure 5.3)

Figure 5.3 - Concrete is cracking.

Suggested Action- Replace broken areas of concrete.

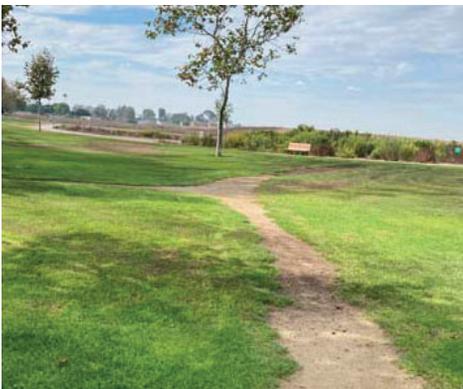
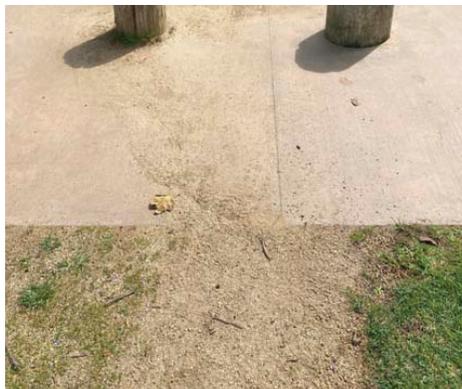
Figure 5.4, 5.5 - The park has inadequate pathways. Natural footpaths have been established in the park. The transition where footpath meets the paved pathway has become a slipping safety hazard.

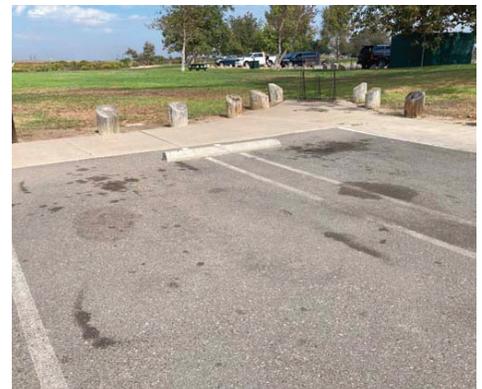
(Figure 5.6)

Figure 5.6 - Parking lot pavement has oil stains and the striping is faded.

Suggested Action- Remove the stains or consider replacing the parking lot pavement. Apply a sealer to the asphalt regularly to protect the surface from damage. Repaint the striping.

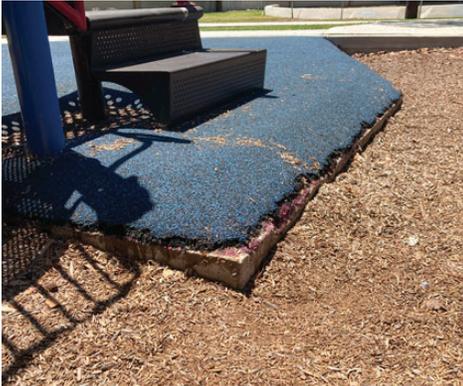
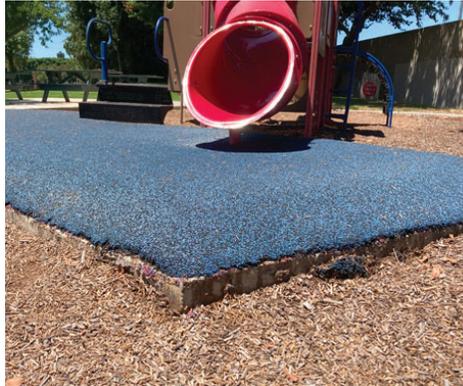
Figure 1.1, 1.2 - The wood fiber level is too low, allowing the base of the rubber safety surfacing to be exposed. The safety surfacing is broken along the edges and no longer covers over the concrete subbase.

Suggested Action- Ensure wood fiber level is at proper depth for fall safety requirements, as the wood fiber compacts over time. Additionally, maintain wood fiber level to be within 2-3 inches to the top of the beveled edge of the rubber safety surfacing. Replace the rubber safety surfacing. Consider removing the wood fiber and replace with rubber safety surfacing.
