CITY OF COSTA MESA
PARKS AND COMMUNITY SERVICES COMMISSION
Agenda

PARK ASSESSMENT

2025

Park Assessments were conducted at all public parks within the City of Costa Mesa and have been documented herein. The report identifies physical condition of amenities, structures, pathways, playgrounds, and existing program elements in each park. This parks assessment is essential for the City of Costa Mesa in identifying and prioritizing improvements, allowing for safe, functional and enjoyable spaces for the community to recreate and enjoy.

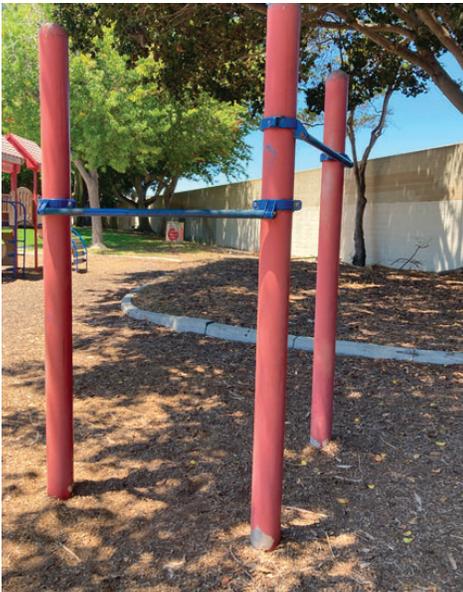
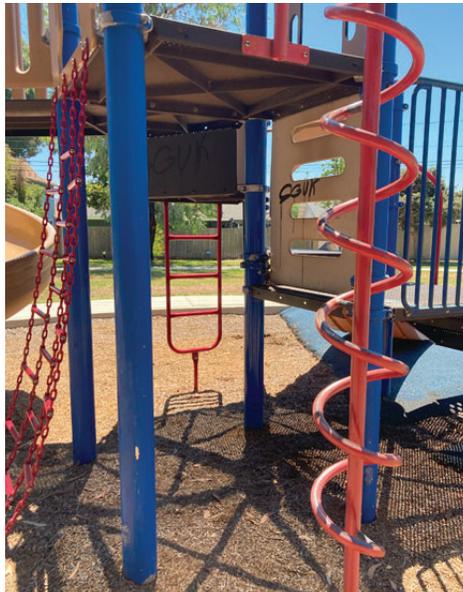
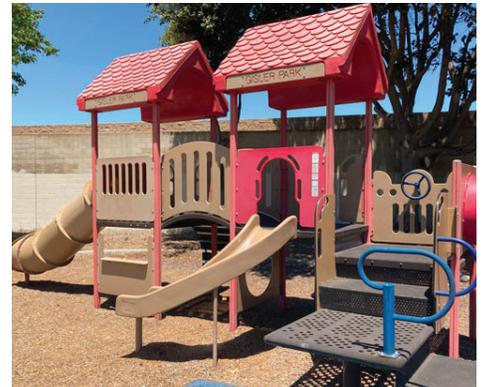
Figure 1.4, 1.5, 1.6 - The play equipment has damaged or worn off powder coating on posts, caps, and components.

Manufacturer: Landscape Structures
Year Installed: 1995
(Play equipment is 30 years old in 2025)

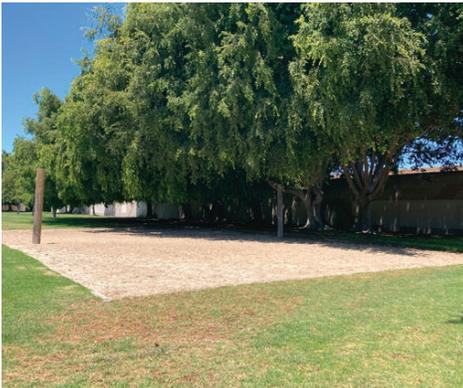
(Figure 3.1)

Figure 3.1 - The sand volleyball court is located near trees that are covering the court. The court is not playable due to the tree branches.

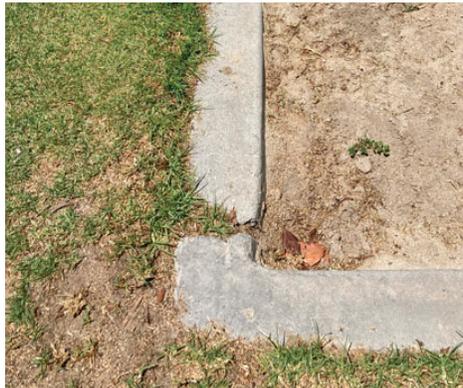
(Figure 3.2)

Figure 3.2 - The concrete band is cracking.

Suggested Action- Remove concrete band if relocating the volleyball court. Repair if court stays in current location.

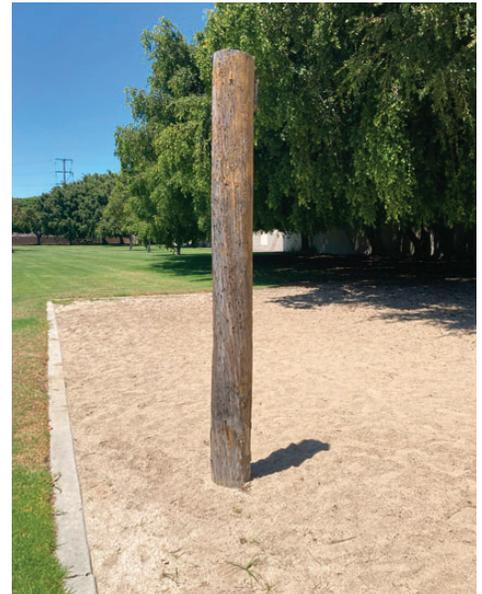
(Figure 3.3)

Figure 3.3 - The wood volleyball posts are old and is missing the net.

Suggested Action- Consider replacing the posts and net.

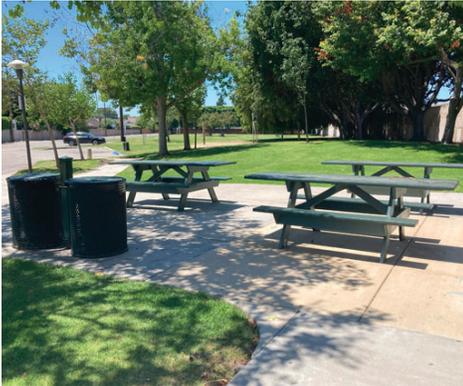
(Figure 4.1)

Figure 4.1 - Picnic tables are well located on concrete paving near the playground and some trees.

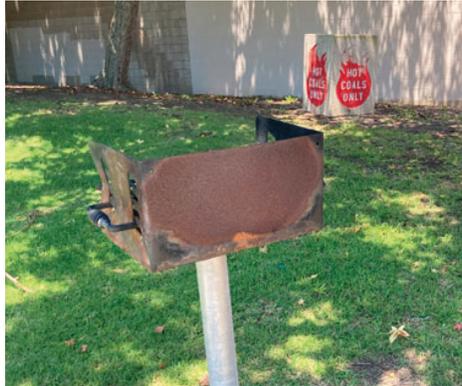
(Figure 4.2)

Figure 4.2 - The BBQ grill is rusted and warping.

Suggested Action- Replace the grill and place the hot coals receptacle nearer to the grill.

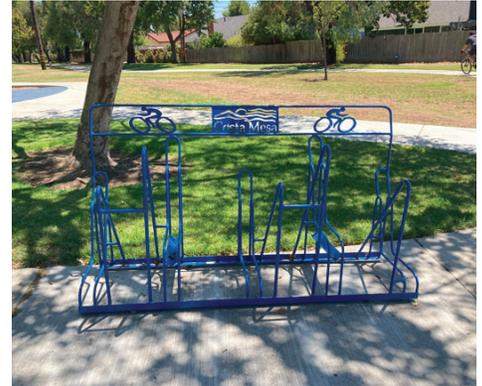
(Figure 4.3)

Figure 4.3 - The bike rack is in good condition. Color is bright, minor scratches or chipping of paint is observed. City logo is visible.

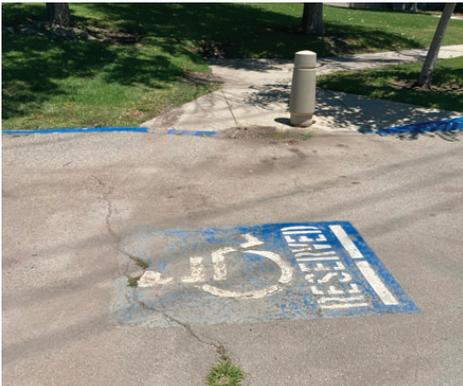
(Figure 5.1)

Figure 5.1 - Cracks observed in the parking lot, the painting for the accessible parking marker is faded, and tire marks are seen in the dried mud indicate a vehicle going onto the paved pathway.

Suggested Action- Repair cracks in the asphalt parking lot. Repaint parking lot markers that are faded. Assess if there is need for a vehicular pavement path as there is utility infrastructure located at the east end of the park.

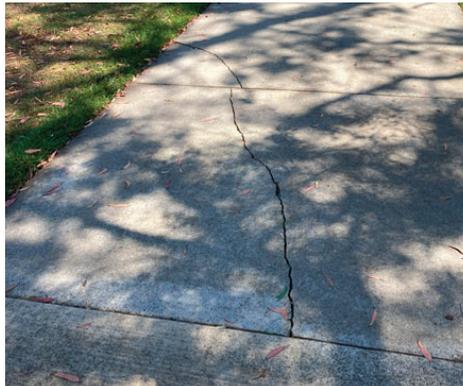
(Figure 5.2)

Figure 5.2 - Paved pathway is cracking.

Suggested Action- Replace areas of broken concrete.

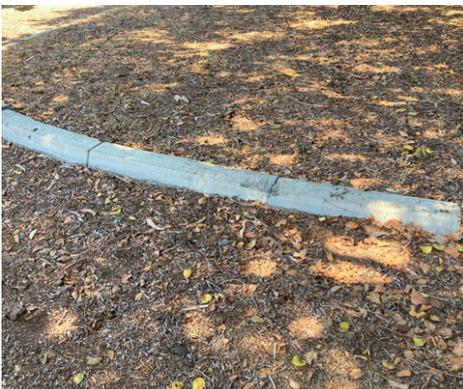
(Figure 5.4)

Figure 5.4 - Concrete curb at the playground is cracking.

Suggested Action- Replace concrete curb.

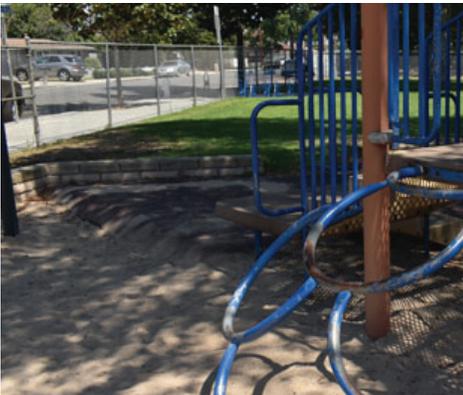
(Figure 1.3)

Figure 1.3 - Turf area is damaged along the concrete maintenance band of the rubber safety surfacing.

Suggested Action- Repair and level the turf, concrete maintenance band and safety surfacing to prevent a trip hazard.

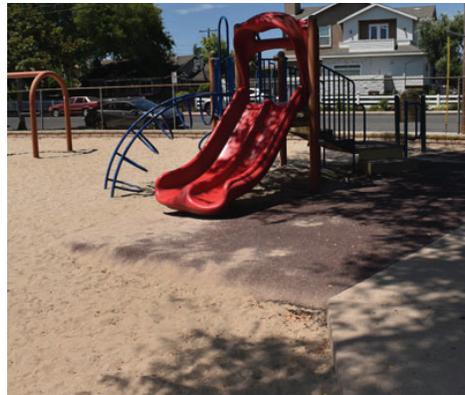
(Figure 1.4)

Figure 1.4, 1.5 - Rubber safety surfacing edge is exposed above the level of sand. Sand is spread over the top of the rubber safety surfacing, which can cause premature wear and tear of the safety surfacing.

Suggested Action- Ensure sand level is at proper depth for fall safety requirements, as sand compacts over time. Additionally, maintain sand level to be within 2-3 inches to the top of the beveled edge of the rubber safety surfacing. Consider removing the sand and replace with rubber safety surfacing.

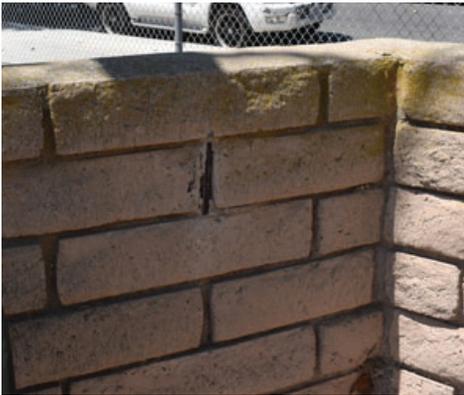
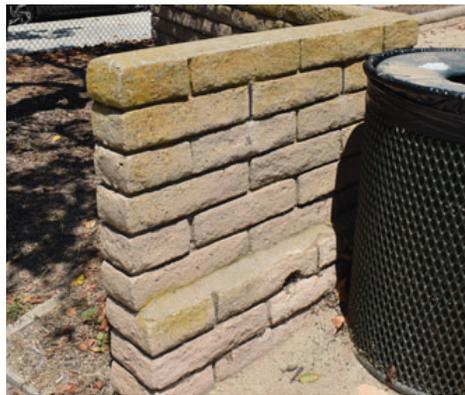
Figure 2.1, 2.2 - Portions of the wall are broken, exposing rebar. Algae/mold growth is observed where there is persistent moisture, predominantly at the top of the wall. Structure may be weakened by the water damage.

Suggested Action- Replace the wall.

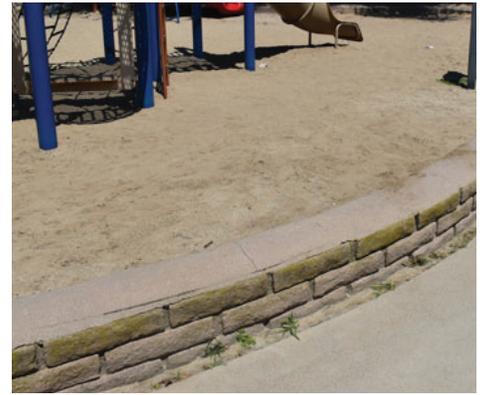
(Figure 2.3)

Figure 2.3 - Cracking is observed on the low wall cap. Algae/mold growth indicates the cap is not protecting the wall from moisture.

Suggested Action- Replace the low wall.

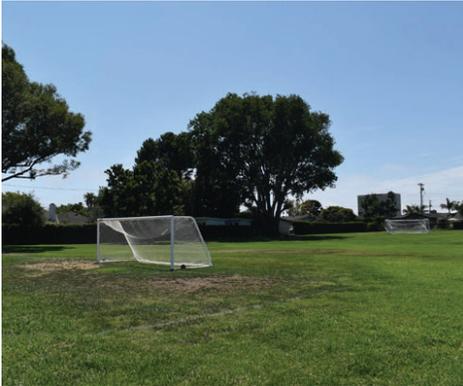
(Figure 3.1)

Figure 3.1 - The soccer fields have some areas where turf is struggling to grow.

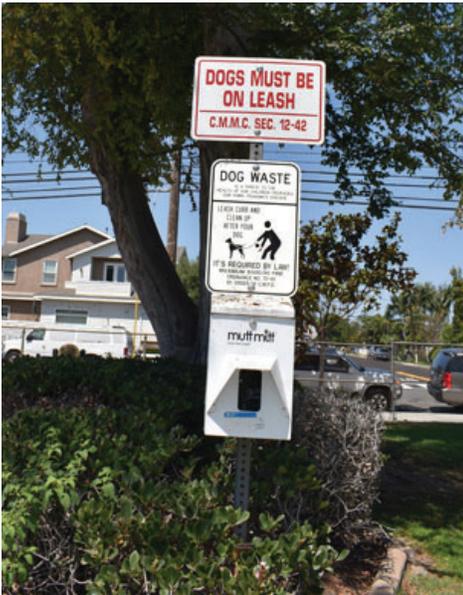
(Figure 4.1)

Figure 4.1 - Regulatory signs for dogs and dog waste dispenser are combined on one sign post. The number of signs and location are visible and legible.

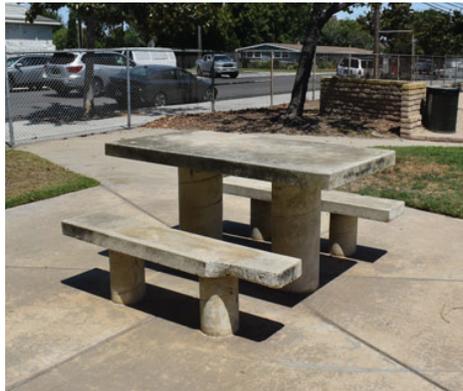
(Figure 4.2)

Figure 4.2 - Picnic table bench is broken and the bench legs are cracking.

Suggested Action- Replace the damaged bench, or replace the picnic table and bench set.

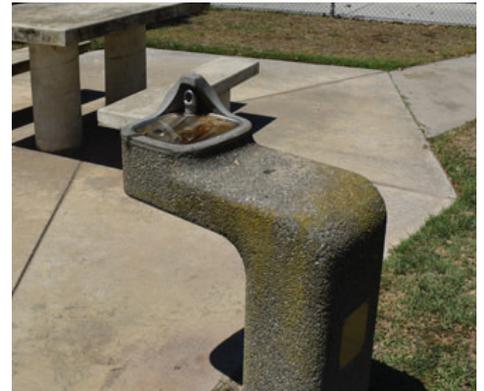
(Figure 4.3)

Figure 4.3 - The drinking fountain has algae/mold growth on the concrete pedestal from persistent moisture over time.

Suggested Action- Replace the drinking fountain.

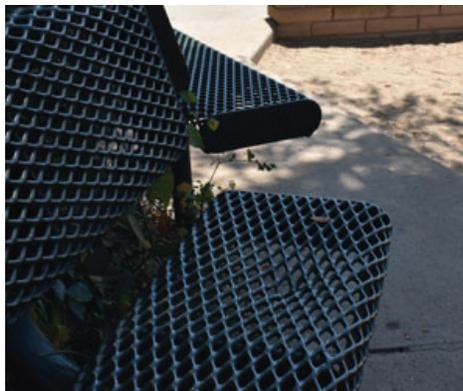
(Figure 4.4)

Figure 4.4 - A portion of the bench is dented, but the vinyl coating is intact. The bench is usable and safe, in fair to good condition.

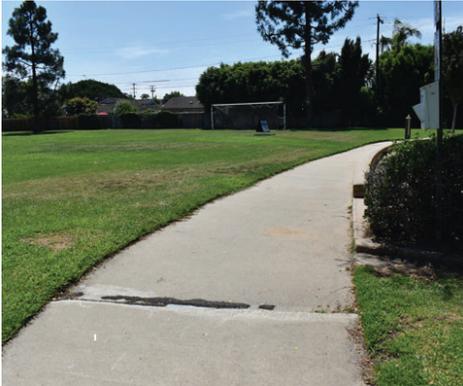
(Figure 5.1)

Figure 5.1 - Section of concrete is lifting, creating potential trip hazards.

Suggested Action- Replace the lifted concrete sections to eliminate trip hazards, ensure accessibility and ADA compliance.

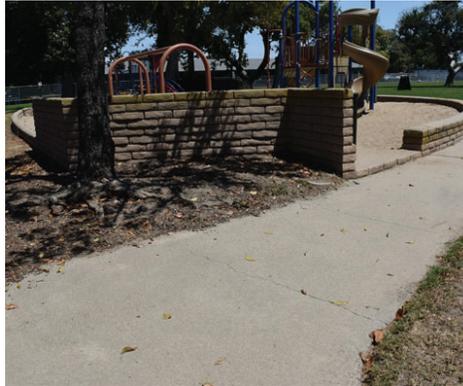
(Figure 5.2)

Figure 5.2 - Concrete pavement is cracking.

Suggested Action- Replace broken areas of concrete paving to ensure accessibility and ADA compliance.

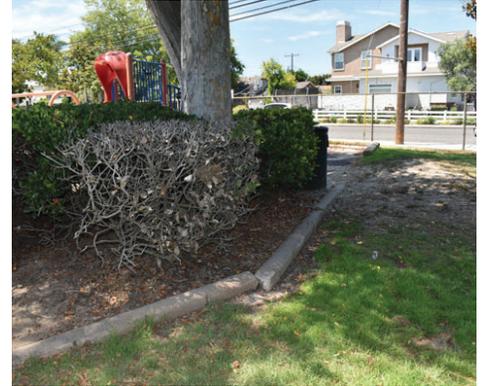
(Figure 5.3)

Figure 5.3 - Concrete curb is broken.

Suggested Action- Replace concrete curb.

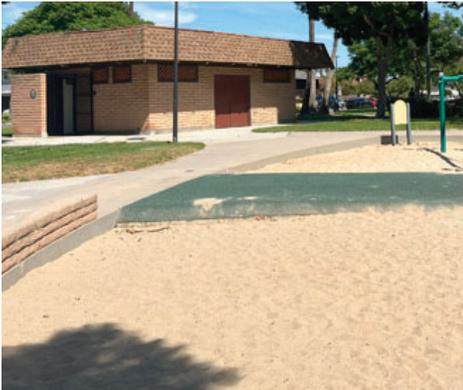
(Figure 1.1)

Figure 1.1 - Rubber safety surfacing edge is exposed above the level of sand. Sand is spread over the top of the rubber safety surfacing, which can cause premature wear and tear of the safety surfacing.

Suggested Action- Ensure sand level is at proper depth for fall safety requirements, as sand compacts over time. Additionally, maintain sand level to be within 2-3 inches to the top of the beveled edge of the rubber safety surfacing. Consider removing the sand and replace with rubber safety surfacing.

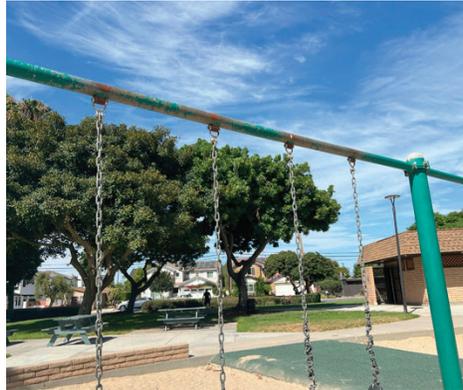
(Figure 1.2)

Figure 1.2 - The swing set has worn off powder coating on the posts, caps, and components of the belt/basket swing set and the tire swing set. There is rust over the two belt swings.

Suggested Action- Monitor the swing set and replace the belt/basket swing set when needed. The tire swing set is in fair to good condition.

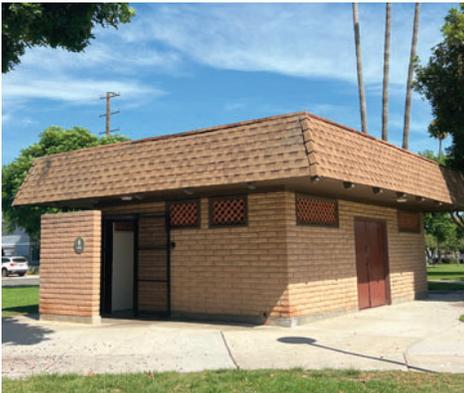
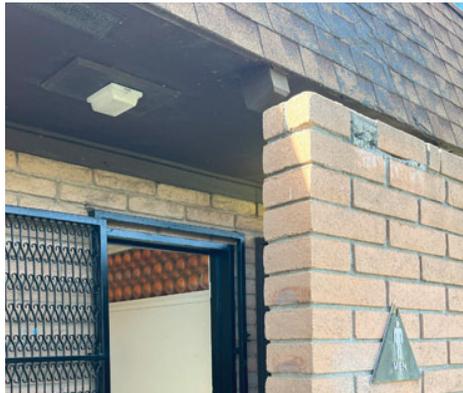
Figure 2.1, 2.2 - The exterior of the restroom building is in fair condition. The building is showing signs of decline such as blackening on the roof, patching and crumbling on the wall, and chipped signage near the men's restroom entrance.

Suggested Action- Continue repairs and maintenance of the building. Consider a new restroom building.

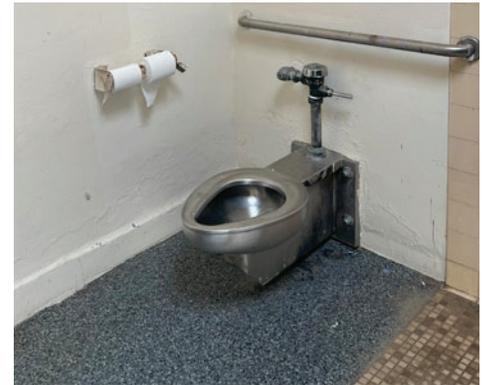
(Figure 2.3)

Figure 2.3 - The flooring and wall in the interior of the restroom do not match. The wall behind the toilet appears to have water damage.

Suggested Action- Continue repairs and maintenance of the building. Consider a new restroom building.

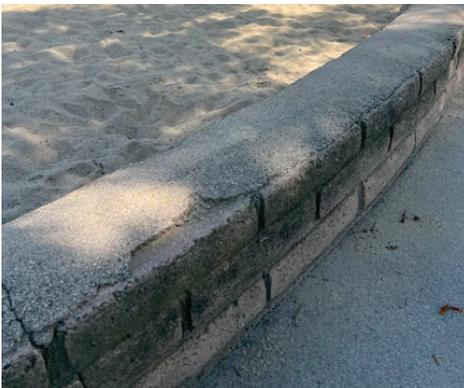
(Figure 2.4)

Figure 2.4 - Cracking is observed on the low wall cap. Algae/mold growth indicates the cap is not protecting the wall from moisture.

Suggested Action- Replace the low wall.

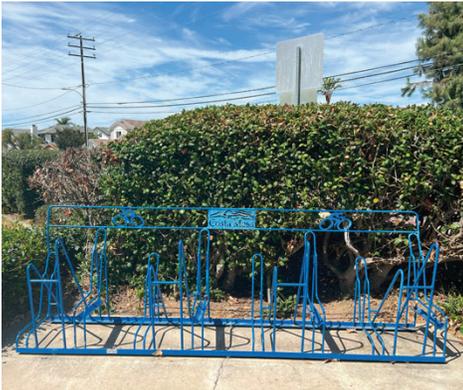
(Figure 4.1)

Figure 4.1 - The bike rack is in good condition. Color is bright, minor scratches or chipping of paint is observed. City logo is visible.

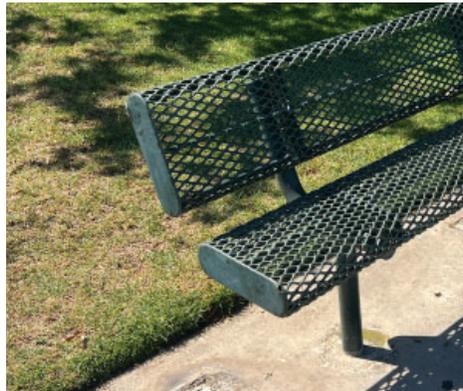
(Figure 4.2)

Figure 4.2 - This park bench has some broken spots in the plastic coating at the end of the bench, but the bench is still usable and safe. However, there is potential for rust to form on the exposed metal.

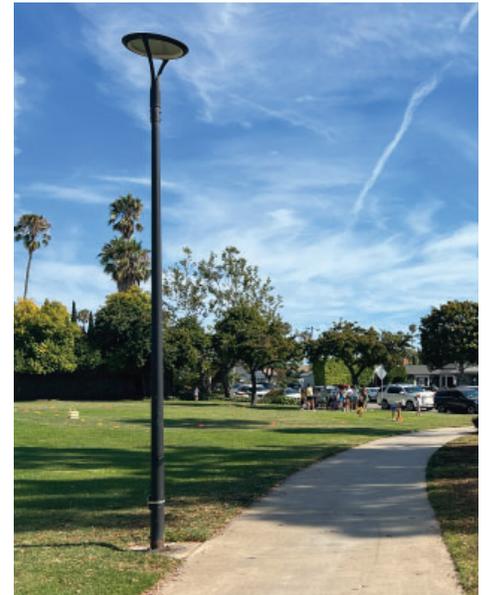
(Figure 4.3)

Figure 4.3 - Lighting system was not assessed. The light poles have matching fixtures. This light pole pictured has rust forming at the base.

Suggested Action- Monitor the rust condition and replace the light pole when needed. Protect against exposure to water.

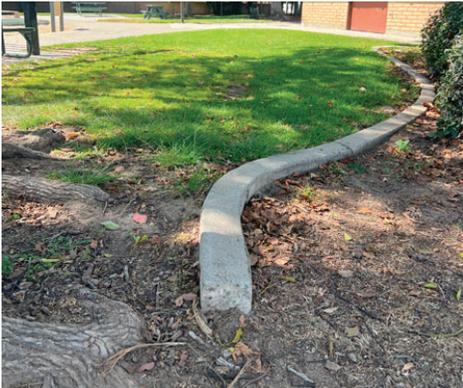
(Figure 5.1)

Figure 5.1 - The concrete curb is broken.
Suggested Action- Replace the missing section of concrete curb.

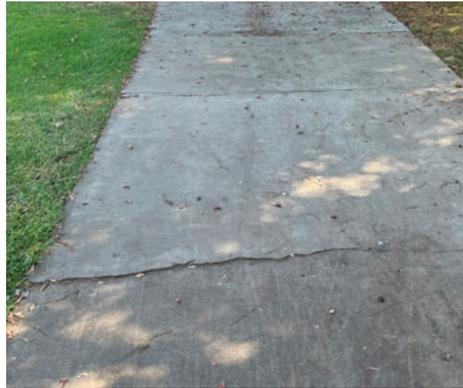
(Figure 5.2)

Figure 5.2 - The paved pathway is cracking.
Suggested Action- Replace broken sections of concrete to ensure accessibility and ADA compliance.

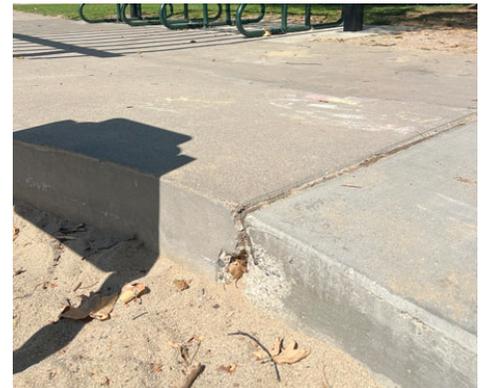
(Figure 5.3)

Figure 5.3 - The concrete slabs surrounding the playground sand is chipping and breaking.
Suggested Action- Replace the broken concrete.

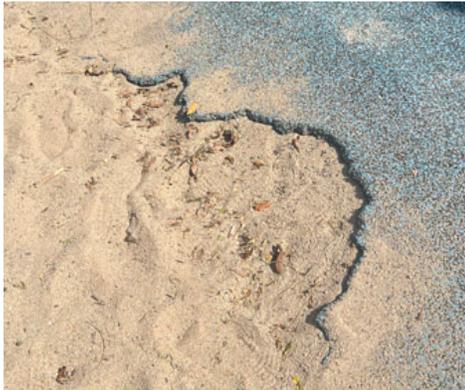
(Figure 1.1)

Figure 1.1 - The rubber safety surfacing is breaking down, and wearing out quicker due to the frequent abrasion from sand. The sand level is low, so that the edges of the rubber safety surfacing are showing.

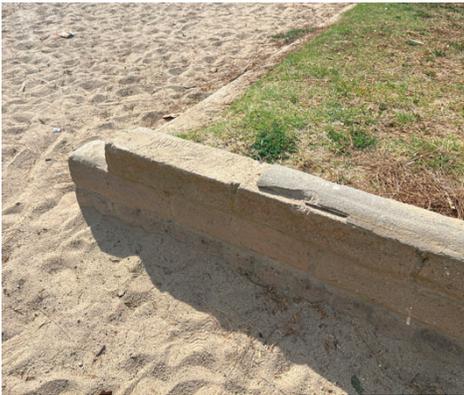
(Figure 2.1)

Figure 2.1 - The low wall cap is broken and less effective at keeping moisture out of the wall.
Suggested Action- Replace the low wall.

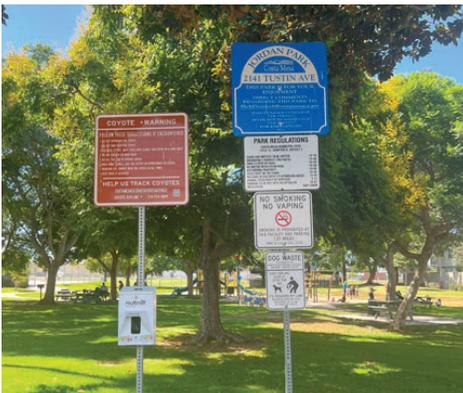
(Figure 4.1)

Figure 4.1 - The signs at the top of the posts have some bird droppings beginning to cover the informational content.
Suggested Action- Add bird deterrents to the tops of signs and/or posts.

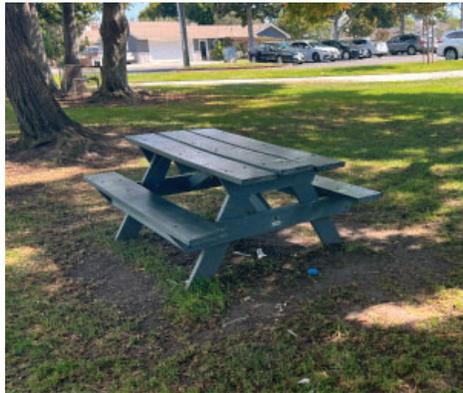
(Figure 4.2)

Figure 4.2 - Picnic tables are placed in turf area; turf will struggle to grow where there is soil compaction.
Suggested Action- Relocate picnic table and repair damaged turf.

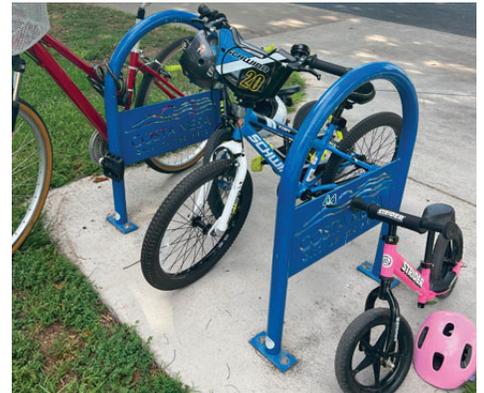
(Figure 4.3)

Figure 4.3 - Bike rack is in good condition. Color is bright, no scratches or chipping of paint is observed. City logo is visible.

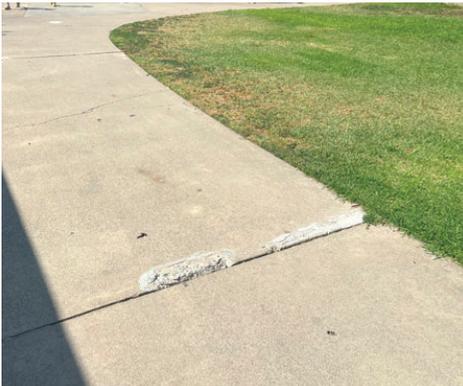
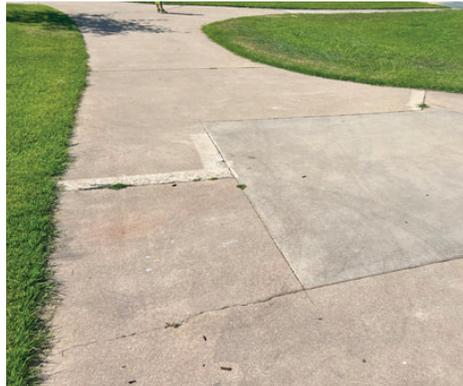
Figure 5.1, 5.2 - The paved pathway has areas of cracking, patching, and edges that have been ground down to be level with adjacent paving.

Suggested Action- Replace paved pathway to ensure accessibility and ADA compliance.

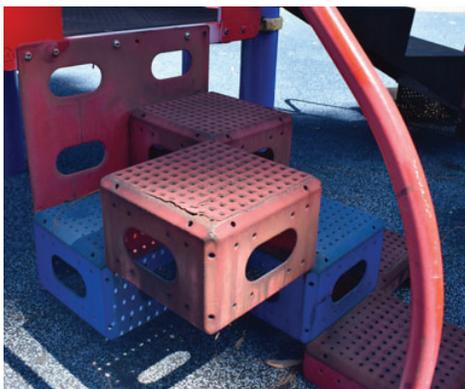
(Figure 1.1)

Figure 1.1 - Powder coating has completely detached from block climber component and rust has formed.

Suggested Action- The block climber component should be removed and replaced.

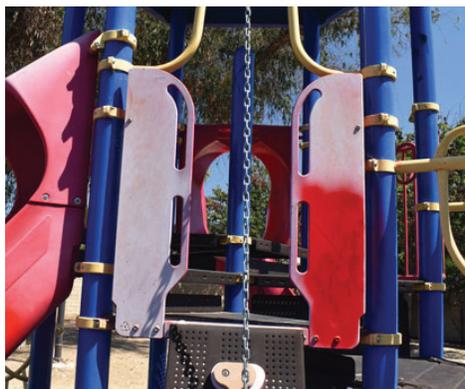
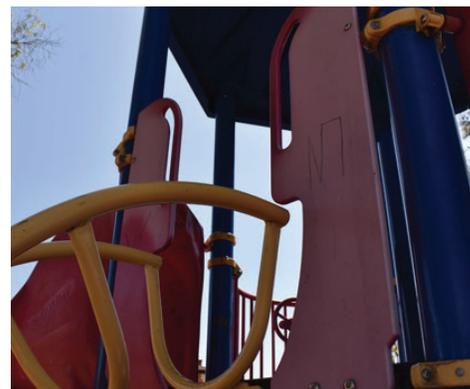
Figure 1.2, 1.3 - Damage from extensive sun exposure has weakened the plastic of the handhold panels and altered the color. The panels show defacing.

Suggested Action- Replace the handhold panels.

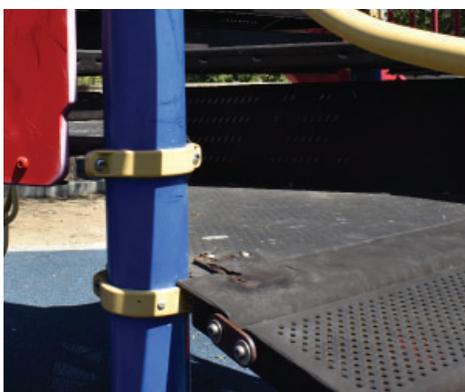
(Figure 1.4)

Figure 1.4 - Bridge fasteners are breaking and/or rusting.

Suggested Action- Replace the fasteners.

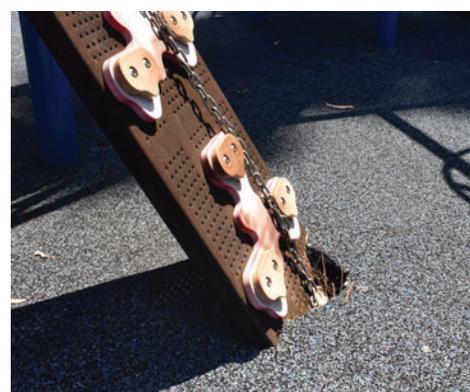
(Figure 1.6)

Figure 1.6 - The rubber safety surfacing has broken around the base of the climber.

Suggested Action- Repair by patching the hole with matching rubber granules and binder as required by industry standards.

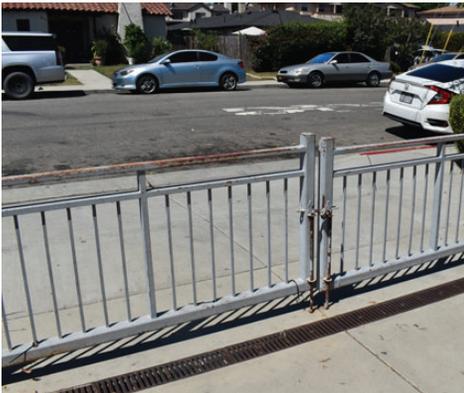
(Figure 2.1)

Figure 2.1 - Metal gate at the front of the park is rusting.

Suggested Action- Repair by thoroughly cleaning the surfaces and using a rust-inhibiting primer before painting with exterior-grade metal paint.

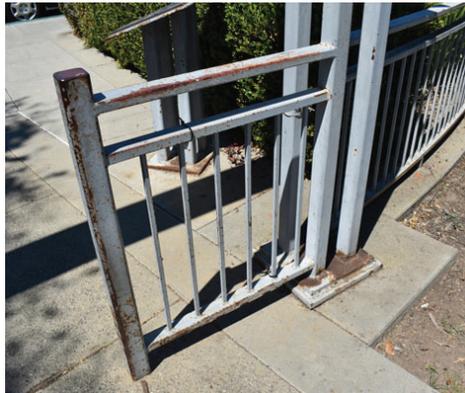
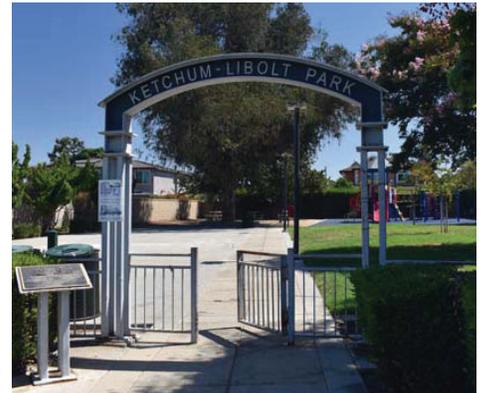
Figure 2.2, 2.3 - Rust observed on the base of the post for the park archway sign.

Suggested Action- Assess for structural integrity and repair or replace as required to meet building and safety codes. Divert moisture from accumulating on the metal surfaces.

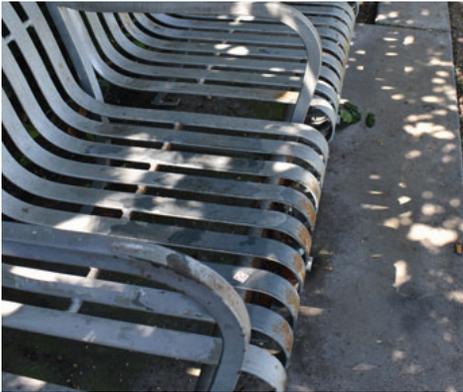
(Figure 4.1)

Figure 4.1 - Park benches are rusting.

Suggested Action- Repair by thoroughly cleaning the surfaces and using a rust-inhibiting primer before painting with exterior-grade metal paint. Divert moisture from accumulating on the metal surfaces. Consider replacing the damaged benches.

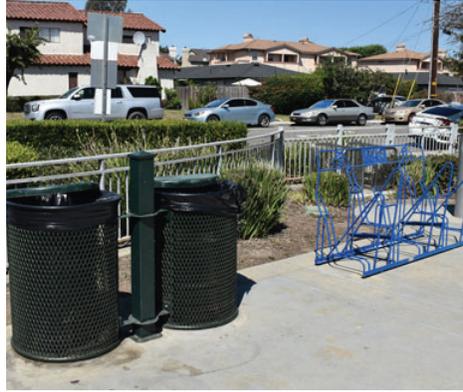
(Figure 4.2)

Figure 4.2 - Bike rack is in good condition. Color is bright, no scratches or chipping of paint is observed. City logo is visible. The waste receptacles are in fair condition. There are small spots of broken plastic coating on the waste receptacles that are allowing rust to form on the metal mesh.

Suggested Action- Continue to monitor the rusting and replace waste receptacle when needed.

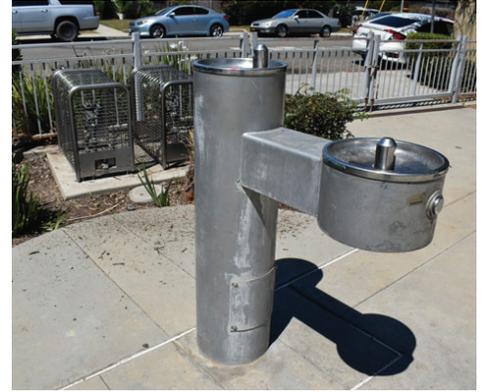
(Figure 4.3)

Figure 4.3 - Drinking fountain is in fair condition. The finish on the exterior is scratched, peeling, and damaged by water.

Suggested Action- Repair by cleaning thoroughly and monitor for any rust formation.

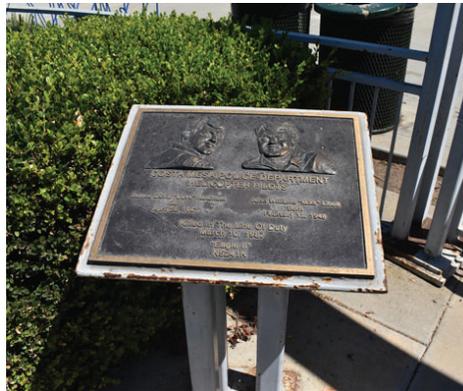
(Figure 4.5)

Figure 4.5 - Rust was observed on the park's memorial plaque.

Suggested Action- Repair by thoroughly cleaning the surfaces and using a rust-inhibiting primer before painting with exterior-grade metal paint. Divert moisture from accumulating on the metal surfaces..

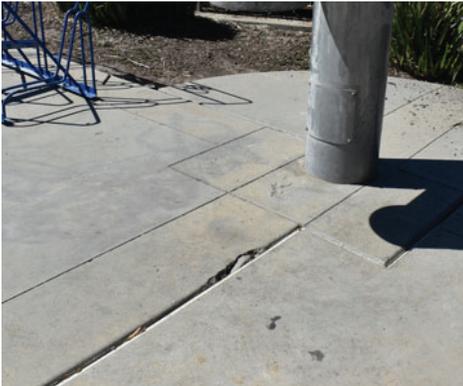
(Figure 5.1)

Figure 5.1 - There are cracks and broken pieces in the concrete pavement in various areas throughout the park.
Suggested Action- Clean out broken pieces and repair as needed to ensure accessibility and ADA compliance.

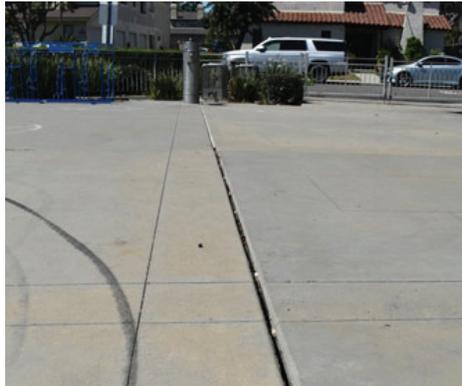
(Figure 5.2)

Figure 5.2 - There is a noticeable gap between the slabs of concrete. It is filled with joint filler that is degrading and coming out of the gaps.
Suggested Action- Clean out the broken pieces of joint filler and repair as needed.

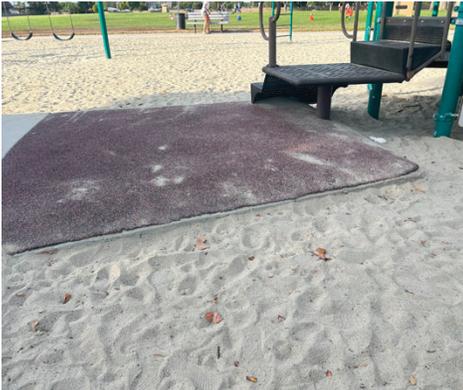
(Figure 1.1)

Figure 1.1 - The playground has a sand and rubber safety surfacing combination. The sand level does not cover the bottom of the rubber safety surfacing.

Suggested Action- Ensure sand level is at proper depth for fall safety requirements, as sand compacts over time. Additionally, maintain sand level to be within 2-3 inches to the top of the beveled edge of the rubber safety surfacing. Consider removing the sand and replace with rubber safety surfacing.

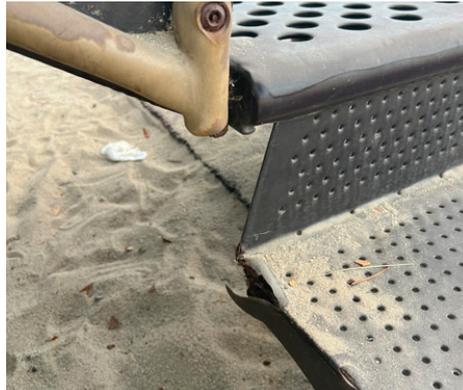
(Figure 1.2)

Figure 1.2 - The powder coating on the platform is breaking, exposing sharp edges that can cause injury.

Suggested Action- Replace the component.

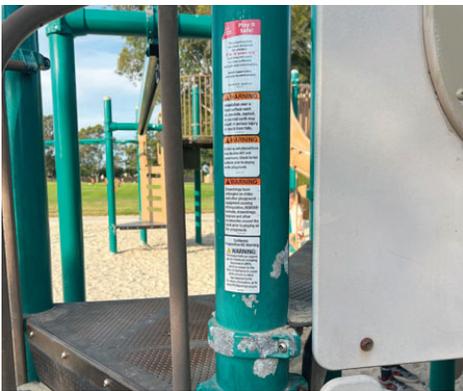
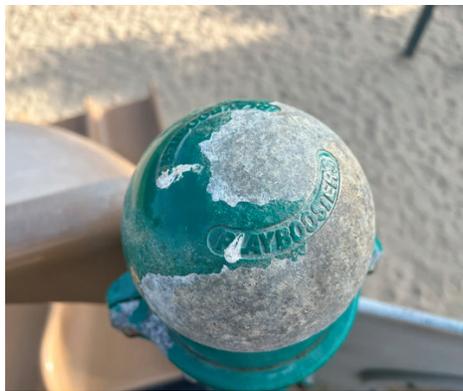
Figure 1.4, 1.5 - The play structure has damaged or worn off powder coating on posts, caps, and components.

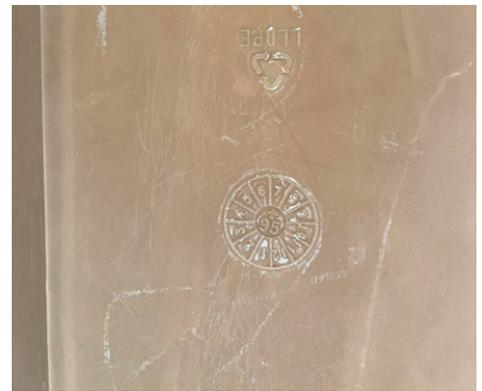
(Figure 1.6)

Figure 1.6 - The manufacturer's date of installation for the play structure is shown under the slide.

Manufacturer: Landscape Structures
Year Installed: 1995
(Play equipment is 30 years old in 2025)

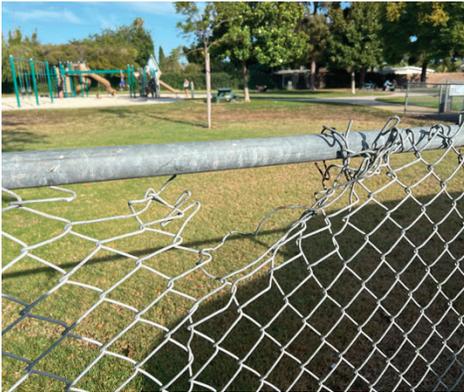
(Figure 2.1)

Figure 2.1 - Chain link fabric is broken, sharp ends exposed.

Suggested Action- Repair and assess chain link fence for further repair needs.

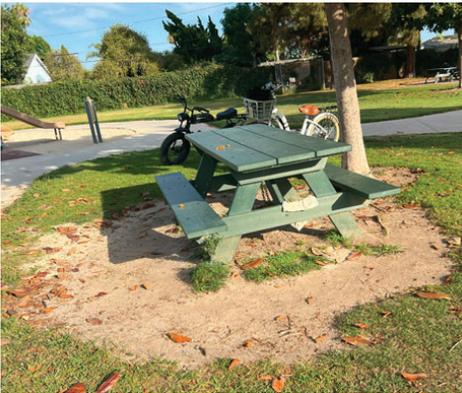
(Figure 4.1)

Figure 4.1 - Picnic tables are placed in turf area; turf will struggle to grow where there is soil compaction.
Suggested Action- Relocate picnic table and repair damaged turf.

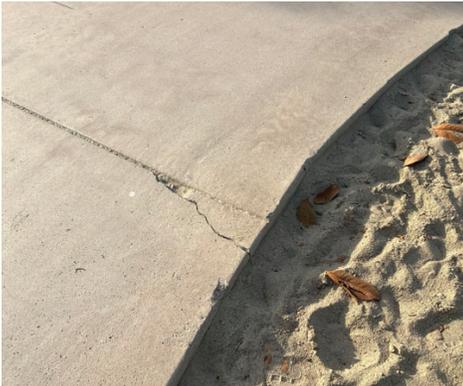
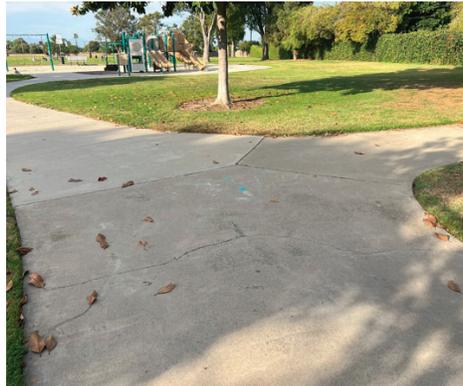
Figure 5.1, 5.2 - Cracks in the paved pathway are observed in various areas throughout the park.

Suggested Action- Replace or repair sections of broken concrete to ensure accessibility and ADA compliance.

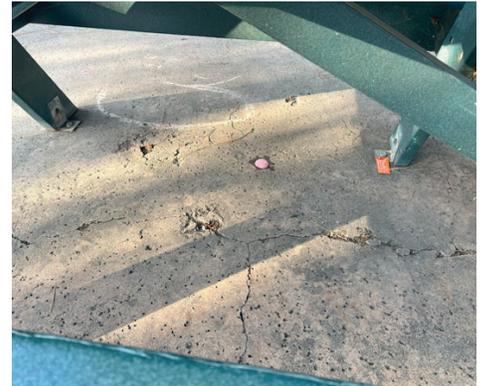
(Figure 5.3)

Figure 5.3 - The cracking in the circular concrete pad under the picnic tables has pieces breaking off and leaving holes in the surface.

Suggested Action- Replace the concrete pad under the picnic tables area.

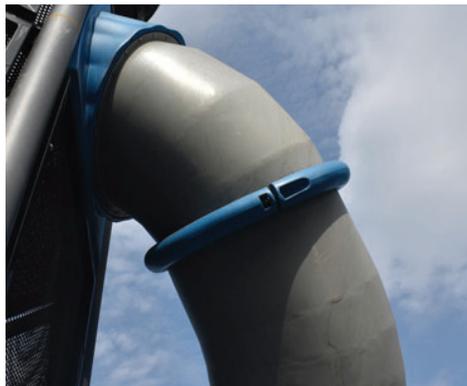
(Figure 1.1)

Figure 1.1 - There is a visible gap where the fastener around the tube slide is bolted together.

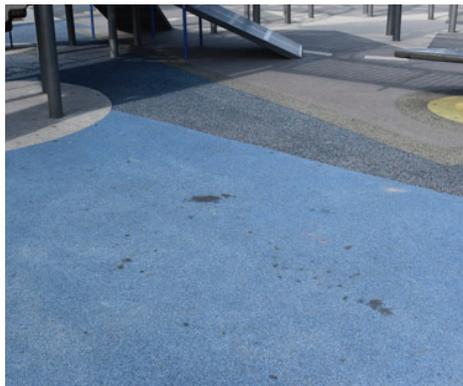
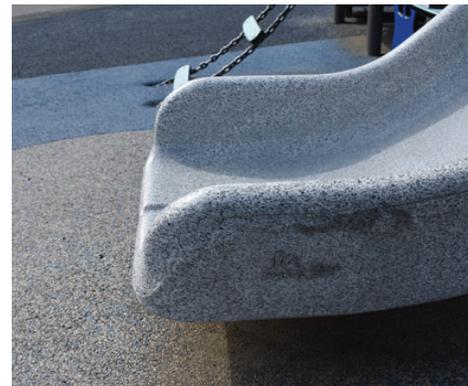
(Figure 1.2)

Figure 1.2, 1.3 - Rubber safety surfacing and play structure components are marked and stained.

Suggested Action- Clean the safety surfacing and play components per manufacturer's recommendations.

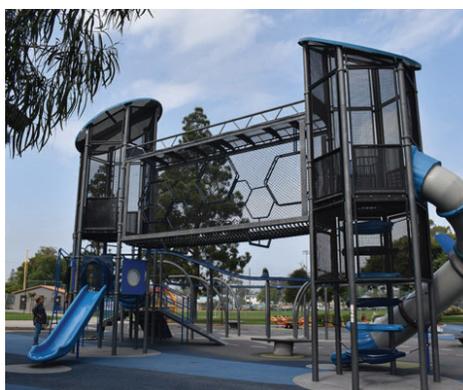
(Figure 1.5)

Figure 1.5 - The play structure is in good to excellent condition. The installation of the play area was four years ago, and the equipment and surfacing look well-used.

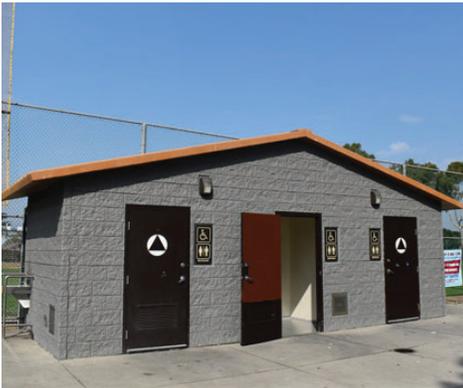
(Figure 2.1)

Figure 2.1 - Restroom building exterior is in good to excellent condition. The walls and roof are whole and intact. The paint has no chipping or signs of repainting. (This restroom building is located near the playground. The other restroom building, located near the softball field, was not open.)

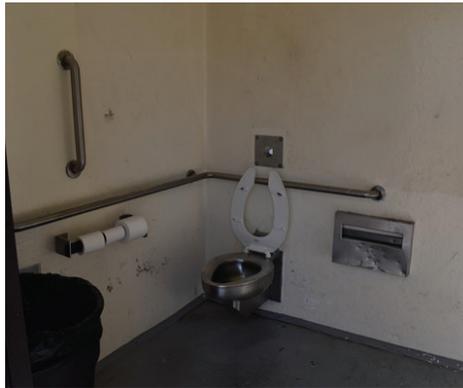
(Figure 2.2)

Figure 2.2 - The interior of the restroom is in fair condition. There are marks on the walls and the toilet seat cover dispenser is dented.

Suggested Action- Clean the scuff marks and replace the dispenser if no longer functioning.

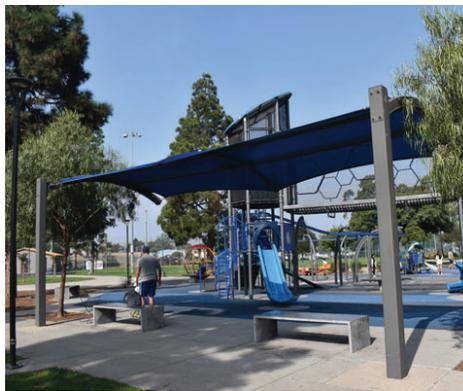
(Figure 2.5)

Figure 2.5 - The shade structure is in excellent condition. The posts are set perpendicular to the ground plane. The shade cover fabric is whole and intact, and the color is rich and vibrant.

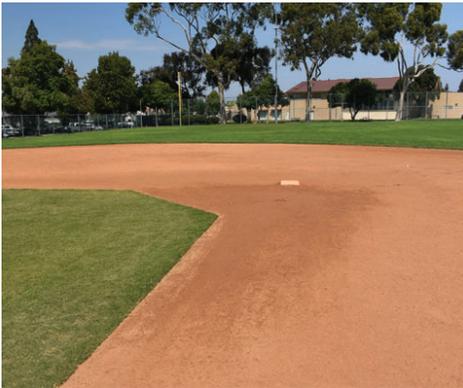
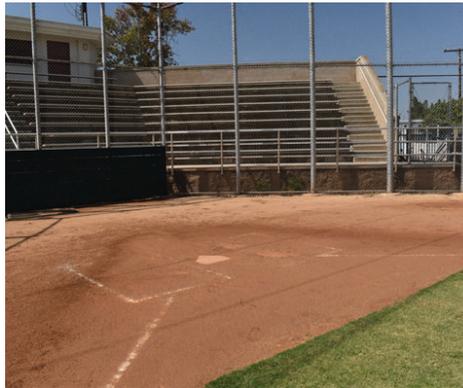
(Figure 3.1)

Figure 3.1, 3.2 - The softball field is in excellent condition. The lines between turf and infield are clear and distinct. The bases are clean and visible. The backstop boards and chain link fencing are whole and intact.

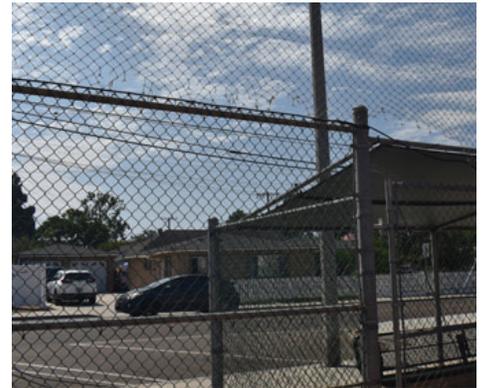
(Figure 3.3)

Figure 3.3 - The safety netting is fraying in the area above the dugout.
Suggested Action- Repair the safety netting where needed.

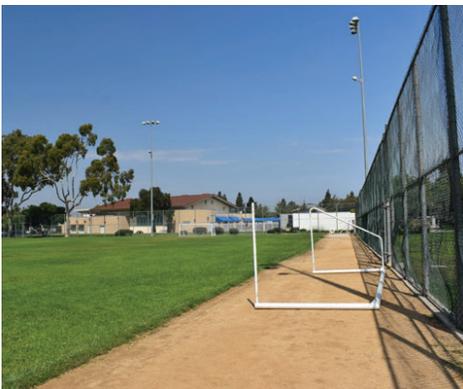
(Figure 3.4)

Figure 3.4 - A soccer goal off the field is broken.
Suggested Action- Replace or repair broken components.

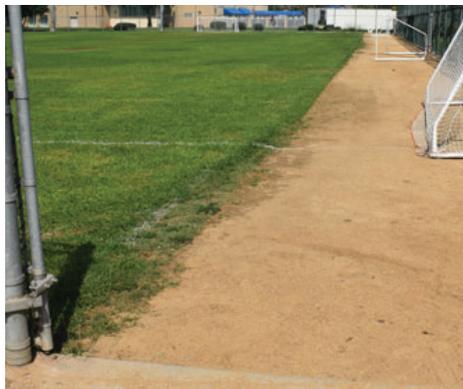
(Figure 3.5)

Figure 3.5 - Turf is growing out into the decomposed granite area (service road).
Suggested Action- Consider adding a concrete curb to separate the turf from the decomposed granite.

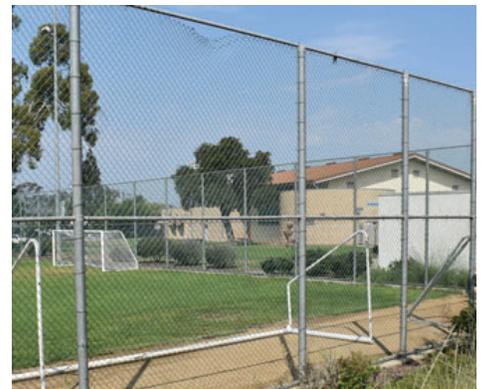
(Figure 3.6)

Figure 3.6 - The chain link fence fabric is detached from the top rail.
Suggested Action- Repair the chain link fence where needed.

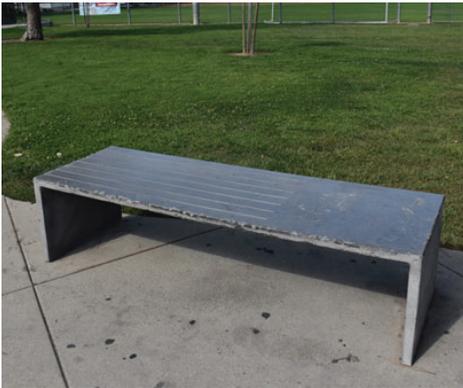
(Figure 4.1)

Figure 4.1 - The bench has damage from skateboard use.
Suggested Action- Add a skateboard deterrent to the bench.

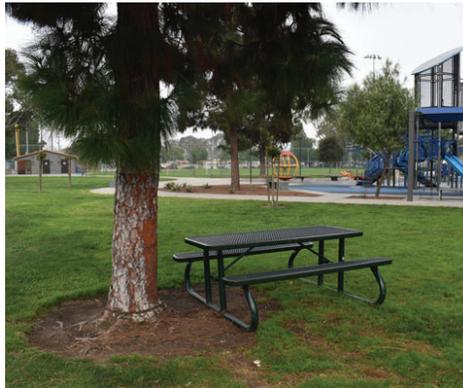
(Figure 4.2)

Figure 4.2 - The picnic table is placed on top of turf, making the soil prone to compaction due to frequent foot traffic.
Suggested Action- Relocate the picnic table and repair damaged turf.

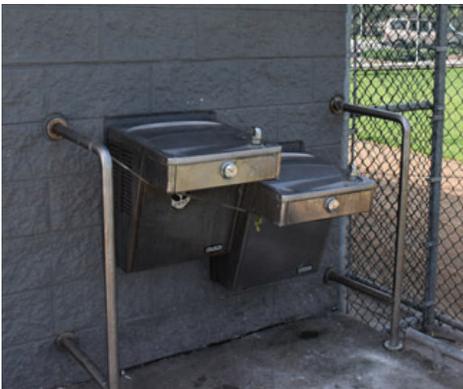
(Figure 4.4)

Figure 4.4 - The drinking fountains (located on the restroom building exterior) are in good condition. There is staining on the surfaces, and a rope has been tied from handrail to handrail.
Suggested Action- Remove the rope and assess the structure of the drinking fountains are intact. Repair as needed. Clean the staining.

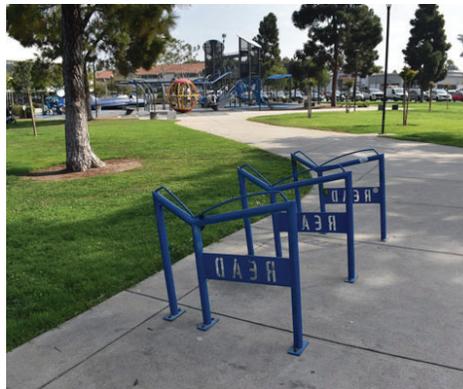
(Figure 4.5)

Figure 4.5 - Bike rack is in good condition. Color is bright, no scratches or chipping of paint is observed.

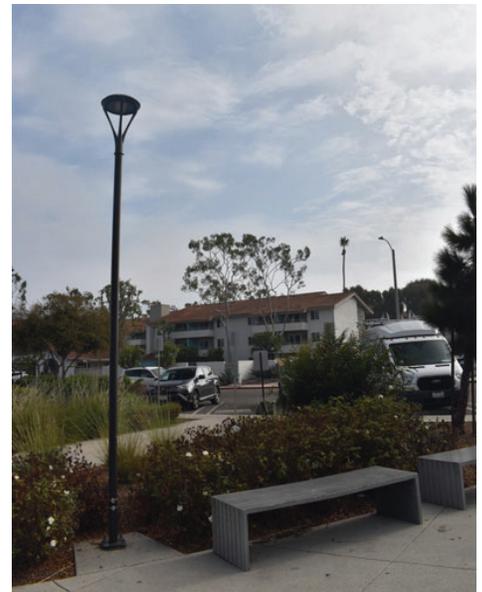
(Figure 4.6)

Figure 4.6 - Lighting system was not assessed. The light poles are in good condition.

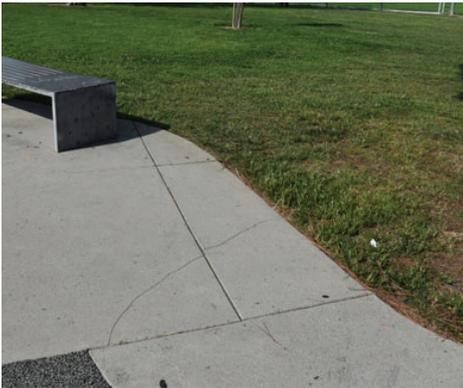
(Figure 5.1)

Figure 5.1 - Cracking observed in the paved pathway.

Suggested Action- The amount of cracking in the paved pathway throughout the park is minimal. There are no changes in level or widening gaps observed. Continue to monitor the condition and repair as needed.

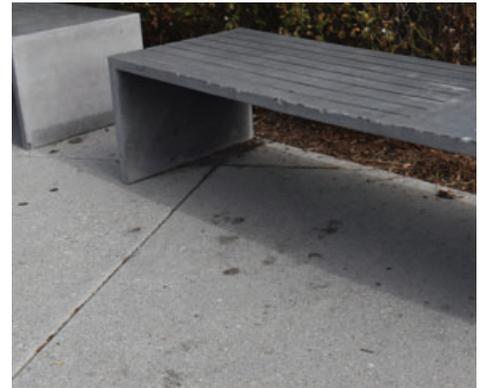
(Figure 5.3)

Figure 5.3 - Extensive staining observed on the paved pathway.

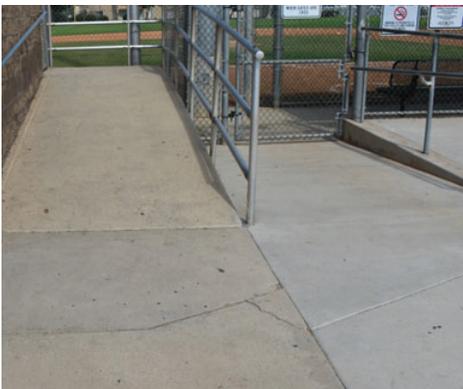
(Figure 5.4)

Figure 5.4 - Cracking observed in the paved pathway at the base of the ramp to the bleacher seating at Luke Davis Field.

Suggested Action- The amount of cracking in the paved pathway throughout the park is minimal but there are uneven surfaces forming. Continue to monitor the condition and repair as needed to ensure accessibility and ADA compliance.

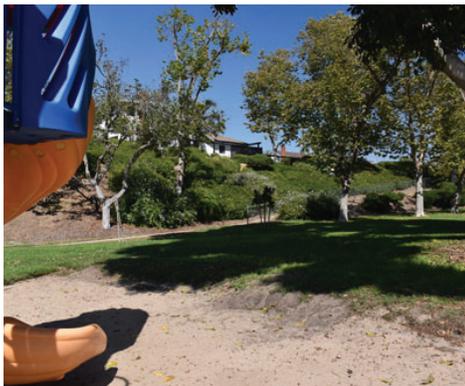
(Figure 1.1)

Figure 1.1 - Erosion runoff from the hillside and turf area is traveling to the sand area of the playground.

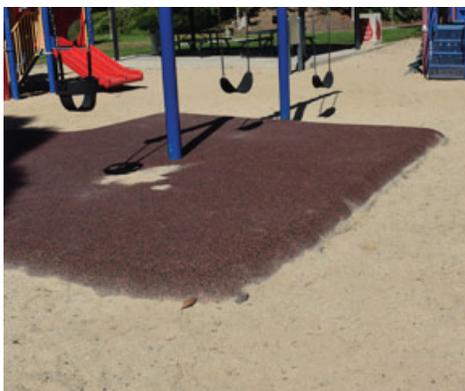
(Figure 1.4)

Figure 1.4 - The sand level is low to where the edges of the rubber safety surfacing is beginning to be exposed. A corner of the safety surfacing is tearing away, and may be wearing out quicker due to the frequent abrasion from sand.

Suggested Action- Ensure sand level is at proper depth for fall safety requirements, as sand compacts over time. Additionally, maintain sand level to be within 2-3 inches to the top of the beveled edge of the rubber safety surfacing. Consider removing the sand and replace with rubber safety surfacing.

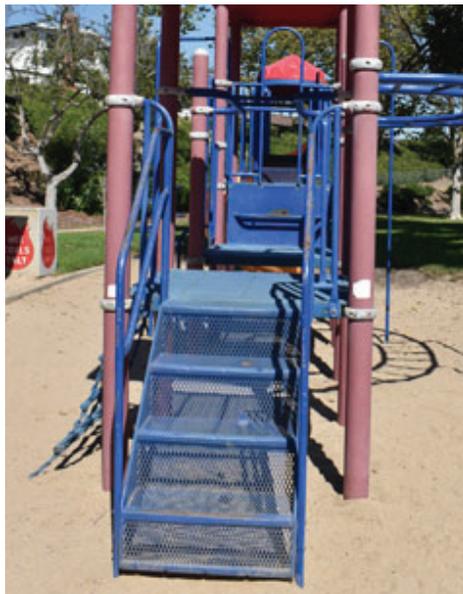
(Figure 1.2)

Figure 1.2 - Powder coating is damaged and worn off on posts, caps, and components. Rust is observed on the metal components.

Suggested Action- Considering the age of the play equipment exceeds 15 years and the current condition of its parts, it is suggested to replace the play equipment.*

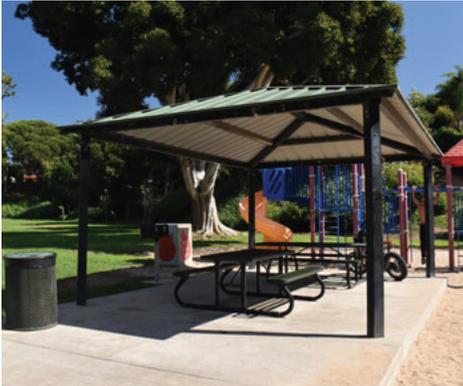
(Figure 2.1)

Figure 2.1 - The shade structure over the picnic area is in excellent condition. The posts are clean, the powder coating is whole and intact.

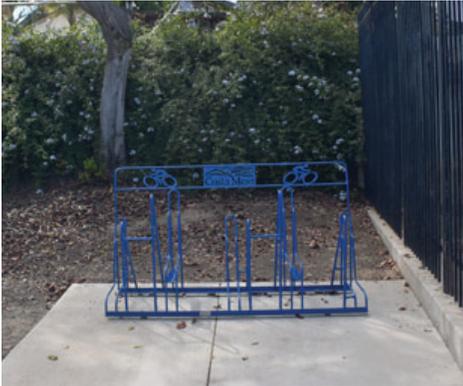
(Figure 4.1)

Figure 4.1 - Bike rack is in good condition. The color is bright, the city logo is visible. Minimal signs of wear and tear.
