CITY OF COSTA MESA
PARKS AND COMMUNITY SERVICES COMMISSION
Agenda

PARK ASSESSMENT

2025

Park Assessments were conducted at all public parks within the City of Costa Mesa and have been documented herein. The report identifies physical condition of amenities, structures, pathways, playgrounds, and existing program elements in each park. This parks assessment is essential for the City of Costa Mesa in identifying and prioritizing improvements, allowing for safe, functional and enjoyable spaces for the community to recreate and enjoy.

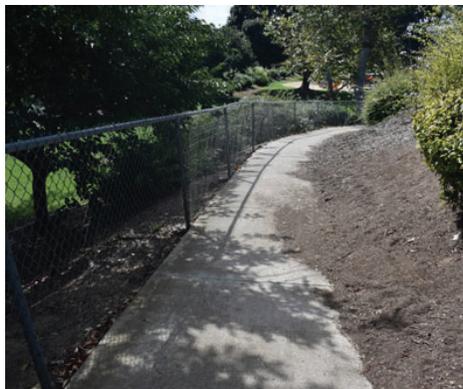
(Figure 5.4)

Figure 5.4- Algae/mold growth on the paved pathway indicate the consistent presence of moisture.

Suggested Action- Regularly monitor the paved pathway for signs of decline from being exposed to moisture. Consider installing swales to divert water from hardscape.

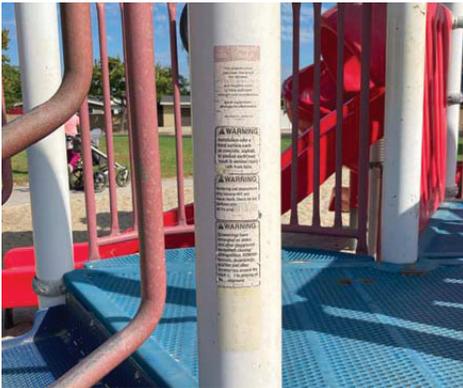
(Figure 1.1)

Figure 1.1 - The safety labels on the play structure are faded.

Suggested Action- Replace safety labels per industry standards.

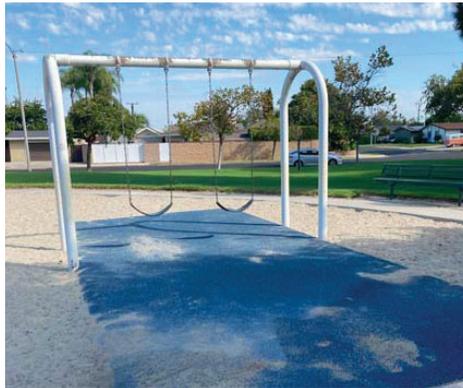
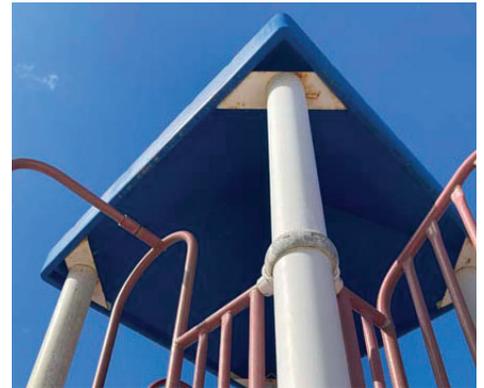
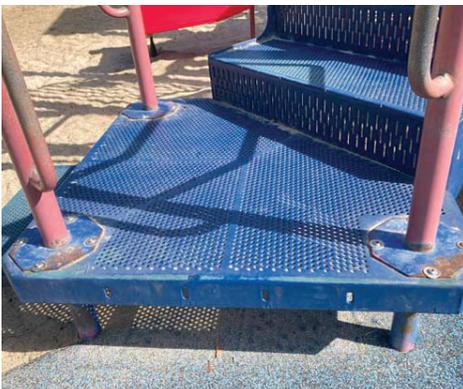
Figure 1.2, 1.3, 1.4 - Powder coating is damaged and worn off on posts, caps, and components. Rust has formed on the play equipment.

Manufacturer: Miracle Recreation
Year Installed: 1997
(Play equipment is 28 years old in 2025)

Suggested Action- Considering the age of the play equipment exceeds 15 years and the current condition of its parts, it is suggested to replace the play equipment.

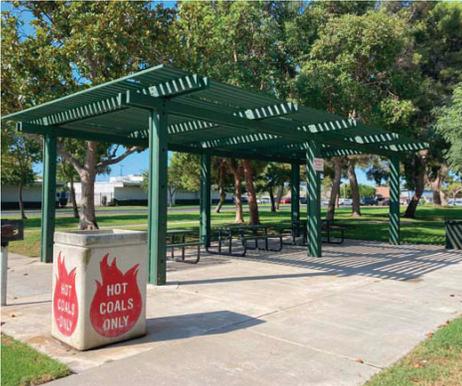
(Figure 2.1)

Figure 2.1 - The shade structure over the picnic table area is in good condition. The area is clean and connected to the paved pathway. The concrete at the base of the posts show cracking (see Hardscape section).

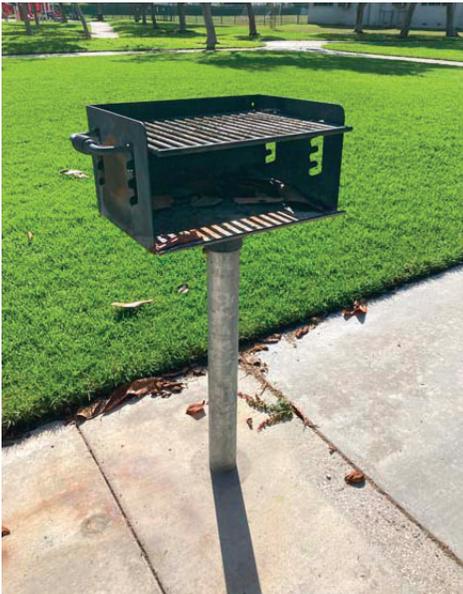
(Figure 4.1)

Figure 4.1 - BBQ grill is in good condition. No holes or warping observed.

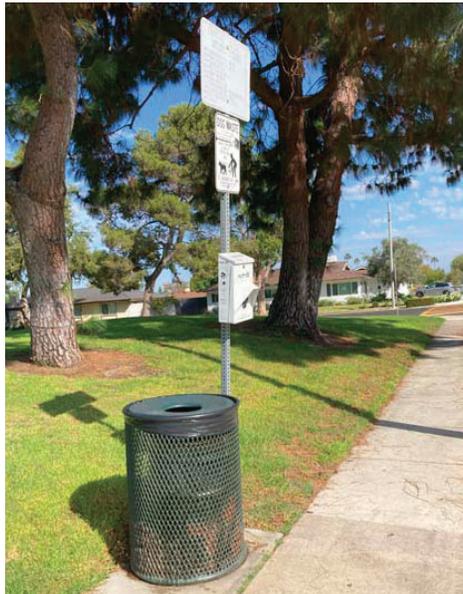
(Figure 4.2)

Figure 4.2 - Waste receptacle is rusting where the plastic coating has broken.
Suggested Action- Monitor and replace waste receptacle when needed.

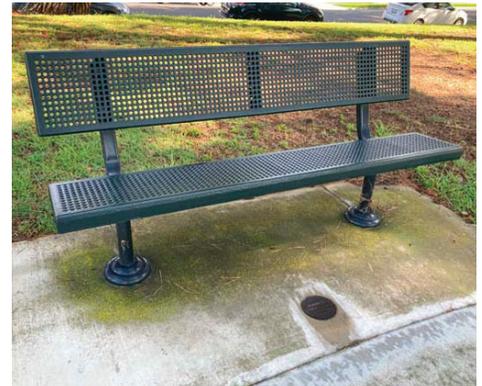
(Figure 4.3)

Figure 4.3 - Benches are in good condition. No tears, bending or rusting observed. The concrete pad underneath shows signs of persistent moisture, which may lead to earlier signs of decline.

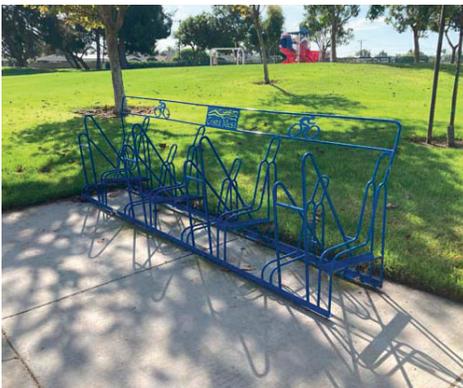
(Figure 4.4)

Figure 4.4 - Bike rack is in good condition. Color is bright, no scratches or chipping of paint is observed. City logo is visible.

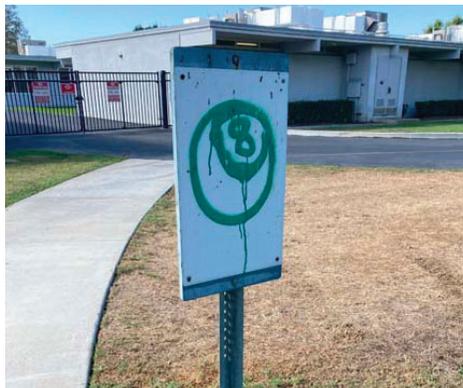
(Figure 4.5)

Figure 4.5 - Sign has been painted over.
Suggested Action- Remove or replace sign.

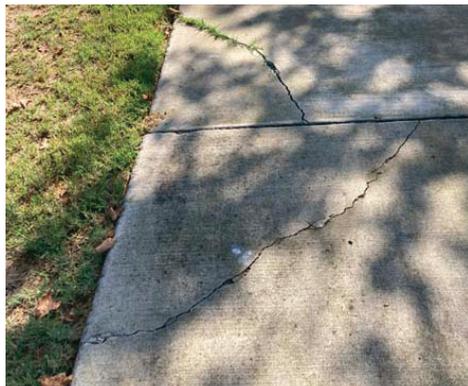
(Figure 5.1)

Figure 5.1- Cracks observed in the concrete walkway.

Suggested Action- Replace areas of broken concrete to ensure accessibility and ADA compliance.

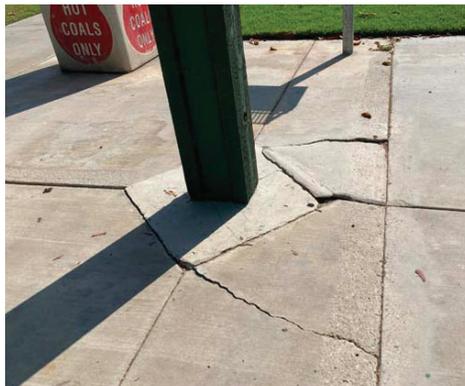
(Figure 5.2)

Figure 5.2- Concrete is cracking around several posts of the shade structure.

Suggested Action- Further assess for damage to the post foundation. Repair or replace as needed.

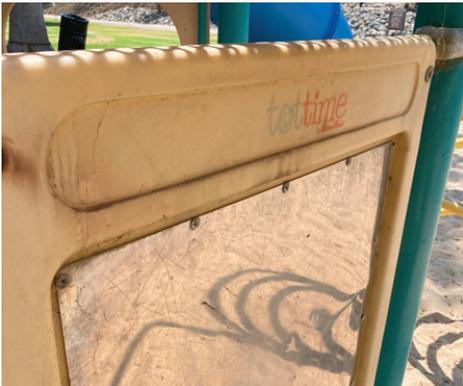
(Figure 1.1)

Figure 1.1 - Component of the play structure is in decline; there is cracking and staining in the plastic.

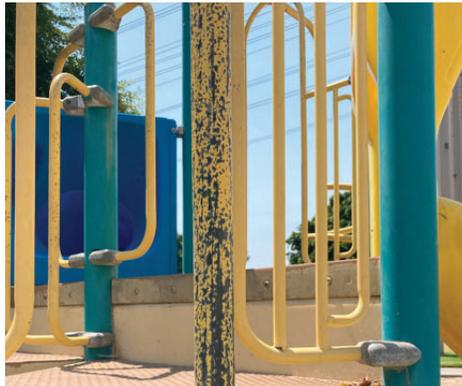
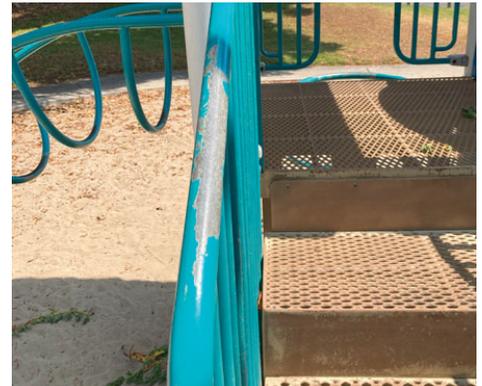
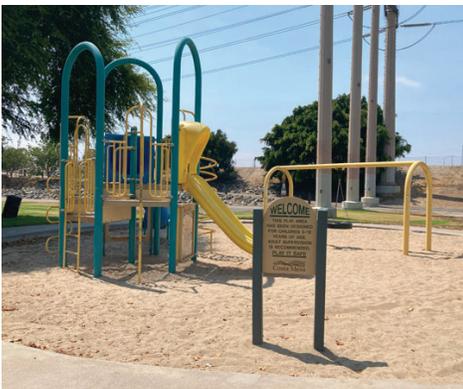
Figure 1.2, 1.3, 1.4 - The play structure has damaged or worn off powder coating on posts, caps, and components.

Suggested Action- Considering the age of the play equipment exceeds 15 years and the current condition of its parts, it is suggested to replace the play equipment.

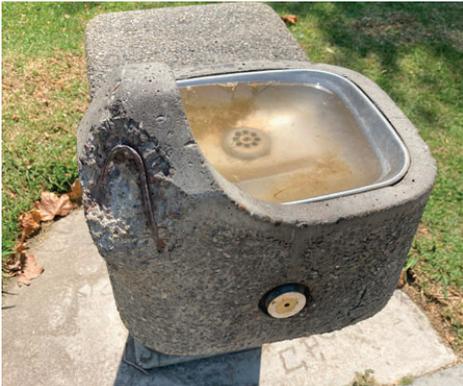
(Figure 4.1)

Figure 4.1 - The drinking fountain concrete pedestal is broken.

Suggested Action- Replace the drinking fountain.

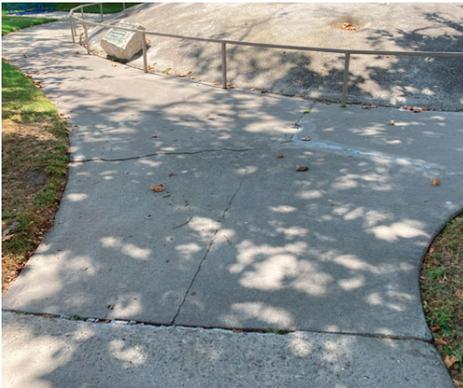
(Figure 5.1)

Figure 5.1- Cracks observed in the paved pathway.

Suggested Action- Replace areas of broken concrete throughout the park to ensure accessibility and ADA compliance.

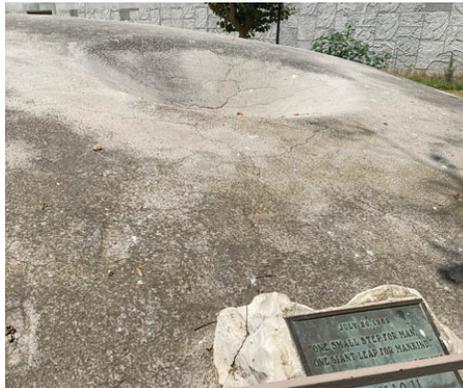
(Figure 5.2)

Figure 5.2- The "moon" feature and dedication boulder have some cracking.

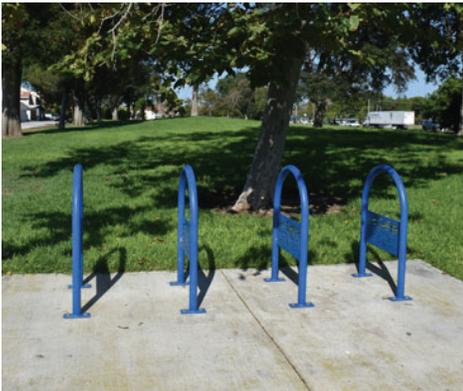
(Figure 4.1)

Figure 4.1 - Bike rack is in good condition. The color is bright and the city logo is visible.

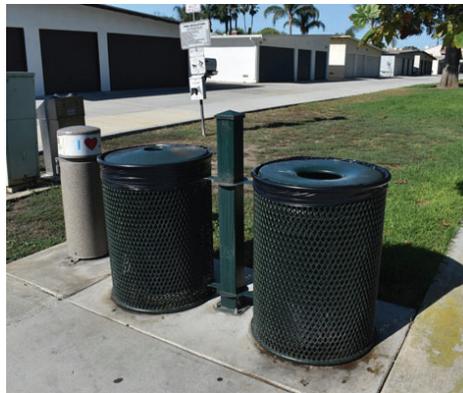
(Figure 4.5)

Figure 4.5 - The waste receptacles and bollard are in good condition.

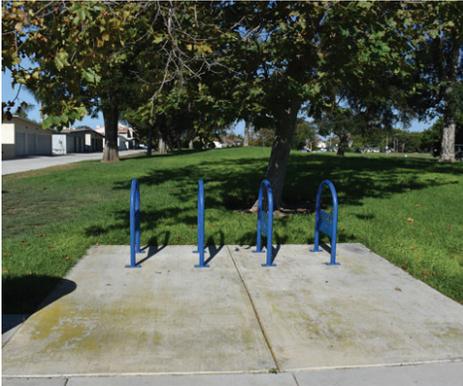
(Figure 5.1)

Figure 5.1 - Concrete pad has algae/mold growth.

Suggested Action- Clean and assess the source of moisture to eliminate the continued growth.

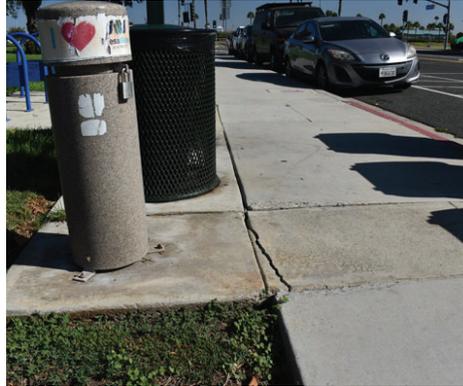
(Figure 5.2)

Figure 5.2 - Cracking and uneven pavers observed in the paved pathway.

Suggested Action- Repair or replace to ensure accessibility and ADA compliance.

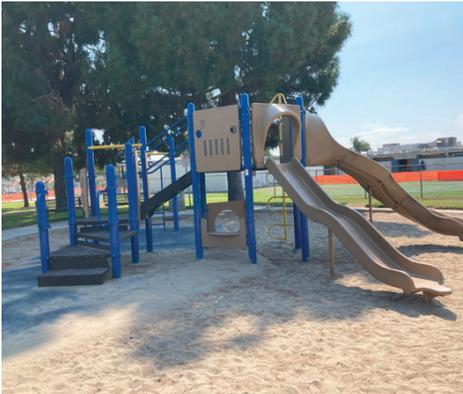
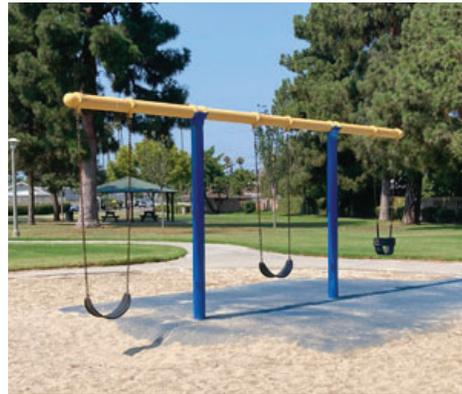
Figure 1.1, 1.2 - The play structures are in good to excellent condition. The color is vibrant, the components are whole and intact. There is minimal wear and tear.

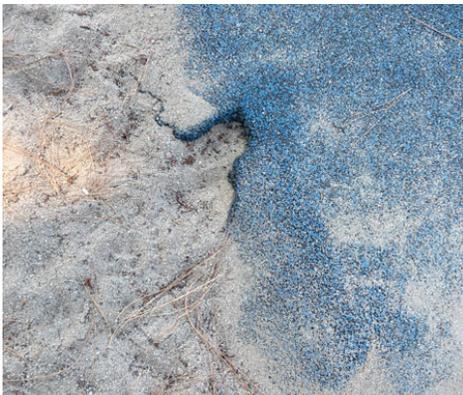
(Figure 1.4)

Figure 1.4 - The rubber safety surfacing is breaking down, and wearing out quicker due to the frequent abrasion from sand. The sand level is low, so that the edges of the rubber safety surfacing are showing.

Suggested Action- Ensure sand level is at proper depth for fall safety requirements, as sand compacts over time. Additionally, maintain sand level to be within 2-3 inches to the top of the beveled edge of the rubber safety surfacing. Consider removing the sand and replace with rubber safety surfacing.

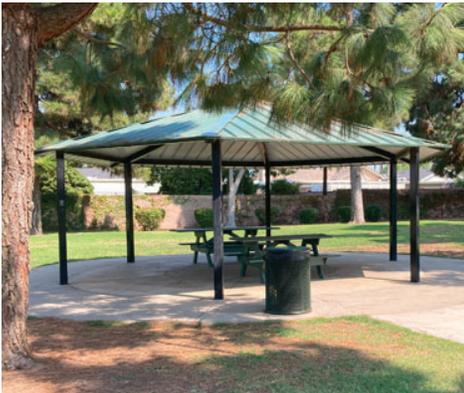
(Figure 2.1)

Figure 2.1 - The shade structure is in excellent condition. The posts are clean, the powder coating is whole and intact. The metal roof has some dust and pine needles collecting on its top, but discoloration from outdoor exposure is minimal.

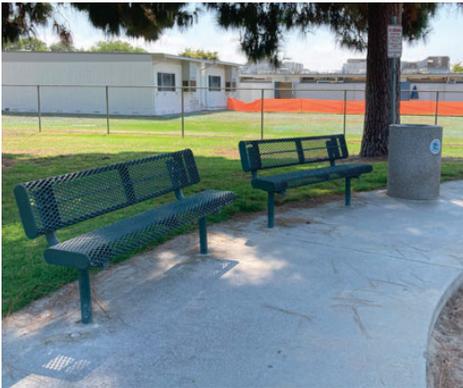
(Figure 4.1)

Figure 4.1 - The benches and waste receptacle are in good condition. The vinyl covered mesh is whole and intact. The waste receptacle is clean.

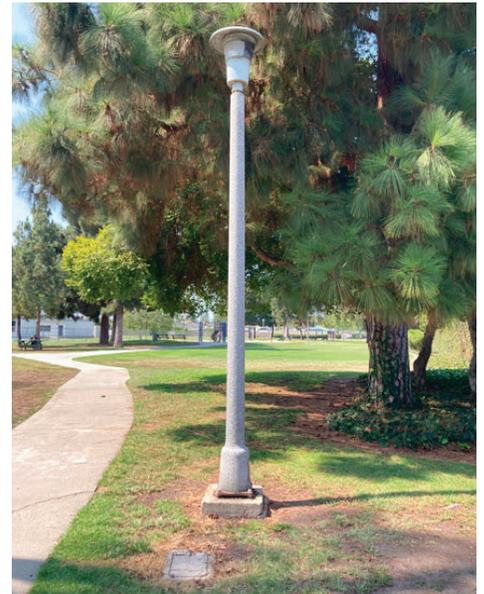
(Figure 4.3)

Figure 4.3 - Lighting system was not assessed. The pole and fixture look aged, and the base of the pole shows some rusting.

Suggested Action- Update the light poles and fixtures. Change lights to energy efficient LED if that has not already been done.

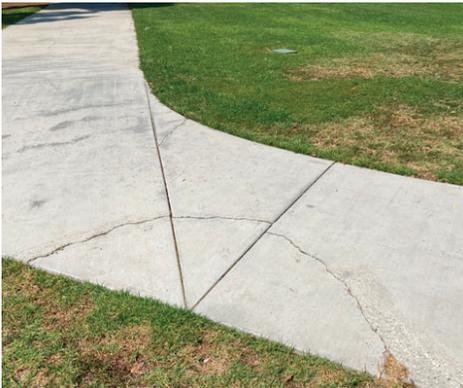
(Figure 5.1)

Figure 5.1 - Cracks observed in the concrete walkway.

Suggested Action- Replace areas of broken concrete to ensure accessibility and ADA compliance.

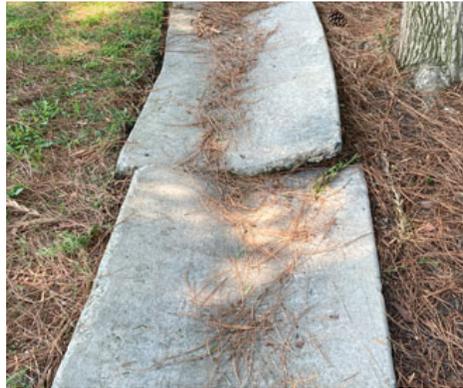
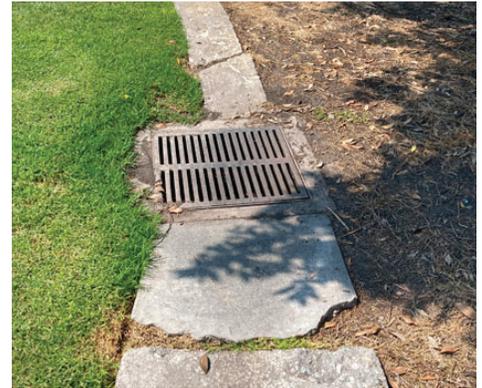
Figure 5.2, 5.3 - Cracks observed in the concrete swale.

Suggested Action- Replace areas of broken concrete to restore the full function of the swale.

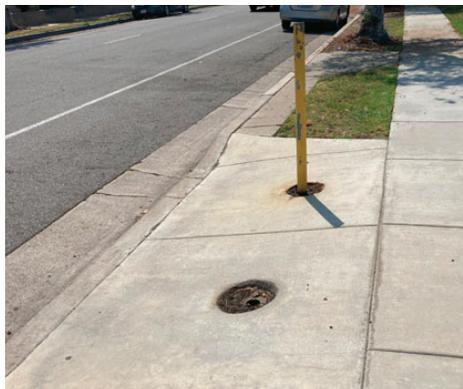
(Figure 5.5)

Figure 5.5 - Bollard is missing. The size of the bollard remaining leaves a sizeable gap in the concrete.

Suggested Action- Replace bollards and patch the gap at the concrete surface to ensure accessibility and ADA compliance.

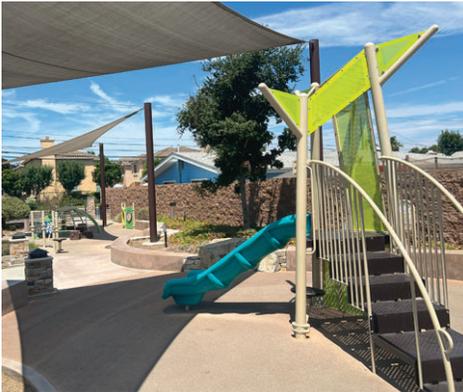
(Figure 1.1)

Figure 1.1 - The play equipment is in good to excellent condition. The components are whole and intact, and the colors are bright and vibrant.

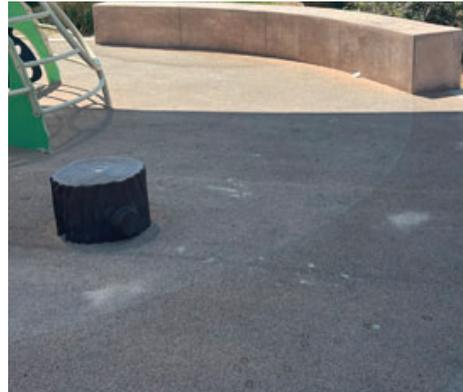
(Figure 1.2)

Figure 1.2 - The rubber safety surfacing has some dirt and stain spots.
Suggested Action- Clean the safety surfacing with mild soap and water.

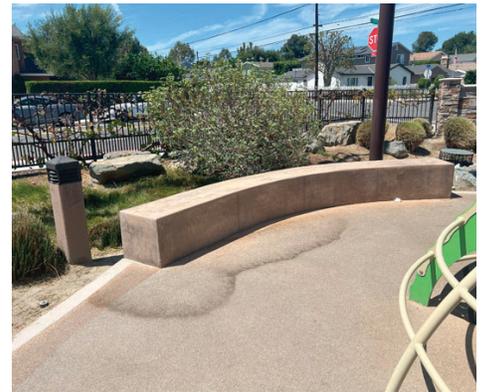
(Figure 1.3)

Figure 1.3 - Water damage was observed in the safety surfacing.
Suggested Action- Assess the irrigation system for leaking or overspray and repair as needed.

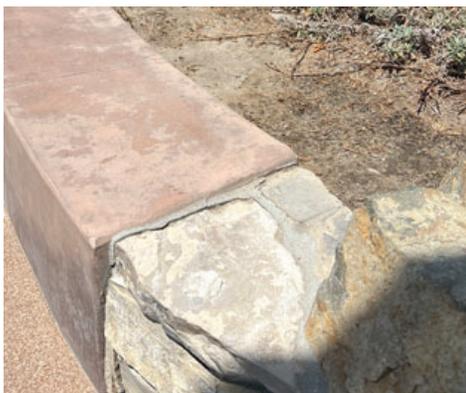
(Figure 2.1)

Figure 2.1 - The filler used in the rock retaining wall is showing some decline.
Suggested Action- Monitor and repair as needed.

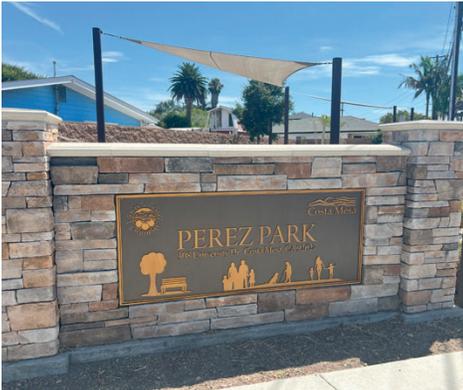
(Figure 4.1)

Figure 4.1 - A few letters by the county seal were observed missing.
Suggested Action- Replace missing letters.

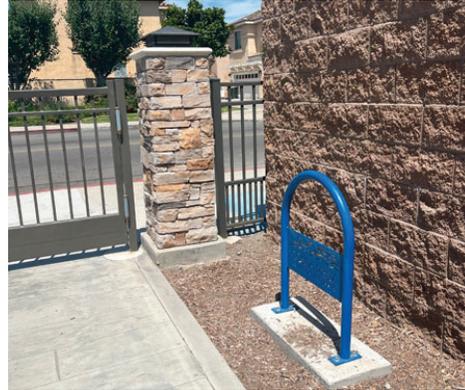
(Figure 4.2)

Figure 4.2 - Bike rack is in good condition. The color is bright, the city logo is visible. Minimal signs of wear and tear.

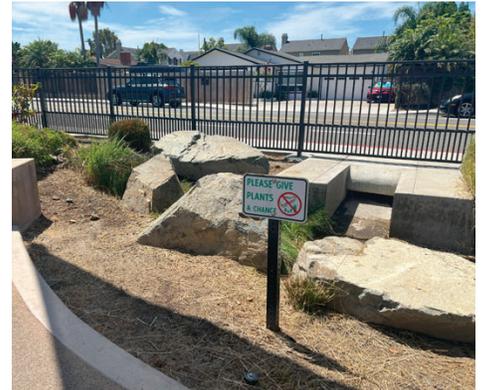
(Figure 4.3)

Figure 4.3 - Park regulation signage is visible, legible, in good condition.

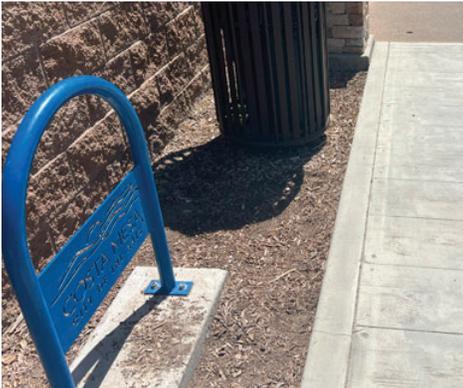
(Figure 5.1)

Figure 5.1 - Minor cracking observed in concrete band.

Suggested Action- Monitor for any change in the cracking. Repair as needed to ensure accessibility and ADA compliance.

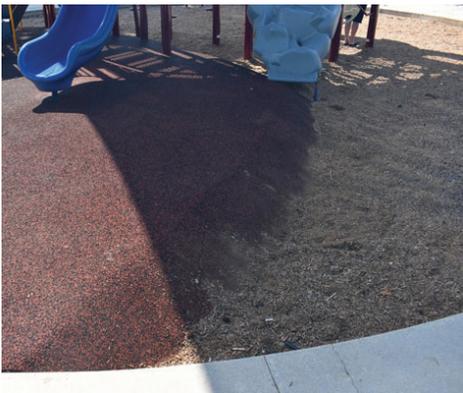
(Figure 1.1)

Figure 1.1 - The playground has a wood fiber and rubber safety surfacing combination. The wood fiber level covers the bottom of the rubber safety surfacing.

Suggested Action- Ensure wood fiber level is at proper depth for fall safety requirements, as wood fiber compacts over time. Additionally, maintain wood fiber level to be within 2-3 inches to the top of the beveled edge of the rubber safety surfacing. Consider removing the wood fiber and replace with rubber safety surfacing.

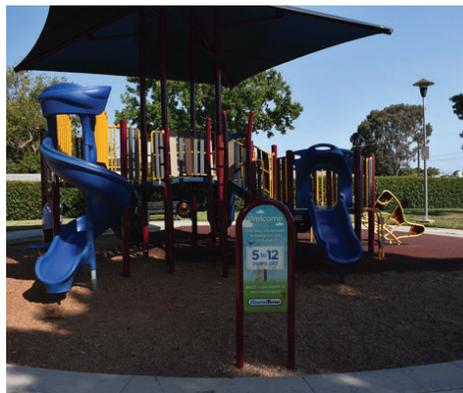
(Figure 1.2)

Figure 1.2, 1.3 - Play structure is in excellent condition. The play area is well shaded by the shade structure.

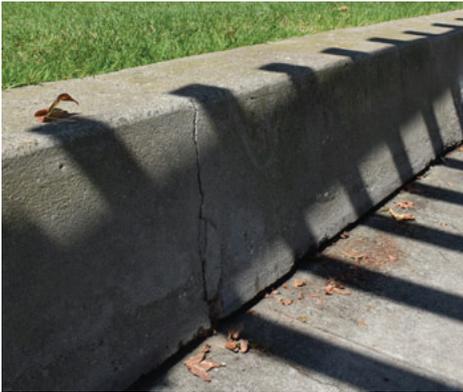
(Figure 2.1)

Figure 2.1 - Cracks were observed on the retaining wall.

Suggested Action- Repair with concrete filler. If structural integrity begins to fail, consider replacement of the retaining wall.

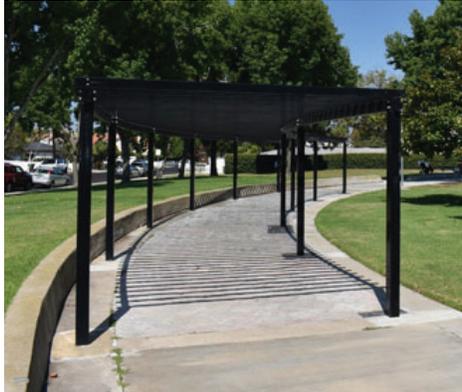
(Figure 2.2)

Figure 2.2 - The shade structure is in excellent condition; the posts are straight, the finish is bright and clean, no chipping on the surfaces.

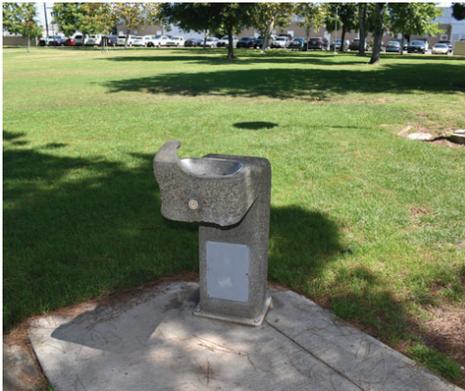
(Figure 4.1)

Figure 4.1 - Concrete pedestal of the drinking fountain is chipped and has algae/mold growth. The bowl and spout have algae/mold growth as well.

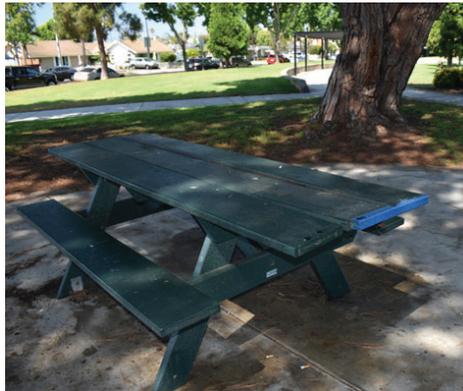
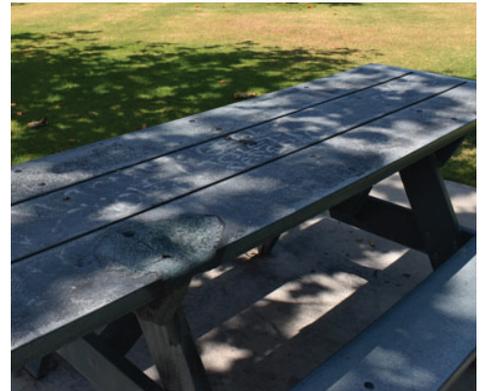
Figure 4.2, 4.3 - The picnic tables have broken parts.

Suggested Action- Repair the edge of the table so there are no sharp edges; replace the picnic table with the damaged tabletop.

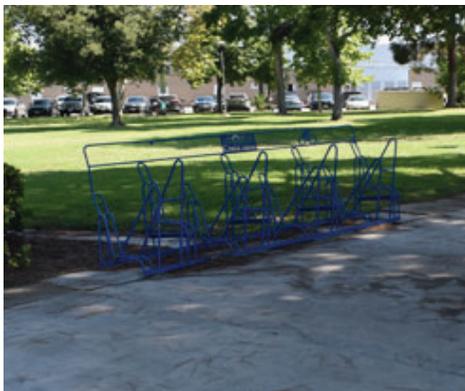
(Figure 4.4)

Figure 4.4 - Bike rack is in good condition. Color is bright with some chipping of paint observed. City logo is visible.

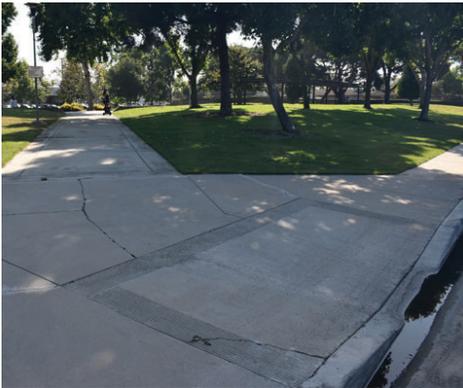
(Figure 5.1)

Figure 5.1 - Cracks observed in the paved pathway throughout the park

Suggested Action- Replace areas of broken concrete to ensure accessibility and ADA compliance.

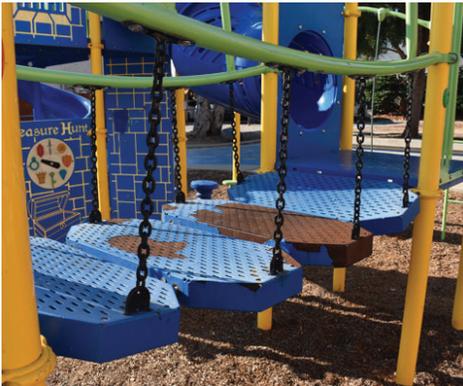
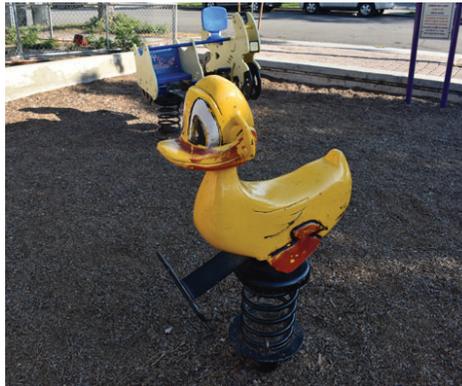
(Figure 1.1)

Figure 1.1, 1.2 - The play equipment have damaged or worn off powder coating on posts, caps, and components. Rust is forming.

Suggested Action- Considering the high amount of areas damaged, it is suggested to replace the play equipment.*

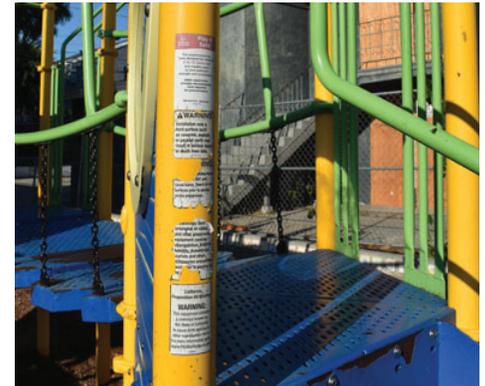
(Figure 1.3)

Figure 1.3 - Manufacturer's safety labels are deteriorating.

Suggested Action- Replace labels to be in compliance with industry standards.

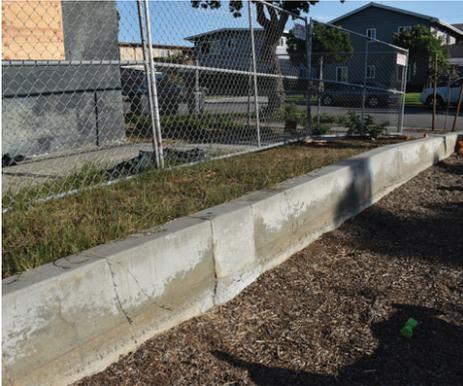
(Figure 2.1)

Figure 2.1 - Base of concrete wall is exposed over the level of wood fiber.

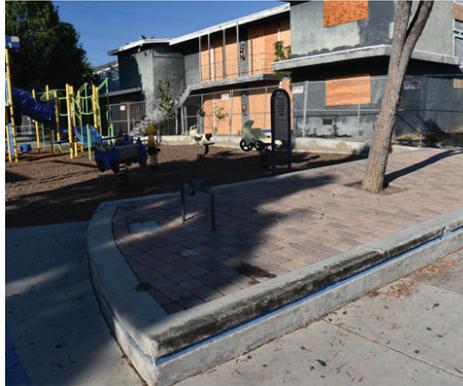
(Figure 2.2)

Figure 2.2 - Concrete low wall damaged from skateboarding. Concrete pieces have broken off.

Suggested Action- Replace low walls as needed. Consider installing skateboard deterrents.

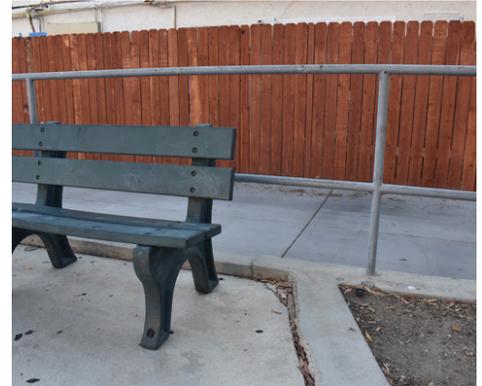
(Figure 2.3)

Figure 2.3 - Concrete curb is cracking and broken.

Suggested Action- Replace concrete curb.

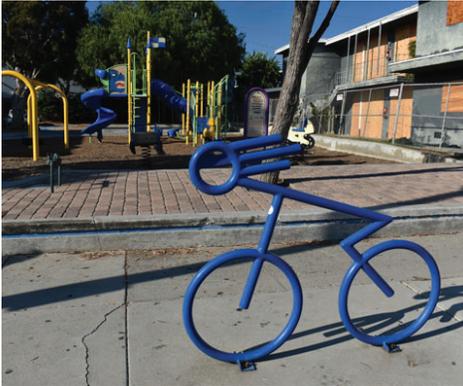
(Figure 4.1)

Figure 4.1 - Bike rack is in good condition. Color is bright, minor scratches or chipping of paint is observed.

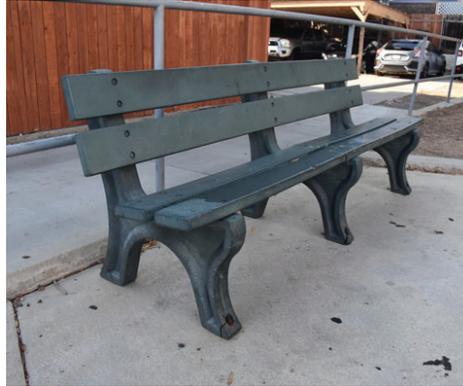
(Figure 4.2)

Figure 4.2 - Benches in the park show wear and tear. One of the benches was observed to have cracks in the legs where mounted to the concrete.

Suggested Action- Replace benches as needed.

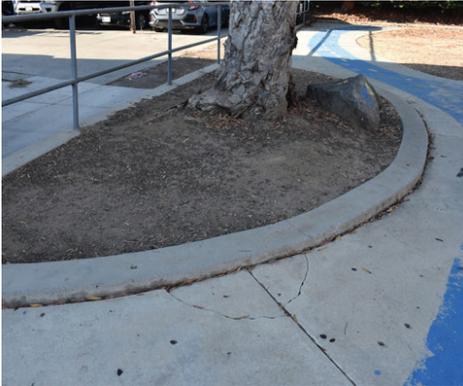
(Figure 5.1)

Figure 5.1 - Cracks observed in the paved pathway.

Suggested Action- Replace areas of broken concrete to ensure accessibility and ADA compliance.

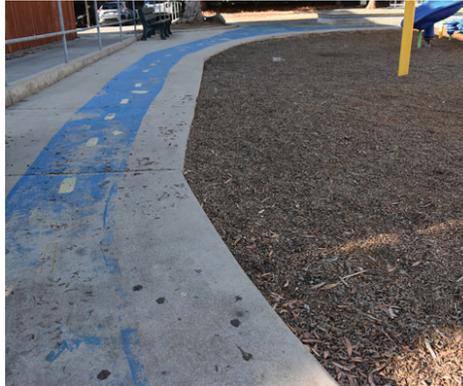
(Figure 5.2)

Figure 5.2 - Paint has worn off the paved pathway.

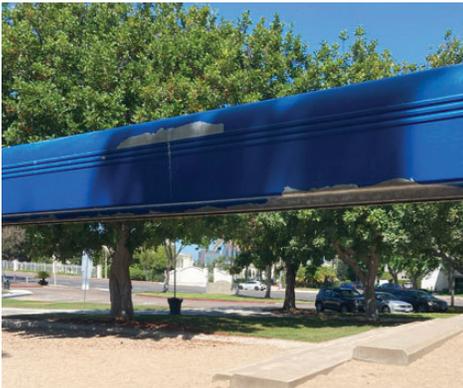
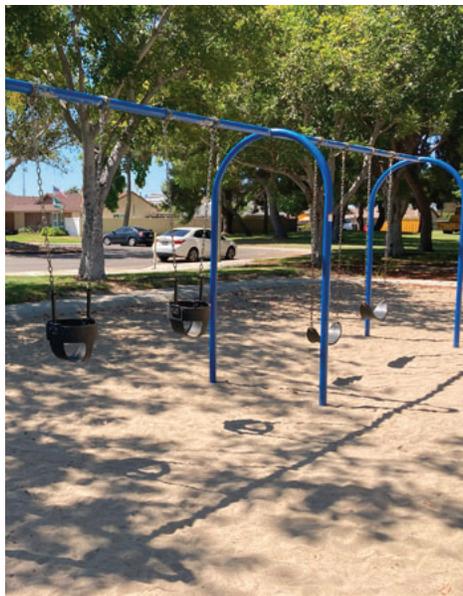
(Figure 1.1)

Figure 1.1, 1.5 - The play equipment have damaged or worn off powder coating on posts, caps, and components.

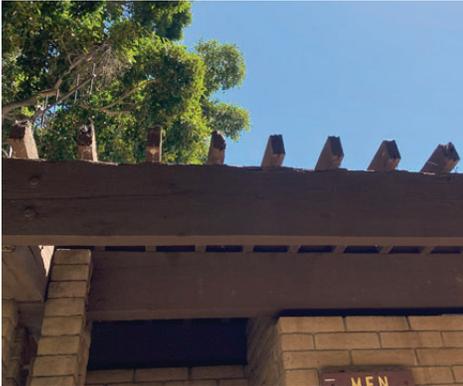
(Figure 2.1)

Figure 2.1 - The restroom structure roof rafters have noticeable termite damage.
Suggested Action- Replace/repair the damaged areas and repaint.

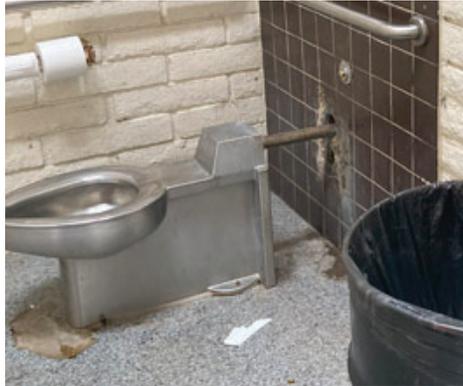
(Figure 2.2)

Figure 2.2 - Existing restroom interior has broken floor and wall tiles around the toilet.
Suggested Action- Repair floor and wall tiles.

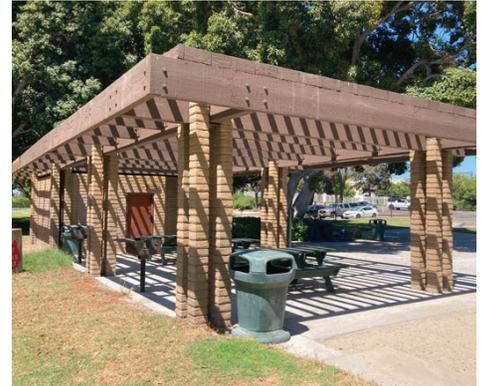
(Figure 2.3)

Figure 2.3 - The shade structure over the picnic area is in good condition.

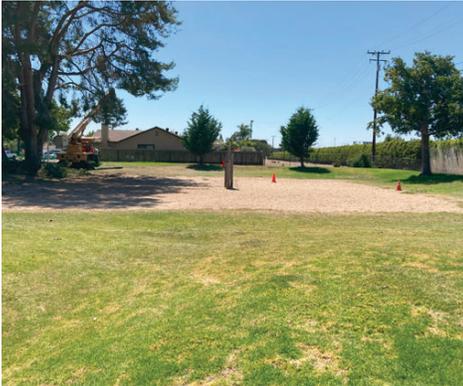
(Figure 3.1)

Figure 3.1 - There is no clear delineation where the sand volleyball court begins from the turf.

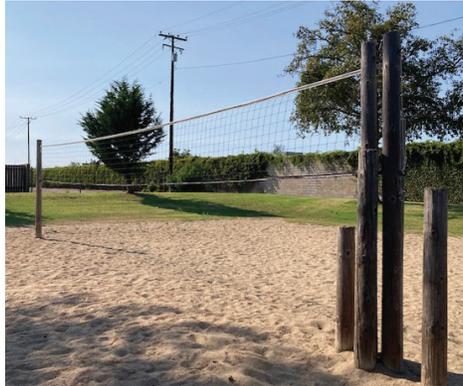
(Figure 3.2)

Figure 3.2 - The volleyball posts and net are in fair condition. The posts are wooden and are splintering.

Suggested Action- Replace volleyball posts.

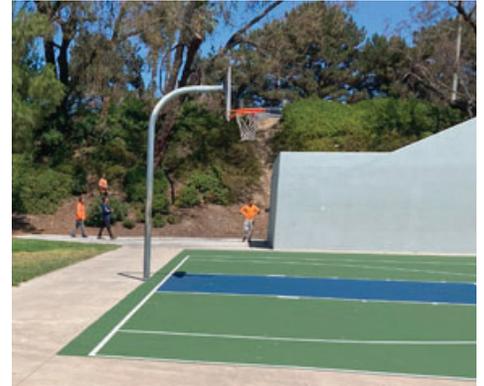
(Figure 3.3)

Figure 3.3 - The basketball court and court surface are in excellent condition. The color is vibrant, the lines are clear, and the pavement has no cracking.

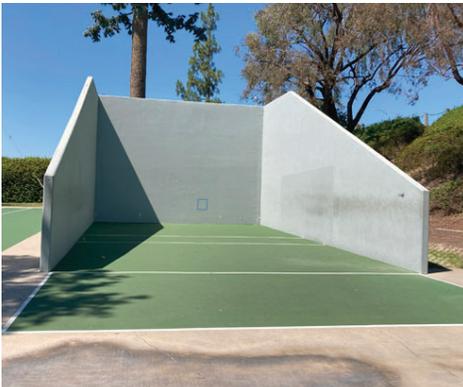
(Figure 3.4)

Figure 3.4 - The handball court appears to be in good condition. The color is vibrant and the lines are clear. The concrete beyond the court lines has cracked and shows water damage.

Suggested Action- Replace areas of broken concrete.

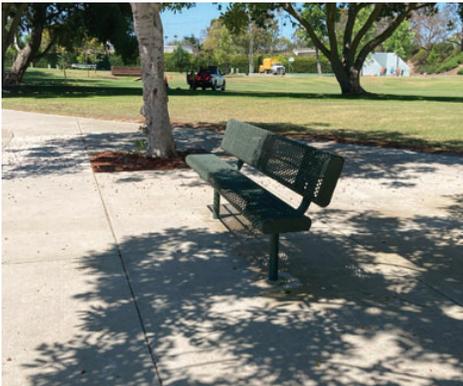
(Figure 4.1)

Figure 4.1 - Benches appear to be in good condition. The color is bright and there are minimal signs of wear and tear.

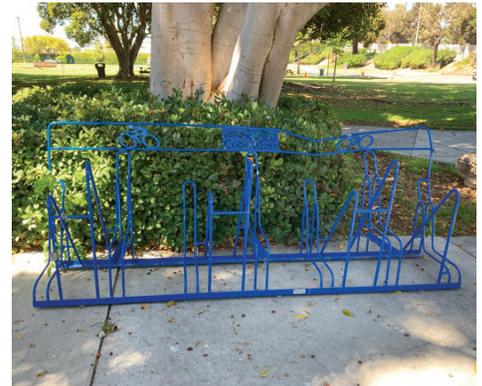
(Figure 4.3)

Figure 4.3 - The metal bike rack has been damaged on the decorative portion; the rack is still functional. (There are 2 other bike racks in the park which are concrete; both are in good condition.)

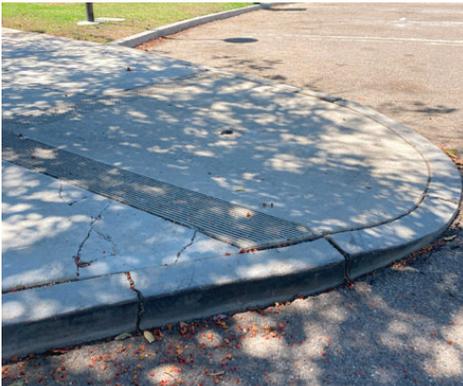
(Figure 5.1)

Figure 5.1- Cracks observed in the concrete ramp adjacent to the parking lot.
Suggested Action- Replace areas of broken concrete to ensure accessibility and ADA compliance.

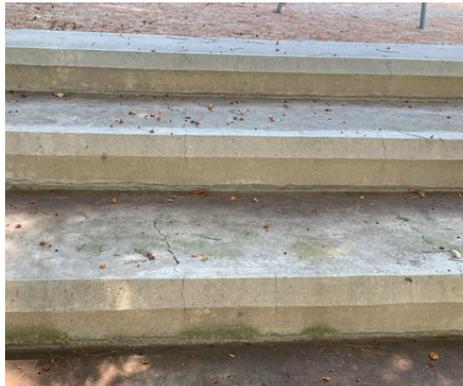
(Figure 5.2)

Figure 5.2- Concrete bleachers are cracking.
Suggested Action- Repair cracks. Consider replacement.

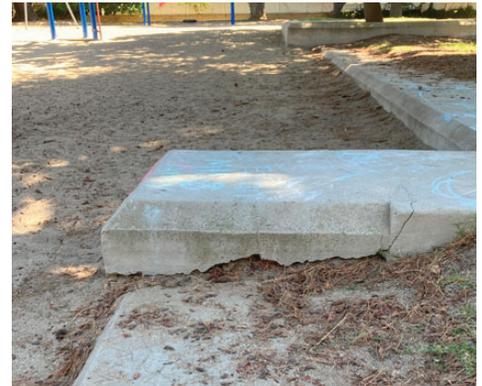
(Figure 5.3)

Figure 5.3- Concrete seat wall/retaining wall is broken.
Suggested Action- Replace the wall.

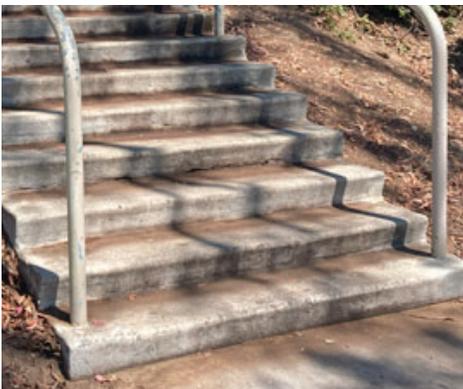
(Figure 5.4)

Figure 5.4- Concrete stairs are cracking.
Suggested Action- Repair or replace concrete stairs.

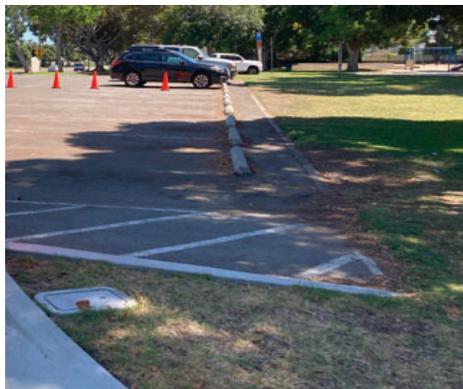
(Figure 5.5)

Figure 5.5- Concrete band and parking lot paving (located near the painted island striping) is sunken, breaking.
Suggested Action- Repair the band and paving.

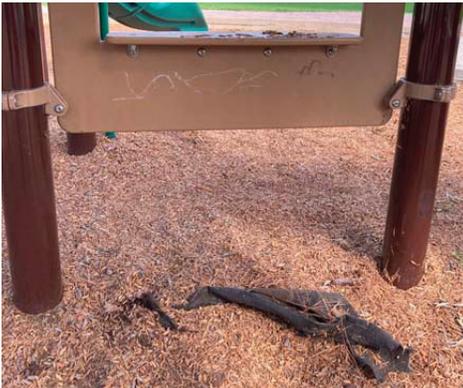
(Figure 1.1)

Figure 1.1 - Wood fiber is thrown onto the play equipment. Weed barrier is being exposed from displaced and/or low levels of wood fiber.

Suggested Action- Ensure wood fiber level is at proper depth for fall safety requirements, as the wood fiber compacts over time. Additionally, maintain wood fiber level to be within 2-3 inches to the top of the beveled edge of the rubber safety surfacing. Replace the rubber safety surfacing. Consider removing the wood fiber and replace with rubber safety surfacing.

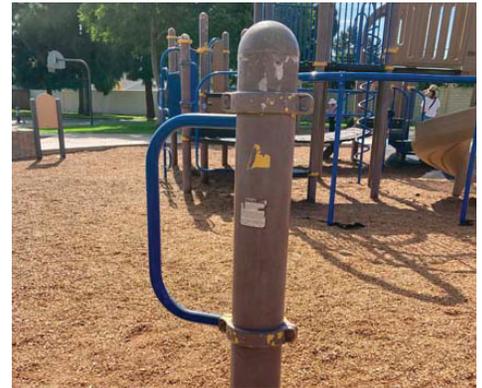
(Figure 1.3)

Figure 1.3 - Manufacturer's safety labels have worn off.

Suggested Action- Replace labels per industry standards.

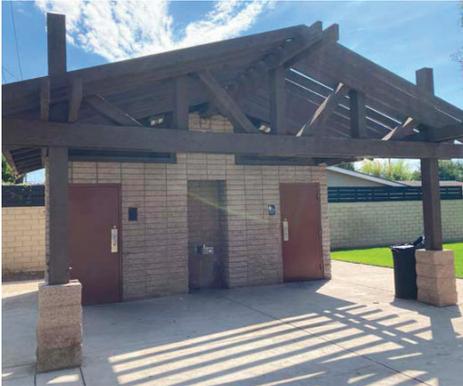
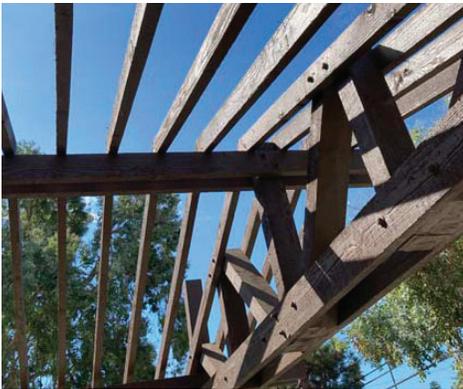
Figure 2.1, 2.4 - The restroom building and attached pergola are in good condition. The wood is not splintering and the paint color looks fresh and complete. The brick walls look cleaned and well-maintained.

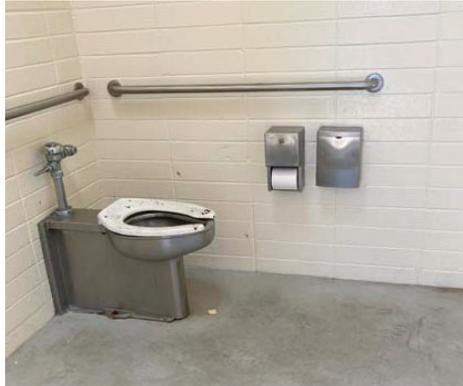
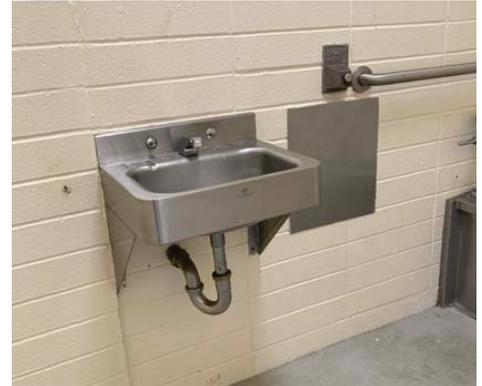
Figure 2.2, 2.3 - The interior of the restroom is clean. The paint on the toilet seat is chipped.

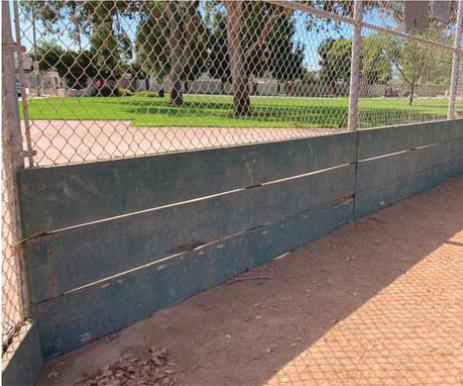
(Figure 3.1)

Figure 3.1 - Backstop at the softball field is broken in several spots.

Suggested Action- Replace boards.

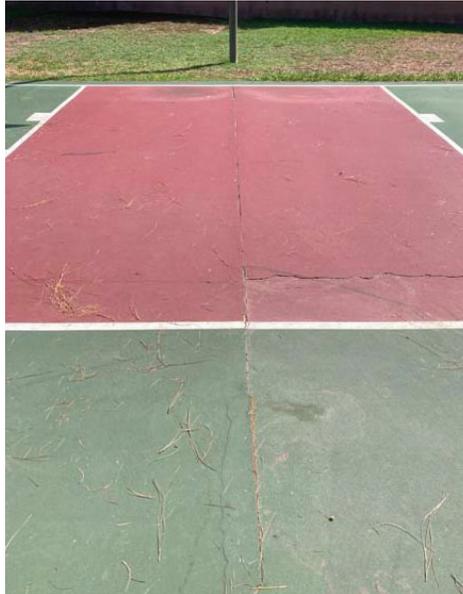
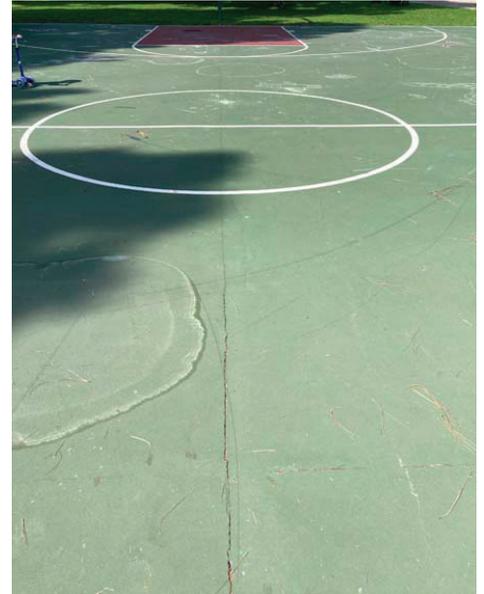
Figure 3.2, 3.3 - The concrete surface of the basketball court is cracking. It is cracked all throughout the middle of the court. There is water damage on the court surface.

Suggested Action- Consider replacement of the court surface.

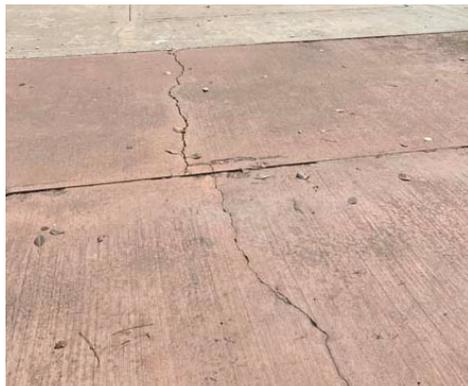
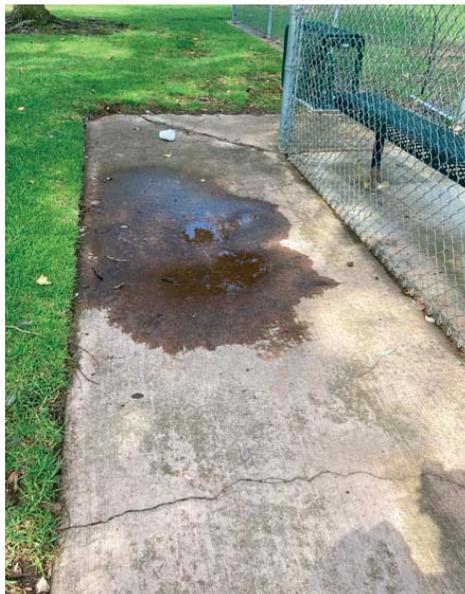
Figure 5.1, 5.2 - Cracks and gaps observed in the paved area around the softball field. This pavement appears to be older than the rest of the paved pathways in the park.

Suggested Action- Replace areas of broken concrete to ensure accessibility and ADA compliance.

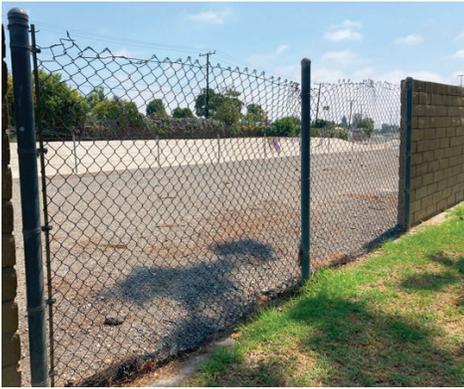
(Figure 2.1)

Figure 2.1 - The chain-link fence is warped in several sections along the wall.

Suggested Action- Repair or replace damaged sections.

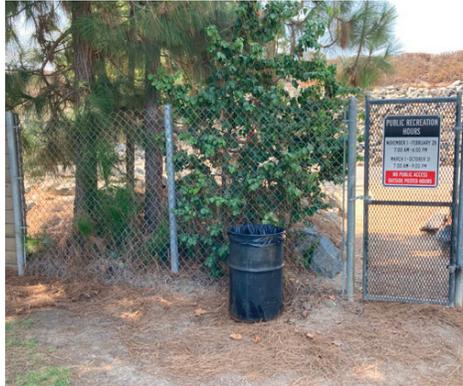
(Figure 4.2)

Figure 4.2- Trash receptacle by the gate is rusting at the bottom.
Suggested Action- Replace receptacle when needed.

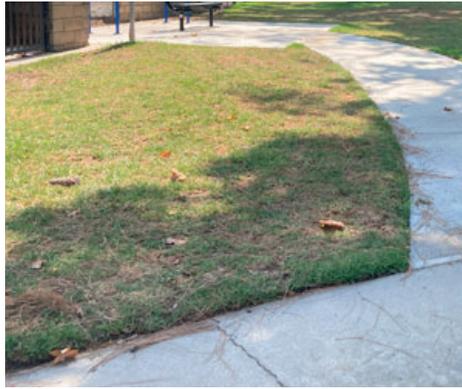
(Figure 5.2)

Figure 5.2- An area of cracking on the driveway apron was observed along the park boundary.

Suggested Action- Repair or replace with new concrete to ensure accessibility and ADA compliance.

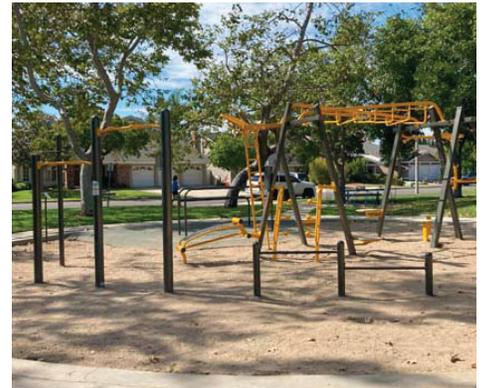
(Figure 1.3)

Figure 1.3 - The playground has a sand and rubber safety surfacing combination. The sand level covers the bottom of the rubber safety surfacing for the most part but in Figure 2.3 the edge of the safety surfacing is exposed above the sand level. *Suggested Action*- Ensure sand level is at proper depth for fall safety requirements, as sand compacts over time. Additionally, maintain sand level to be within 2-3 inches to the top of the beveled edge of the rubber safety surfacing. Consider removing the sand and replace with rubber safety surfacing.

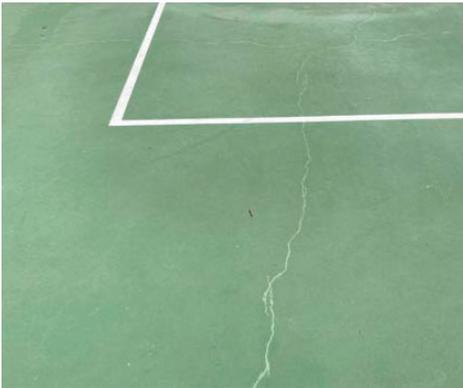
(Figure 3.1)

Figure 3.1 - The concrete at the volleyball court has some cracking.

Suggested Action- Monitor and assess when replacement may be necessary.

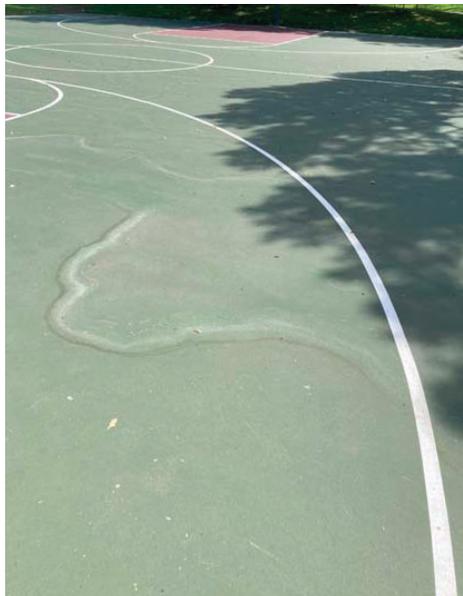
(Figure 3.5)

Figure 3.5 - The basketball court surface has colors that are vibrant and clearly painted lines. There is some water damage.

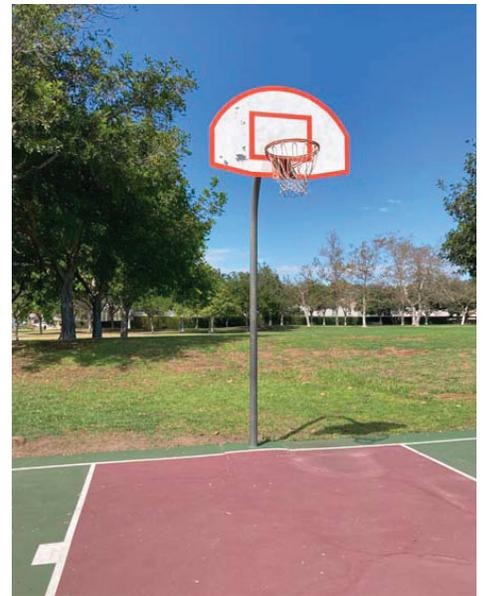
(Figure 3.6)

Figure 3.6 -The basketball backboard has some chipping paint.

Suggested Action- Repaint backboard.

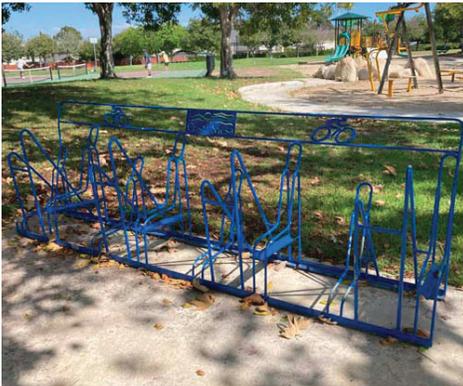
(Figure 4.1)

Figure 4.1 - Bike rack is in good condition. Color is bright with some chipping of paint observed. City logo is visible.

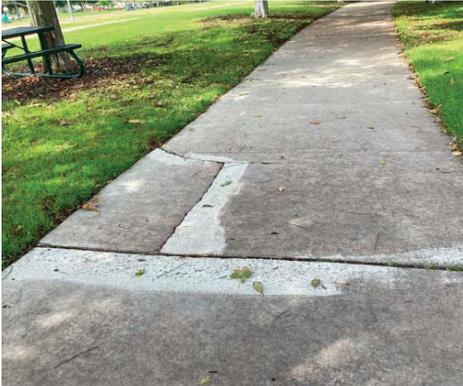
(Figure 5.1)

Figure 5.1- Cracks observed in the paved pathway.

Suggested Action- Replace areas of broken concrete to ensure accessibility and ADA compliance.
