CITY OF COSTA MESA
PARKS AND COMMUNITY SERVICES COMMISSION
Agenda

PARK ASSESSMENT

2025

Park Assessments were conducted at all public parks within the City of Costa Mesa and have been documented herein. The report identifies physical condition of amenities, structures, pathways, playgrounds, and existing program elements in each park. This parks assessment is essential for the City of Costa Mesa in identifying and prioritizing improvements, allowing for safe, functional and enjoyable spaces for the community to recreate and enjoy.

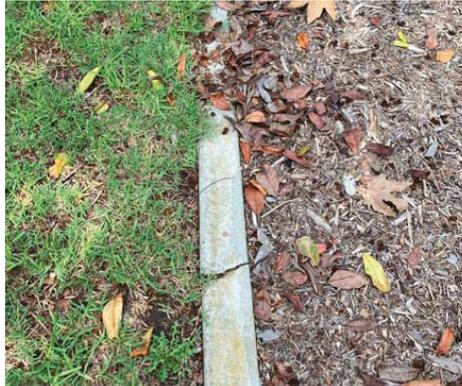
(Figure 5.2)

Figure 5.2- Concrete curb along the planting area has some broken areas.

Suggested Action- Replace concrete curb.

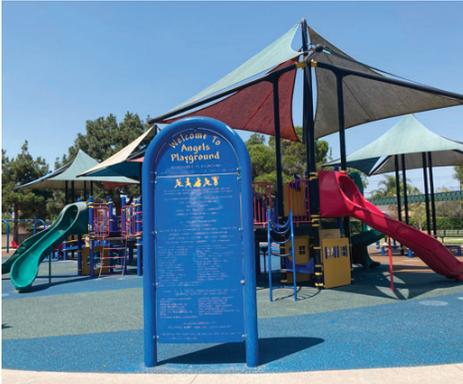
(Figure 1.1)

Figure 1.1 - The play equipment is in good condition; the components are bright and the equipment is well shaded. The play structure has insignificant damaged or worn off powder coating on posts, caps, and components. The shade sails are stained and the color looks faded.

Suggested Action- Considering the age of the play structure, it does not show extensive damage. The rubber surfacing may have kept the play equipment in better condition as compared to play structures in sand.

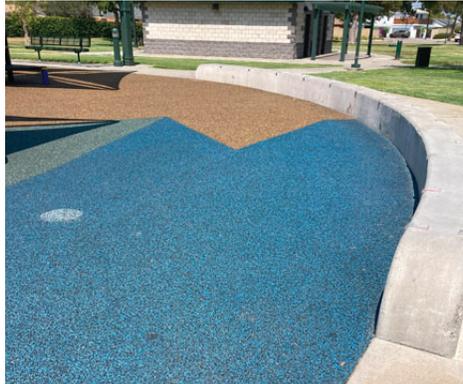
(Figure 1.2)

Figure 1.2 - Rubber safety surfacing is in good condition. The surface show some light staining, but edges are neat and level with adjacent concrete.

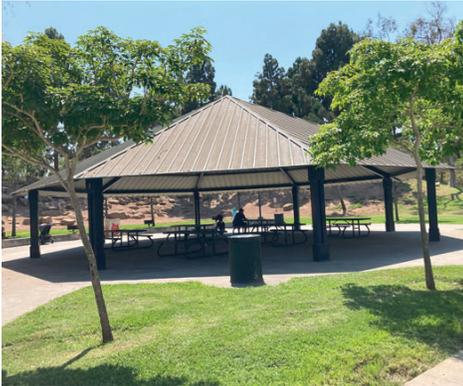
(Figure 2.1)

Figure 2.1 - The shade structures over the picnic table areas are in good condition and are clean and accessible from the paved pathway.

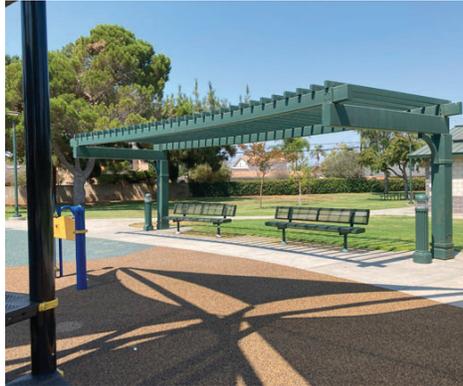
(Figure 2.2)

Figure 2.2 - The pergolas around the playground are in good condition. They match the benches and bollards and create areas with clear sightlines on the play structure.

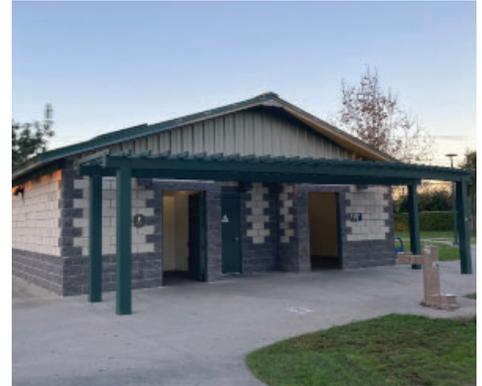
(Figure 2.3)

Figure 2.3 - The restroom building near the playground is in good condition. The brick walls and metal roofing are whole and intact. The adjacent green pergola tie in aesthetically with the other site furnishings in the park.

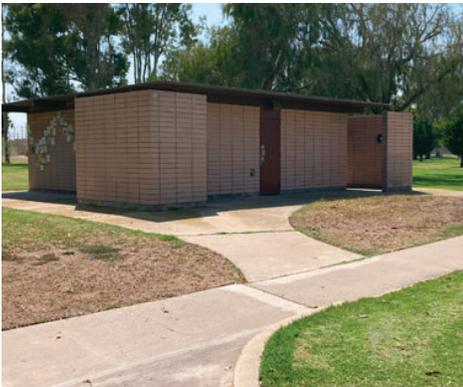
(Figure 2.4)

Figure 2.4 - This restroom structure is older than the restroom near the playground. There is artful tile inlay in the restroom building exterior wall, which is a unique addition to the park. It was locked at the time of the assessment site visit, so it may not be regularly available to park visitors. The brick is dull, and paint has come off the base of the building. *Suggested Action*- Given the age of the restroom structure, it is recommended to update the building.

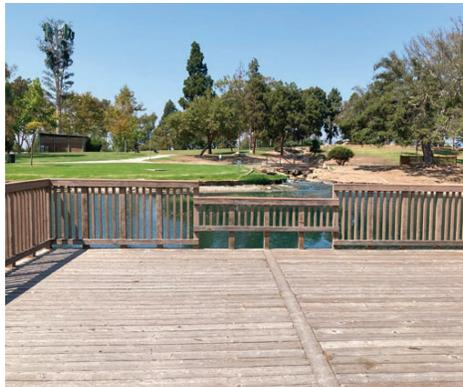
(Figure 2.5)

Figure 2.5 - This pier is a nice spot to view the lake and parkgrounds. The wood is splintering and breaking in some areas. *Suggested Action*- Assess the wood planks of the platform and repair where necessary. Consider adding seating.

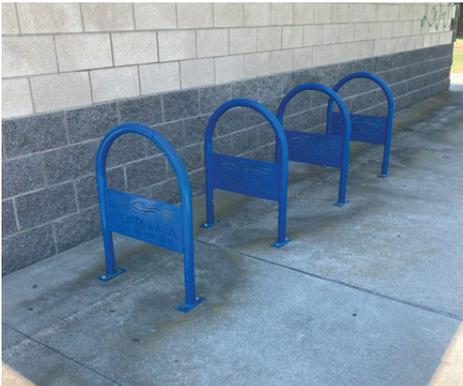
(Figure 4.1)

Figure 4.1 - Bike rack is in good condition. Color is bright, no scratches or chipping of paint is observed. City logo is visible.

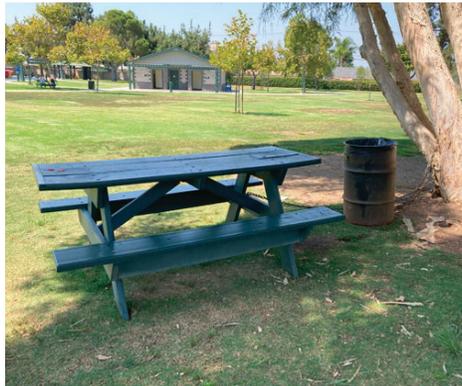
(Figure 4.2)

Figure 4.2 - Picnic table is located in the turf area; turf will struggle to grow where there is soil compaction.
Suggested Action- Relocate picnic table and repair damaged turf.

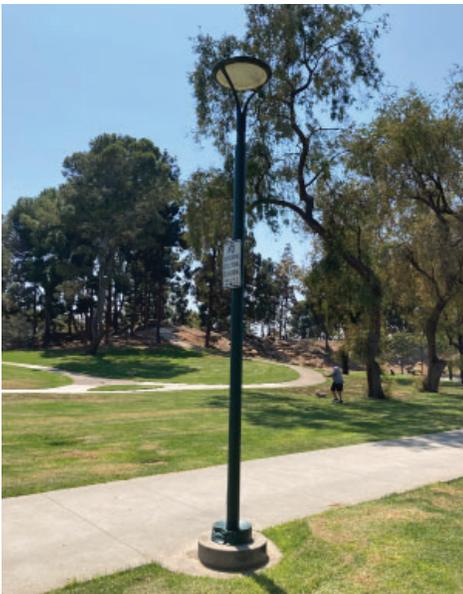
(Figure 4.4)

Figure 4.4 - Lighting was not assessed. Base cover of light pole is dented.
Suggested Action- Replace base cover.

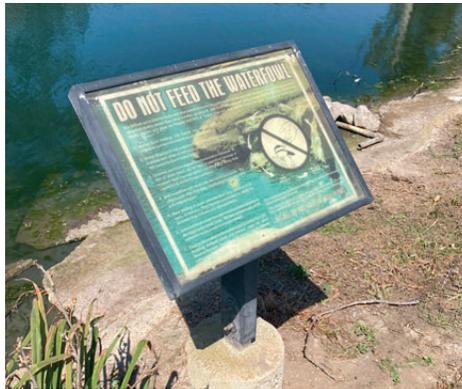
(Figure 4.5)

Figure 4.5 - Sign by the lake shows extensive sun damage.
Suggested Action- Replace sign.

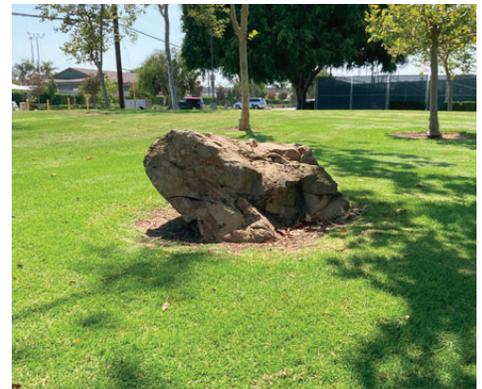
(Figure 4.6)

Figure 4.6 - Boulders in turf create challenges in mowing and maintenance.
Suggested Action- Maintenance can be simplified by moving the turf edge away from the boulders.

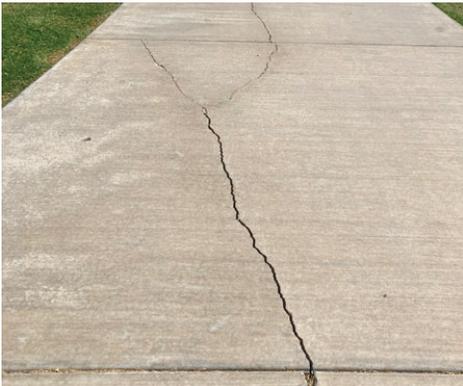
(Figure 5.1)

Figure 5.1- Cracks observed in the concrete walkway.

Suggested Action- Replace sections of broken concrete to ensure accessibility and ADA compliance.

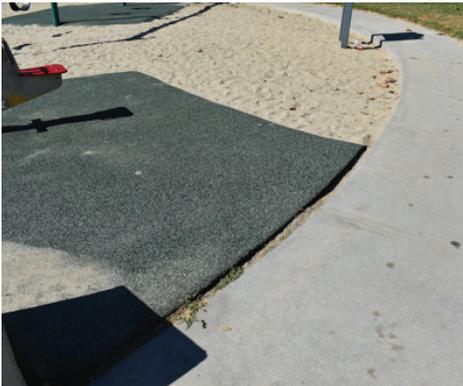
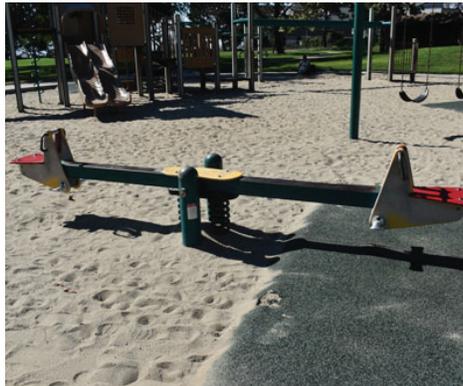
Figure 1.1, 1.2 - The playground has a sand and rubber safety surfacing combination. The sand level covers the bottom of the rubber safety surfacing. There is a large gap between the safety surfacing and the paved pathway (Figure 2.1). The safety surfacing is broken (Figure 2.2).

Suggested Action- Ensure sand level is at proper depth for fall safety requirements, as sand compacts over time. Additionally, maintain sand level to be within 2-3 inches to the top of the beveled edge of the rubber safety surfacing. Consider removing the sand and replace with rubber safety surfacing.

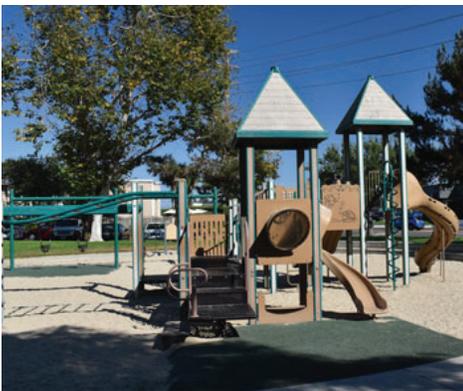
(Figure 1.4)

Figure 1.4 - Powder coating is damaged and worn off on posts, caps, and components due to wear and tear. There is no obvious damage to the play structure.

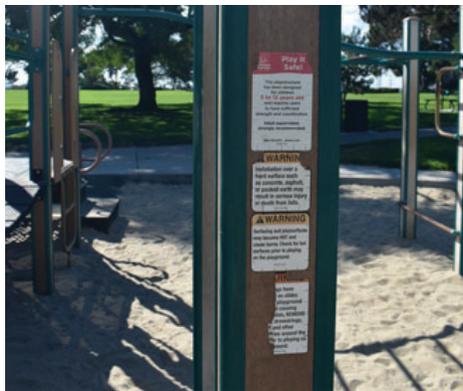
(Figure 1.5)

Figure 1.5 - Manufacturer's safety labels are deteriorating.

Suggested Action- Replace labels per industry standards.

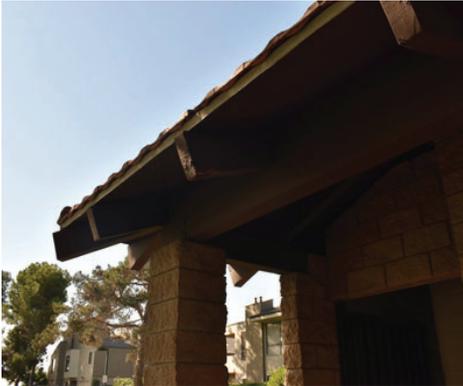
(Figure 2.1)

Figure 2.1 - There are signs of termite damage on the roof rafters.

Suggested Action- Replace the damaged wood on roof.

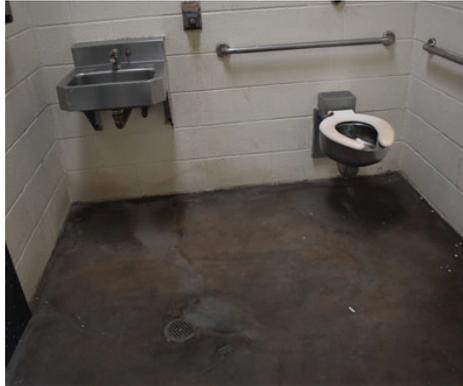
(Figure 2.2)

Figure 2.2 - The interior of the restroom is clean. The sink faucet handle is damaged. The floor and wall are stained.

Suggested Action- Repair sink as needed. Replace/repair flooring and wall as needed.

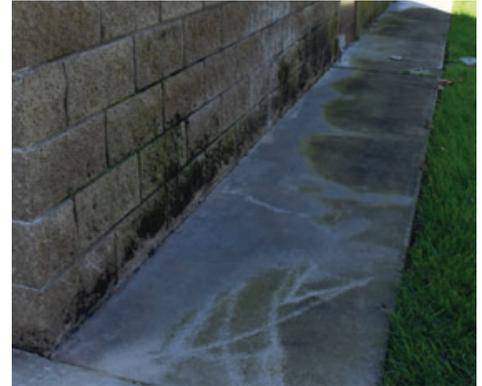
(Figure 2.3)

Figure 2.3 - The exterior wall shows extensive mold/algae growth from persistent moisture.

Suggested Action- Assess the source of moisture and divert the source and/or apply sealers to the walls and concrete.

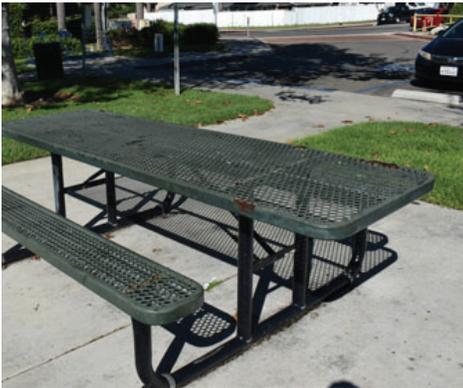
(Figure 4.1)

Figure 4.1 - The plastic coating on the picnic table has broken and the metal is rusting.

Suggested Action- Replace picnic tables as needed.

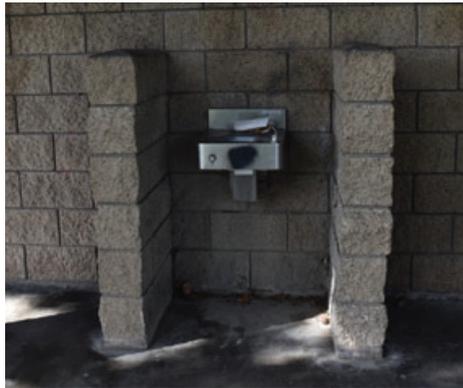
(Figure 4.2)

Figure 4.2 - The drinking fountain is located on the restroom building exterior and is in good condition. The surface is generally clean, no signs of leaking.

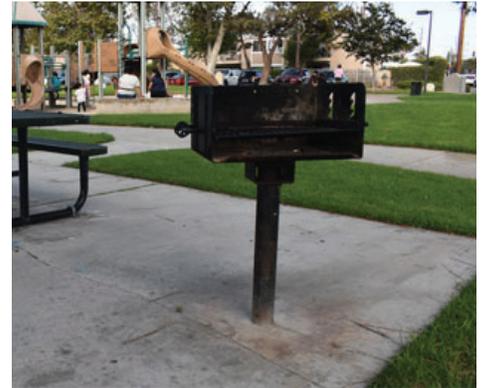
(Figure 4.3)

Figure 4.3 - BBQ grill is in fair condition. There are signs of damage from heat (wear and tear), but the grills are usable.

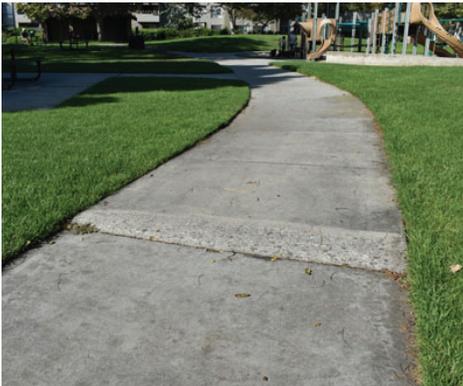
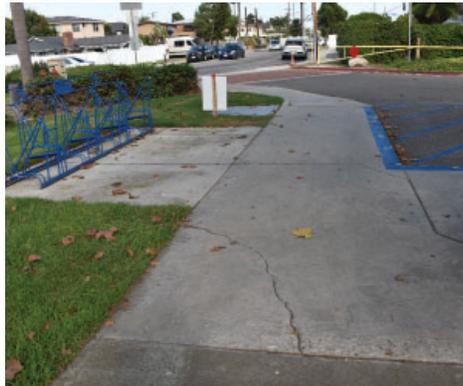
Figure 5.1, 5.2 - Lifted concrete and cracking observed in the paved pathway.

Suggested Action- Repair broken or uneven concrete sections to ensure accessibility and ADA compliance.

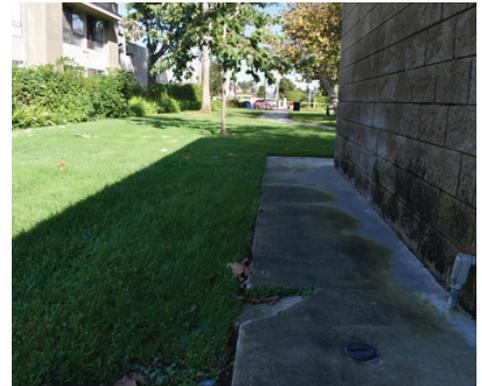
(Figure 5.3)

Figure 5.3 - Concrete paving around the restroom building is damaged by water from the turf. Mold/algae is growing and the concrete is breaking.

Suggested Action- Replace concrete as needed. Adjust irrigation to prevent overspray on paving and structures.

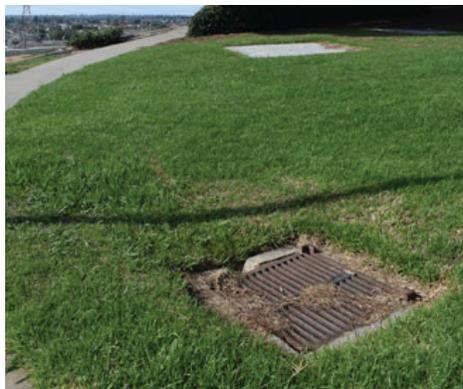
(Figure 5.5)

Figure 5.5 - Concrete collar around the drain cover is broken.

Suggested Action- Replace concrete collar.

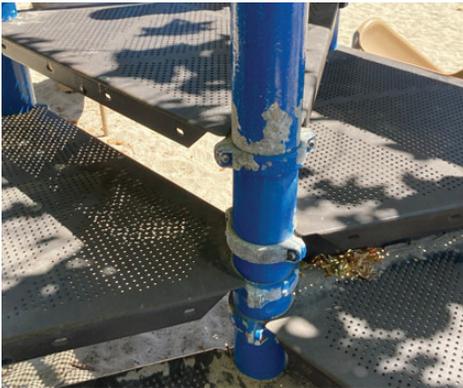
(Figure 1.1)

Figure 1.1 - Powder coating is damaged and worn off on posts, caps, and components.

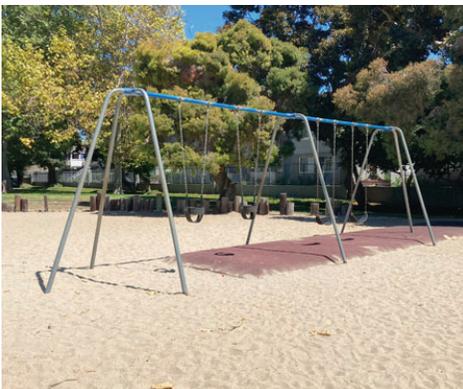
(Figure 1.4)

Figure 1.4 - Swing sets have extensive powder coating damage on the top beam.

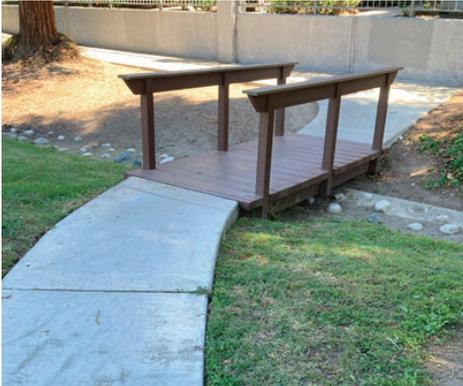
(Figure 2.1)

Figure 2.1 - Bridge is in good condition. Color is bright, with no significant scratches or chipping of paint observed.

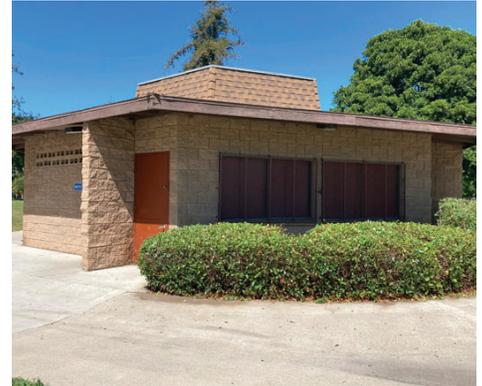
(Figure 2.3)

Figure 2.3 - The restroom/storage structure is in good condition but paint is peeling off the fascia board of the roof. There may also be termite damage in the wood.

Suggested Action- Repaint and/or repair the fascia board.

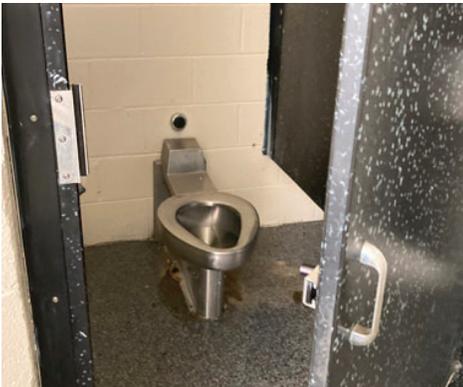
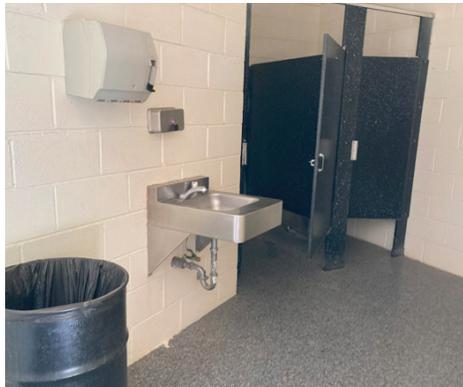
Figure 2.4, 2.5 - The interior of the restroom building looks fairly clean and in working condition. There appears to be some leaking around the toilet.

Suggested Action- Assess for any signs of water damage and repair any leaks in the restroom.

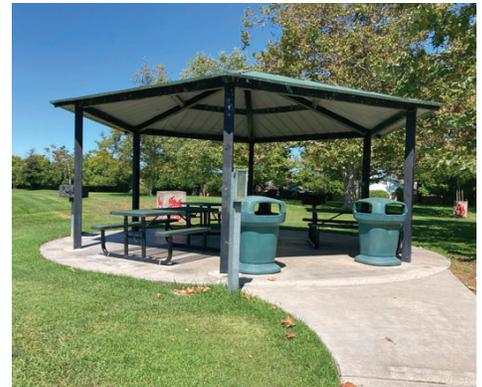
(Figure 2.6)

Figure 2.6 - The shade structure over the picnic area is in good condition, but has remnants of stickers accumulating on the beams and posts.

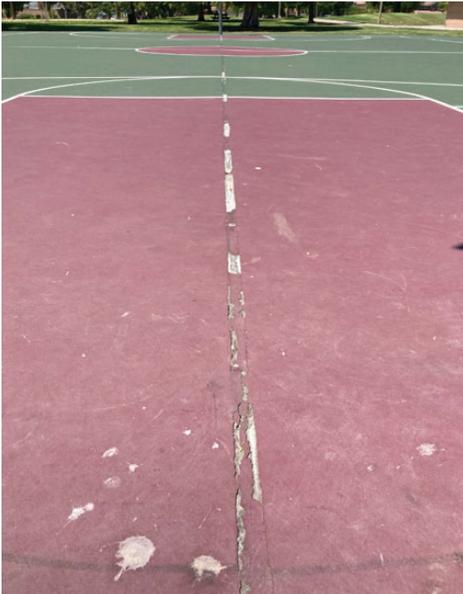
(Figure 3.1)

Figure 3.1 - The basketball court surface shows deterioration between the slabs of paving.
Suggested Action- Replace the basketball court paving to ensure a smooth playing surface.

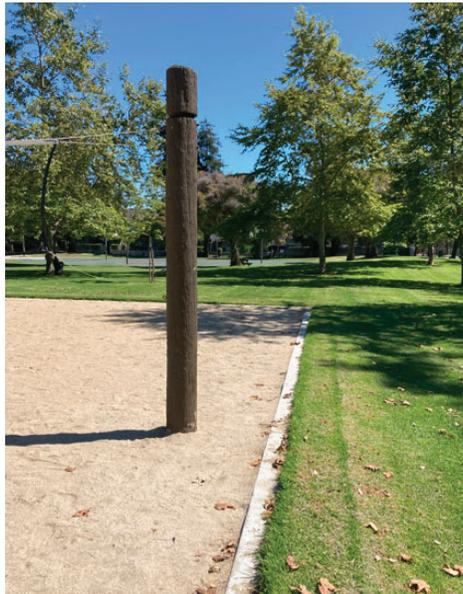
(Figure 3.2)

Figure 3.2 - The wooden post of the sand volleyball court is splintering and shows signs of paint chipping.
Suggested Action- Replace volleyball posts.

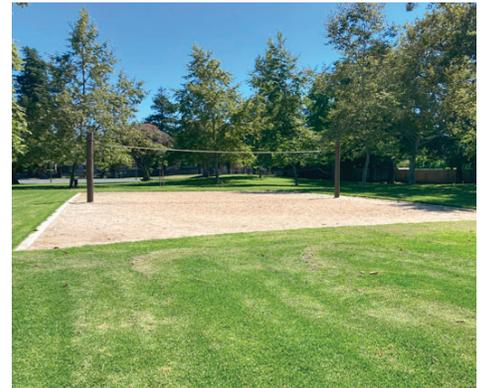
(Figure 3.3)

Figure 3.3 - The sand volleyball court is located in the turf. Minor cracking in the concrete curb.
Suggested Action- Monitor condition and repair as needed.

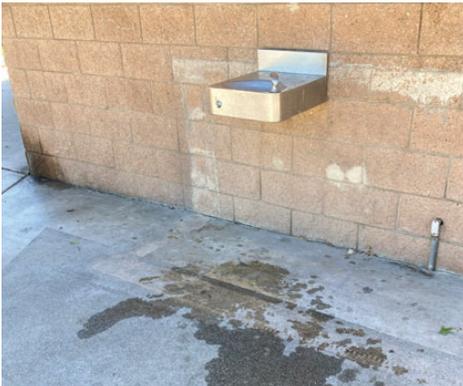
(Figure 4.1)

Figure 4.1 - The drinking fountain (located on the exterior of the restroom building) is in good condition. The surface is clean, no signs of leaking.

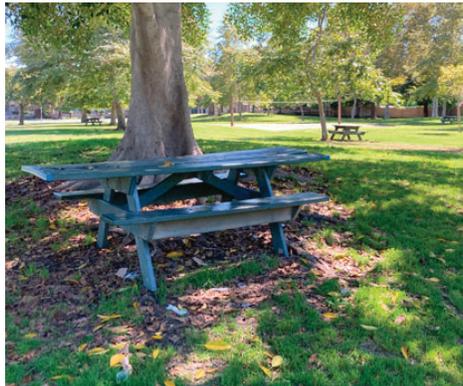
(Figure 4.2)

Figure 4.2 - The picnic table is located in the turf area; turf will struggle to grow where there is soil compaction.
Suggested Action- Relocate picnic table and repair damaged turf.

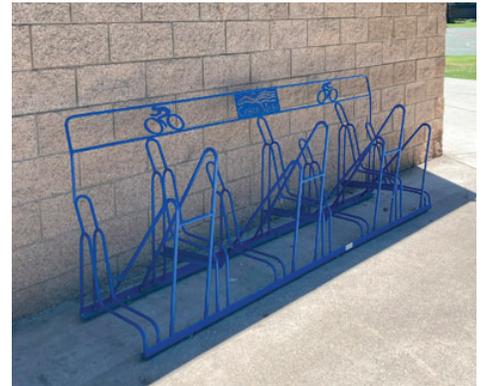
(Figure 4.3)

Figure 4.3 - Bike rack is in good condition. Color is bright, minor scratches or chipping of paint is observed. City logo is visible.

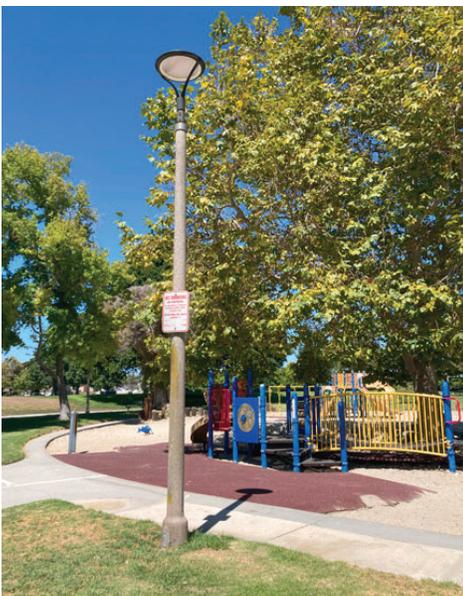
(Figure 4.4)

Figure 4.4 - Lighting system was not assessed. The light poles have matching fixtures.

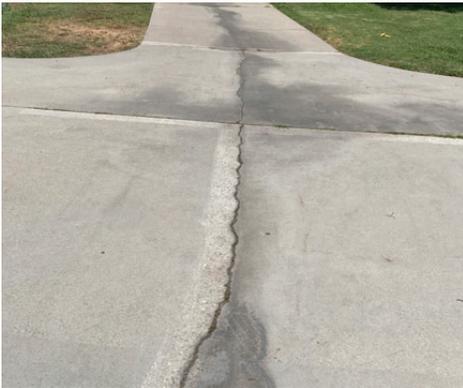
(Figure 5.1)

Figure 5.1 - Multiple areas of cracking were observed on the paved pathway in the park.
Suggested Action- Replace areas of broken concrete to ensure accessibility and ADA compliance.

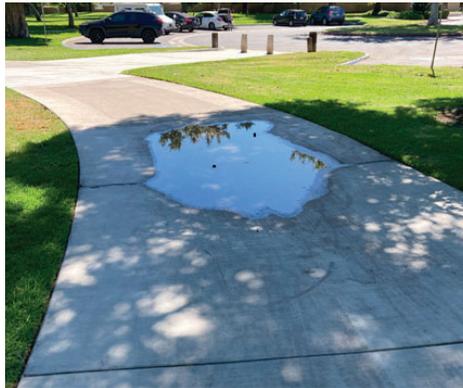
(Figure 5.2)

Figure 5.2 - Water is accumulating in the paved pathway, due to the pathway designed to also act as a concrete swale. Water damage on the pavement observed.
Suggested Action- Monitor concrete condition and repair or replace as needed.

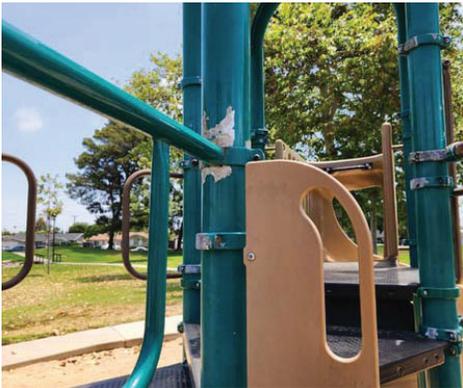
(Figure 1.1)

Figure 1.1 - The play structure has damaged or worn off powder coating on posts, caps, and components.

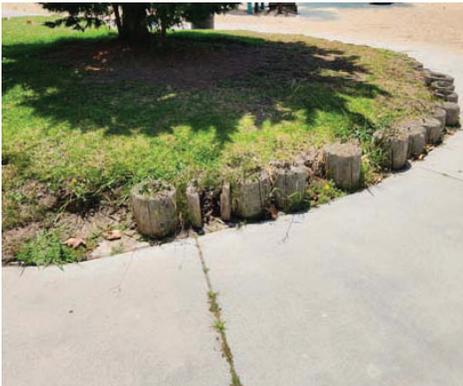
(Figure 2.1)

Figure 2.1 - Wood posts are rotted out in various areas.
Suggested Action- Replace or remove wood posts.

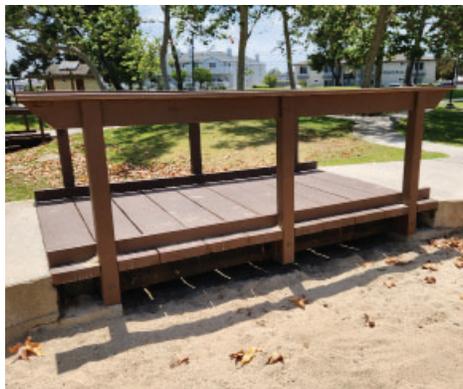
(Figure 2.5)

Figure 2.5 - The bridge area creates a potential hiding spot near the playground.
Suggested Action- Consider closing off the gap underneath.

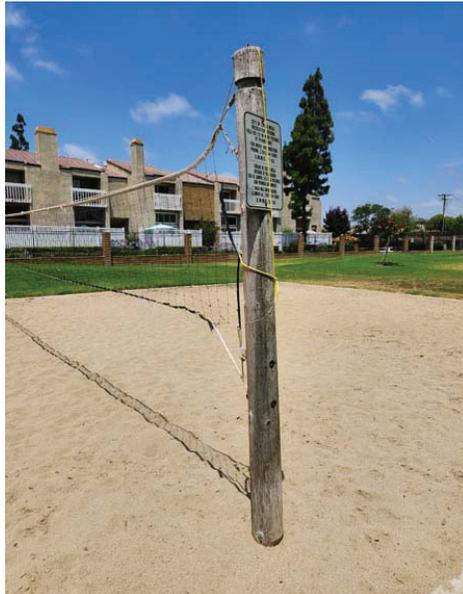
(Figure 3.1)

Figure 3.1 - The sand volleyball court is delineated by a concrete curb that separates sand from turf.

Suggested Action- Monitor the condition of the concrete curb and repair/replace as needed.

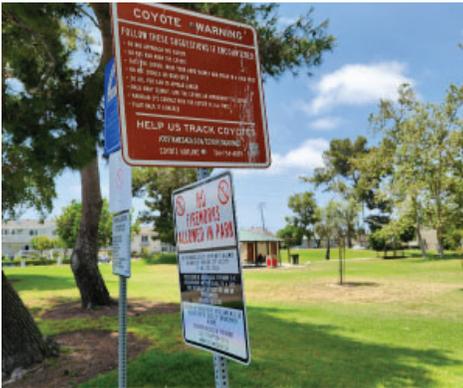
(Figure 4.1)

Figure 4.1 - The park's sign has bird droppings on it.

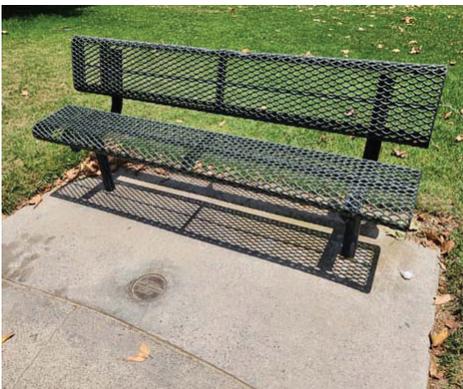
(Figure 4.4)

Figure 4.4 - The backrest of the bench is dented, but the vinyl coating is intact. The bench is usable and in good condition.

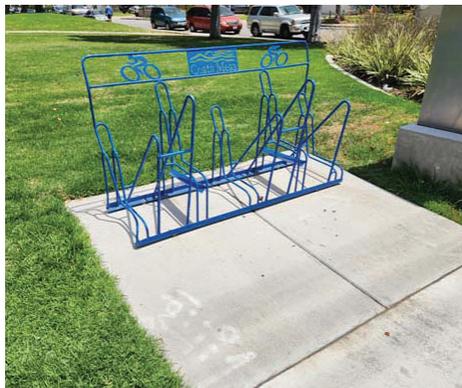
(Figure 4.5)

Figure 4.5 - Bike rack is in good condition. Color is bright, minor scratches or chipping of paint is observed. City logo is visible.

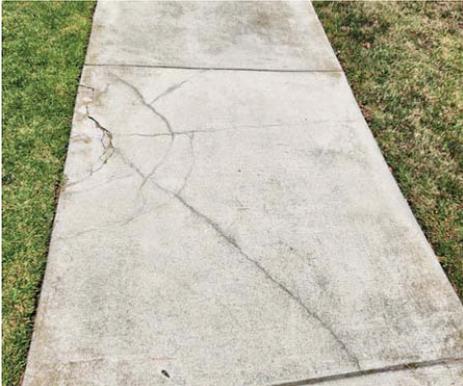
(Figure 5.1)

Figure 5.1 - Cracks observed in the paved pathways at various areas throughout the park.

Suggested Action- Replace sections of broken concrete to ensure accessibility and ADA compliance.

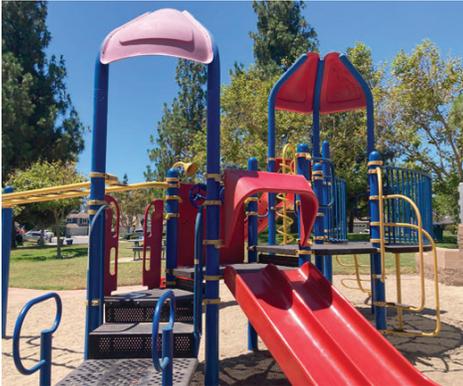
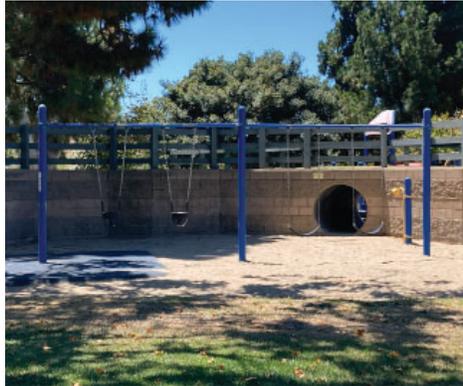
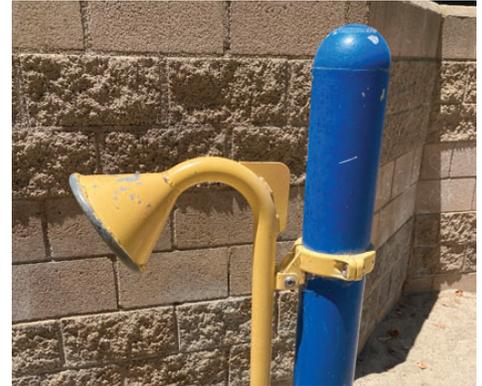
Figure 1.1, 1.2, 1.3 - The play equipment have damaged or worn off powder coating on posts, caps, and components; some components look damaged from long exposure to the sun.

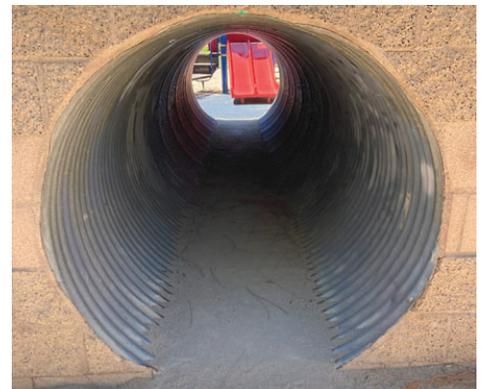
(Figure 1.6)

Figure 1.6 - The tunnel appears to be in good condition, and is a unique play element for this park.

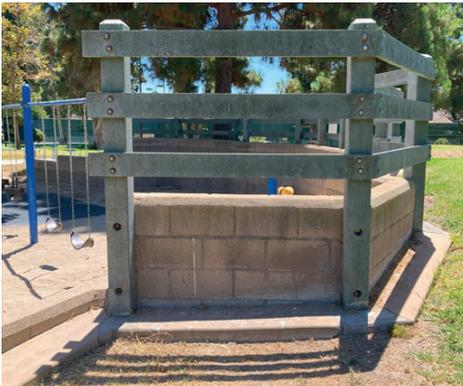
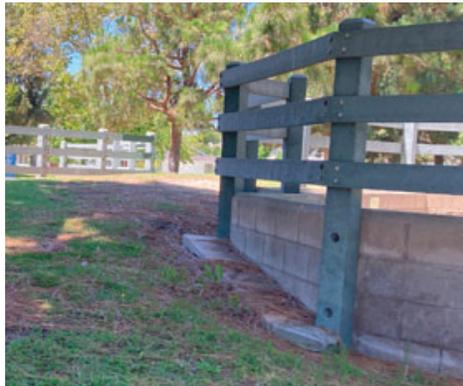
Figure 2.1, 2.2 - Guardrail and retaining wall are in good condition. There is some soil erosion near the concrete base for the guardrail.

Suggested Action- Assess for structural integrity and repair as needed to meet safety standards.

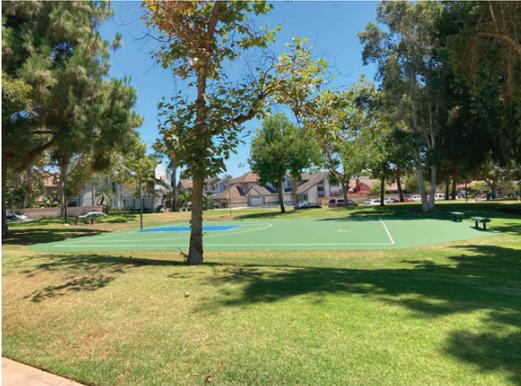
(Figure 3.1)

Figure 3.1 - The basketball half-court is in excellent condition. The color is vibrant, the lines are clear, and the pavement has no cracking.

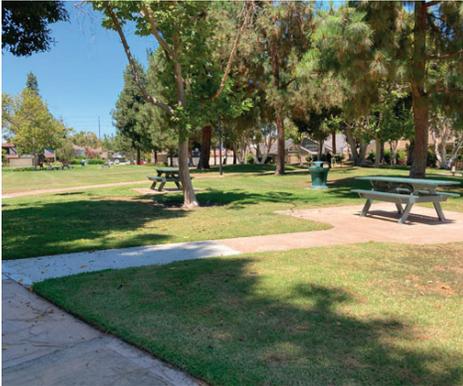
(Figure 4.1)

Figure 4.1 - There is one picnic table area connected to the paved pathway. Other picnic tables are each on a small concrete pad surrounded by turf.

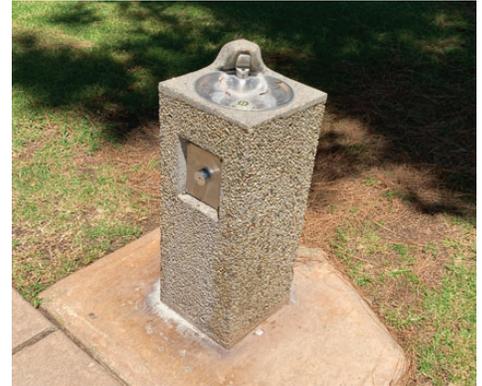
(Figure 4.3)

Figure 4.3 - The two drinking fountains are in good condition. The concrete pedestals are clean, whole and intact.

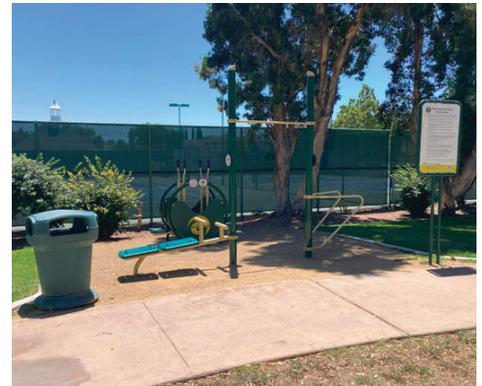
(Figure 4.6)

Figure 4.6 - The four Fitness Zone areas are in good to excellent condition. Color is bright, minor scratches or chipping of paint is observed.

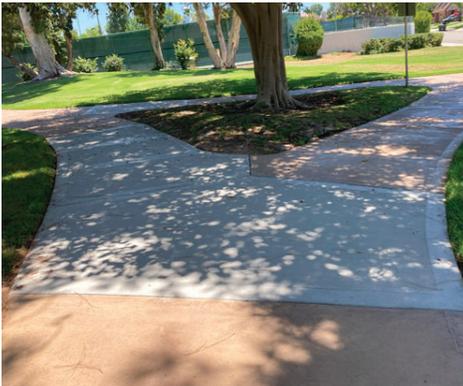
(Figure 5.1)

Figure 5.1 - Concrete is shown in different colors; it appears the newer concrete was installed in a different color than the existing concrete.

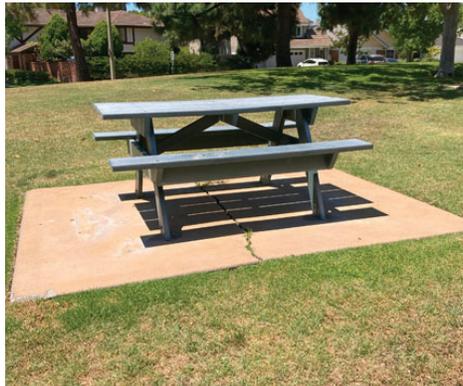
(Figure 5.2)

Figure 5.2 - Concrete pads are cracking beneath picnic tables, corners of the concrete are chipping.
Suggested Action- Replace concrete pads under the picnic tables.

- The isolated "floating" concrete pads under picnic tables and waste receptacles are all cracked and/or chipped at the corners.
- See also specific repairs suggestions noted in the preceding Criteria Review Sections.

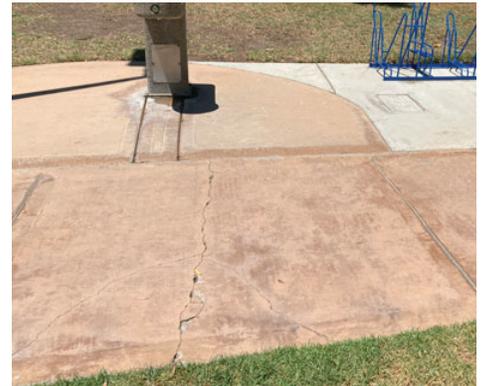
(Figure 5.3)

Figure 5.3 - Cracks and lifted concrete observed in the paved pathway at various areas throughout the park.
Suggested Action- Repair or replace sections of concrete to ensure accessibility and ADA compliance.

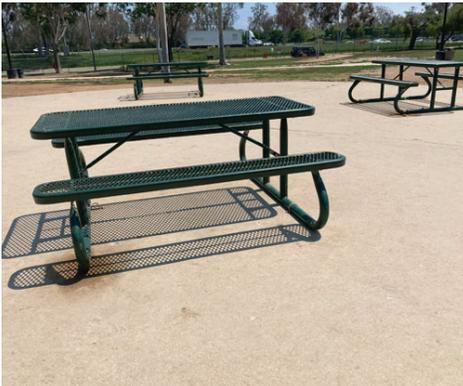
(Figure 4.1)

Figure 4.1 - The picnic tables in the paved area approached with a spiral shaped paved pathway is a focal point in the Large Dog Area. This space lacks shade and feels open and exposed.

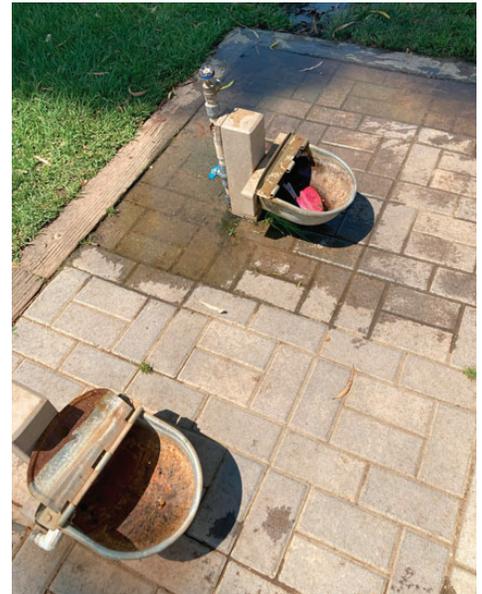
(Figure 4.3)

Figure 4.3 - The dog bowls in the Small Dog Area are rusted. A dog owner at the park commented the bowls do not drain properly.

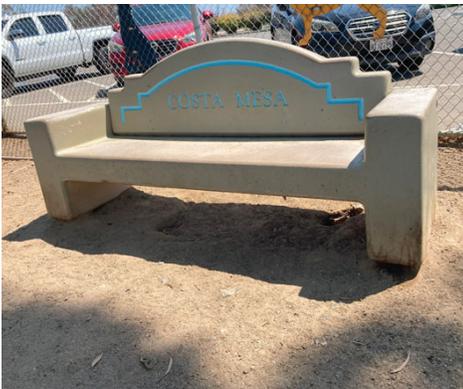
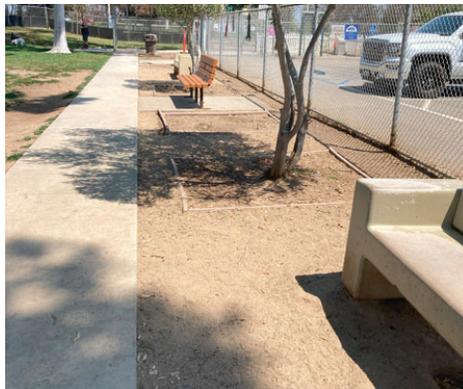
Figure 4.4, 4.5 - There are many places to sit in the Small Dog Area. Some benches provide appealing conditions for dog urination.

Suggested Action- Regularly clean the benches and consider selecting a style of bench less attractive for dogs to urinate on. The bench in the middle (shown here in Figure 4.3) with narrow, recessed legs is a good example.

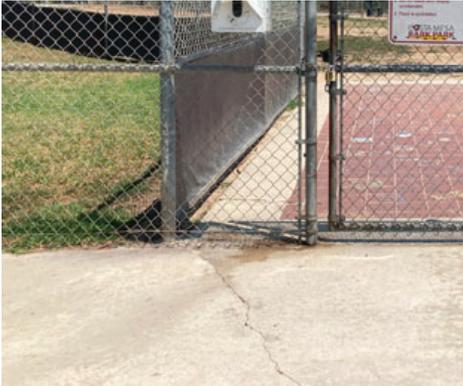
(Figure 5.1)

Figure 5.1 - Cracking observed in the paved pathway in the park.

Suggested Action- Replace areas of broken concrete to ensure accessibility and ADA compliance.

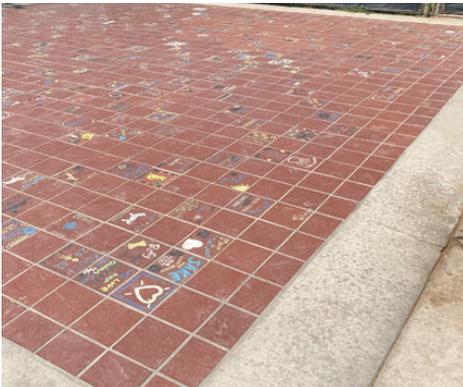
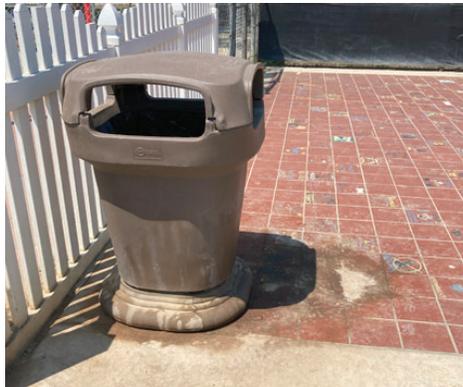
Figure 5.4, 5.5 - Decorative tile floor appears to be in good condition except in the area around the waste receptacle where there is damage from dog urination.

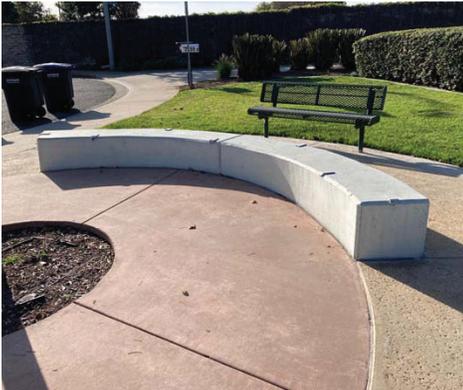
(Figure 4.1)

Figure 4.1 - Concrete seatwall is in good condition. The form is whole and intact. Very little cracking observed on the surfaces.

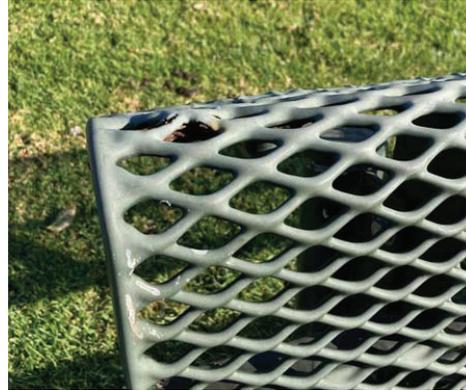
(Figure 4.2)

Figure 4.2 - Benches are in fair to good condition. The coating on the mesh is beginning to decline.
Suggested Action- Monitor condition and replace as needed.

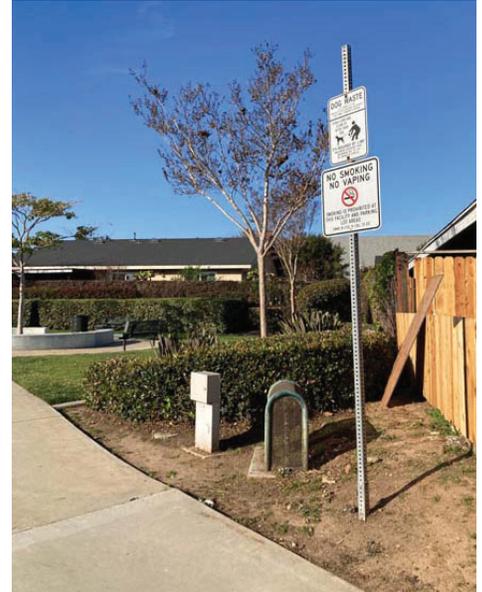
(Figure 4.3)

Figure 4.3 - Park regulation signage is visible, legible, in good condition.

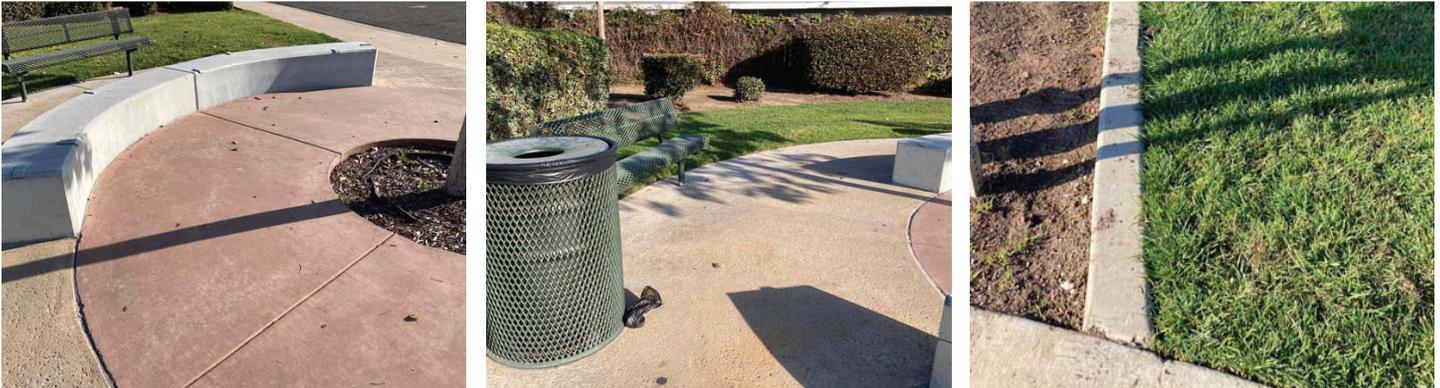
(Figure 5.1)

Figure 5.1, 5.2 - Paved pathway is in excellent condition. No cracking observed. Joint filler is declining slightly.
Suggested Action- Monitor and repair as needed to ensure accessibility and ADA compliance.
