June 28, 2024

Re: 660 Baker St – Structural Due Diligence Survey  
660 Baker Street, Costa Mesa, CA 92626  
Review of Existing Structure and Site  
RSG Job #24-1-070.00

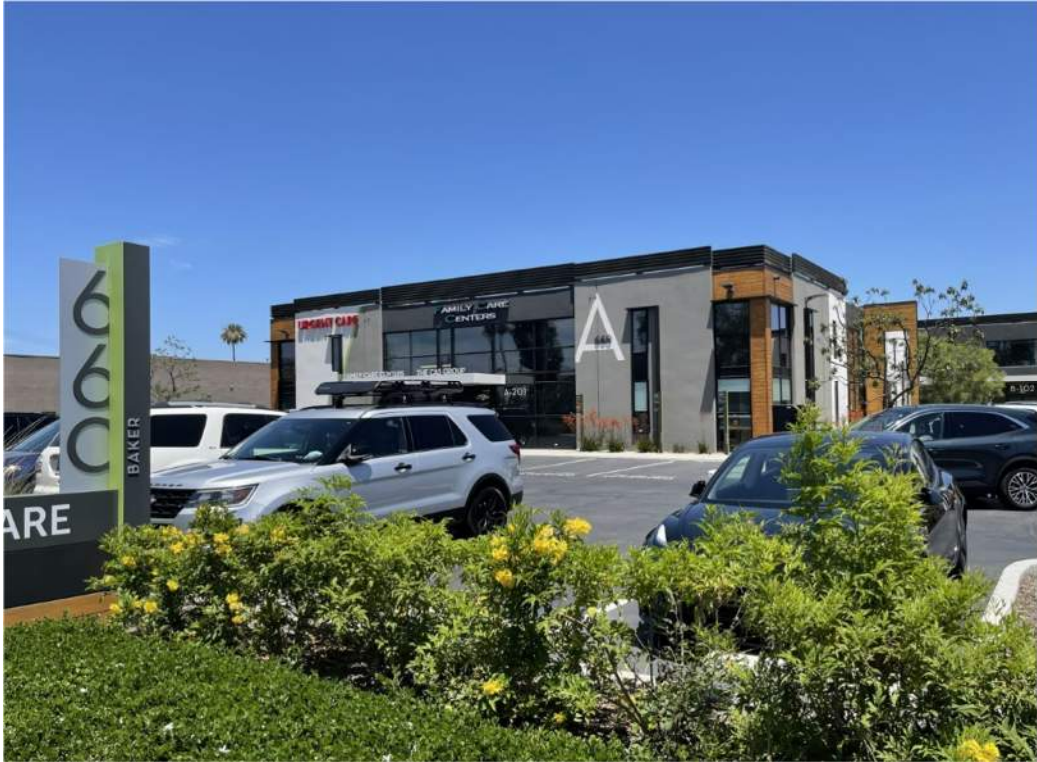
*Image 1 - South Side of Building A*

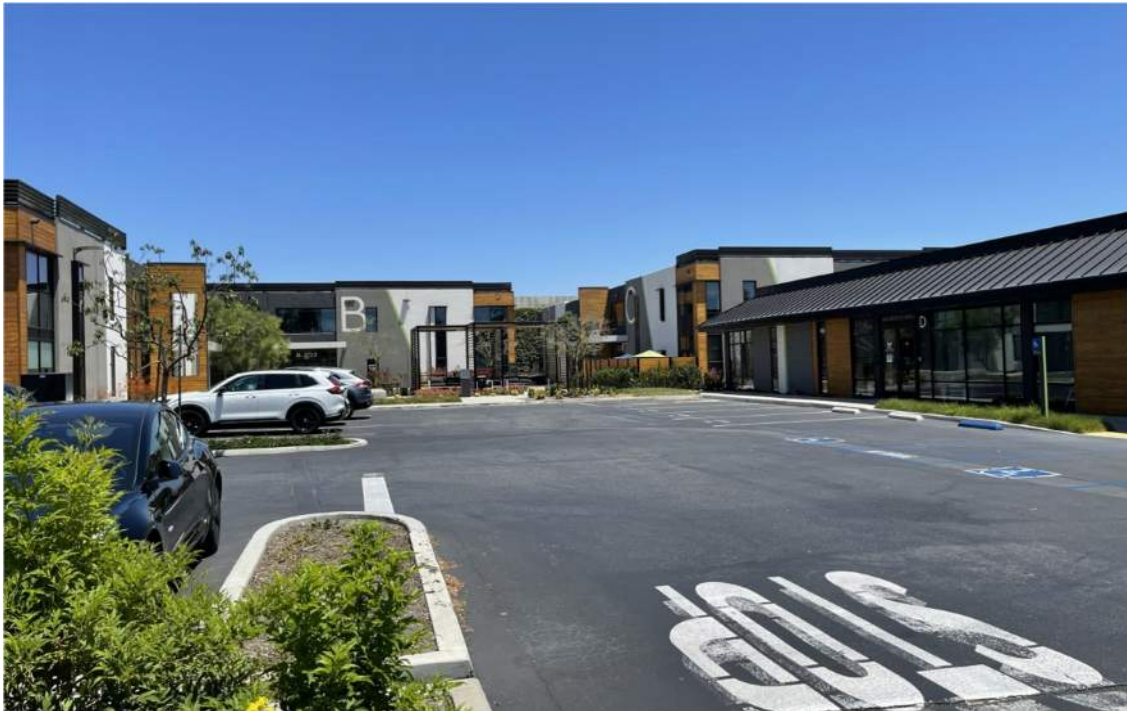
*Image 2 - South Side of Buildings B, C, & D*

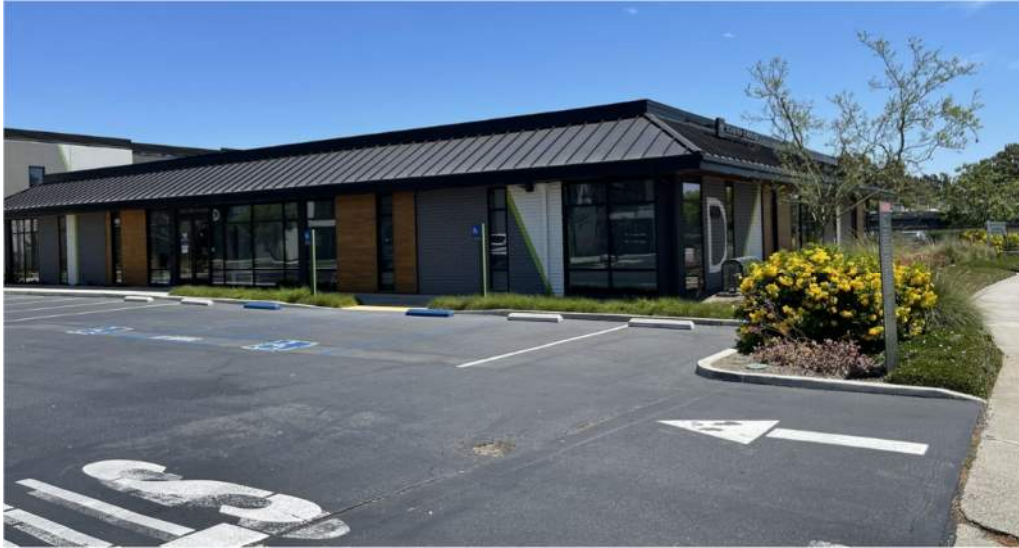
*Image 3 - South-West corner of Building D*

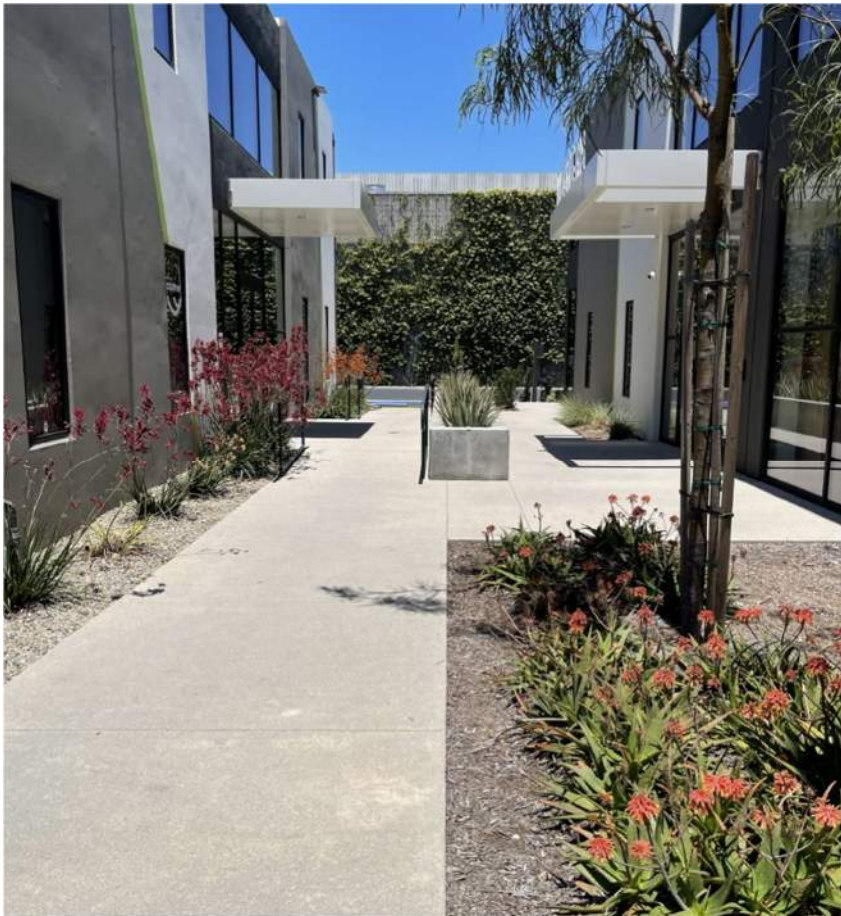
*Image 4 - Breezeway Between Bldg. B & C Looking North*

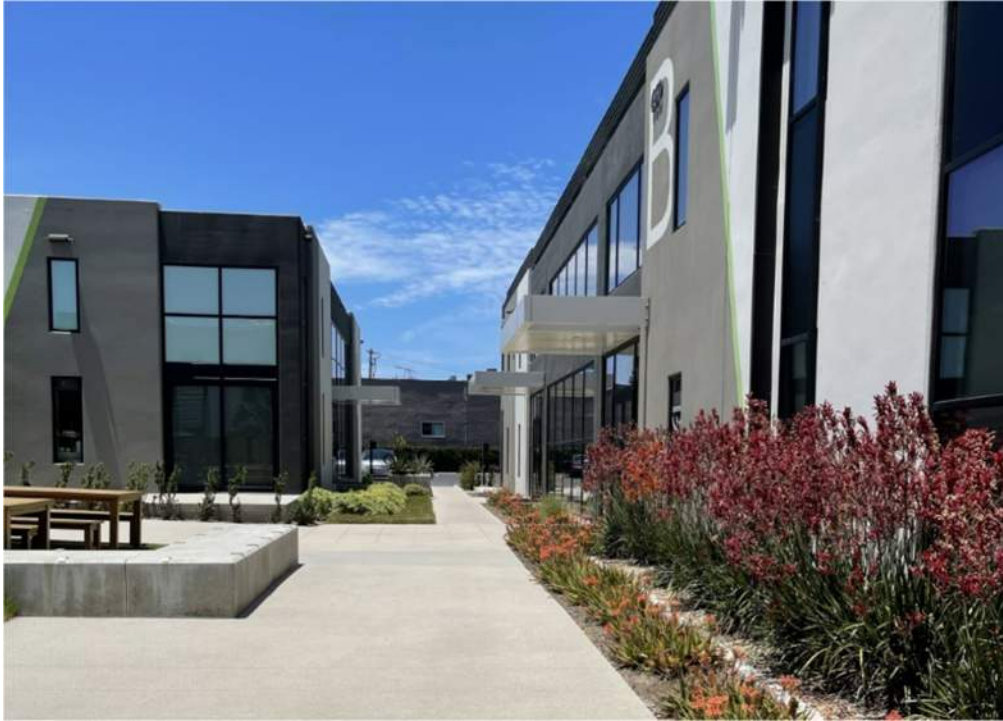
*Image 5 - Breezeway Between Bldg. A&B Looking West*

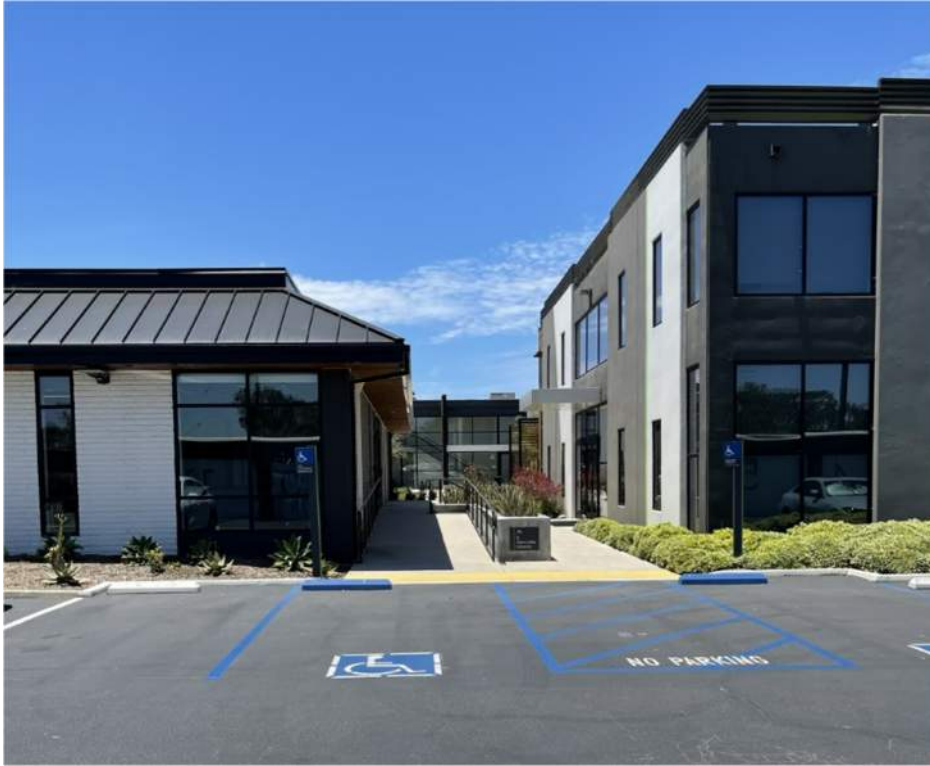
*Image 7 - Breezeway Between Bldg. C&D Looking West*

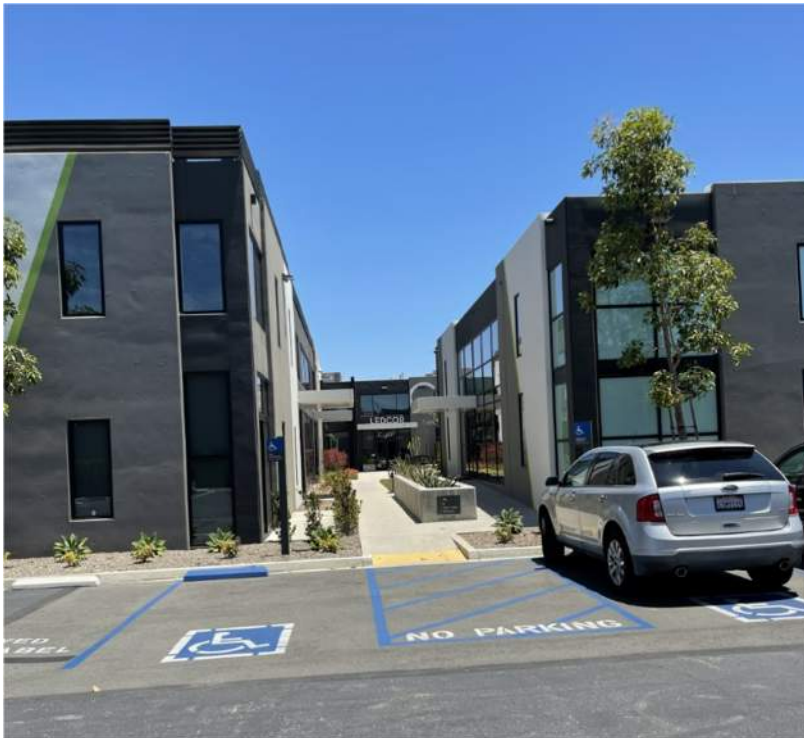
*Image 10 - Breezeway Between Bldg. A&B Looking East*

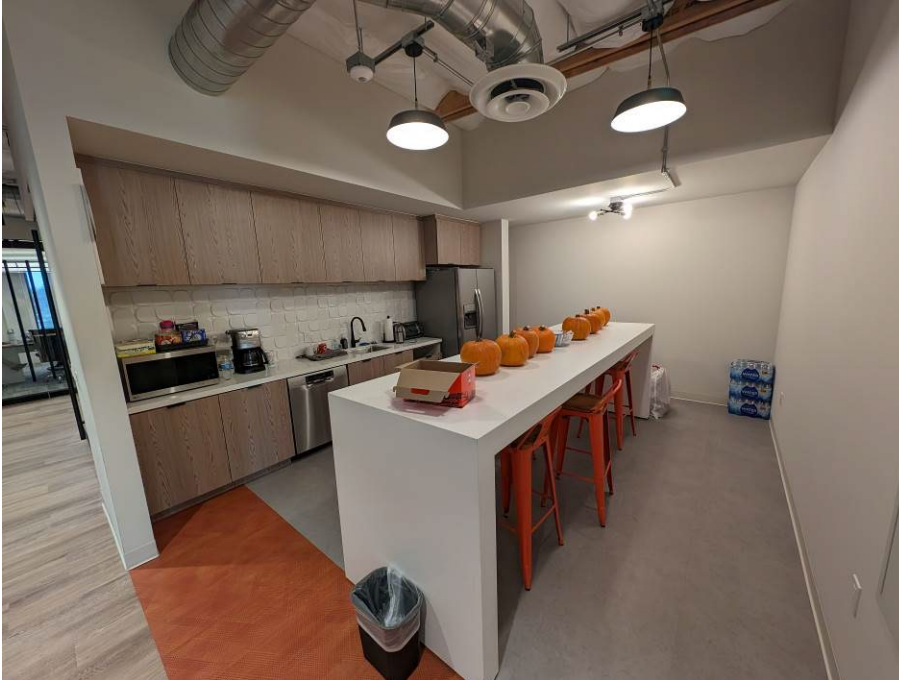
11. View of the interior of Unit B-250 showing non-asbestos sheetrock and joint compound.

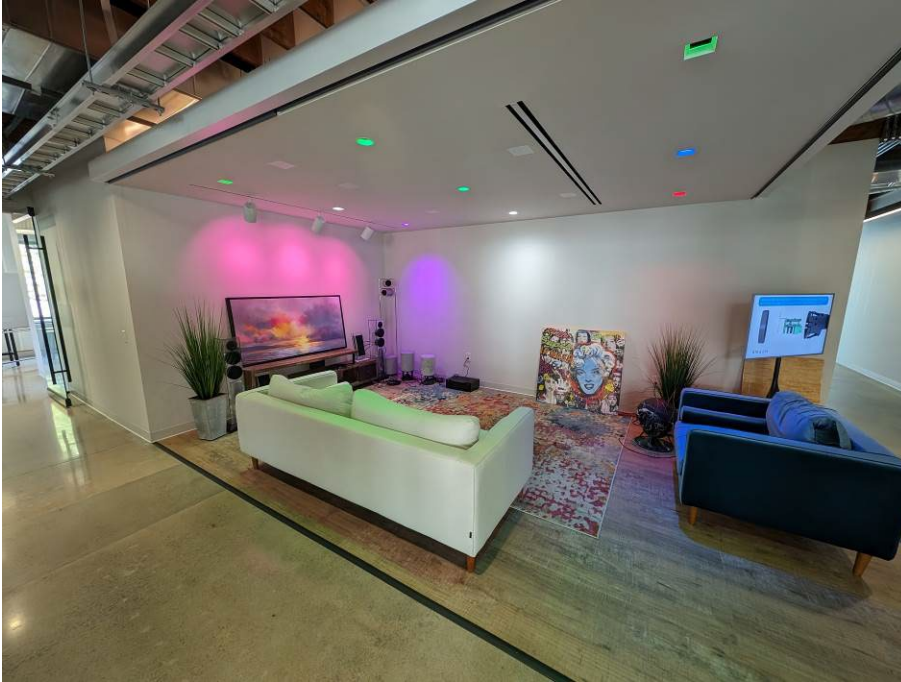
13. View of the interior of Unit C-102 showing non-asbestos sheetrock and joint compound.

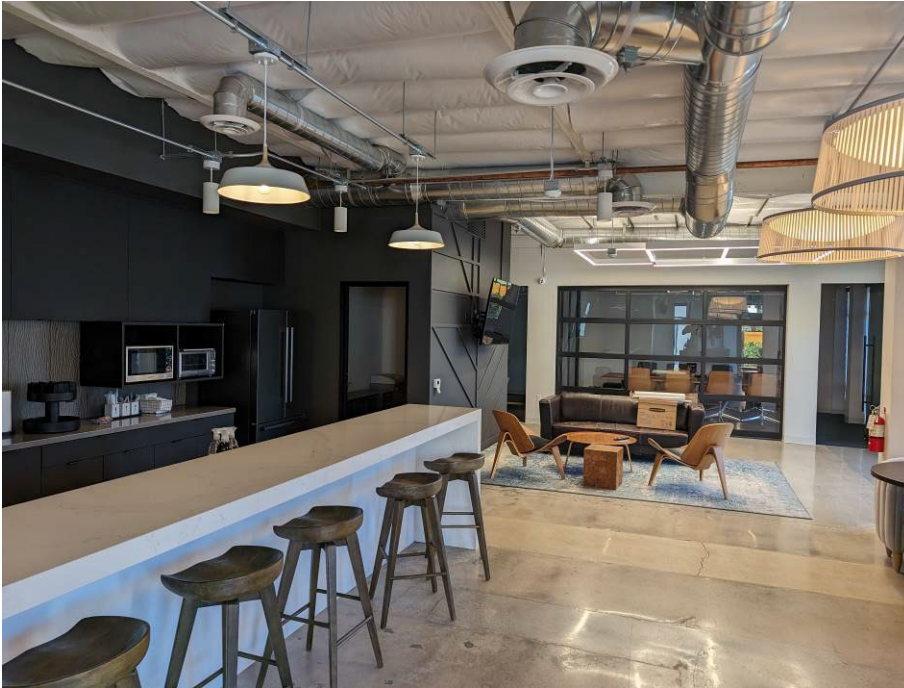
15. View of the interior of Unit D-101 showing non-asbestos sheetrock and joint compound.

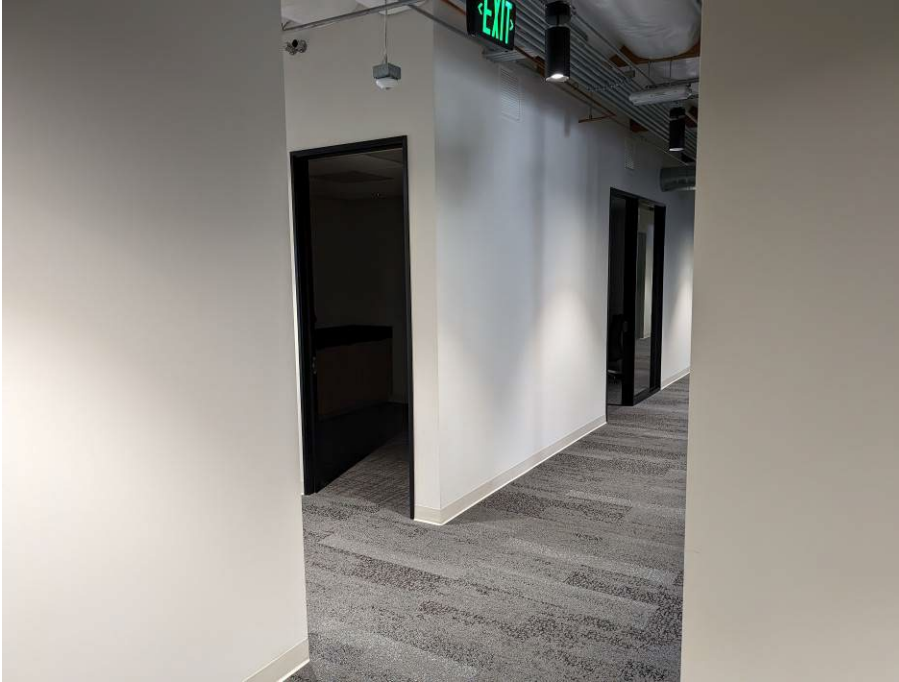
17. View of the interior of Unit C-200 showing non-asbestos sheetrock and joint compound.

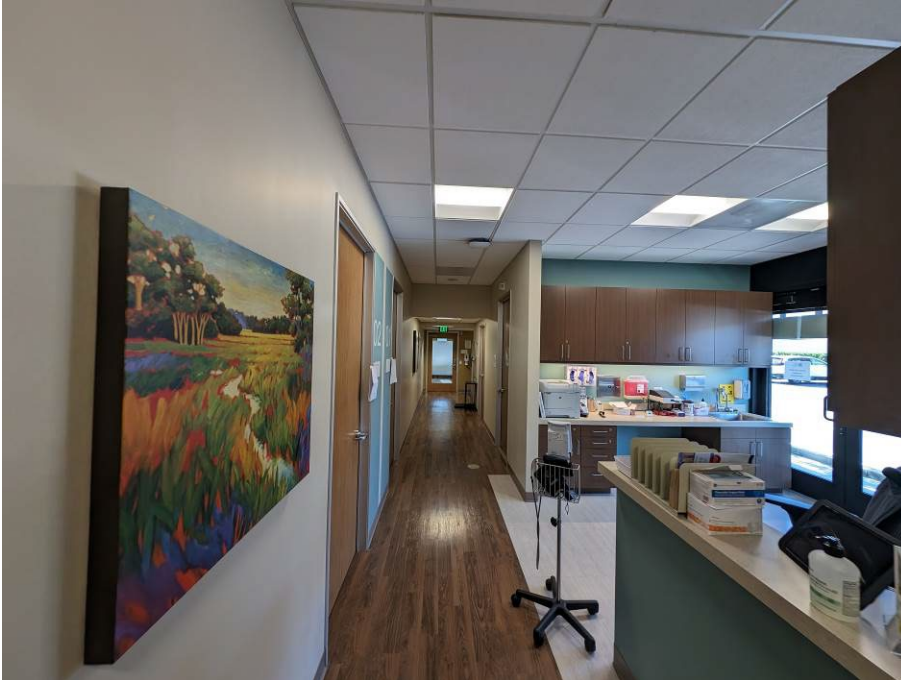
19. View of the interior of Unit A-101 showing non-asbestos sheetrock, joint compound, and ceiling tile.

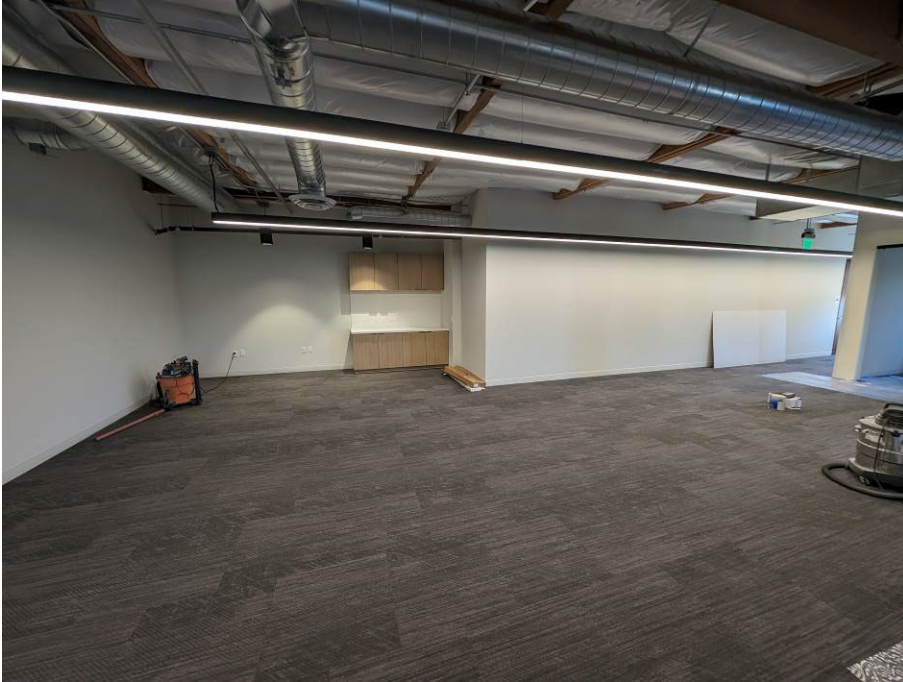
23. View of the interior of Unit B-220 showing non-asbestos sheetrock and joint compound.
