# PARK ASSESSMENT

2025

Prepared by  
DVD Creative

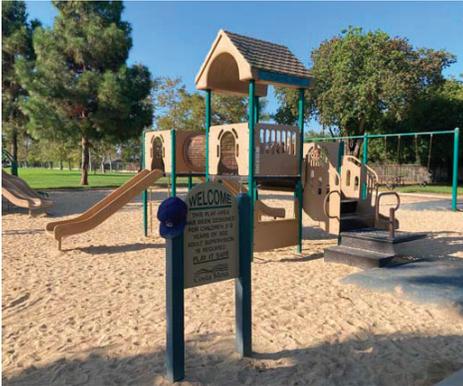
(Figure 1.1)

**Figure 1.1** - The playground has a sand and rubber safety surfacing combination. The sand level covers the bottom of the rubber safety surfacing.

**Suggested Action-** Ensure sand level is at proper depth for fall safety requirements, as sand compacts over time. Additionally, maintain sand level to be within 2-3 inches to the top of the beveled edge of the rubber safety surfacing. Consider removing the sand and replace with rubber safety surfacing.

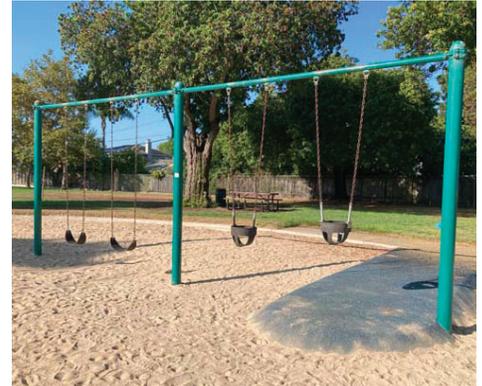
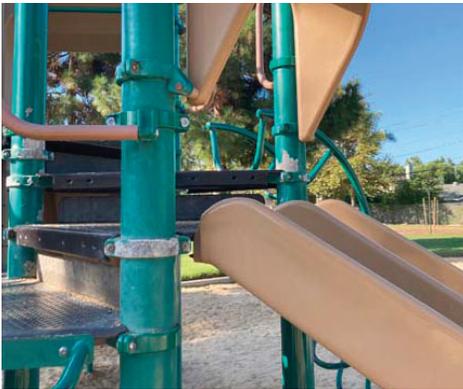
(Figure 1.3)

**Figure 1.3, 1.4** - Powder coating is damaged and worn off on posts, caps, and components.

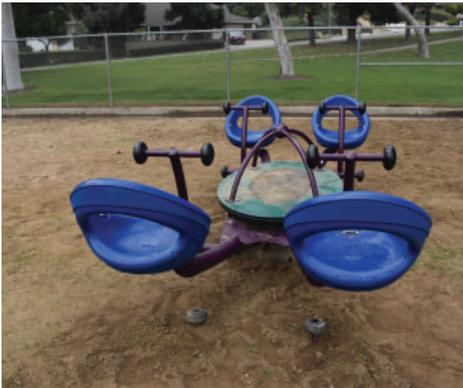
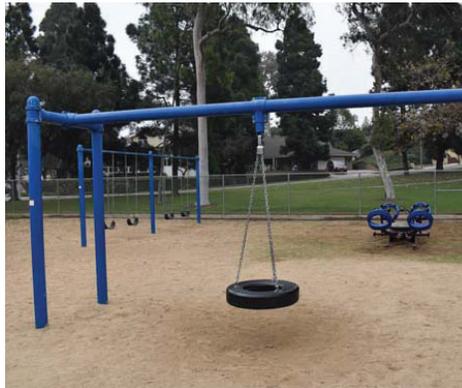
(Figure 1.01)

**Figure 1.01, 1.02** - Play components are in good condition, parts are intact, color is bright.

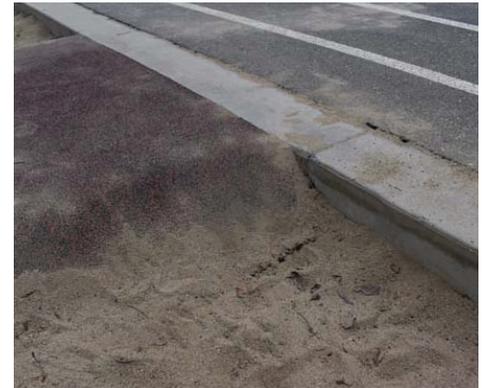
(Figure 1.03)

**Figure 1.03** - The playground has a sand and rubber safety surfacing combination. The sand level is lower than the bottom of the rubber safety surfacing.

**Suggested Action-** Ensure sand level is at proper depth for fall safety requirements, as sand compacts over time. Additionally, maintain sand level to be within 2-3 inches to the top of the beveled edge of the rubber safety surfacing. Consider removing the sand and replace with rubber safety surfacing.

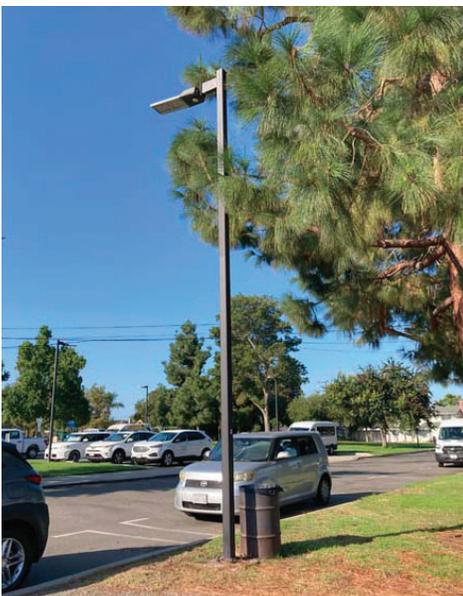
(Figure 4.4)

**Figure 4.4** - Lighting was not assessed, but the fixtures appear to be energy efficient LED.

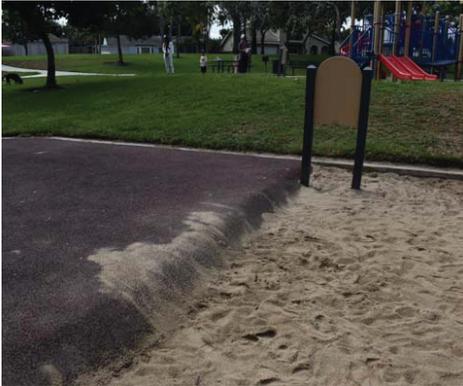
(Figure 1.1)

**Figure 1.1** - Rubber safety surfacing edge is exposed above the level of sand.

**Suggested Action-** Ensure sand level is at proper depth for fall safety requirements, as sand compacts over time. Additionally, maintain sand level to be within 2-3 inches to the top of the beveled edge of the rubber safety surfacing. Consider removing the sand and replace with rubber safety surfacing.

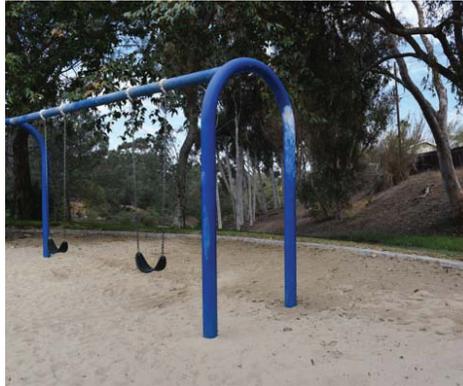
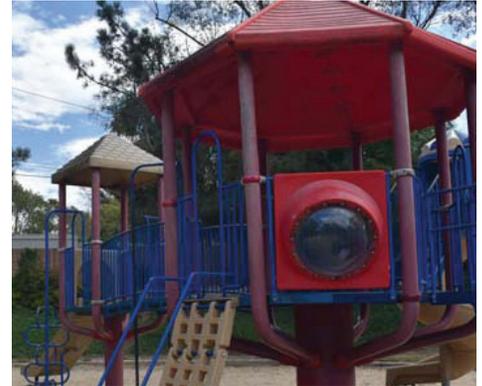
**Figure 1.2, 1.3** - The play equipment has damaged or worn off powder coating on posts, caps, and components. The pyramid roofs on the play structure are blackened.

**Manufacturer:** Miracle Recreation  
**Year Installed:** 1997  
*(Play equipment is 28 years old in 2025)*

**Suggested Action-** Given the age of the play equipment and the current condition of its parts, it is recommended to replace the play structures.

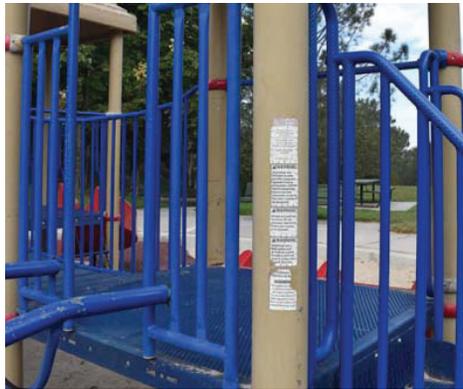
(Figure 1.5)

**Figure 1.5** - Manufacturer's warning labels are deteriorating.

**Suggested Action-** Replace labels to be in compliance with industry standards.

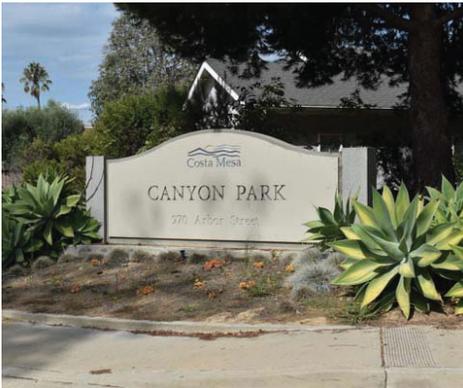
(Figure 4.1)

**Figure 4.1** - Park monument sign is in good to excellent condition.

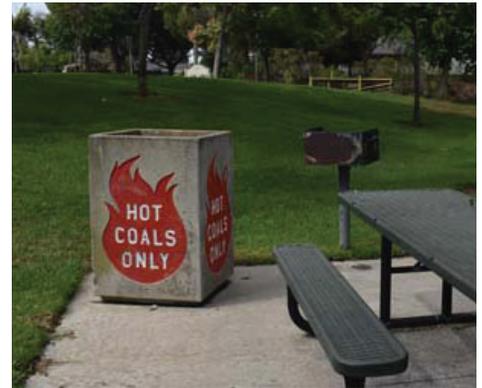
(Figure 4.3)

**Figure 4.3** - BBQ grill shows extreme heat damage from repeated use over time. The picnic table has several small, broken spots.  
*Suggested Action*- Replace with a new BBQ grill and picnic table.

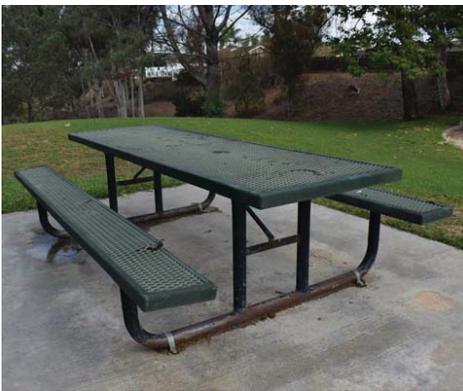
(Figure 4.4)

**Figure 4.4** - Picnic table bench seat is torn and unsafe for sitting. The frame and table, bench surfaces are rusting.  
*Suggested Action*- Replace with a new picnic table.

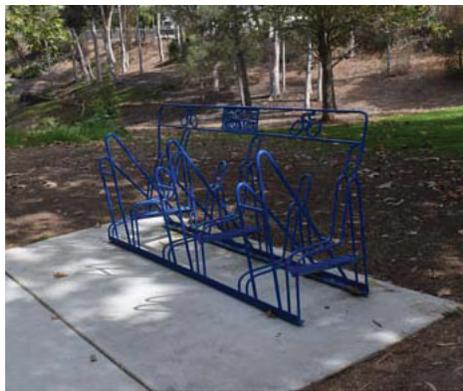
(Figure 4.5)

**Figure 4.5** - Bike rack is in good condition, mounted securely to concrete, and well-located next to the road.

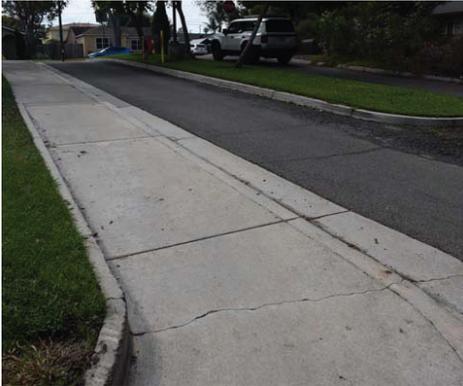
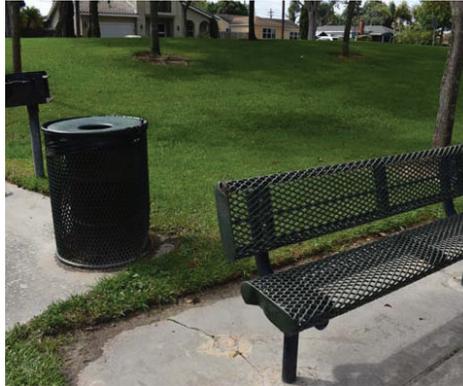
**Figure 5.1, 5.2** - Cracks observed in the sidewalk, paved pathway and paved areas in the park.  
*Suggested Action*- Replace areas of broken concrete.

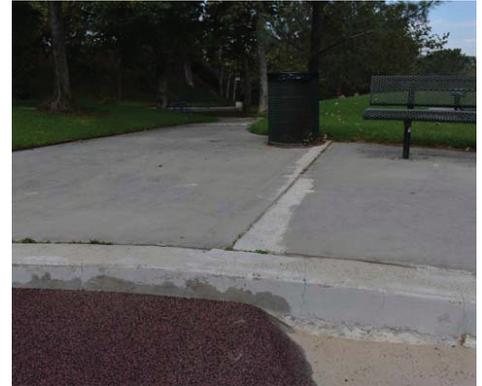
(Figure 5.3)

**Figure 5.3** - Cracks observed in the concrete band at the playground.  
*Suggested Action*- Replace concrete band.

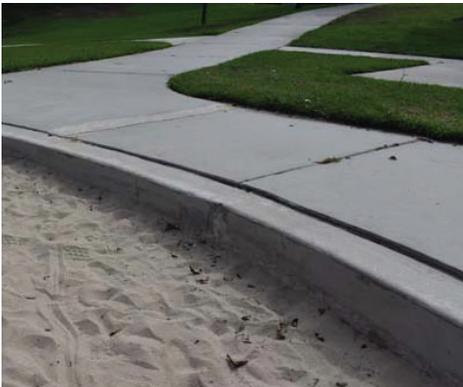
(Figure 5.4)

**Figure 5.4** - Paved pathway is lifting from the concrete band at the playground.  
*Suggested Action*- Monitor lifting and repair as needed.

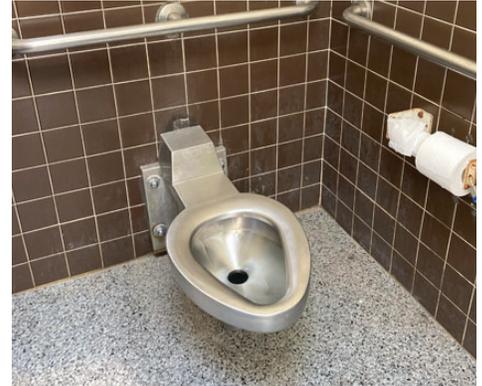
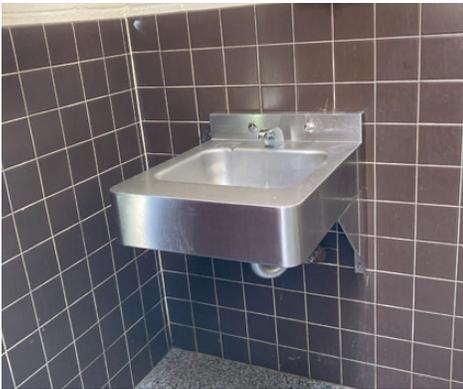
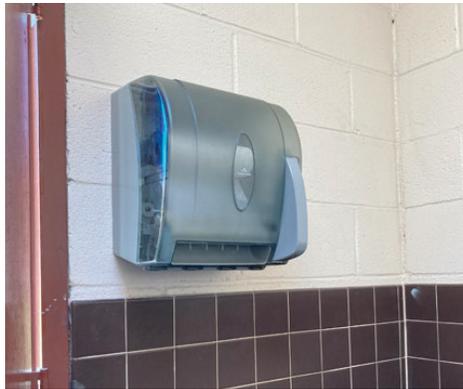
**Figure 2.3, 2.4, 2.5** - Existing restroom interior is clean and is in good condition.

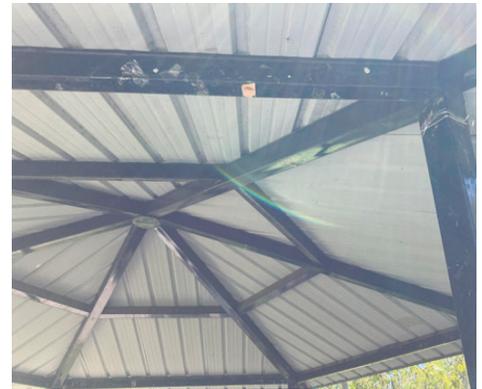
(Figure 2.6)

**Figure 2.6** - The shade structure over the picnic area is in good condition, but has remnants of decorations accumulating on the beams and posts.

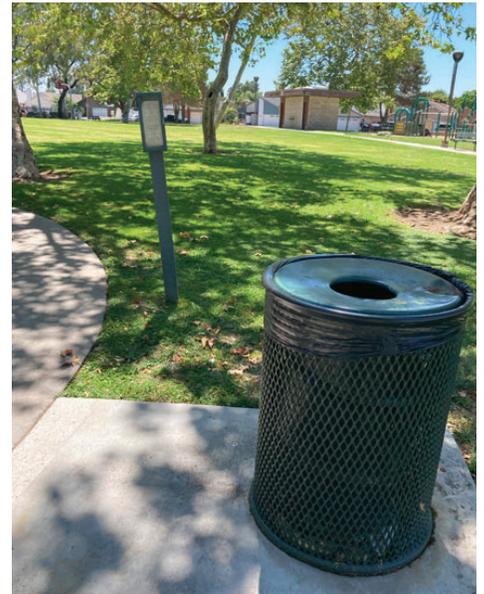
(Figure 4.3)

**Figure 4.3** - Waste receptacles located throughout the park. No staining on the concrete underneath. Minimal damage to the lid on the waste receptacle pictured.  
*Suggested Action*- Consider replacing with waste/recycling combination receptacles at the picnic shelter area.

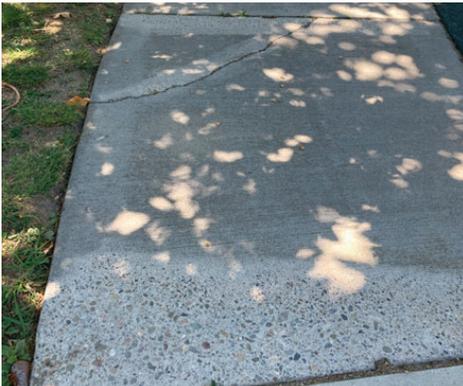
(Figure 5.1)

**Figure 5.1** - Cracks observed in the concrete walkway.

*Suggested Action*- Replace areas of broken concrete.

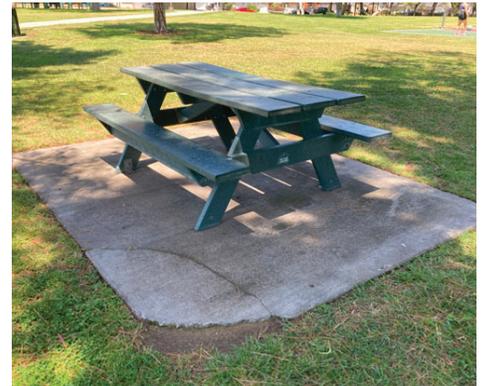
(Figure 5.3)

**Figure 5.3** - Cracks in the concrete pads under the picnic tables.

*Suggested Action*- Replace concrete pads.

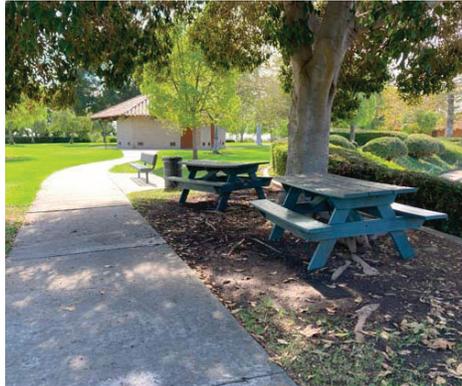
(Figure 4.2)

**Figure 4.2** - Picnic tables are placed in turf area; turf will struggle to grow where there is soil compaction from frequent foot traffic.  
*Suggested Action*- Relocate picnic tables and repair the damaged turf areas.

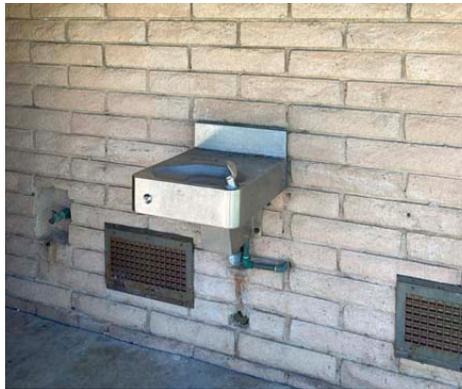
(Figure 4.5)

**Figure 4.5** - The drinking fountain is located on the restroom building exterior and is in fair condition. There is some water staining on the walls from the piping.

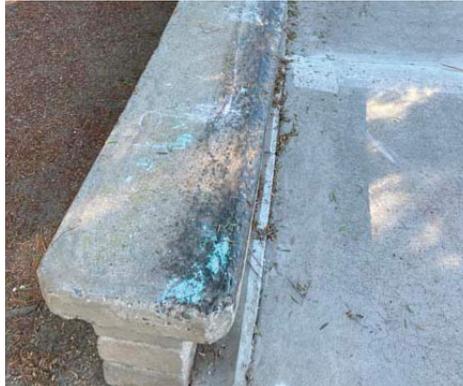
(Figure 4.8)

**Figure 4.8** - Concrete bench is scraped and is in poor condition (this is part of the Hillside Pathway).

**Suggested Action-** Replace bench and install anti-skateboarding guards on the new bench.

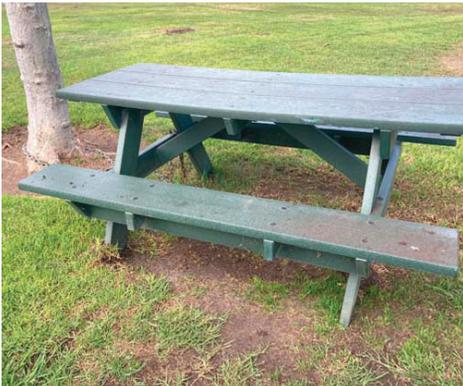
(Figure 4.1)

**Figure 4.1** - Picnic tables are placed in turf area; turf will struggle to grow where there is soil compaction.  
*Suggested Action*- Relocate picnic table and repair damaged turf.

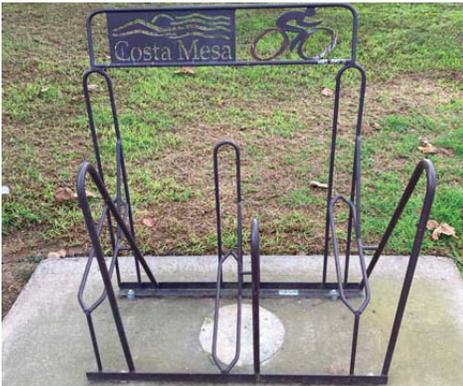
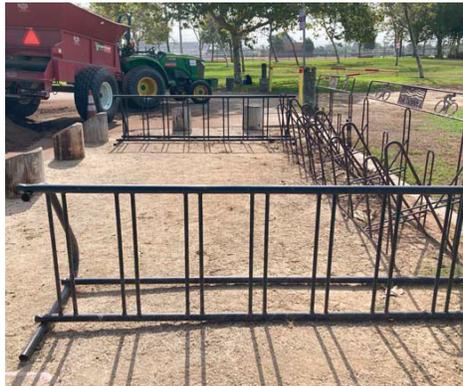
**Figure 4.7, 4.8** - Bike racks are in good condition. There are multiple bike trails within the park, and the Santa Ana River Bike Trail and Talbert Nature Reserve Trail are accessible from this park.

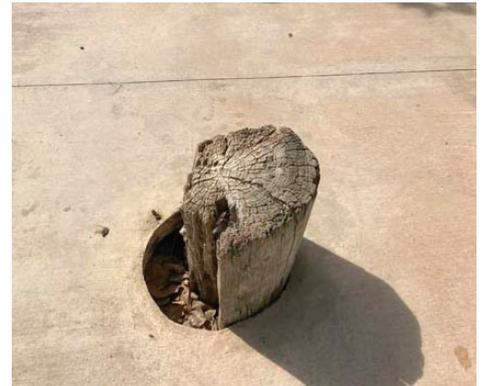
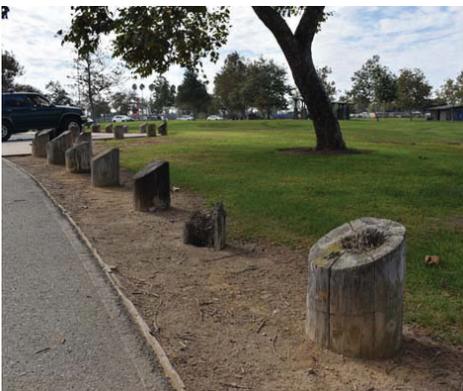
**Figure 4.9, 4.10** - The wood bollards around the parking lot are in decline. Some are placed in bare earth and some are located in the paved pathway.

**Suggested Action-** Remove wood bollards and replace with more durable material. Consider small boulders, which are already placed in a few places in the line of bollards.

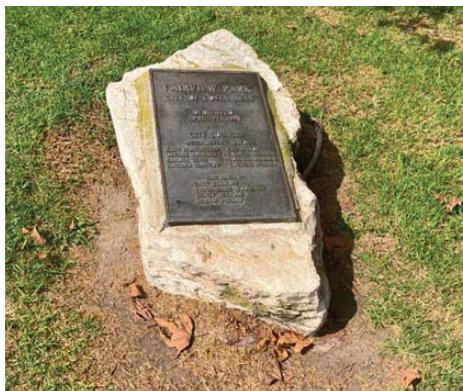
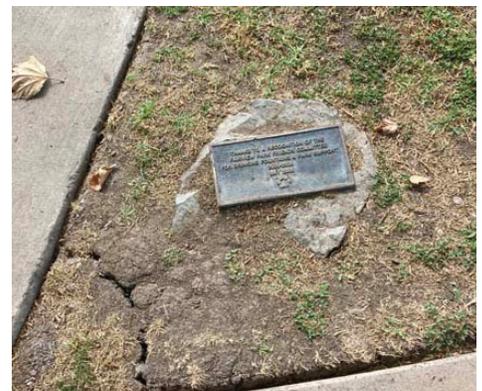
**Figure 4.11, 4.12** - Boulders in turf create challenges in mowing and maintenance. One boulder with plaque is small and partially buried (near the drinking fountain) and should be reset.

**Suggested Action-** Maintenance could be simplified by keeping the turf away from the base of the boulders.

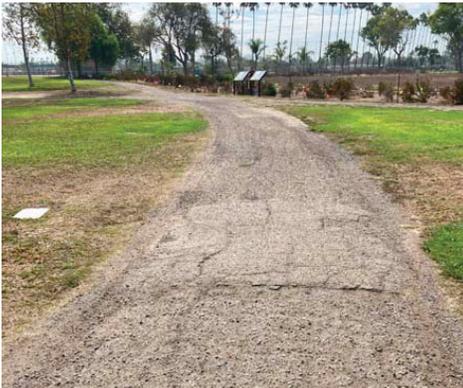
(Figure 5.1)

**Figure 5.1** - Asphalt pathway is cracking and surface is uneven.

**Suggested Action-** Consider replacement with a paved pathway that ensures accessibility and ADA compliance.

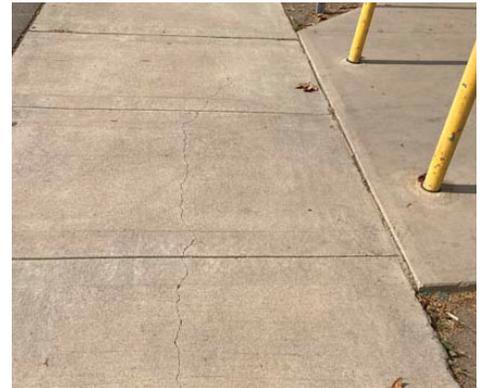
(Figure 5.3)

**Figure 5.3** - Concrete is cracking.

**Suggested Action-** Replace broken areas of concrete.

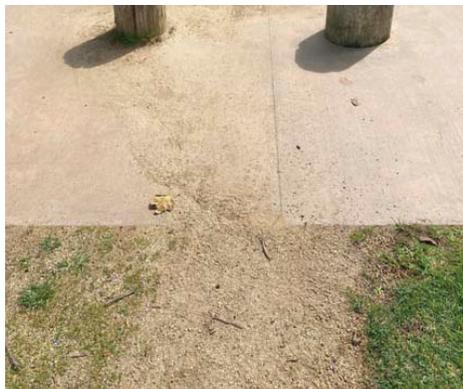
**Figure 5.4, 5.5** - The park has inadequate pathways. Natural footpaths have been established in the park. The transition where footpath meets the paved pathway has become a slipping safety hazard.

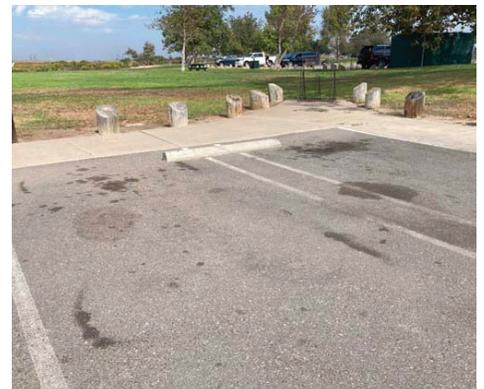
(Figure 5.6)

**Figure 5.6** - Parking lot pavement has oil stains and the striping is faded.

**Suggested Action-** Remove the stains or consider replacing the parking lot pavement. Apply a sealer to the asphalt regularly to protect the surface from damage. Repaint the striping.

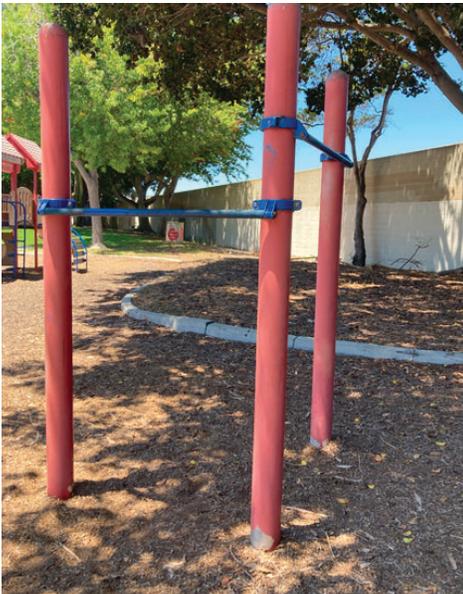
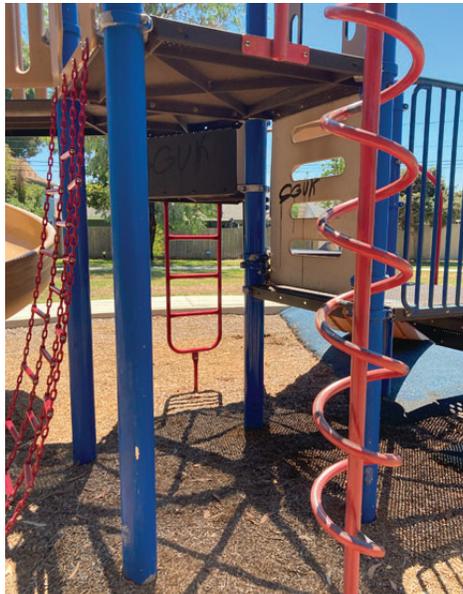
**Figure 1.4, 1.5, 1.6** - The play equipment has damaged or worn off powder coating on posts, caps, and components.

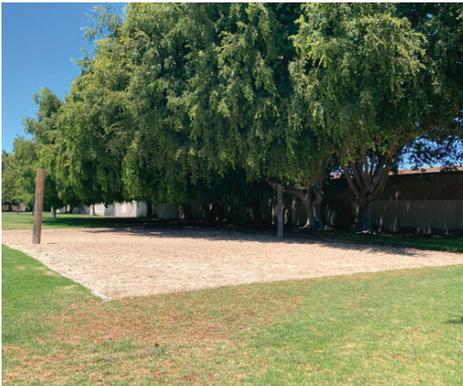
(Figure 3.1)

**Figure 3.1** - The sand volleyball court is located near trees that are covering the court. The court is not playable due to the tree branches.

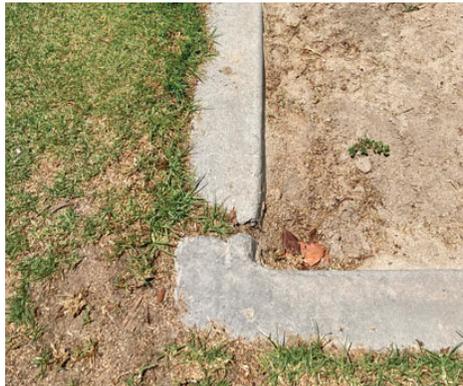
(Figure 3.2)

**Figure 3.2** - The concrete band is cracking.

*Suggested Action*- Remove concrete band if relocating the volleyball court. Repair if court stays in current location.

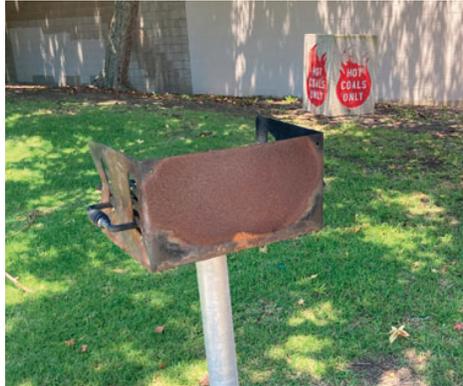
(Figure 4.2)

**Figure 4.2** - The BBQ grill is rusted and warping.

*Suggested Action*- Replace the grill and place the hot coals receptacle nearer to the grill.

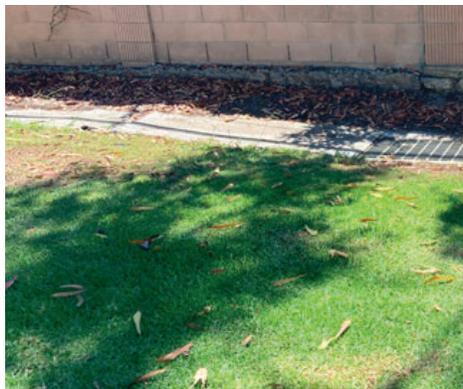
(Figure 5.5)

**Figure 5.5** - Concrete gutter is lifting up and cracking.

**Suggested Action**- Repair concrete gutter where needed.

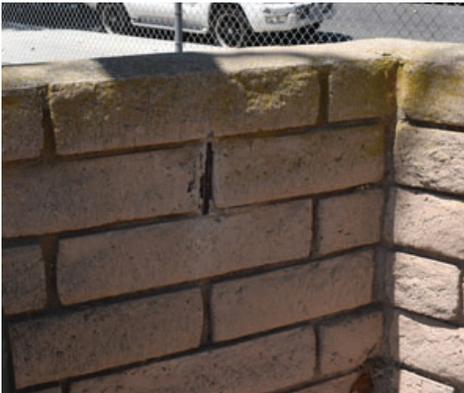
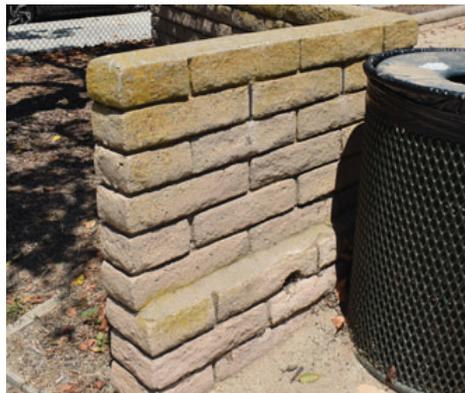
**Figure 2.1, 2.2** - Portions of the wall are broken, exposing rebar. Algae/mold growth is observed where there is persistent moisture, predominantly at the top of the wall. Structure may be weakened by the water damage.

*Suggested Action*- Replace the wall.

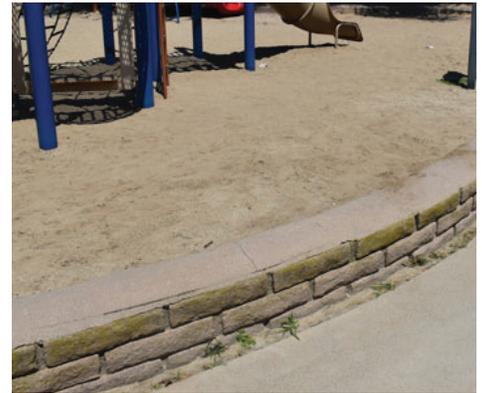
(Figure 2.3)

**Figure 2.3** - Cracking is observed on the low wall cap. Algae/mold growth indicates the cap is not protecting the wall from moisture.

*Suggested Action*- Replace the low wall.

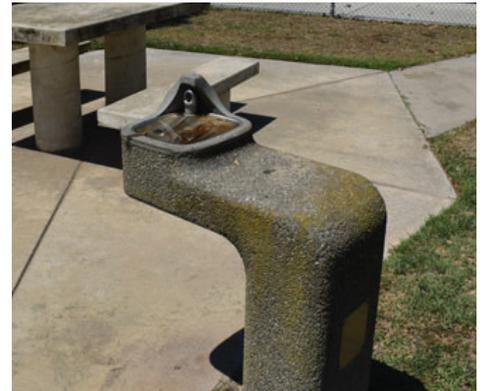
(Figure 4.3)

**Figure 4.3** - The drinking fountain has algae/mold growth on the concrete pedestal from persistent moisture over time.

*Suggested Action*- Replace the drinking fountain.

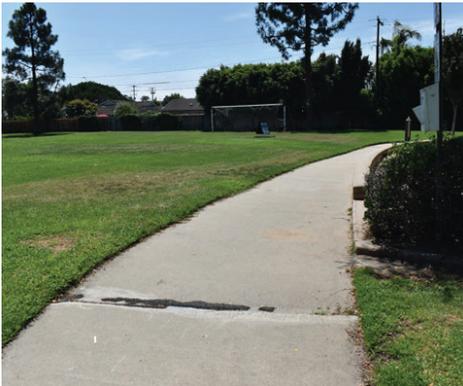
(Figure 5.1)

**Figure 5.1** - Section of concrete is lifting, creating potential trip hazards.

*Suggested Action*- Replace the lifted concrete sections to eliminate trip hazards, ensure accessibility and ADA compliance.

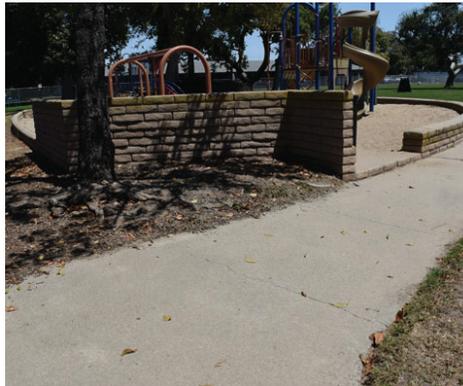
(Figure 5.2)

**Figure 5.2** - Concrete pavement is cracking.

*Suggested Action*- Replace broken areas of concrete paving to ensure accessibility and ADA compliance.

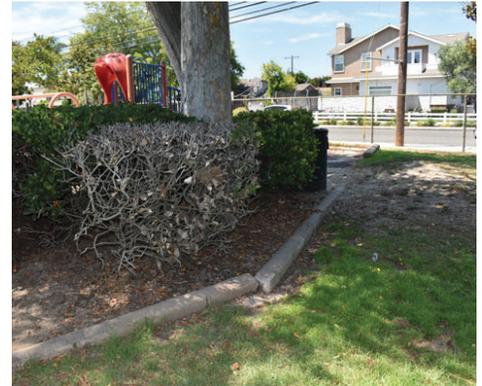
(Figure 5.3)

**Figure 5.3** - Concrete curb is broken.

*Suggested Action*- Replace concrete curb.

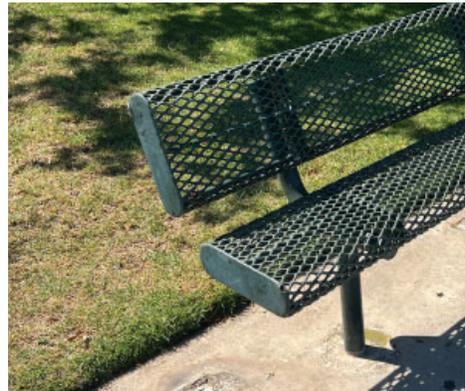
(Figure 4.2)

**Figure 4.2** - This park bench has some broken spots in the plastic coating at the end of the bench, but the bench is still usable and safe. However, there is potential for rust to form on the exposed metal.

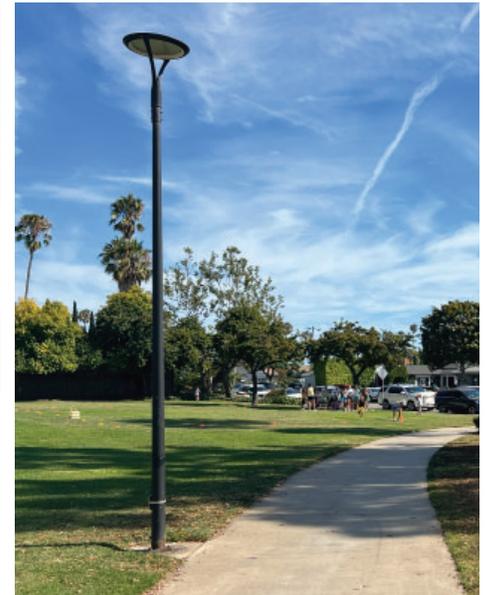
(Figure 4.3)

**Figure 4.3** - Lighting system was not assessed. The light poles have matching fixtures. This light pole pictured has rust forming at the base.

**Suggested Action-** Monitor the rust condition and replace the light pole when needed. Protect against exposure to water.

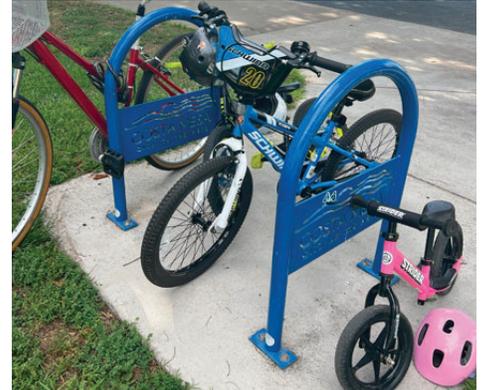
(Figure 4.3)

**Figure 4.3** - Bike rack is in good condition. Color is bright, no scratches or chipping of paint is observed. City logo is visible.

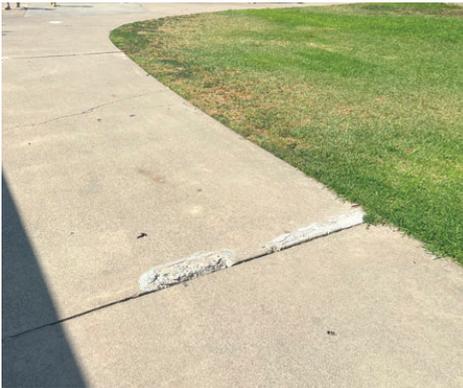
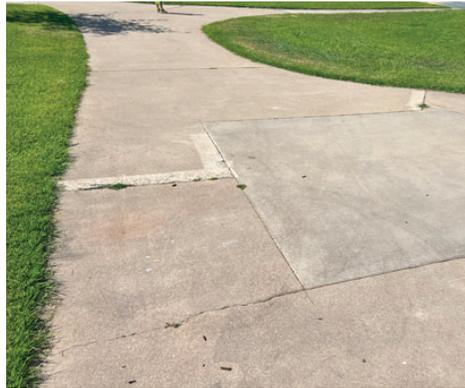
**Figure 5.1, 5.2** - The paved pathway has areas of cracking, patching, and edges that have been ground down to be level with adjacent paving.

**Suggested Action-** Replace paved pathway to ensure accessibility and ADA compliance.

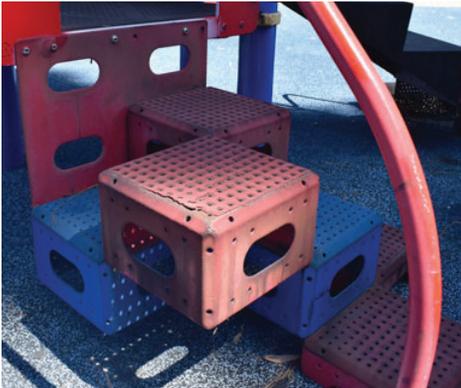
(Figure 1.1)

**Figure 1.1** - Powder coating has completely detached from block climber component and rust has formed.  
*Suggested Action*- The block climber component should be removed and replaced.

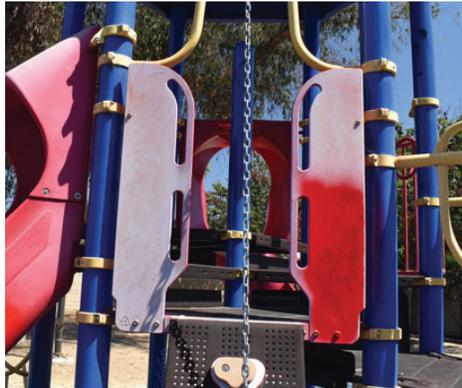
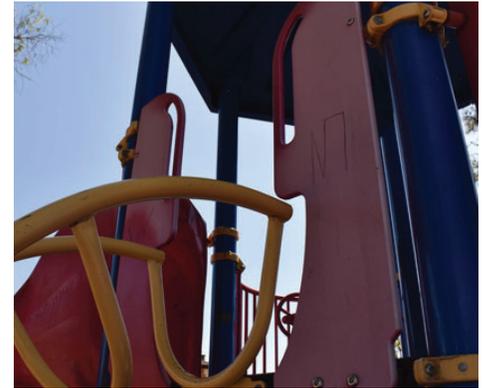
**Figure 1.2, 1.3** - Damage from extensive sun exposure has weakened the plastic of the handhold panels and altered the color. The panels show defacing.  
*Suggested Action*- Replace the handhold panels.

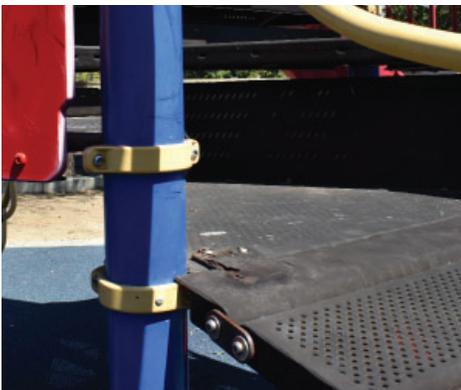
(Figure 1.4)

**Figure 1.4** - Bridge fasteners are breaking and/or rusting.  
*Suggested Action*- Replace the fasteners.

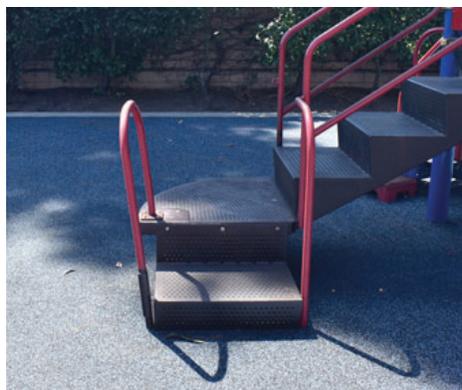
(Figure 1.5)

**Figure 1.5** - The handrail has been bent outward and is less stable for safely climbing the steps.  
*Suggested Action*- Identify the cause for the slanted handrail position and repair as required by industry standards. Additionally, considering the age of the play equipment exceeds 15 years and the current condition of its parts, it is suggested to replace the play equipment.\*

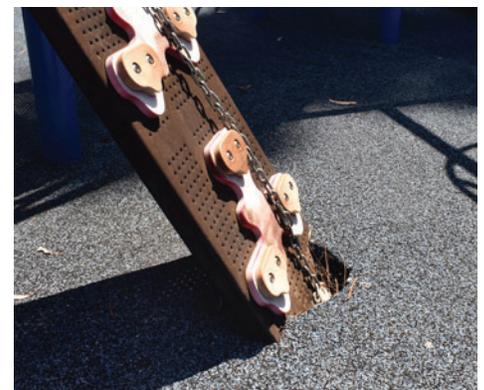
(Figure 1.6)

**Figure 1.6** - The rubber safety surfacing has broken around the base of the climber.  
*Suggested Action*- Repair by patching the hole with matching rubber granules and binder as required by industry standards.

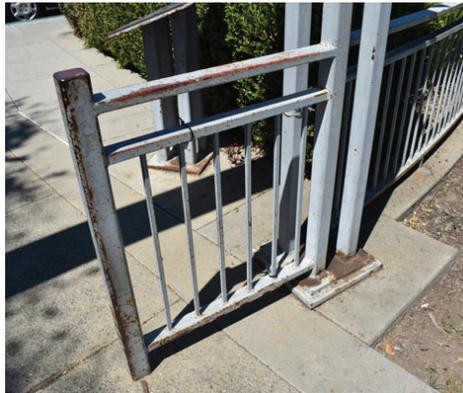
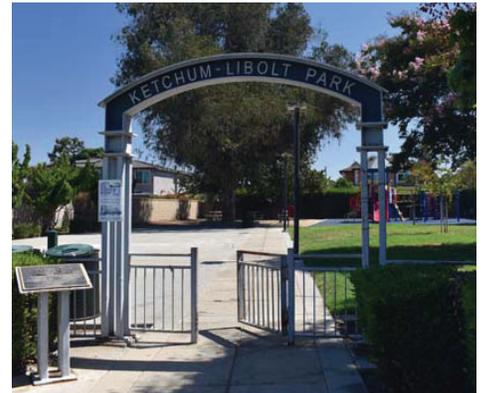
**Figure 2.2, 2.3** - Rust observed on the base of the post for the park archway sign.

**Suggested Action-** Assess for structural integrity and repair or replace as required to meet building and safety codes. Divert moisture from accumulating on the metal surfaces.

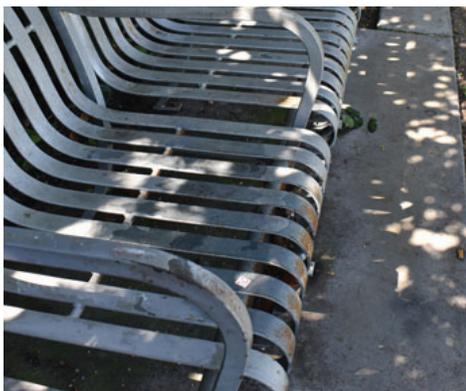
(Figure 4.1)

**Figure 4.1** - Park benches are rusting.

**Suggested Action-** Repair by thoroughly cleaning the surfaces and using a rust-inhibiting primer before painting with exterior-grade metal paint. Divert moisture from accumulating on the metal surfaces. Consider replacing the damaged benches.

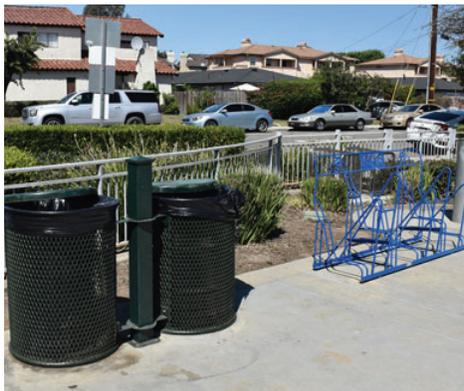
(Figure 4.2)

**Figure 4.2** - Bike rack is in good condition. Color is bright, no scratches or chipping of paint is observed. City logo is visible. The waste receptacles are in fair condition. There are small spots of broken plastic coating on the waste receptacles that are allowing rust to form on the metal mesh.

**Suggested Action-** Continue to monitor the rusting and replace waste receptacle when needed.

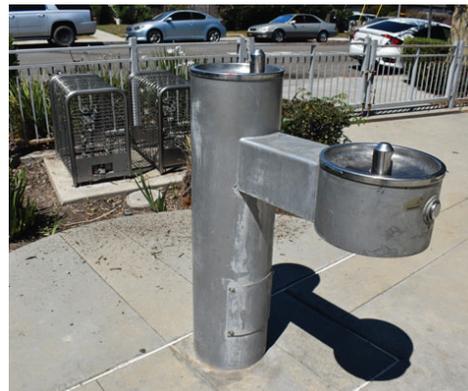
(Figure 4.3)

**Figure 4.3** - Drinking fountain is in fair condition. The finish on the exterior is scratched, peeling, and damaged by water.

**Suggested Action-** Repair by cleaning thoroughly and monitor for any rust formation.

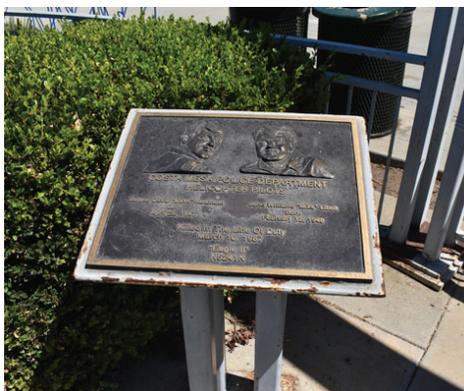
(Figure 4.5)

**Figure 4.5** - Rust was observed on the park's memorial plaque.

**Suggested Action-** Repair by thoroughly cleaning the surfaces and using a rust-inhibiting primer before painting with exterior-grade metal paint. Divert moisture from accumulating on the metal surfaces..

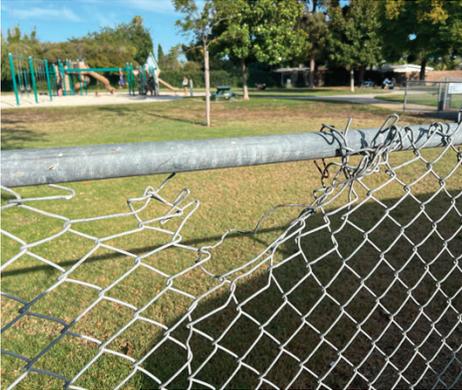
(Figure 2.1)

**Figure 2.1** - Chain link fabric is broken, sharp ends exposed.

**Suggested Action-** Repair and assess chain link fence for further repair needs.

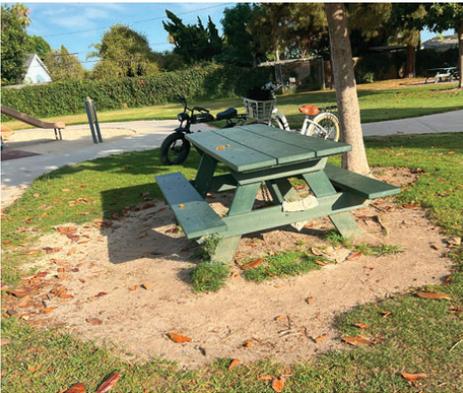
(Figure 4.1)

**Figure 4.1** - Picnic tables are placed in turf area; turf will struggle to grow where there is soil compaction.  
*Suggested Action*- Relocate picnic table and repair damaged turf.

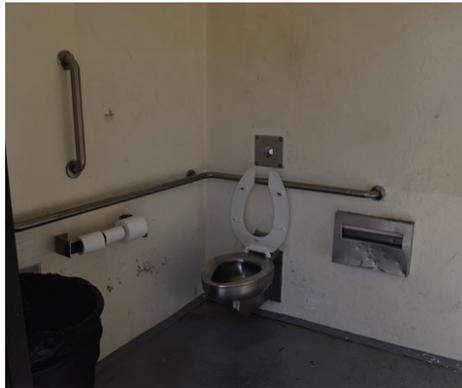
(Figure 2.2)

**Figure 2.2** - The interior of the restroom is in fair condition. There are marks on the walls and the toilet seat cover dispenser is dented.

*Suggested Action*- Clean the scuff marks and replace the dispenser if no longer functioning.

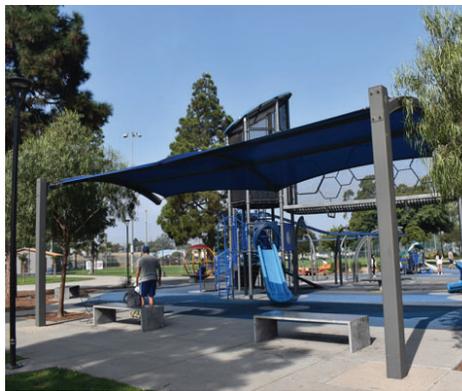
(Figure 2.5)

**Figure 2.5** - The shade structure is in excellent condition. The posts are set perpendicular to the ground plane. The shade cover fabric is whole and intact, and the color is rich and vibrant.

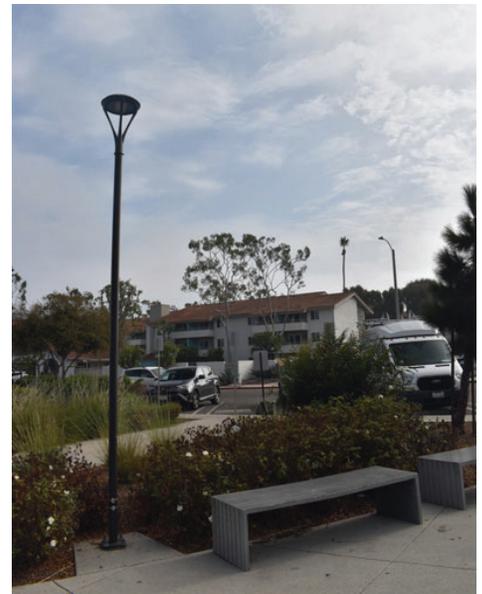
(Figure 4.6)

**Figure 4.6** - Lighting system was not assessed. The light poles are in good condition.

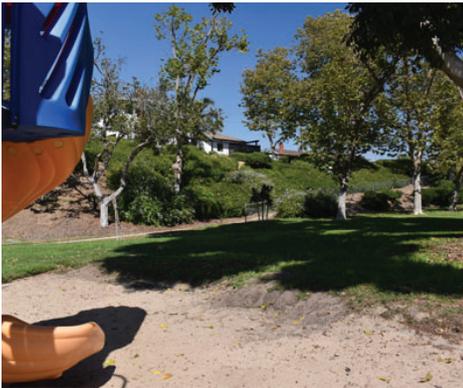
(Figure 1.1)

**Figure 1.1** - Erosion runoff from the hillside and turf area is traveling to the sand area of the playground.

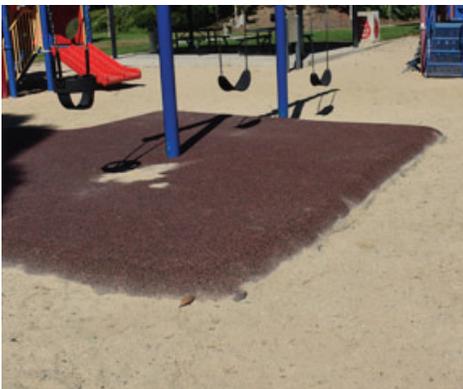
(Figure 1.4)

**Figure 1.4** - The sand level is low to where the edges of the rubber safety surfacing is beginning to be exposed. A corner of the safety surfacing is tearing away, and may be wearing out quicker due to the frequent abrasion from sand.

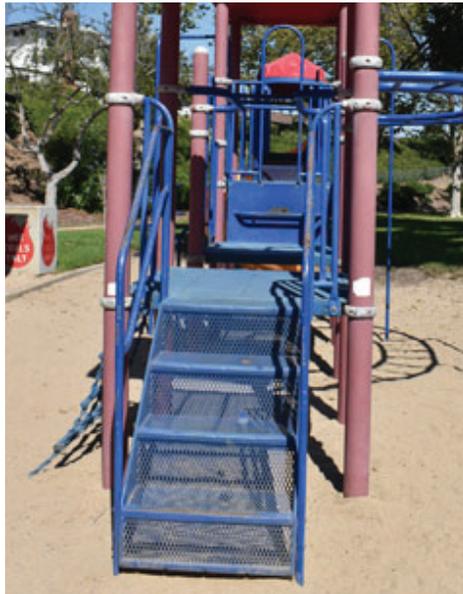
(Figure 1.2)

**Figure 1.2** - Powder coating is damaged and worn off on posts, caps, and components. Rust is observed on the metal components.

**Suggested Action-** Considering the age of the play equipment exceeds 15 years and the current condition of its parts, it is suggested to replace the play equipment.\*

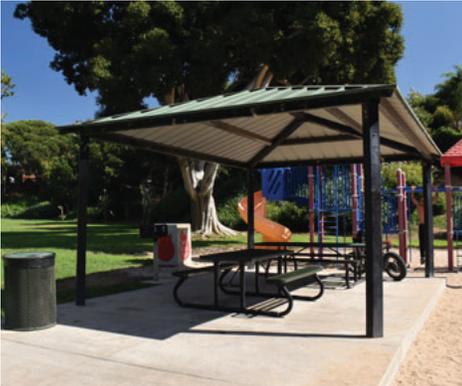
(Figure 2.1)

**Figure 2.1** - The shade structure over the picnic area is in excellent condition. The posts are clean, the powder coating is whole and intact.

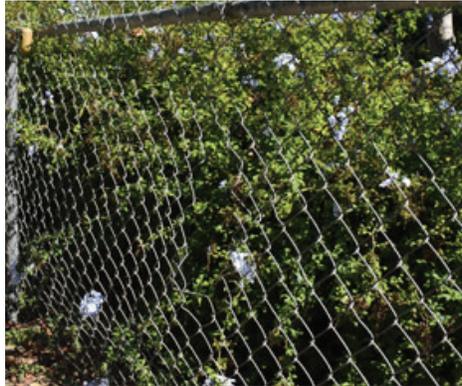
(Figure 2.2)

**Figure 2.2** - Chainlink fence fabric is broken along the paved pathway from Parkcrest Drive.  
*Suggested Action*- Repair broken chain link fence fabric.

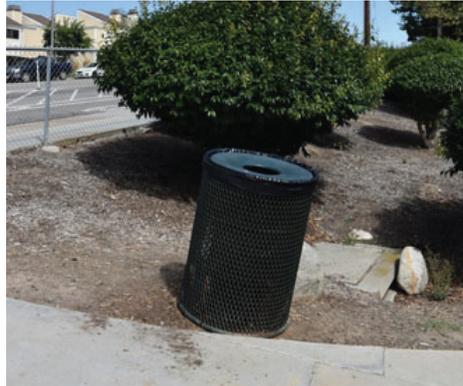
(Figure 4.2)

**Figure 4.2** - Waste receptacle has some broken areas in the plastic coating over the mesh and rust is forming.

*Suggested Action*- Monitor and replace when needed.

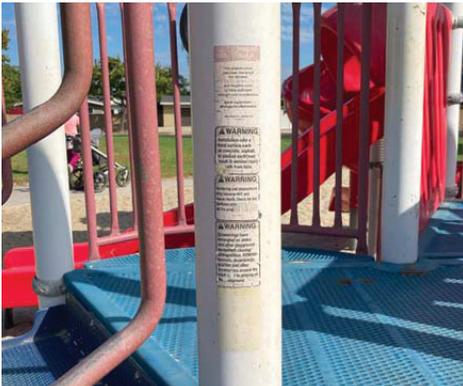
(Figure 1.1)

**Figure 1.1** - The safety labels on the play structure are faded.

**Suggested Action-** Replace safety labels per industry standards.

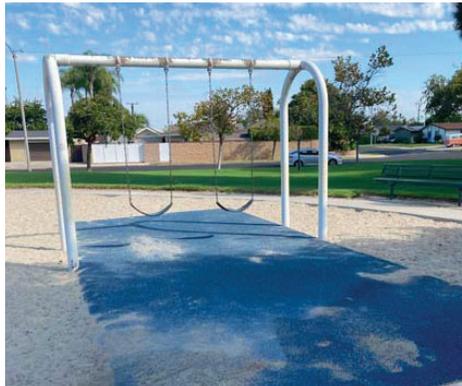
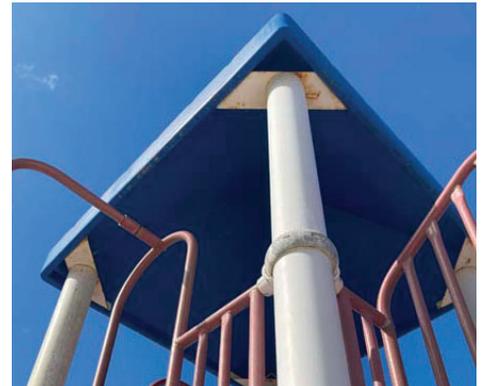
**Figure 1.2, 1.3, 1.4** - Powder coating is damaged and worn off on posts, caps, and components. Rust has formed on the play equipment.

**Manufacturer:** Miracle Recreation  
**Year Installed:** 1997  
*(Play equipment is 28 years old in 2025)*

**Suggested Action-** Considering the age of the play equipment exceeds 15 years and the current condition of its parts, it is suggested to replace the play equipment.

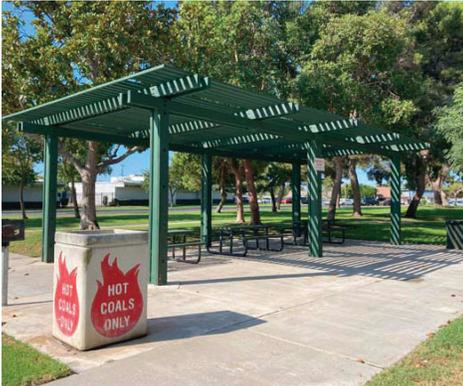
(Figure 2.1)

**Figure 2.1** - The shade structure over the picnic table area is in good condition. The area is clean and connected to the paved pathway. The concrete at the base of the posts show cracking (see Hardscape section).

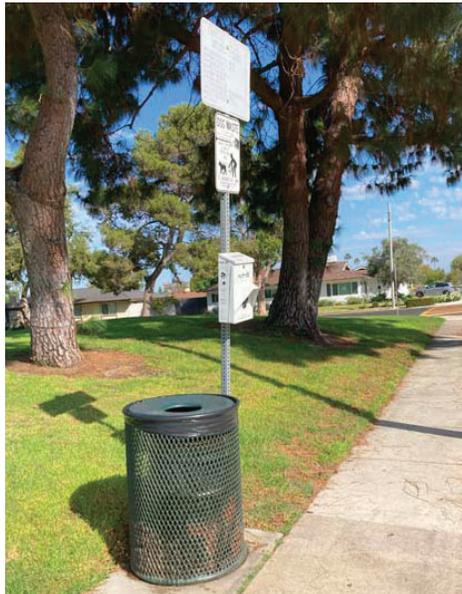
(Figure 4.2)

**Figure 4.2** - Waste receptacle is rusting where the plastic coating has broken.  
*Suggested Action*- Monitor and replace waste receptacle when needed.

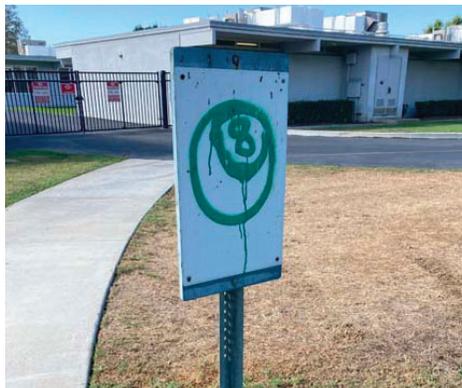
(Figure 4.5)

**Figure 4.5** - Sign has been painted over.  
*Suggested Action*- Remove or replace sign.

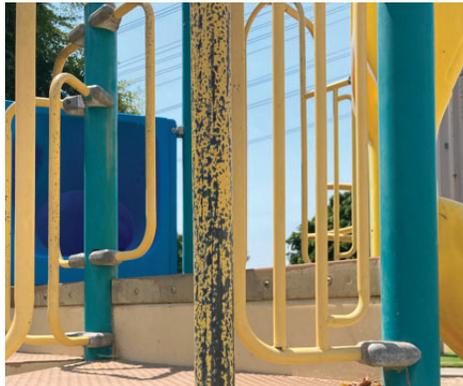
**Figure 1.2, 1.3, 1.4** - The play structure has damaged or worn off powder coating on posts, caps, and components.

**Suggested Action-** Considering the age of the play equipment exceeds 15 years and the current condition of its parts, it is suggested to replace the play equipment.

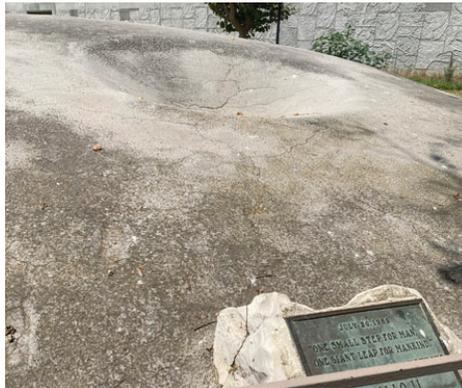
(Figure 5.2)

**Figure 5.2-** The "moon" feature and dedication boulder have some cracking.

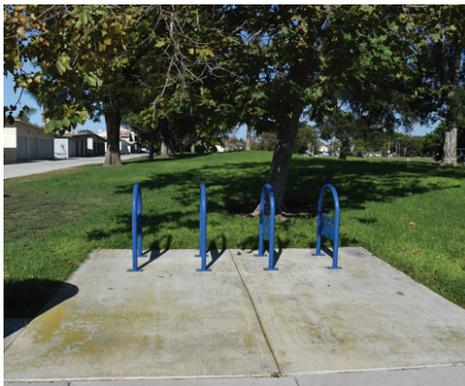
(Figure 5.1)

**Figure 5.1** - Concrete pad has algae/mold growth.

*Suggested Action*- Clean and assess the source of moisture to eliminate the continued growth.

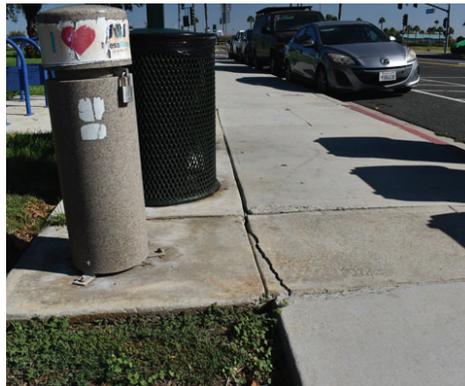
(Figure 5.2)

**Figure 5.2** - Cracking and uneven pavers observed in the paved pathway.

*Suggested Action*- Repair or replace to ensure accessibility and ADA compliance.

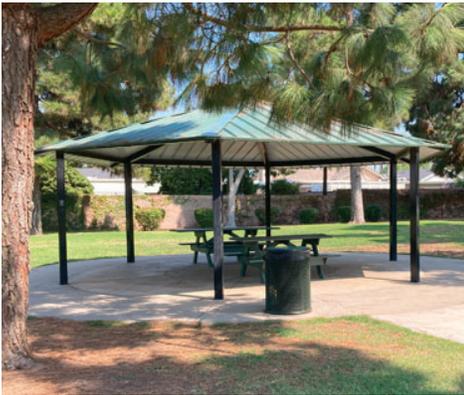
(Figure 2.1)

**Figure 2.1** - The shade structure is in excellent condition. The posts are clean, the powder coating is whole and intact. The metal roof has some dust and pine needles collecting on its top, but discoloration from outdoor exposure is minimal.

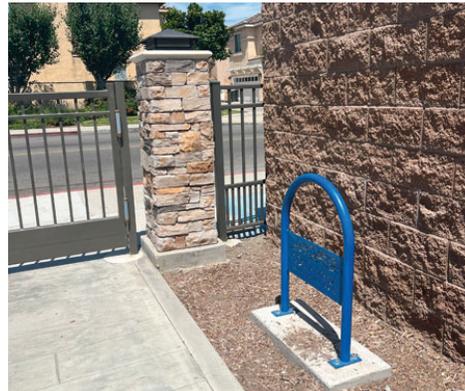
(Figure 4.2)

**Figure 4.2** - Bike rack is in good condition. The color is bright, the city logo is visible. Minimal signs of wear and tear.

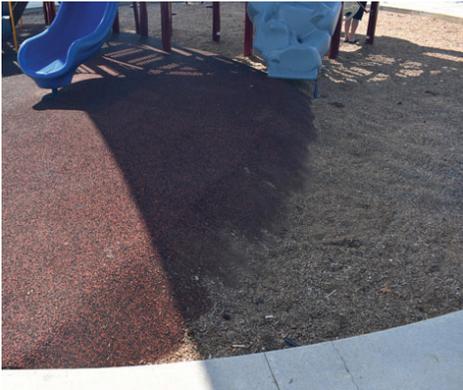
(Figure 1.1)

**Figure 1.1** - The playground has a wood fiber and rubber safety surfacing combination. The wood fiber level covers the bottom of the rubber safety surfacing.

**Suggested Action-** Ensure wood fiber level is at proper depth for fall safety requirements, as wood fiber compacts over time. Additionally, maintain wood fiber level to be within 2-3 inches to the top of the beveled edge of the rubber safety surfacing. Consider removing the wood fiber and replace with rubber safety surfacing.

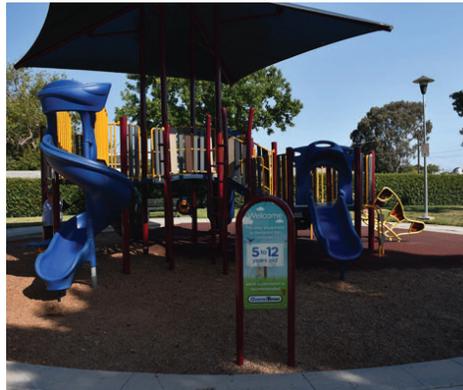
(Figure 1.2)

**Figure 1.2, 1.3** - Play structure is in excellent condition. The play area is well shaded by the shade structure.
