# PARK ASSESSMENT

2025

Prepared by  
DVD Creative

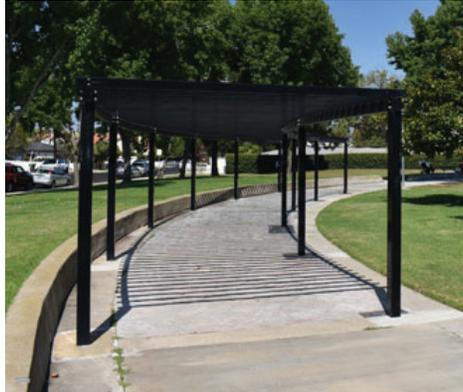
(Figure 2.2)

**Figure 2.2** - The shade structure is in excellent condition; the posts are straight, the finish is bright and clean, no chipping on the surfaces.

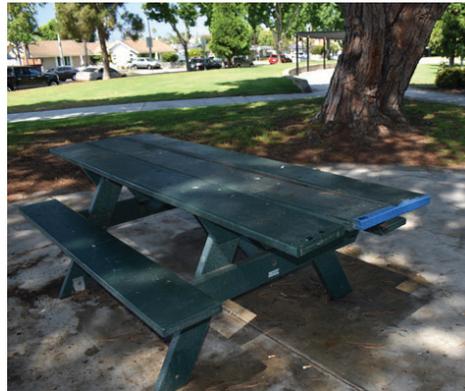
**Figure 4.2, 4.3** - The picnic tables have broken parts.

**Suggested Action-** Repair the edge of the table so there are no sharp edges; replace the picnic table with the damaged tabletop.

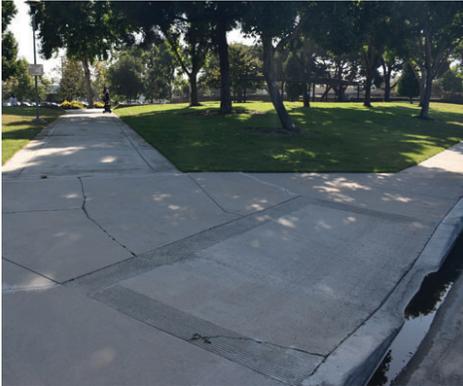
(Figure 5.1)

**Figure 5.1** - Cracks observed in the paved pathway throughout the park

*Suggested Action*- Replace areas of broken concrete to ensure accessibility and ADA compliance.

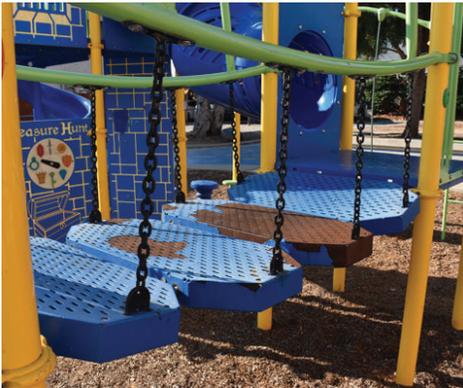
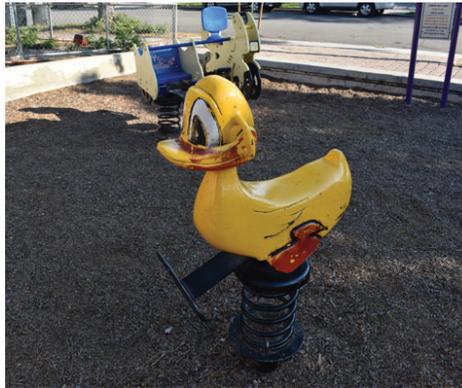
(Figure 1.1)

**Figure 1.1, 1.2** - The play equipment have damaged or worn off powder coating on posts, caps, and components. Rust is forming.

**Suggested Action**- Considering the high amount of areas damaged, it is suggested to replace the play equipment.\*

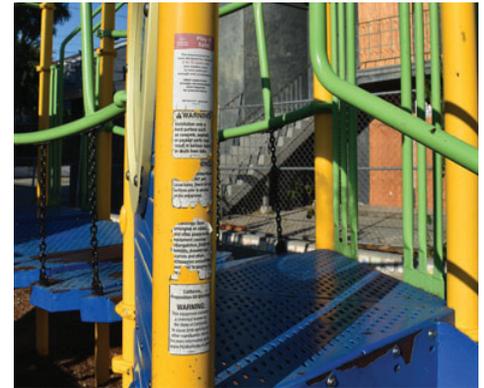
(Figure 1.3)

**Figure 1.3** - Manufacturer's safety labels are deteriorating.

**Suggested Action**- Replace labels to be in compliance with industry standards.

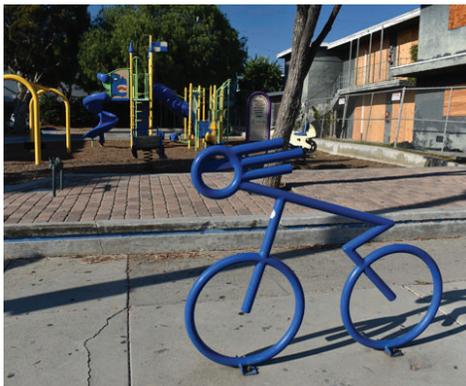
(Figure 4.1)

**Figure 4.1** - Bike rack is in good condition. Color is bright, minor scratches or chipping of paint is observed.

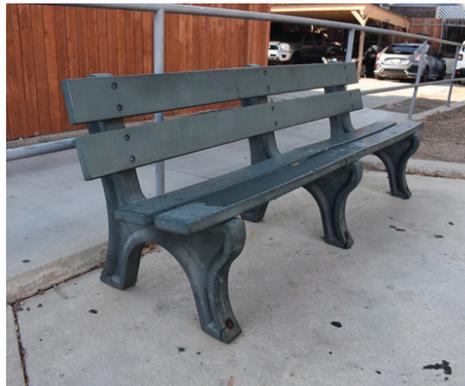
(Figure 4.2)

**Figure 4.2** - Benches in the park show wear and tear. One of the benches was observed to have cracks in the legs where mounted to the concrete.

**Suggested Action**- Replace benches as needed.

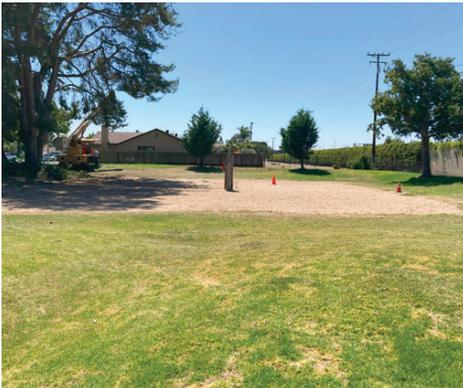
(Figure 3.1)

**Figure 3.1** - There is no clear delineation where the sand volleyball court begins from the turf.

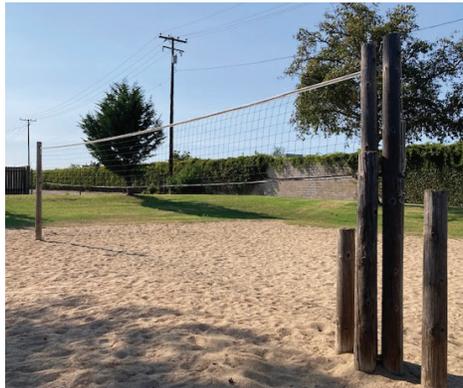
(Figure 3.2)

**Figure 3.2** - The volleyball posts and net are in fair condition. The posts are wooden and are splintering.

*Suggested Action*- Replace volleyball posts.

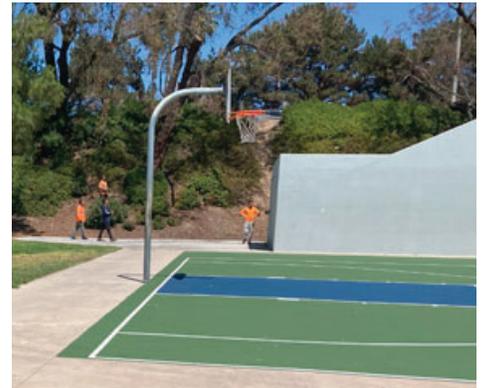
(Figure 3.3)

**Figure 3.3** - The basketball court and court surface are in excellent condition. The color is vibrant, the lines are clear, and the pavement has no cracking.

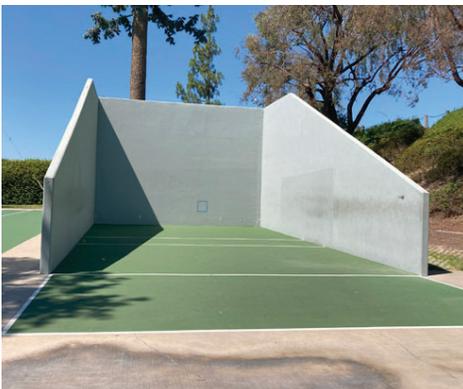
(Figure 3.4)

**Figure 3.4** - The handball court appears to be in good condition. The color is vibrant and the lines are clear. The concrete beyond the court lines has cracked and shows water damage.

*Suggested Action*- Replace areas of broken concrete.

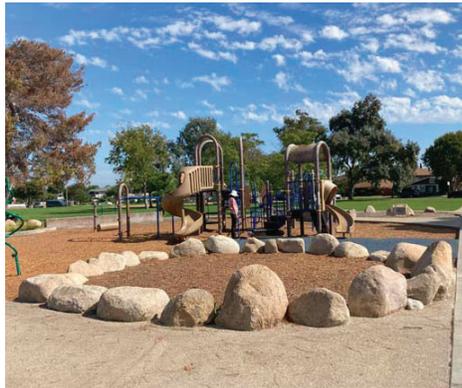
(Figure 1.1)

**Figure 1.1** - Wood fiber is thrown onto the play equipment. Weed barrier is being exposed from displaced and/or low levels of wood fiber.

**Suggested Action-** Ensure wood fiber level is at proper depth for fall safety requirements, as the wood fiber compacts over time. Additionally, maintain wood fiber level to be within 2-3 inches to the top of the beveled edge of the rubber safety surfacing. Replace the rubber safety surfacing. Consider removing the wood fiber and replace with rubber safety surfacing.

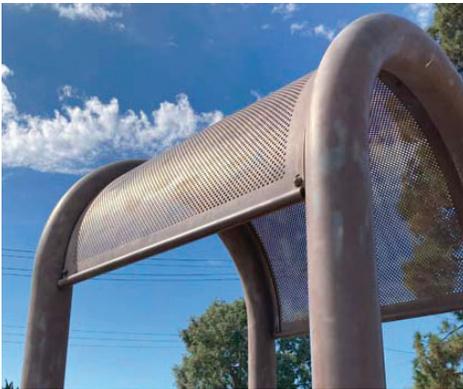
(Figure 1.3)

**Figure 1.3** - Manufacturer's safety labels have worn off.

**Suggested Action-** Replace labels per industry standards.

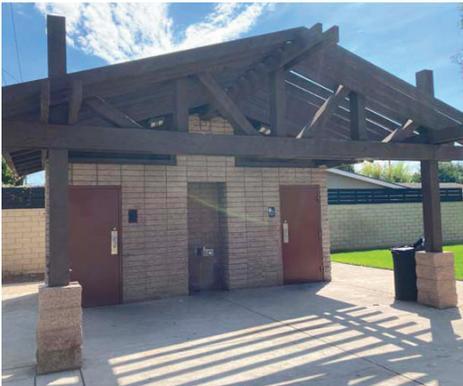
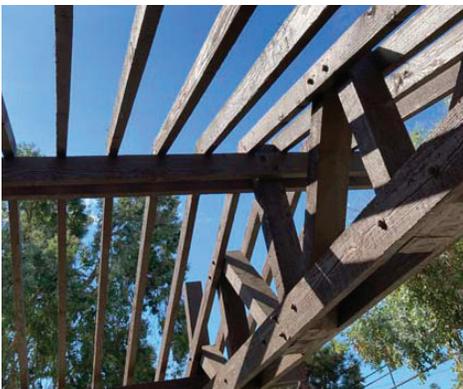
**Figure 2.1, 2.4** - The restroom building and attached pergola are in good condition. The wood is not splintering and the paint color looks fresh and complete. The brick walls look cleaned and well-maintained.

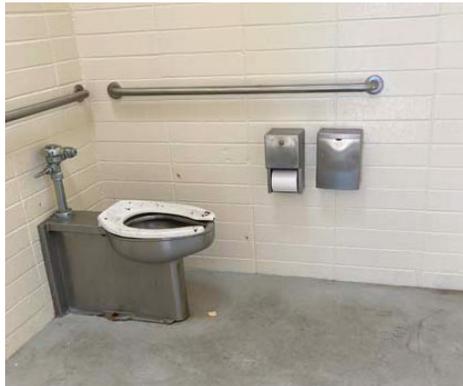
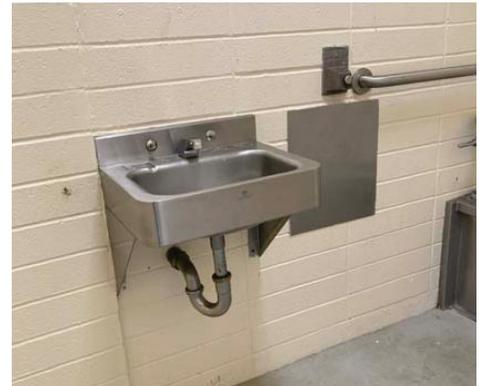
**Figure 2.2, 2.3** - The interior of the restroom is clean. The paint on the toilet seat is chipped.

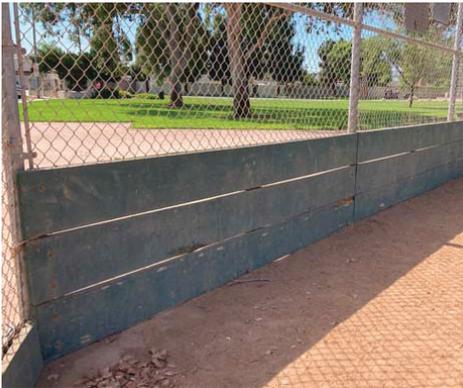
(Figure 3.1)

**Figure 3.1** - Backstop at the softball field is broken in several spots.

*Suggested Action*- Replace boards.

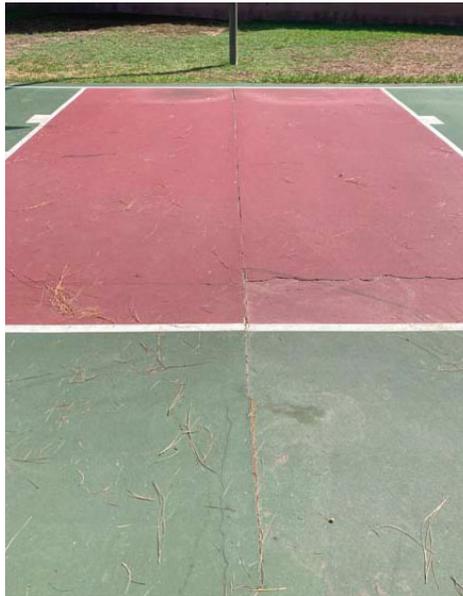
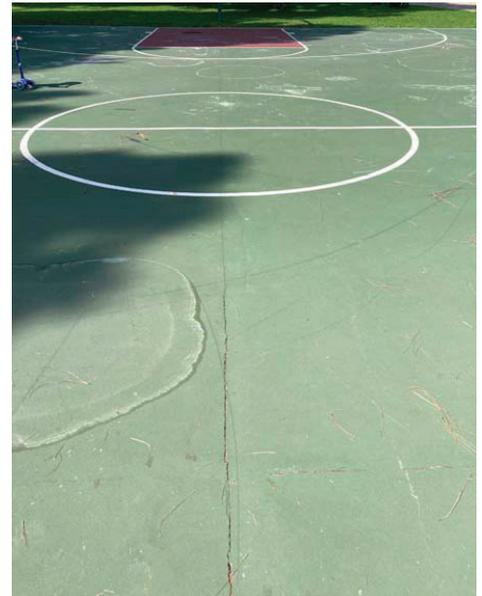
**Figure 3.2, 3.3** - The concrete surface of the basketball court is cracking. It is cracked all throughout the middle of the court. There is water damage on the court surface.

*Suggested Action*- Consider replacement of the court surface.

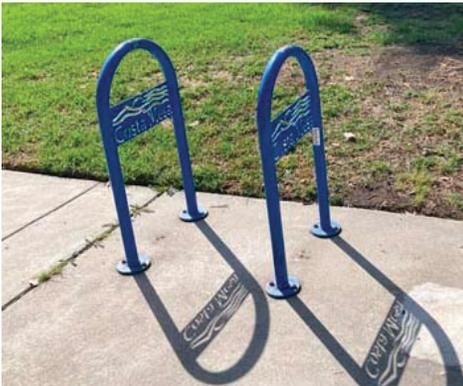
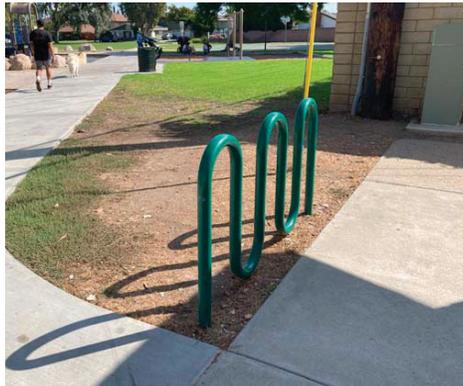
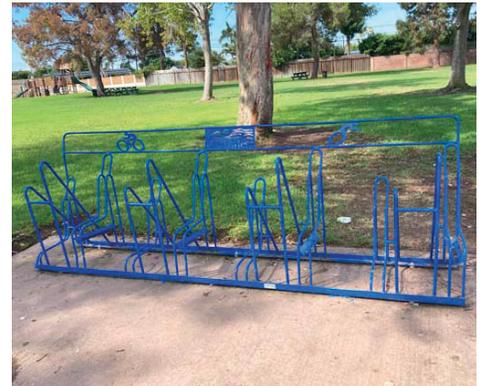
**Figure 4.1, 4.2, 4.3** - Bike racks are in good condition. Styles are varied. Color is bright, no scratches or chipping of paint is observed. City logo is visible.

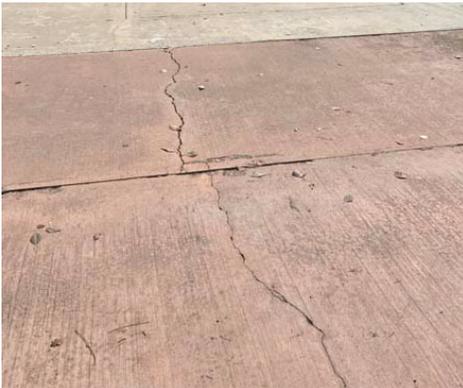
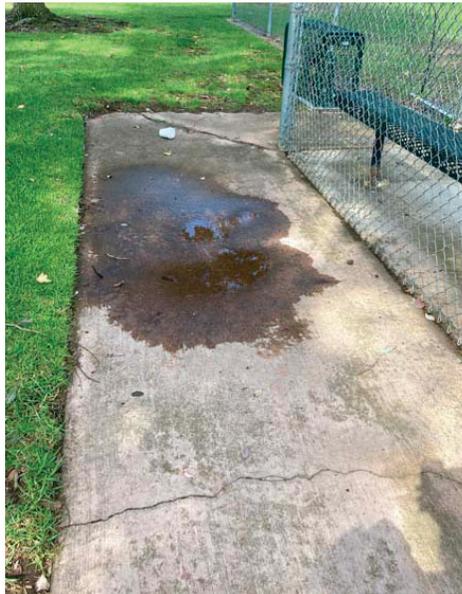
**Figure 5.1, 5.2** - Cracks and gaps observed in the paved area around the softball field. This pavement appears to be older than the rest of the paved pathways in the park.

**Suggested Action-** Replace areas of broken concrete to ensure accessibility and ADA compliance.

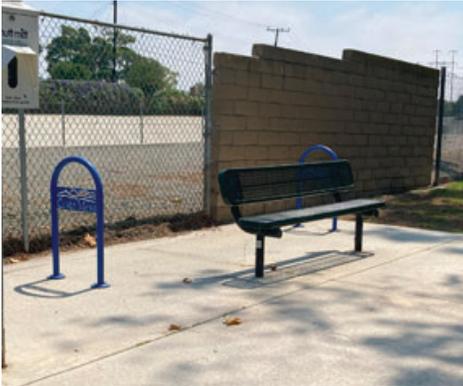
(Figure 4.1)

**Figure 4.1-** Bike racks and bench are located near the entrance.

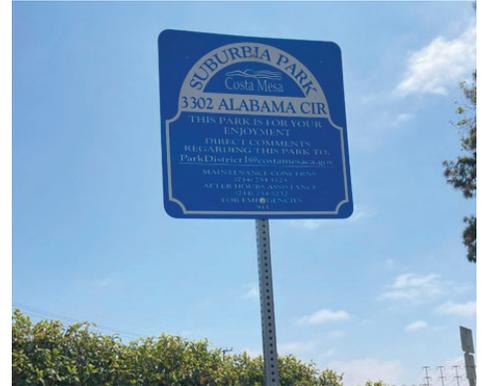
(Figure 4.3)

**Figure 4.3-** Park sign is clean, bright, and legible.

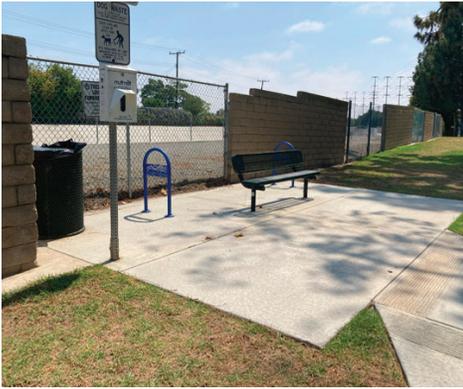
(Figure 5.1)

**Figure 5.1-** Concrete pad under bike racks and bench is in excellent condition; the surface is even and is flush with the turf.

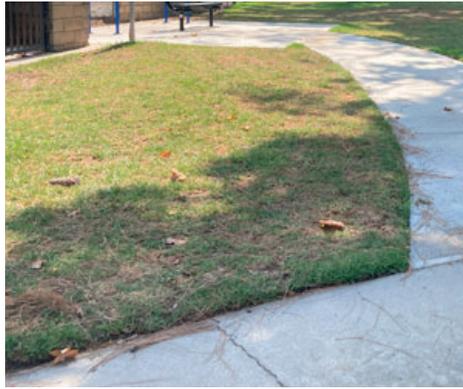
(Figure 5.2)

**Figure 5.2-** An area of cracking on the driveway apron was observed along the park boundary.

**Suggested Action-** Repair or replace with new concrete to ensure accessibility and ADA compliance.

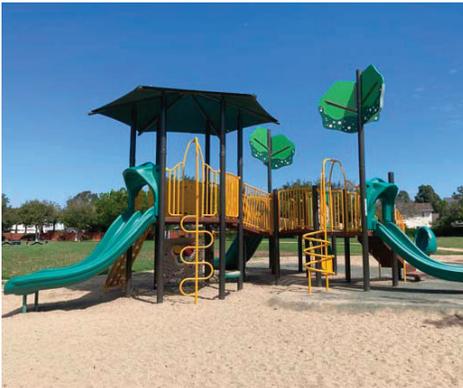
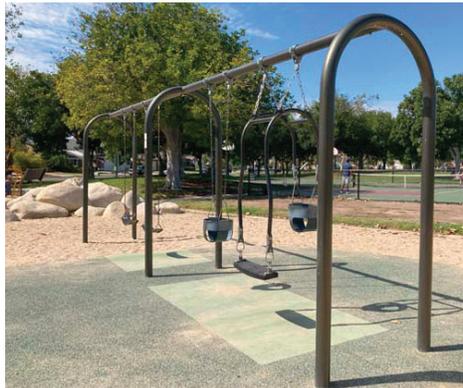
**Figure 1.1, 1.2, 1.3** - The play equipment is in excellent condition. The powder coating on the posts, caps, and components is bright and without blemish.

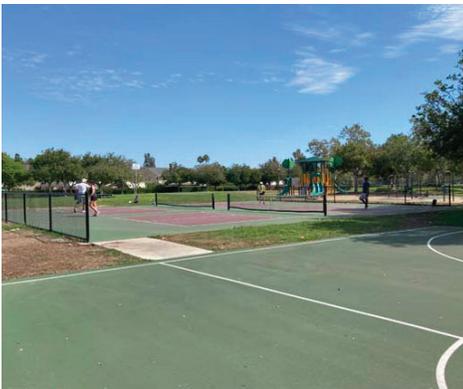
(Figure 3.4)

**Figure 3.4** - The pickleball courts surface is clearly painted with intact fencing. Posts and netting are in good condition.

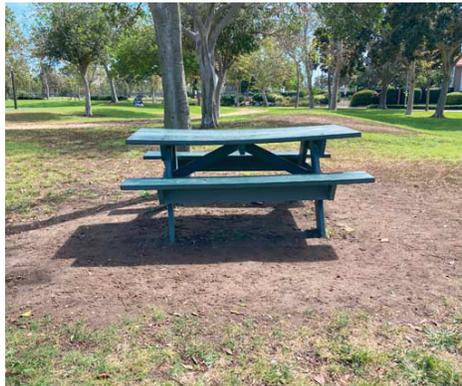
(Figure 4.2)

**Figure 4.2** - Picnic table is located in the turf area; turf will struggle to grow where there is soil compaction.  
*Suggested Action*- Relocate picnic table and repair damaged turf.

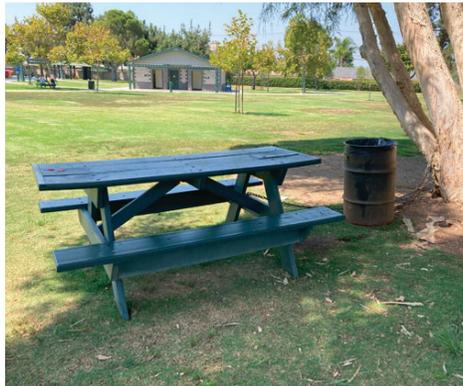
(Figure 4.2)

**Figure 4.2** - Picnic table is located in the turf area; turf will struggle to grow where there is soil compaction.  
*Suggested Action*- Relocate picnic table and repair damaged turf.

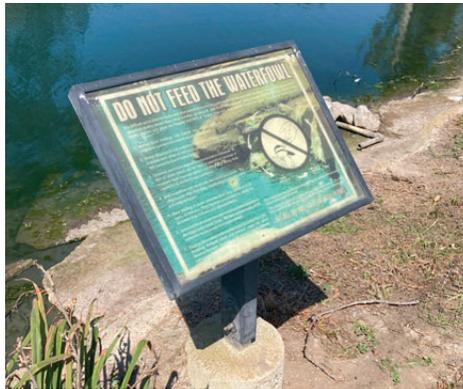
(Figure 4.5)

**Figure 4.5** - Sign by the lake shows extensive sun damage.  
*Suggested Action*- Replace sign.

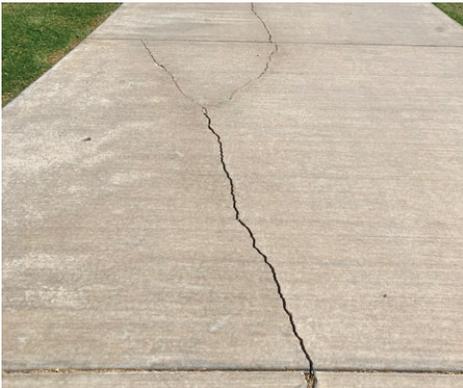
(Figure 5.1)

**Figure 5.1-** Cracks observed in the concrete walkway.

**Suggested Action-** Replace sections of broken concrete to ensure accessibility and ADA compliance.

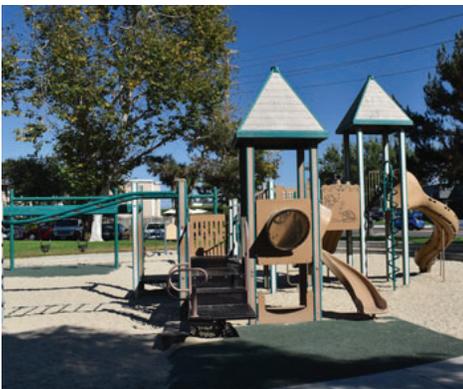
(Figure 1.4)

**Figure 1.4** - Powder coating is damaged and worn off on posts, caps, and components due to wear and tear. There is no obvious damage to the play structure.

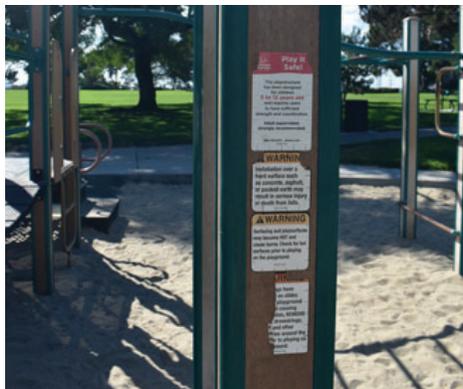
(Figure 1.5)

**Figure 1.5** - Manufacturer's safety labels are deteriorating.

**Suggested Action-** Replace labels per industry standards.

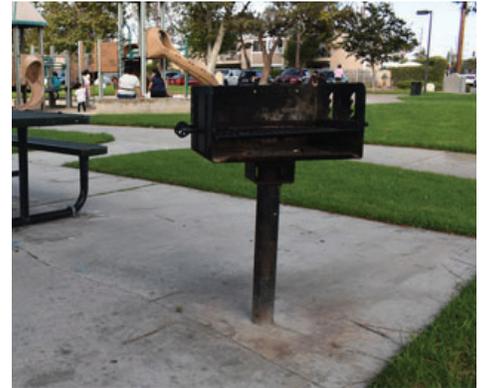
(Figure 4.3)

**Figure 4.3** - BBQ grill is in fair condition. There are signs of damage from heat (wear and tear), but the grills are usable.

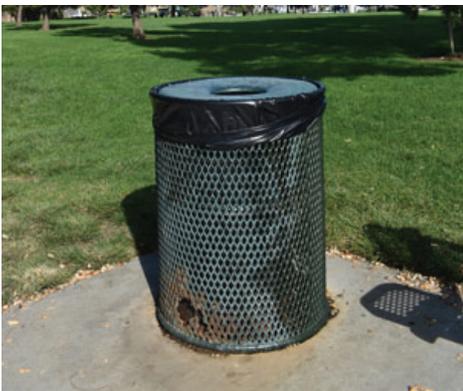
(Figure 4.4)

**Figure 4.4** - The waste receptacle is broken and rusting.

*Suggested Action*- Replace waste receptacles as needed.

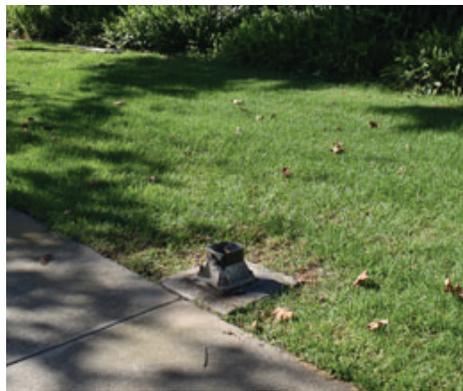
(Figure 4.5)

**Figure 4.5** - Lighting system was not assessed. This base is missing the light pole.

*Suggested Action*- Replace light pole.

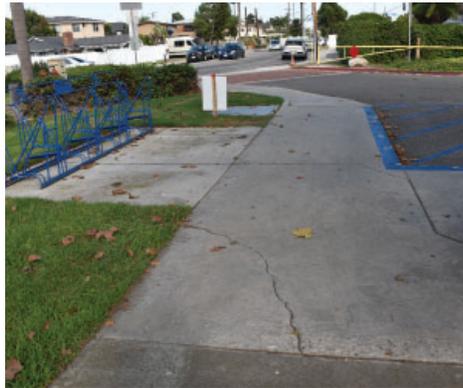
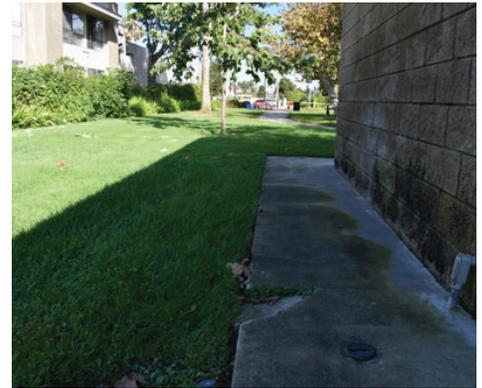
(Figure 5.1)

**Figure 5.1, 5.2** - Lifted concrete and cracking observed in the paved pathway.

*Suggested Action*- Repair broken or uneven concrete sections to ensure accessibility and ADA compliance.

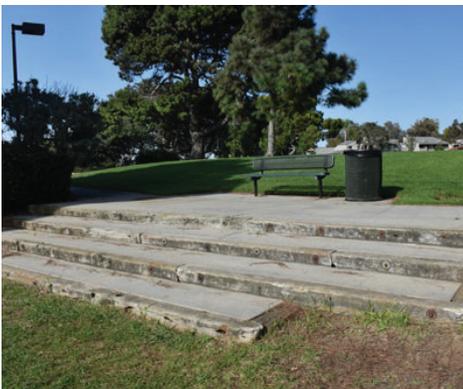
(Figure 5.3)

**Figure 5.3** - Concrete paving around the restroom building is damaged by water from the turf. Mold/algae is growing and the concrete is breaking.

*Suggested Action*- Replace concrete as needed. Adjust irrigation to prevent overspray on paving and structures.

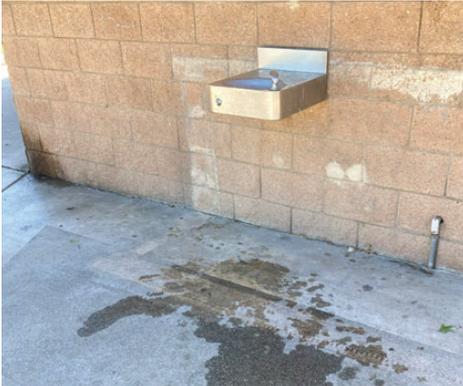
(Figure 4.1)

**Figure 4.1** - The drinking fountain (located on the exterior of the restroom building) is in good condition. The surface is clean, no signs of leaking.

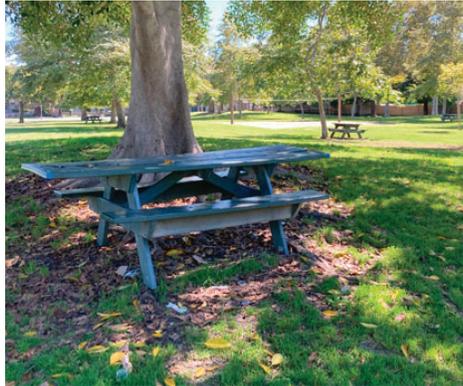
(Figure 4.2)

**Figure 4.2** - The picnic table is located in the turf area; turf will struggle to grow where there is soil compaction.  
*Suggested Action*- Relocate picnic table and repair damaged turf.

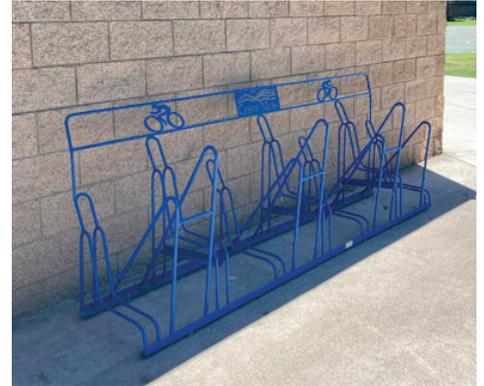
(Figure 4.3)

**Figure 4.3** - Bike rack is in good condition. Color is bright, minor scratches or chipping of paint is observed. City logo is visible.

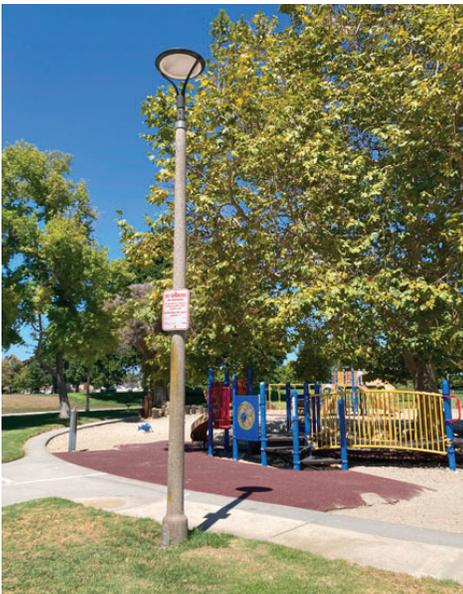
(Figure 4.4)

**Figure 4.4** - Lighting system was not assessed. The light poles have matching fixtures.

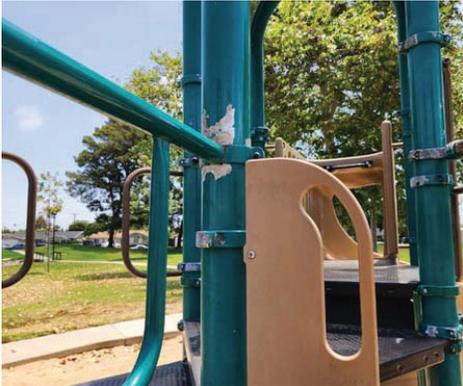
(Figure 1.1)

**Figure 1.1** - The play structure has damaged or worn off powder coating on posts, caps, and components.

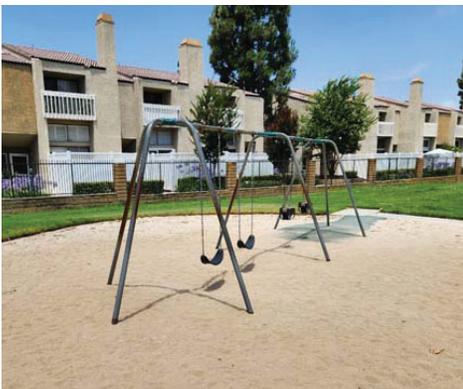
(Figure 1.4)

**Figure 1.4** - The swings have damaged or worn off powder coating on posts, caps, and components. Rust is observed near the swing set hangers.

**Suggested Action-** Given the age of the swing set and the current condition of its parts, it is recommended to replace the swing set.

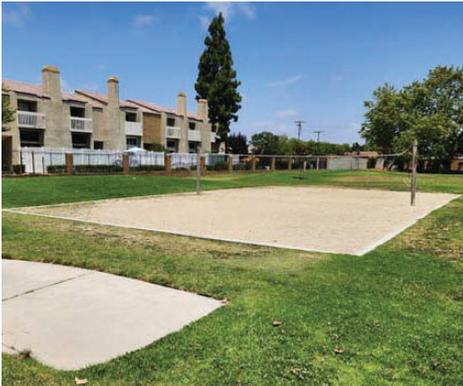
(Figure 3.1)

**Figure 3.1** - The sand volleyball court is delineated by a concrete curb that separates sand from turf.

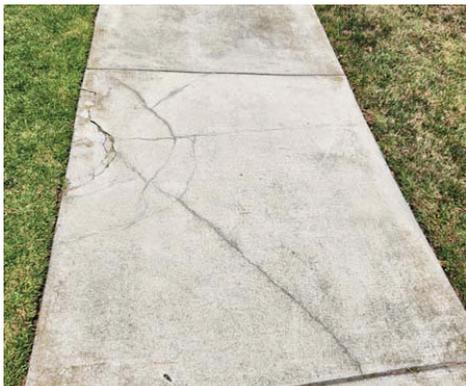
(Figure 5.1)

**Figure 5.1** - Cracks observed in the paved pathways at various areas throughout the park.

**Suggested Action**- Replace sections of broken concrete to ensure accessibility and ADA compliance.

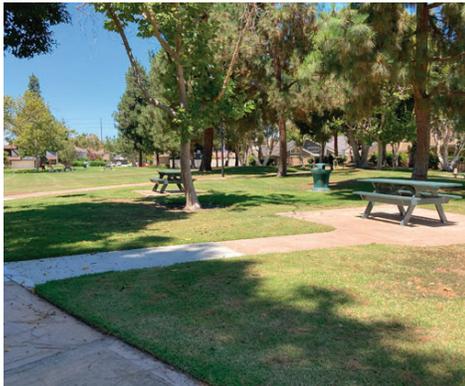
(Figure 4.1)

**Figure 4.1** - There is one picnic table area connected to the paved pathway. Other picnic tables are each on a small concrete pad surrounded by turf.

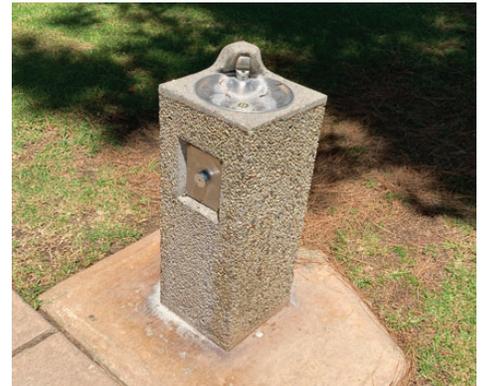
(Figure 4.3)

**Figure 4.3** - The two drinking fountains are in good condition. The concrete pedestals are clean, whole and intact.

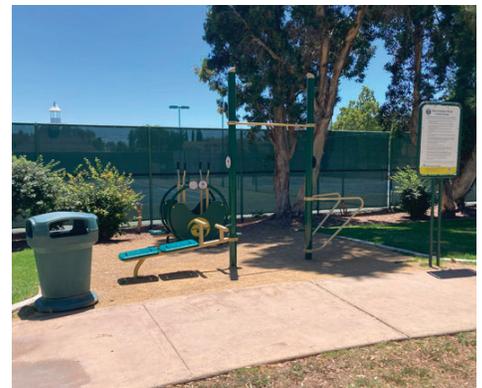
(Figure 4.6)

**Figure 4.6** - The four Fitness Zone areas are in good to excellent condition. Color is bright, minor scratches or chipping of paint is observed.

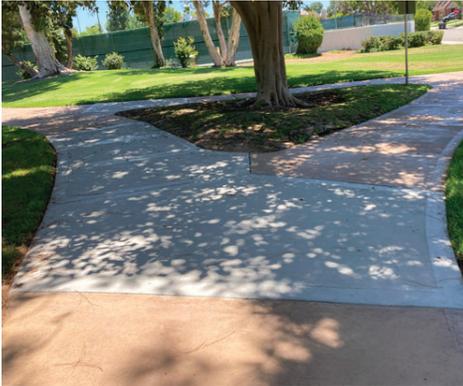
(Figure 5.1)

**Figure 5.1** - Concrete is shown in different colors; it appears the newer concrete was installed in a different color than the existing concrete.

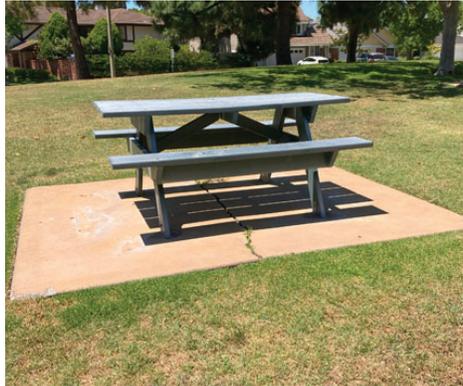
(Figure 5.2)

**Figure 5.2** - Concrete pads are cracking beneath picnic tables, corners of the concrete are chipping.  
*Suggested Action*- Replace concrete pads under the picnic tables.

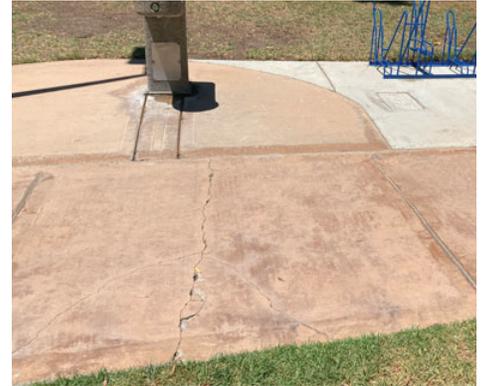
(Figure 5.3)

**Figure 5.3** - Cracks and lifted concrete observed in the paved pathway at various areas throughout the park.  
*Suggested Action*- Repair or replace sections of concrete to ensure accessibility and ADA compliance.

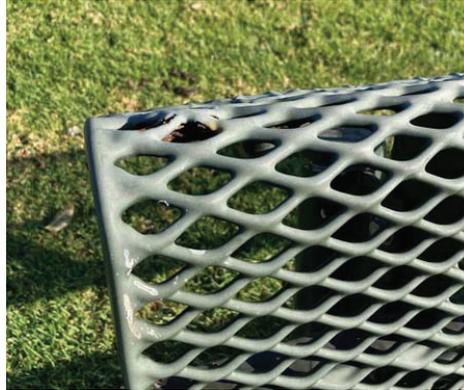
(Figure 4.2)

**Figure 4.2** - Benches are in fair to good condition. The coating on the mesh is beginning to decline.  
*Suggested Action*- Monitor condition and replace as needed.
