**FAIRVIEW PARK VERNAL POOL RESTORATION  
AND  
LONG TERM MAINTENANCE PLAN FOR VERNAL POOLS 5 AND 6,  
AND THE ASSOCIATED WATERSHED  
AREAS WITHIN THE JURISDICTION OF**

**FAIRVIEW PARK  
COSTA MESA, CALIFORNIA**

**JUNE 8, 2018**

**Glenn Lukos Associates, Inc.  
29 Orchard  
Lake Forest, California 92630  
Contact: Tony Bomkamp/Kevin Livergood  
(949) 837-0404**

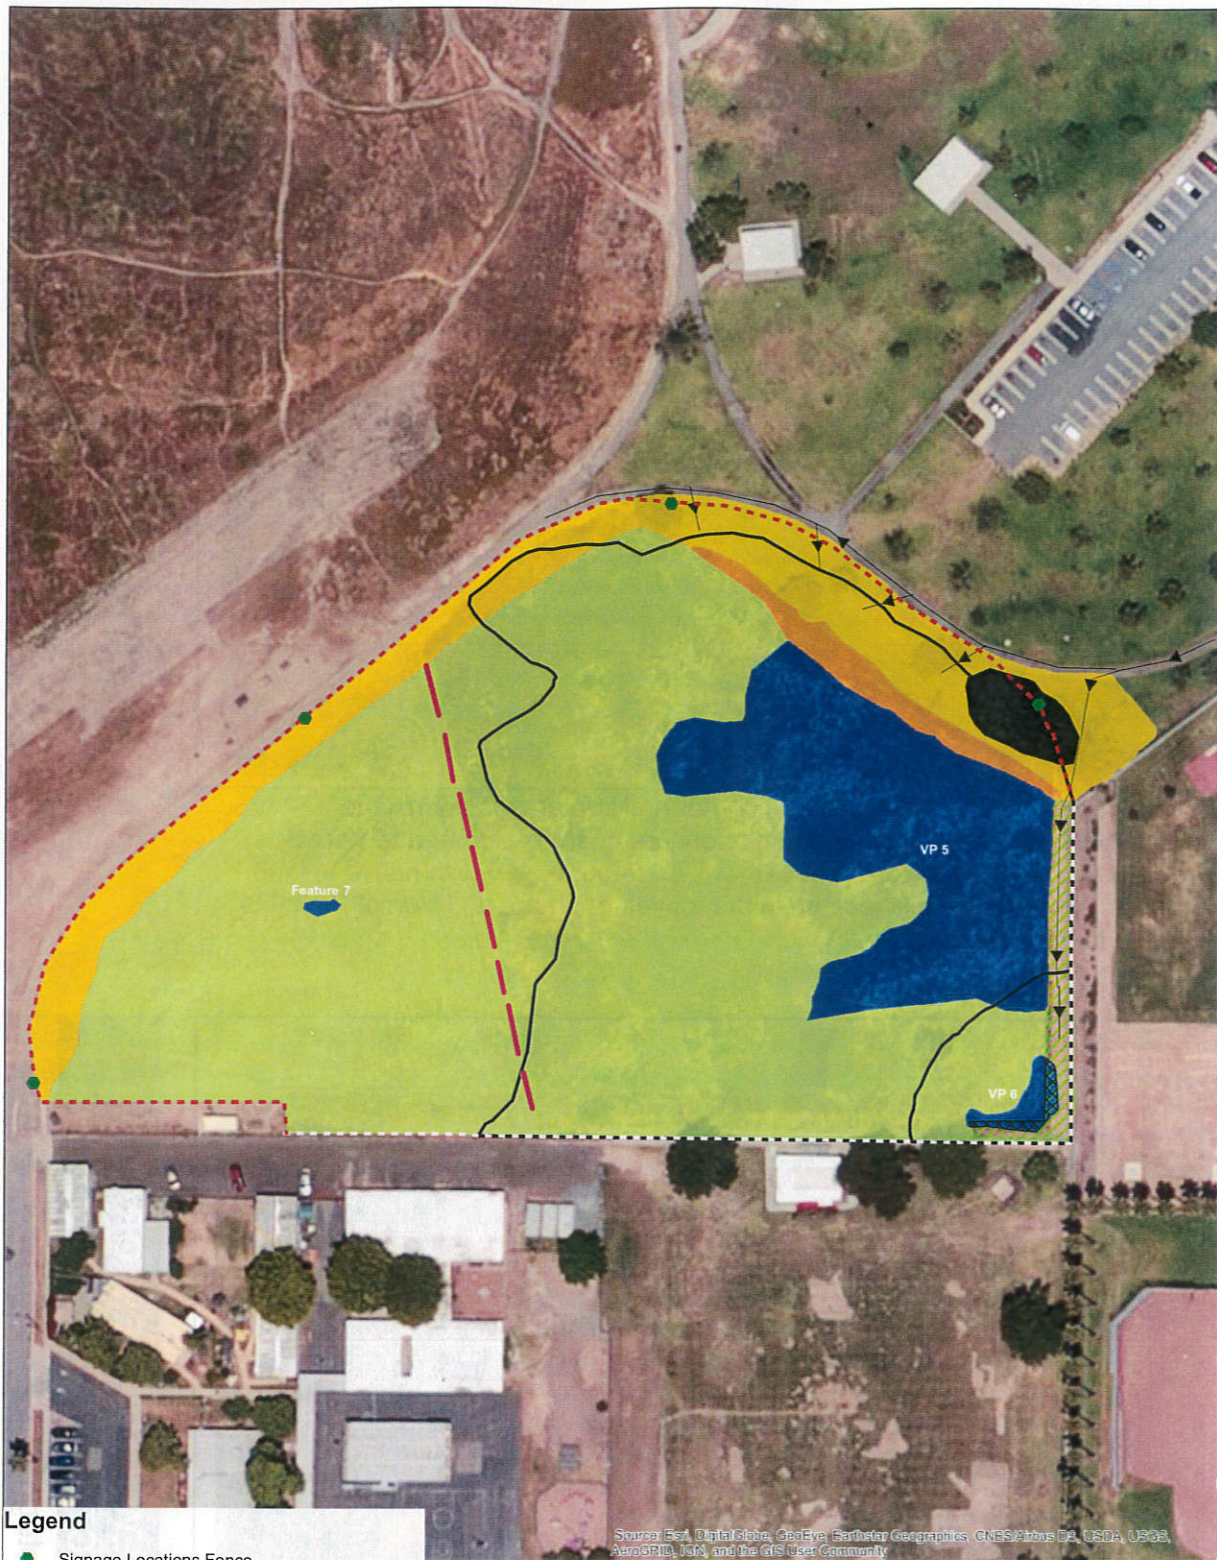
Exhibit 3

- Signage Locations Fence
- Existing Fencing
- - - New Exclusion Fencing
- Site Access
- - - Telephone Pole Indentation (209 ft)
- Stockpile/Staging Area
- Watershed Breaks
- Non-Native Vegetation to be Removed (0.08 ac)
- Foot Path Restoration (0.062 ac)
- Turf Removal and CSS Establishment (0.65 ac)
- Vernal Pool
- Vernal Pool Six Reestablishment Area (0.01 ac)
- Native Grassland Establishment (2.97 ac)

As depicted on Exhibit 3, a portion of Vernal Pool 6 was affected by installation and removal of the decomposed granite foot path. The watershed of Vernal Pool 6 was also affected by the removal of the foot path, which left the ground surface a few inches lower than the adjacent pool basin. Restoration of the impacted watershed area of Vernal Pool 6 is addressed below.

Protective fencing will be installed along the perimeter of the Vernal Pool 5 and 6 Complex, which is inclusive of historical Feature 7 and the associated watershed [Exhibit 3]. Installation of the fencing will be monitored by a qualified biologist to ensure that no incursions occur into vernal pools. Signage prohibiting entry and educating the public of the sensitive habitat will be placed along the fencing at regular intervals as depicted on Exhibit 3.

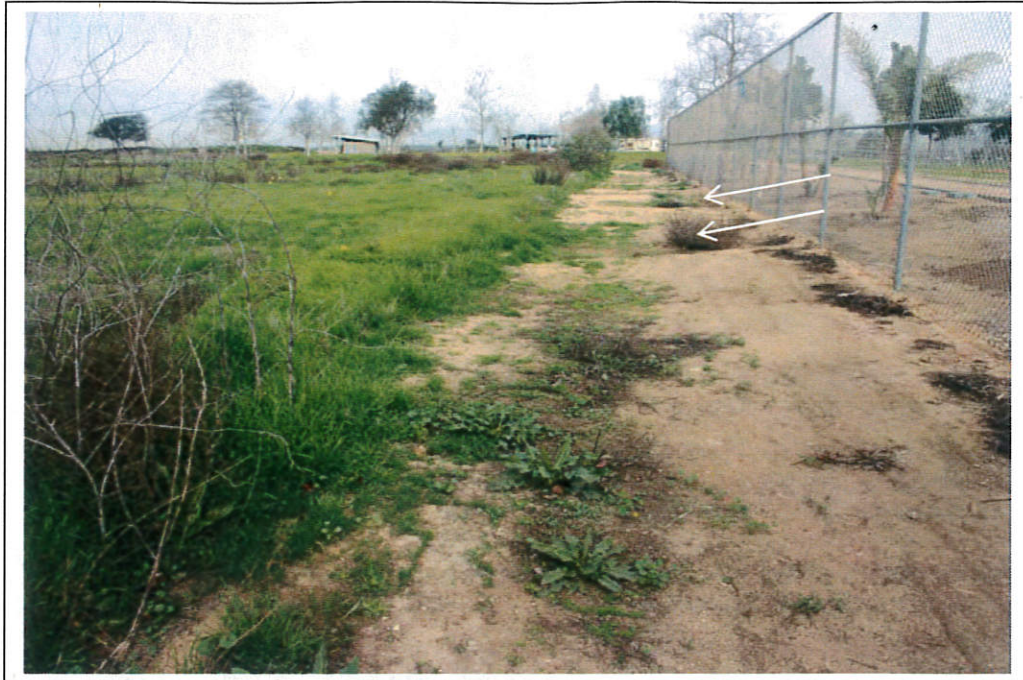
Photograph 1: View of foot path facing north. Note arrows pointing to depressions which will be smoothed to ensure positive drainage to Vernal Pools 5 and 6. The restored foot path will be re-vegetated with native upland species. Vernal Pool 5 is located in the top left of photo, and Vernal Pool 6 is located in the bottom left.

Restoration of the watershed area damaged by the foot path will be conducted simultaneously with reestablishment of Vernal Pool 6 (see Task 1a above). Removal of the decomposed granite foot path created a "lip" outside of the eastern boundary of Vernal Pools 5 and 6 (note: the basin for Vernal Pool 5 was not affected by the foot path construction or associated removal). The "lip" is generally shallow, averaging about 3 inches and reaches 10 inches in one area, causing

rainfall that falls on the former path to pond rather than contributing to the hydrological input for Vernal Pools 5 and 6. The ground surface elevations will be restored to ensure positive drainage to the pools as set forth below:

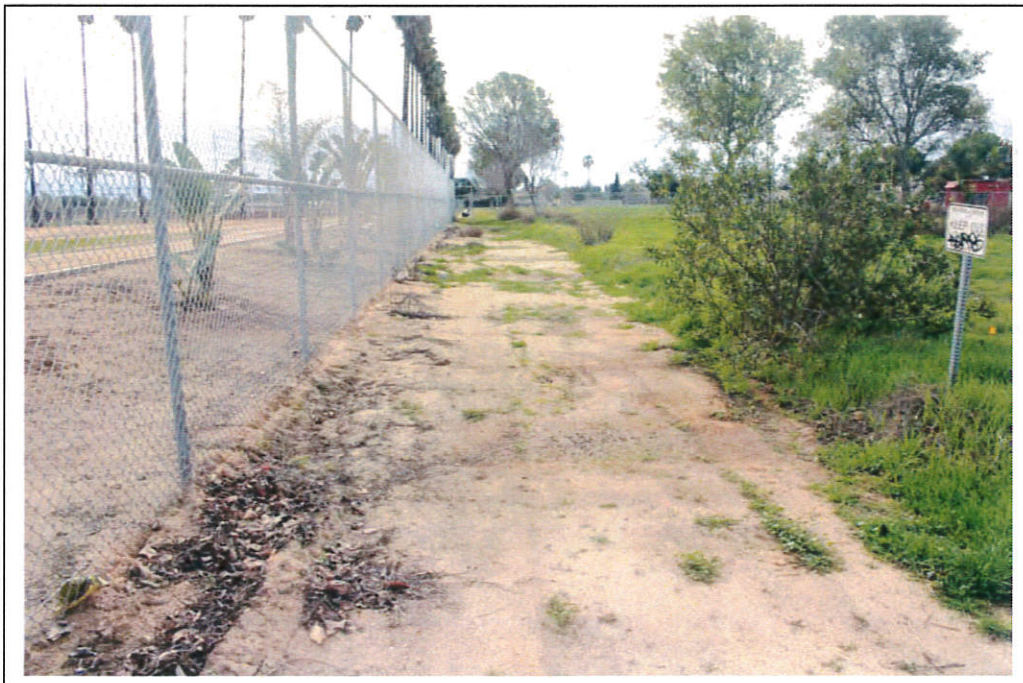
Photograph 2: View of foot path facing south, which will be restored and re-vegetated with native species. Vernal Pool 5 is located to the right of the trail. Vernal Pool 6 is located at the top right of the photograph.

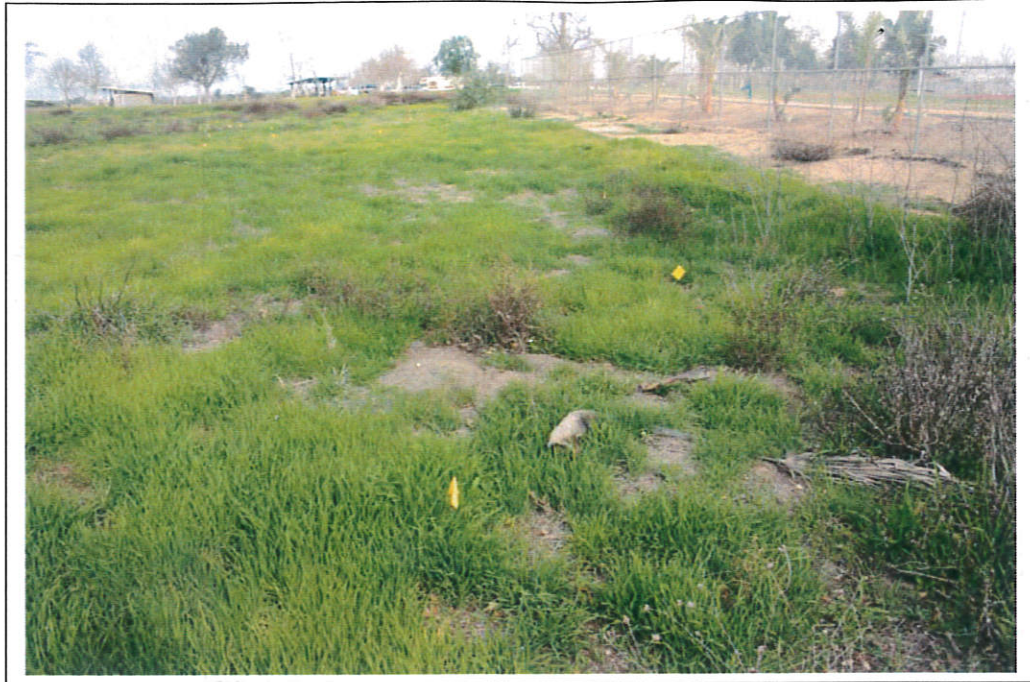
Photograph 3: View of Vernal Pool 6 area (bottom right of photo) to be restored. Note trail in the top right corner of photograph. Vernal Pool 5 is located in the top left of the photo.

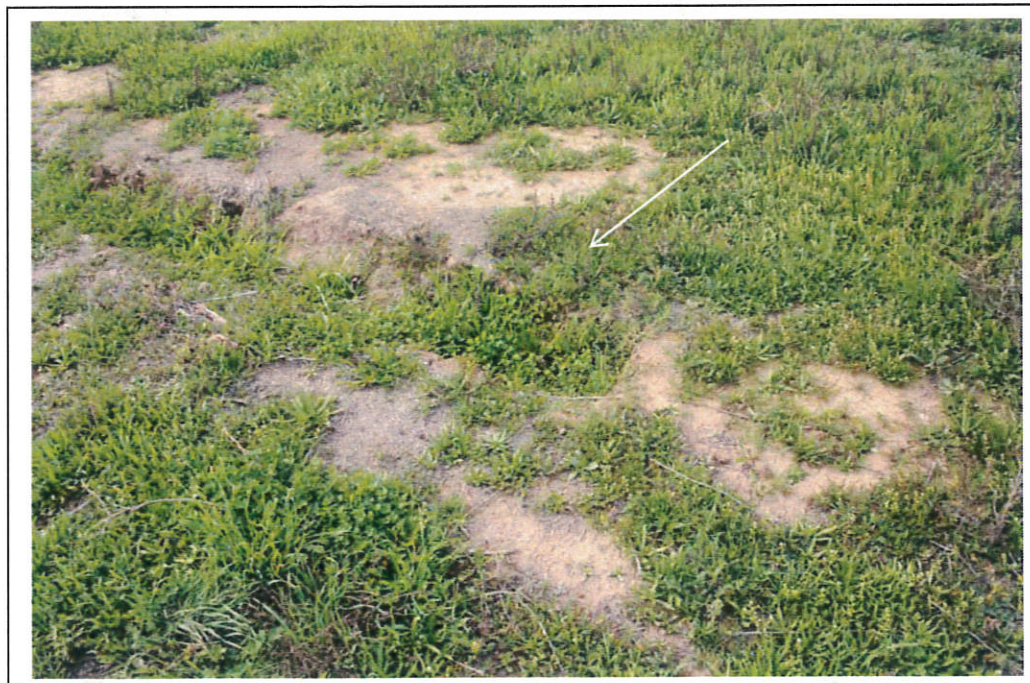
Photograph 4: View of typical indentation in the ground surface where telephone poles were placed to prevent access to Vernal Pools 5 and 6.

Shallow indentations in the ground surface were created where telephone poles were placed to restrict vehicle access to Vernal Pools 5 and 6. The poles were placed in the vicinity of a former feature located within the watershed of Vernal Pools 5 and 6. Due to the sensitivity of pools 5 and 6, the watershed (inclusive of Feature 7) will be re-vegetated with native plant species and topographic irregularities resulting from the placement of the telephone poles will be removed. These areas will be repaired by hand-filling the pole indentations with soil harvested from the borrow area identified for restoration of the foot path at Vernal Pool 6. Hand tools would be used to fill and compact the soil such that the grade on either side of the indentations would match the surrounding topography.

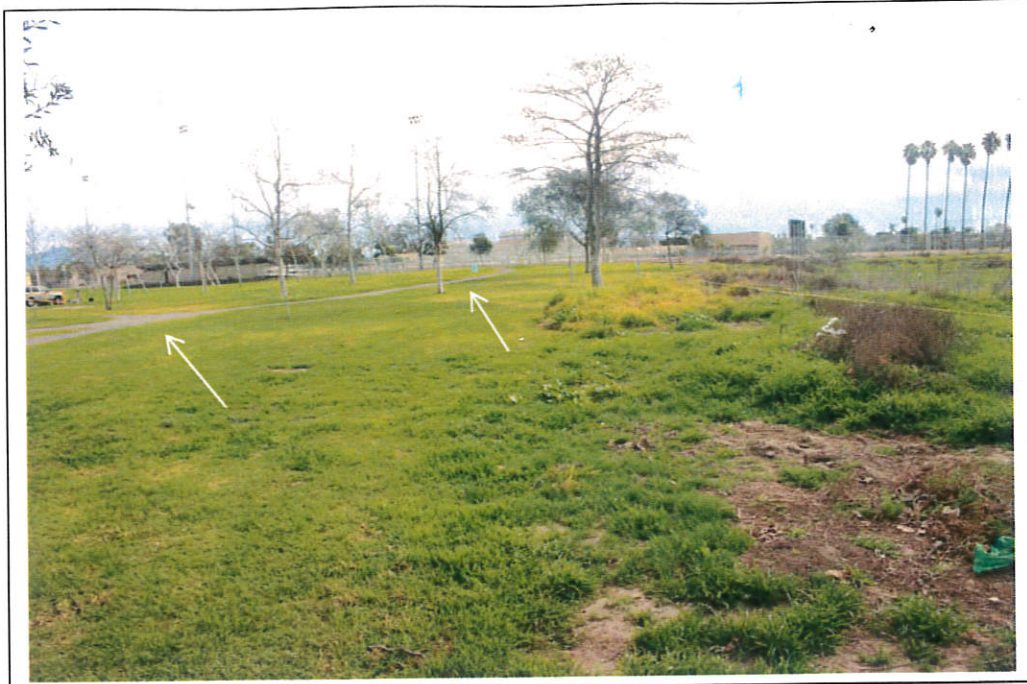
Photograph 5: View of buffer restoration area facing east. Turf grass in the left of the photo and non-native grasses in the right of the photo will be removed and restored with coastal sage scrub species. Note arrow pointing to existing access to the site.

An approximately 0.37-acre area of turf grass along the northern edge of Vernal Pool 5 will be removed using mechanized equipment and hand tools as determined appropriate by the City. Following removal of the turf, the area will be treated, through installation of black tarp, to kill the remaining roots of the turf in a manner that has no potential for effects on Vernal Pool 5. If it is necessary to use chemicals, only chemicals approved for use around wetlands will be used and straw wattle will be placed at the lower edge of the restoration area to limit the potential for chemicals from reaching Vernal Pool 5. Following removal and necessary treatment, the area will be revegetated with native upland species per Table 1 in Section C.5. below. The irrigation that currently exists will remain in place to establish the newly planted upland vegetation.

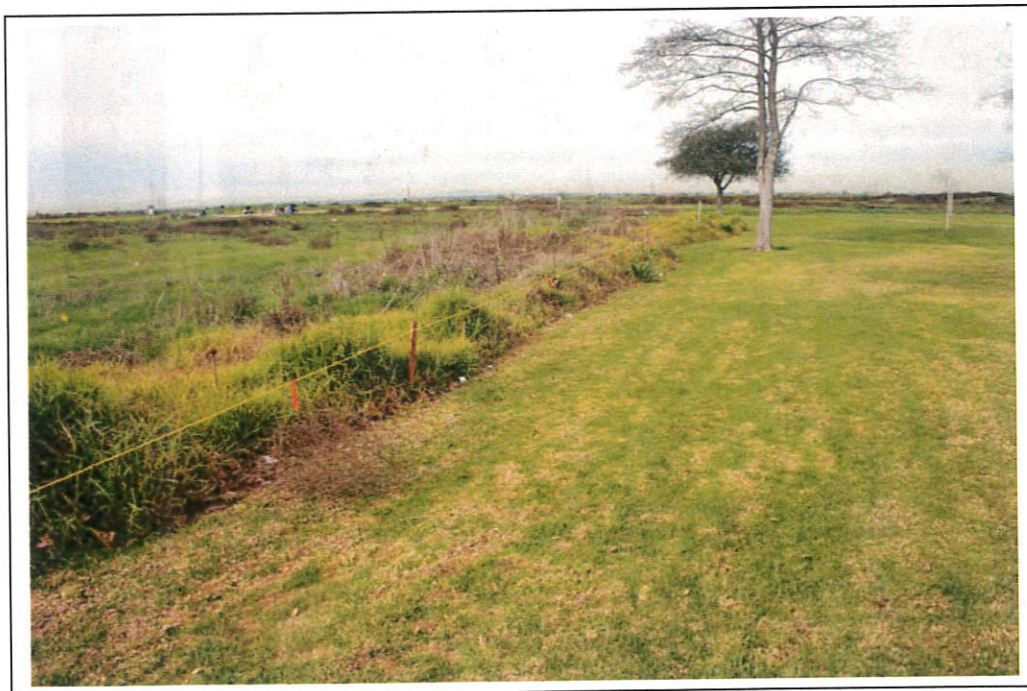
Photograph 6: View of turf restoration area facing west. The rope fencing demarcates the vernal pool watershed boundary.
