## Assessment Report & Recommendations

# TeWinkle Park Lakes

June 2022 – Revised

**Pacific Advanced Civil Engineering, Inc.**  
17520 Newhope Street, Suite 200  
Fountain Valley, CA 92708  
714-481-7300

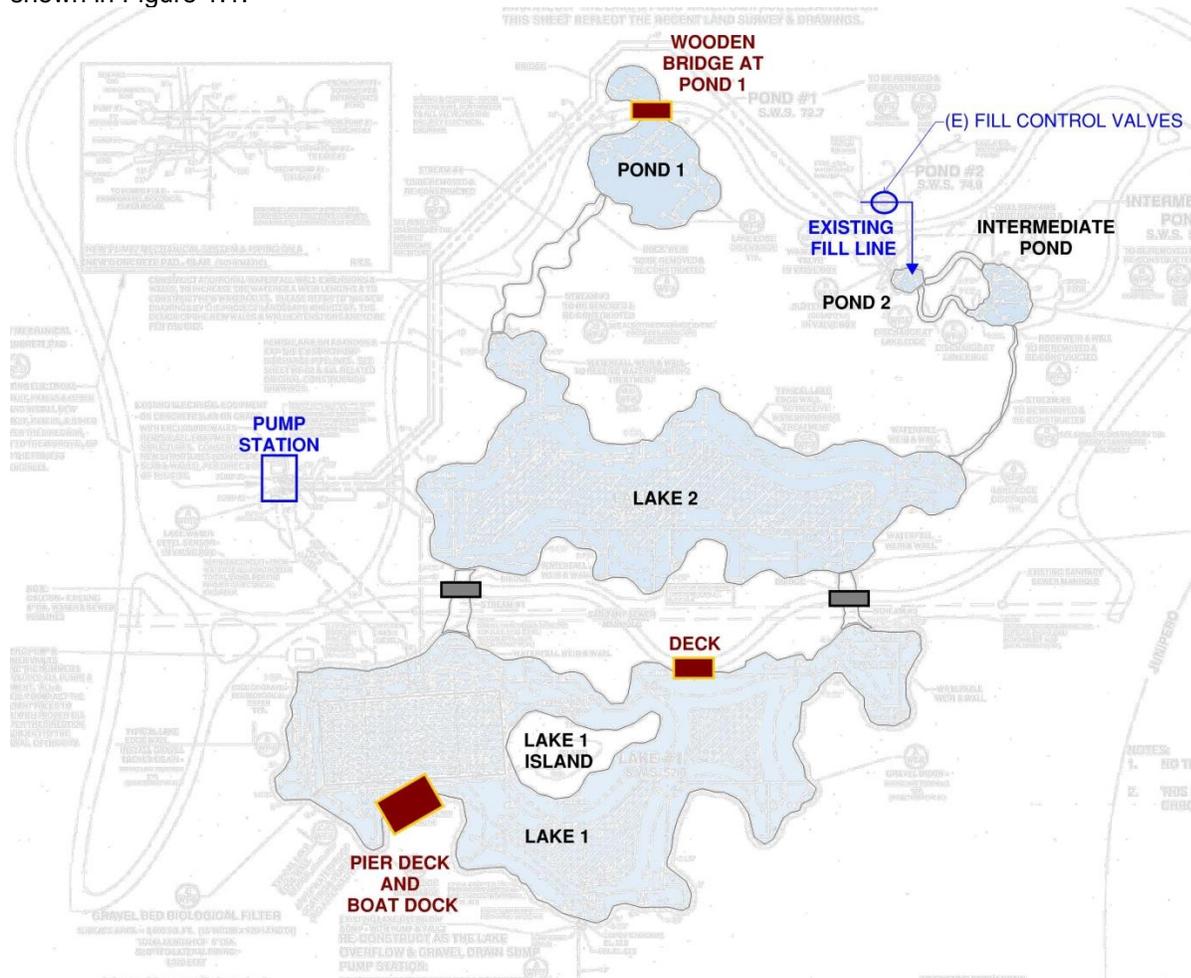
Figure 1-1-1: Park Trail Features

PACE engineers visited the site on 01/26/2022 and reviewed the lake and pump station's current condition. PACE also reviewed the as-built plan for existing conditions. The water surface elevation, perimeter, surface area, average depth, and maximum depth were documented. The data is summarized in Table 1-1 below. This data is based on the as-built plan and may differ from current conditions. The current lake conditions are documented in section 2 of this report. TeWinkle Park Lakes features are shown in Figure 1.1.

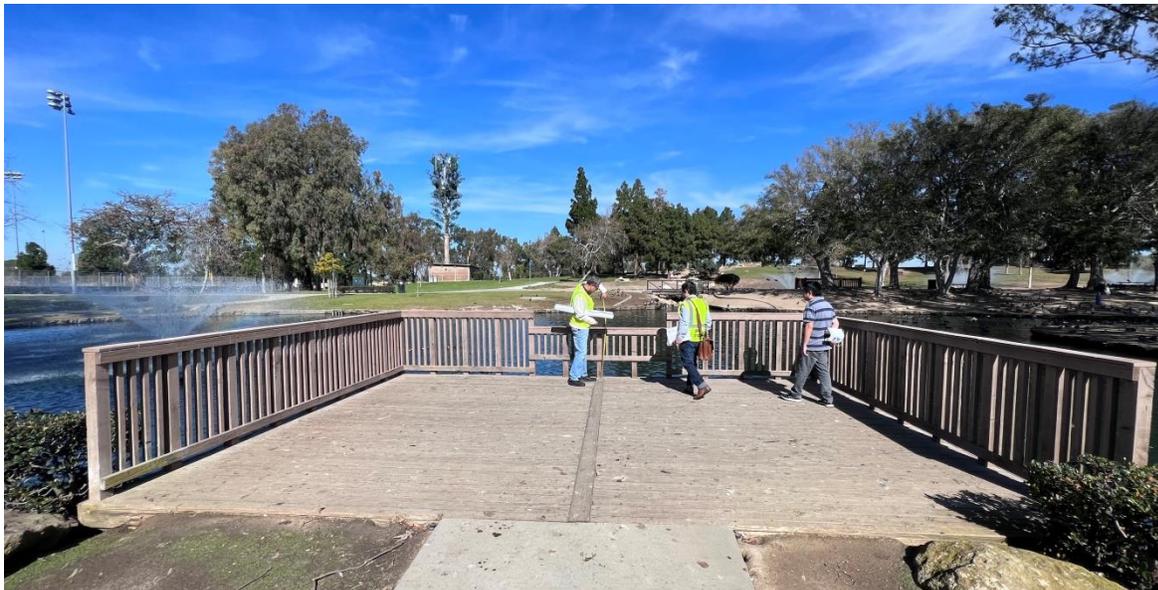
Figure 2-1: Pier Deck at Lake 1 with lower railing section

Pier Deck on the south shoreline of Lake 1 is made of wood and cantilever into the lake with supports. The deck is in good condition. However, there is a lower section of the railing in the middle of the deck. See Figure 2-1.

PACE recommends raising a section of low railing to match the rest of the railing height. The pier deck shall be protected and reused in the renovation. The deck support will need to be examined in more depth to confirm the foundation integrity.

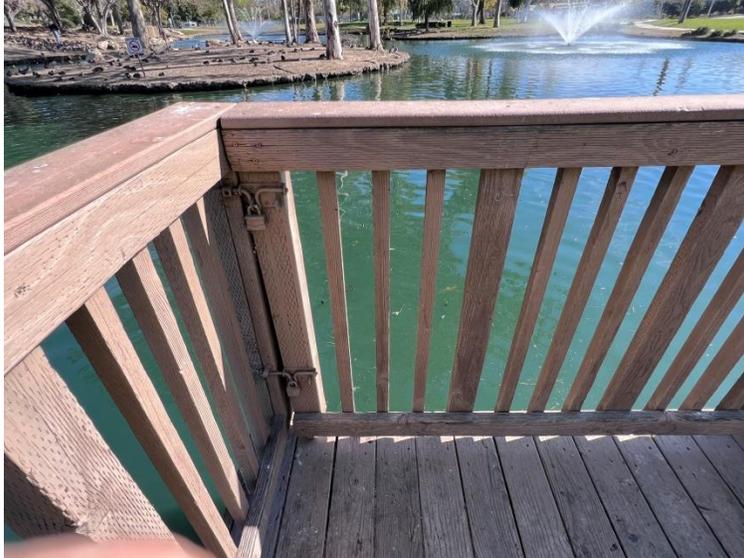
**Figure 2-2: Maintenance Boat Dock at Pier Deck with Lockable Gate**

In addition to the pier deck is a boat dock combination with a lockable gate, which can act as boat access for lake maintenance. This dock is not for recreational purposes. See Figure 2-2.

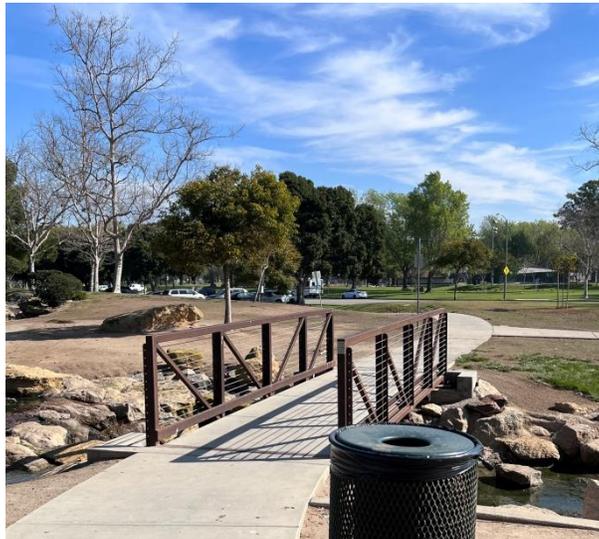
**Figure 2-3: Concrete Bridge**

There are two (2) concrete bridges that connect the lake trail with the island trail. The concrete bridges are in good condition. PACE recommends that these bridges be protected in the renovation.

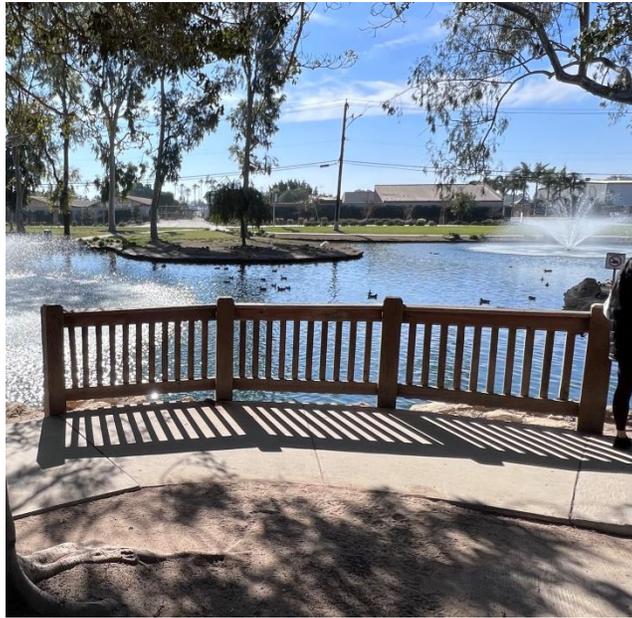
**Figure 2-4: Deck**

An existing deck with wooden guardrails at the North shoreline of Lake 1 is located on the island. This deck is part of Lake 1 shoreline which has damage and cracks inside the lake. PACE recommends keeping and reusing this deck as Lake 1 shoreline will be rebuilt.

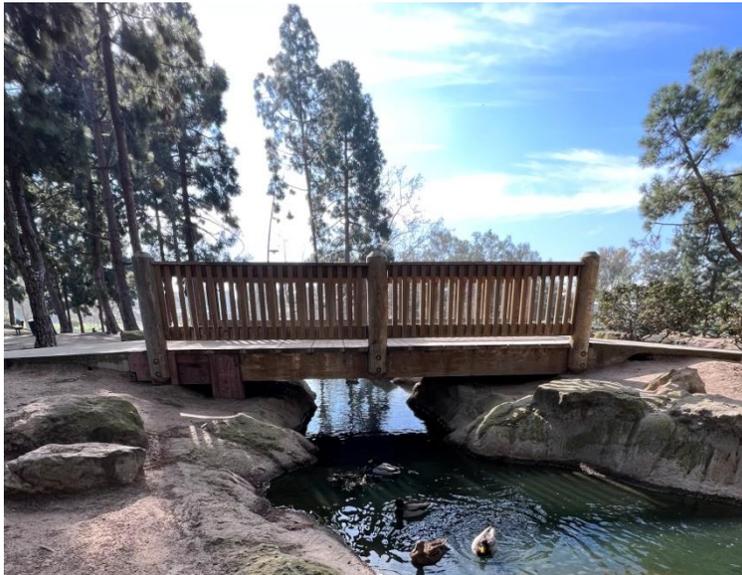
**Figure 2-5: Wooden Bridge at Pond 1**

There is a wooden bridge at Pond 1 that connects the lake trail from the lake to the trail toward Pond 2 and Intermediate Pond. This bridge is in good condition. It can be protected in place and reused in the renovation; however, the City may replace this bridge in the renovation design.

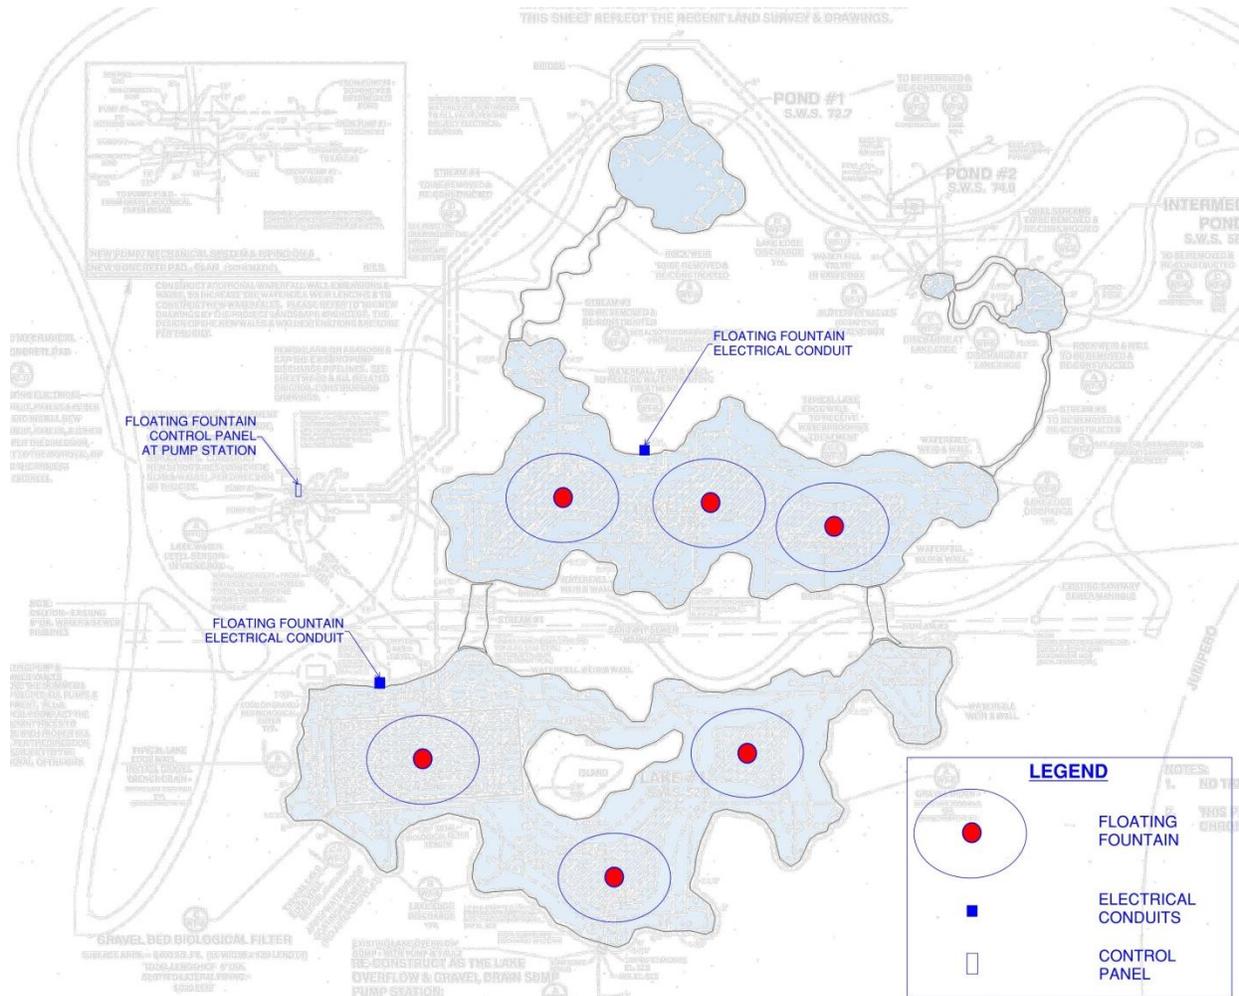
**Figure 2-6: Location of Floating Fountains**

PACE noted a total of six (6) existing floating fountains, three (3) fountains are at Lake 1 and three (3) fountains are at Lake 2. All fountains are functioning as expected. The floating fountains can be removed, protected, and reused during the lake renovation. Locations are shown in Figure 2-6.

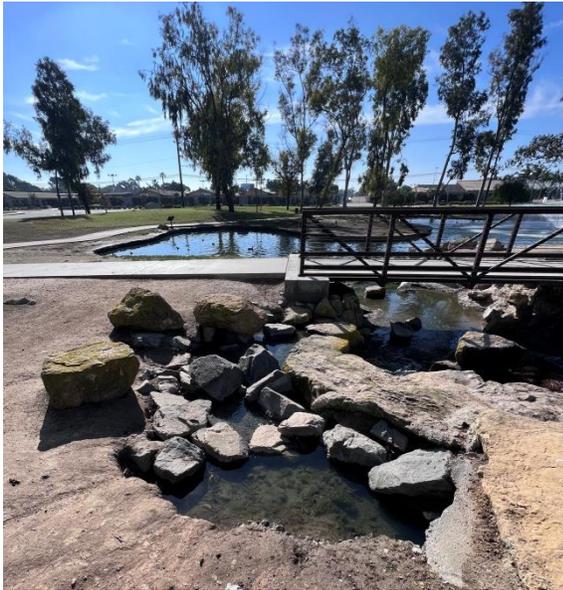
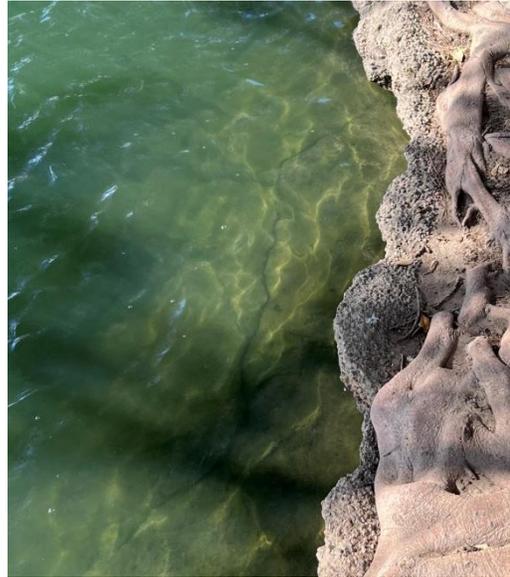
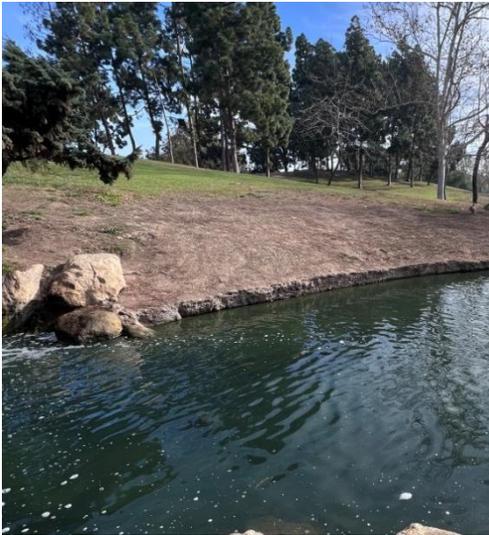
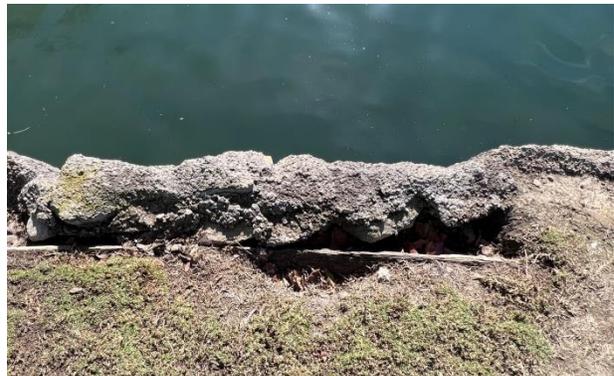
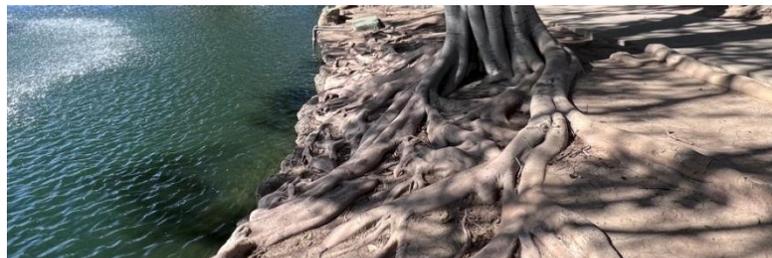
**Figure 2-7: Existing Conditions/Issues at Lake Shoreline**

The shoreline has some major cracks and leaks. At three shoreline areas, the water penetrated through the shoreline. Inside the lake, the concrete veneer was heavily damaged with 3 to 6 inches of concrete cracks. The top of the shoreline appeared to have major erosion due to the stiff slope and no erosion protection landscape. Furthermore, tree roots along the shoreline are also a major problem that can damage the lake. Tree roots can lift up the shoreline or puncture the liner. See Figure 2-7 for the typical shoreline issues and damage.

**a) Major Crack and Leak Shoreline**

**b) Concrete Veneer Crack**

**c) Stiff Slope at Shoreline**

**d) Erosion Behind the Shoreline**

**e) Tree Roots at Shoreline**

Lake liner - The existing lake liner shall be removed and replaced with a new liner to make sure the lake is watertight. See Section 3 – Proposed Liner Solution for more details.

Landscape along the shoreline - Local regrading may need to be done to reduce the slope to a safe slope of 3:1 or 5:1. Alternatively, boulders can be added along the lake shoreline to serve as a barrier. The tree roots shall be cut back behind the shoreline. Any trees that are close to the shoreline shall be removed or relocated to protect the lake shoreline from damage by trees.

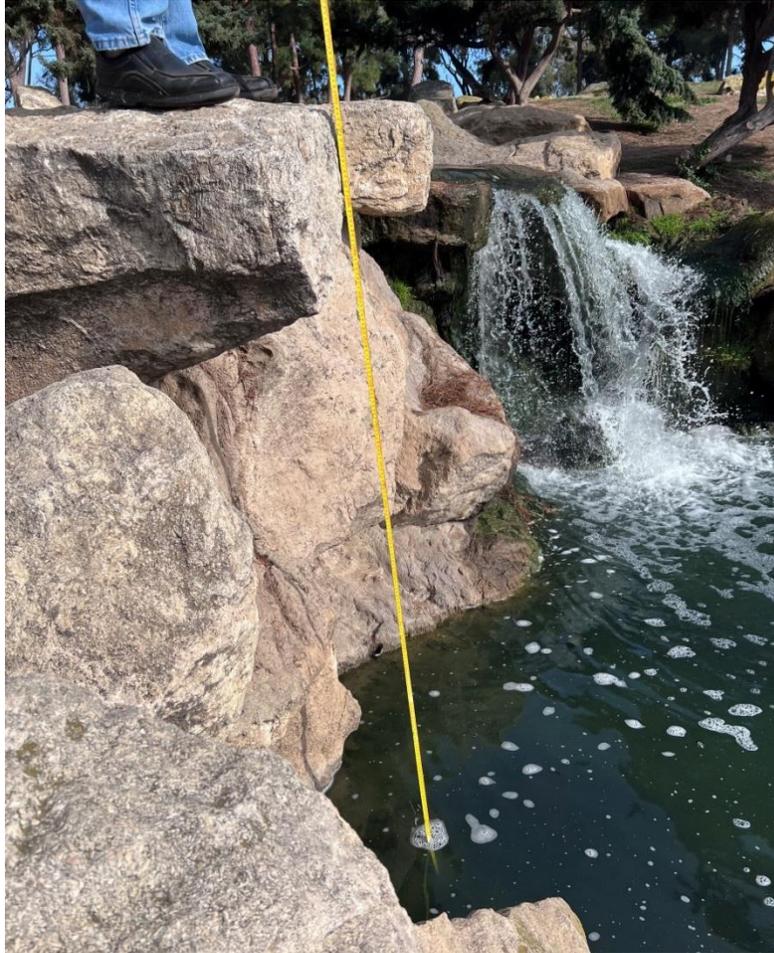
**Figure 2-8: High Elevation at Lake Shoreline**

PACE observed many portions of the lake shoreline that are at a high elevation for public access. In some areas, the shoreline drop is more than 7 feet from the lake bottom. See Figure 2-8 for the high elevation shoreline.

Unsafe conditions along the shoreline - Hedges, boulders or guardrails shall be installed to protect the public from walking into these areas.

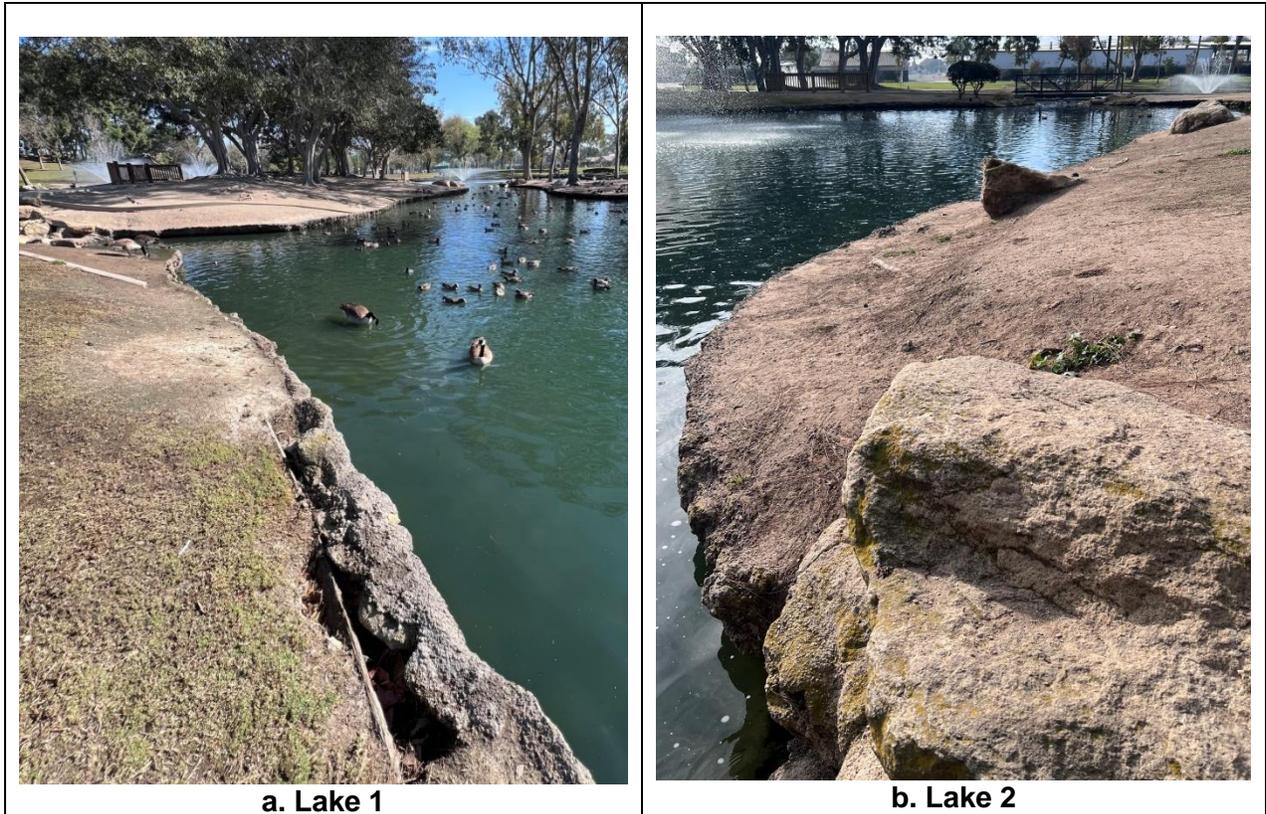
**Figure 2-9: Erosion at Lake Shorelines**

During the site visit, PACE determined that there are no storm drain pipes connecting to the lakes or any of the ponds. However, the surface stormwater is an issue for this site. PACE observed heavy erosion happening along the lake shoreline, especially the area with a steep slope.

PACE recommends that the slope be regraded into a shallow slope of 3:1 to 5:1 and landscape installed to limit the erosion.

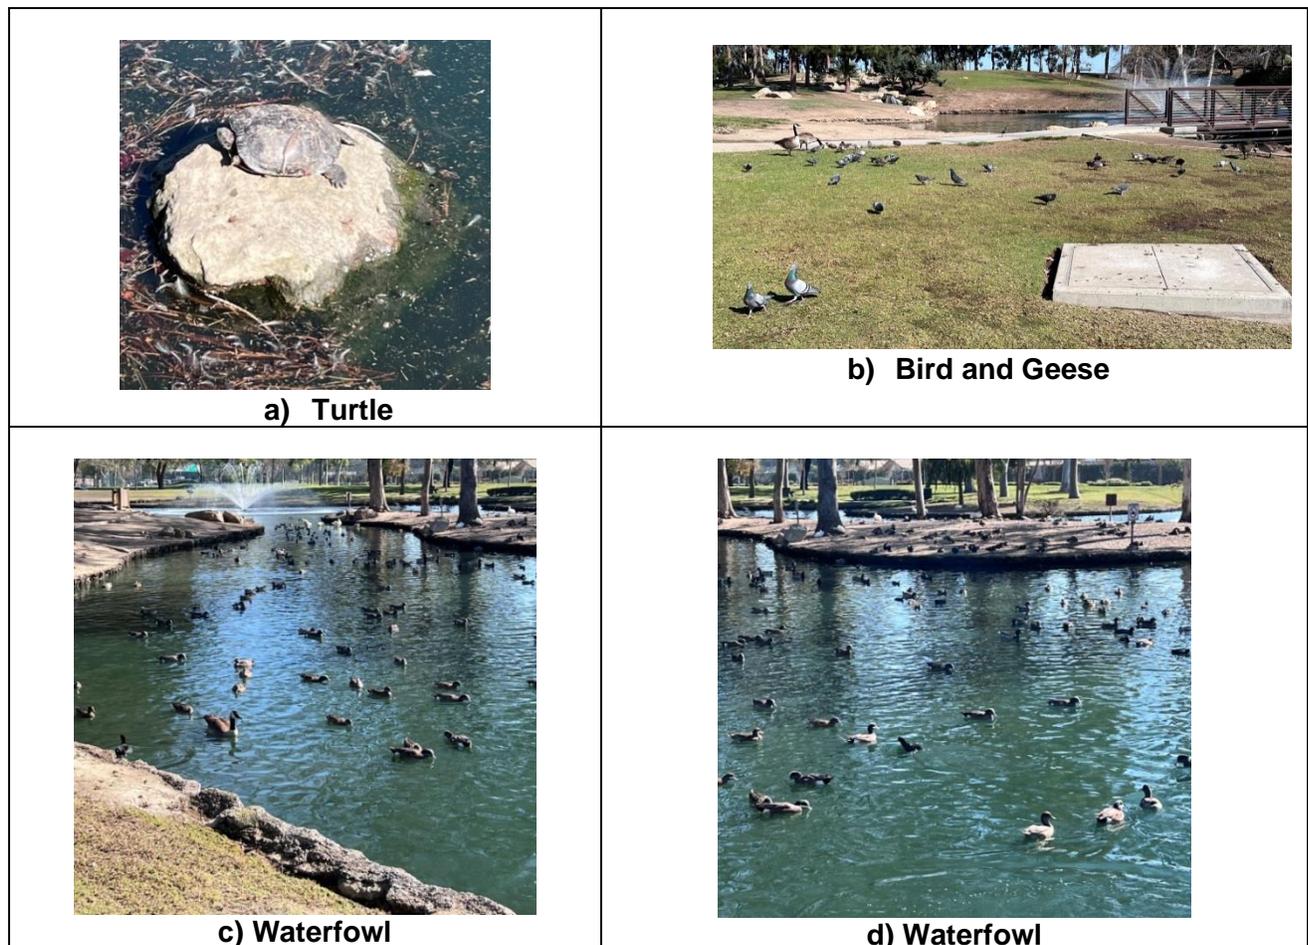
Figure 2-11: Photos of Turtle and Waterfowl

During the TeWinkle Lakes site visit, PACE observed a high count of waterfowl. It was estimated to have about 500 waterfowl (geese and duck). The waterfowl with their waste is a major issue for lake water quality. In addition to waterfowl, there is a low number of fish and turtles inside the lakes. See Figure 2-12.

If the lake were to be drained, then the fish, waterfowl, and turtles will need to be removed. Healthy waterfowl will move on their own, while others will require assistance. There are turtles associations and groups that will help relocate turtles. To remove the fish, the lake should be drained until it is 1 to 2 feet in depth. The fish will then be gathered and transported to other bodies of water, such as ponds for sorting and protection.

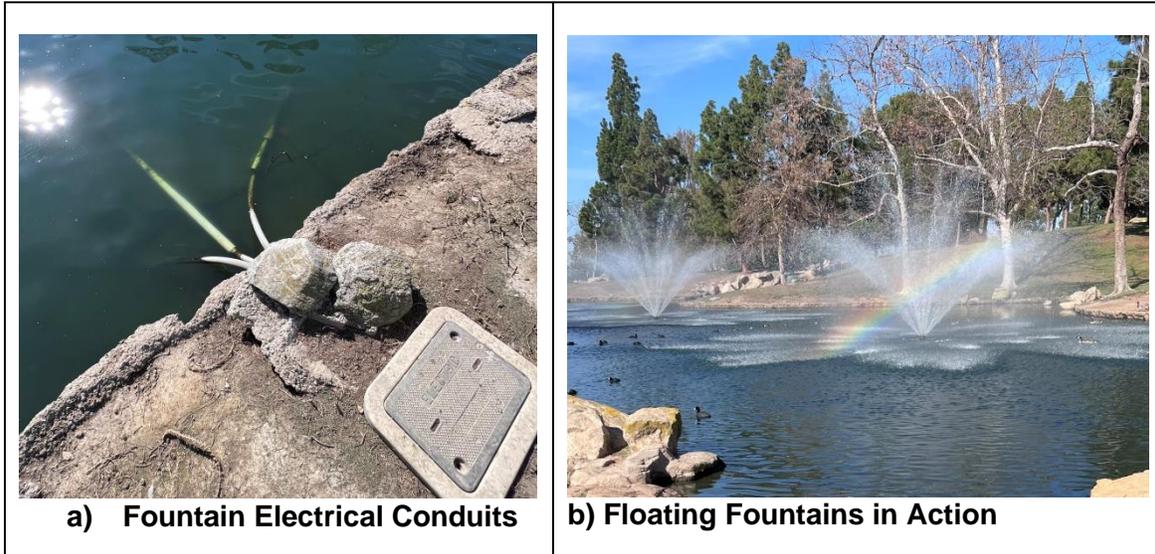
Figure 2-13: Photos of Floating Fountains at Lakes

The floating fountain system at TeWinkle Park Lake is controlled by the panel inside the pump station to the three (3) floating fountains at Lake 1 and the three (3) at Lake 2. The mechanical and control of the floating fountains are functional and in good condition.

PACE recommends removing, protecting, and reusing the floating fountain systems for the renovation.

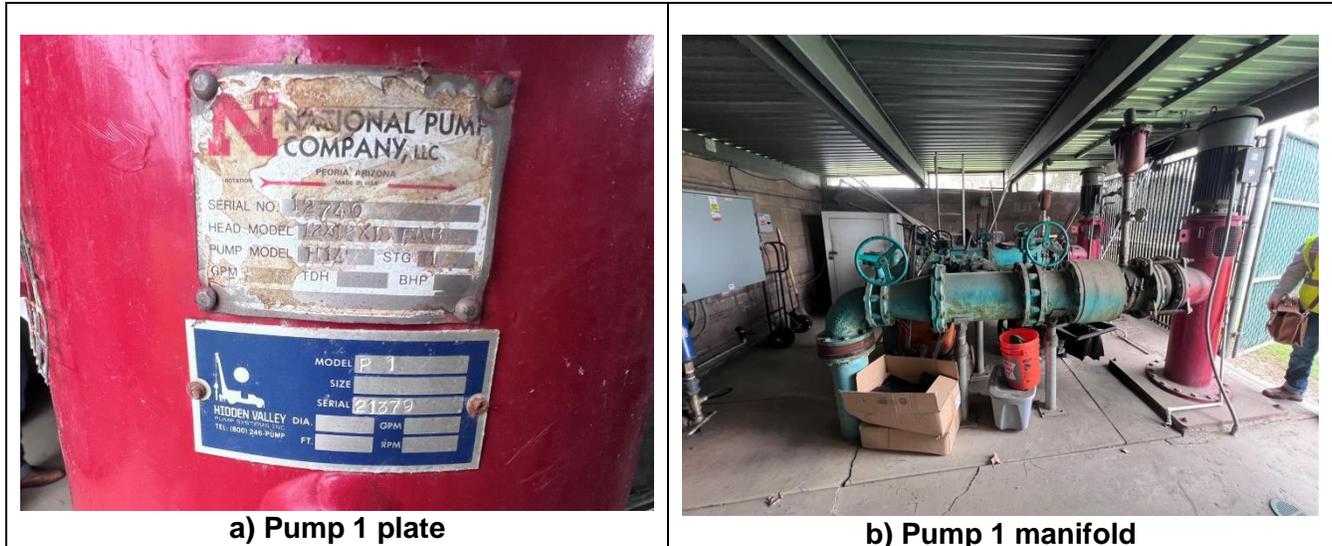
**Figure 2-15: Pond and Stream Pump System**

During the site visit, it was observed that Pump 1 is used for pond water transfer. Pump 1 (Figure 2-15) has a flow of 1,600 GPM at 33 FT, 20 HP, 460V, 3PH, and 1170 RPM. The pump was operating, but the PACE engineer could not verify the performance of the pump due to the broken pressure gauge and lack of a flow meter.

The existing water transfer pipe system appeared to be in good condition and most of it can be reused. The discharge points at the ponds are exposed along the pond shoreline. The discharge point can be redesigned to make the discharge pipe below water to protect the pipe from public access. The existing pipelines are shown on sheet WF-03 of the as-built plan (Appendix A).

PACE recommends pressure testing the existing pipe for any pipe leakage before deciding to reuse the pipe section. The pump shall be tested for performance, and rebuilt (as needed) before being reused in the renovation.

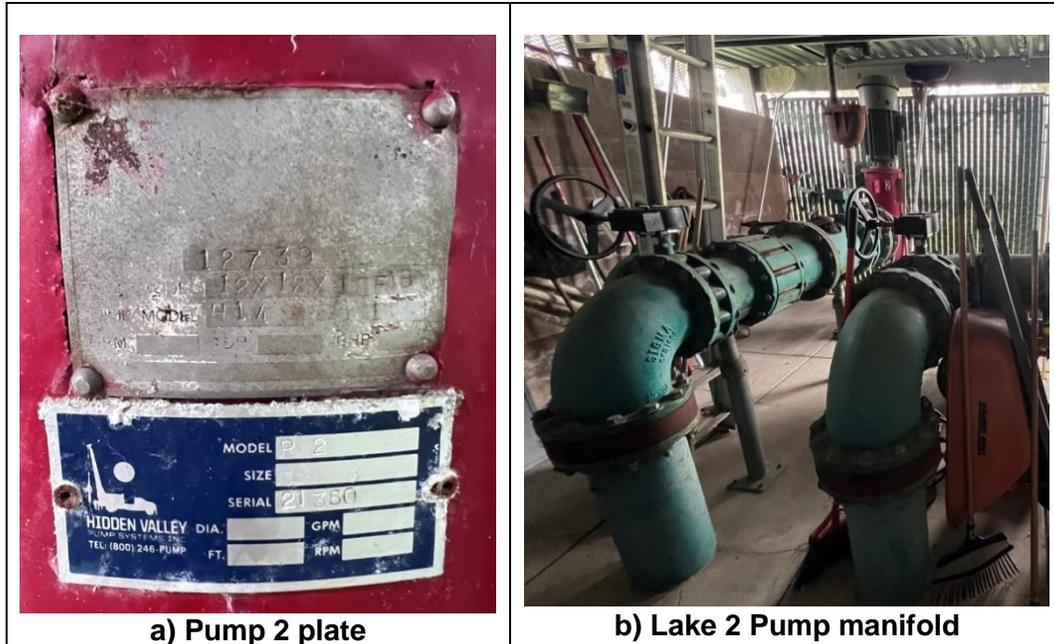
**Figure 2-16: Lake Recirculation Pump System**

During the site visit, it was observed that Pump 2 was used for lakes recirculation. Pump 2 (Figure 2-16) has a flow rate of 2,000 GPM at 17.5 FT, 15HP, 460V, 3HP, and 1170 RPM. The pump is not operating.

The existing recirculation pipes inside the lakes are in bad condition with a floating pipe section at Lake 2 and many exposed piping inside the lakes. The existing pipelines are shown on sheet WF-03 of the as-built plan (Appendix A).

PACE recommends pressure testing the existing pipe for any pipe leakage before deciding to reuse the pipe section. The pump shall be removed, tested, and reused if the pump condition is good. If the pump is in bad condition, a new pump will replace this pump. In the design phase, the recirculation system will be designed and a pump will be sized according to the new system.

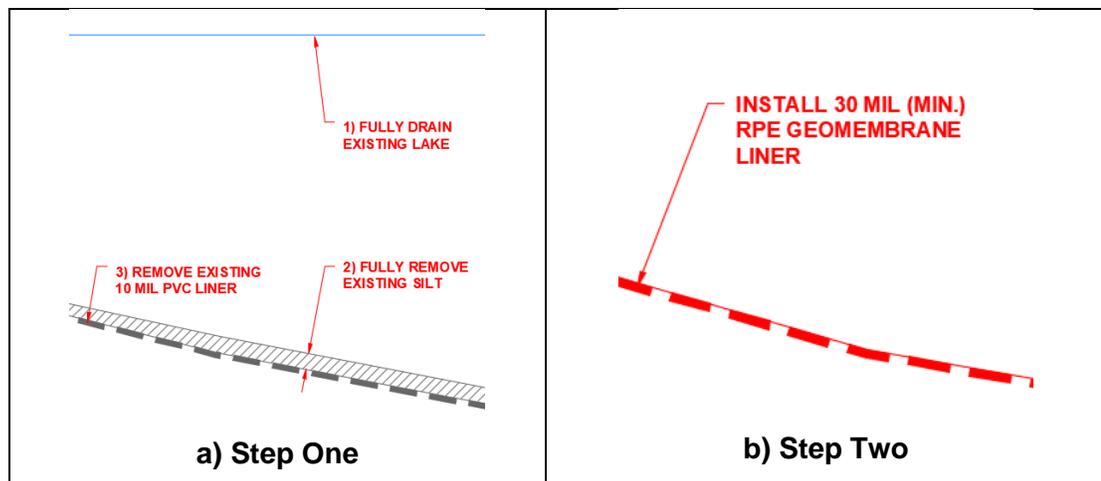
Figure 3-1: 30 mil (min.) RPE Liner

The second liner alternative is to replace the existing liner with an RPE liner that has a minimum thickness of 30 mil. The RPE liners can typically last for 30-50 years and can reduce the lake water loss through seepage by almost 100%.

- The lake needs to be fully drained
- The current liner, fountains, wildlife, and silt debris need to be removed
- The new 30 mil (min.) RPE liner would be installed and the RPE liner will be mechanically sealed to the new shoreline with a pin and strap (*Section 4 – Proposed Shoreline Solution*)

PACE recommends replacing the existing liner with 30 mil (min.) Reinforced Polyethylene (RPE) geomembrane liner as discussed below:

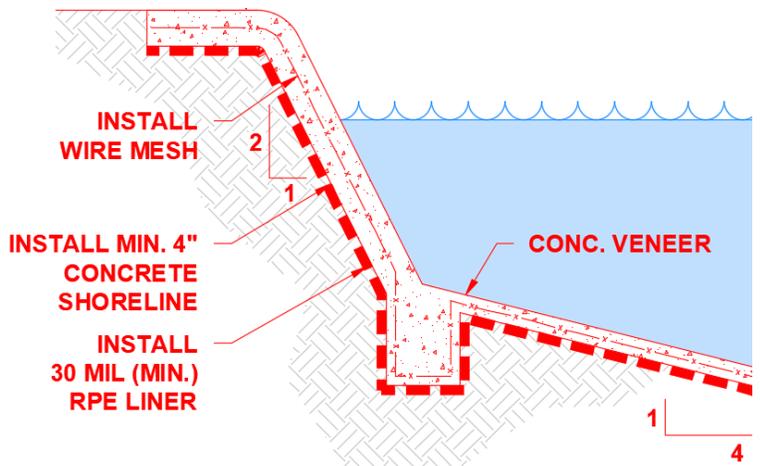
Figure 4-1: Rebuild Shoreline (Regrade) w/ 30 mil. (min) RPE Liner

- Excavate fill material from the deeper portion of the lake and regrade the lake near the shoreline so the shoreline water depth is 18 inches and the slope near the shoreline is 1V:4H
- Install 30 mil (min.) RPE liner along all of the lake and shoreline
- Concrete would need to be transported onsite to install a new 4-inch-thick (min.) shoreline with a wire

- mesh, 2V:1H slope until 18-inch water depth, and 8-inch by 8-inch keyway at the bottom of the new shoreline.
- Install 2-inch (min.) thick concrete veneer with a wire mesh and 1V:4H slope until 3 feet water depth

PACE recommends demolishing, rebuilding a new shoreline, and re-grading the slope around the lake shoreline. This solution is most suitable with liner options where a new liner system is installed (*Section 3 – Proposed Liner Solution*). A new liner system and a new shoreline could provide up to 100% water-tight installation based on the liner decision.

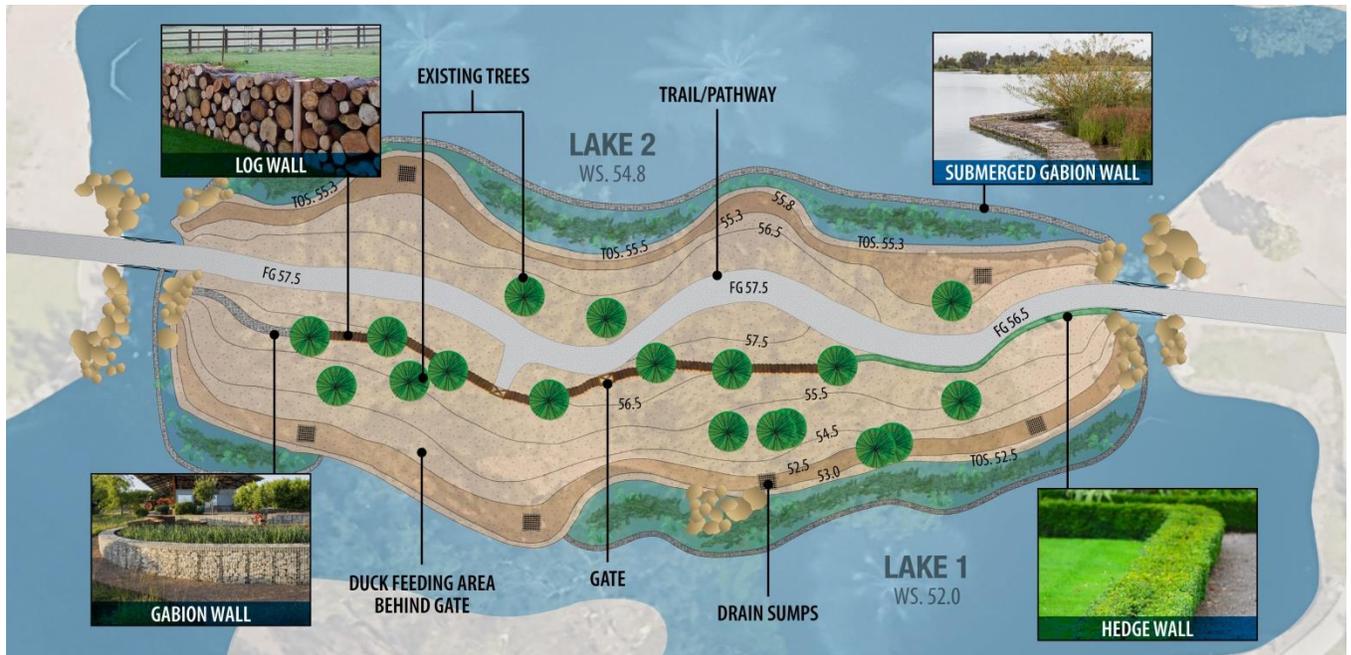
**Figure 4-3: Proposed Island Features**

The drain sumps are designed to connect to each other and slope toward the lowest sump for water drainage. In the lowest sump, a sump pump will pump waste water into the existing sewer system.

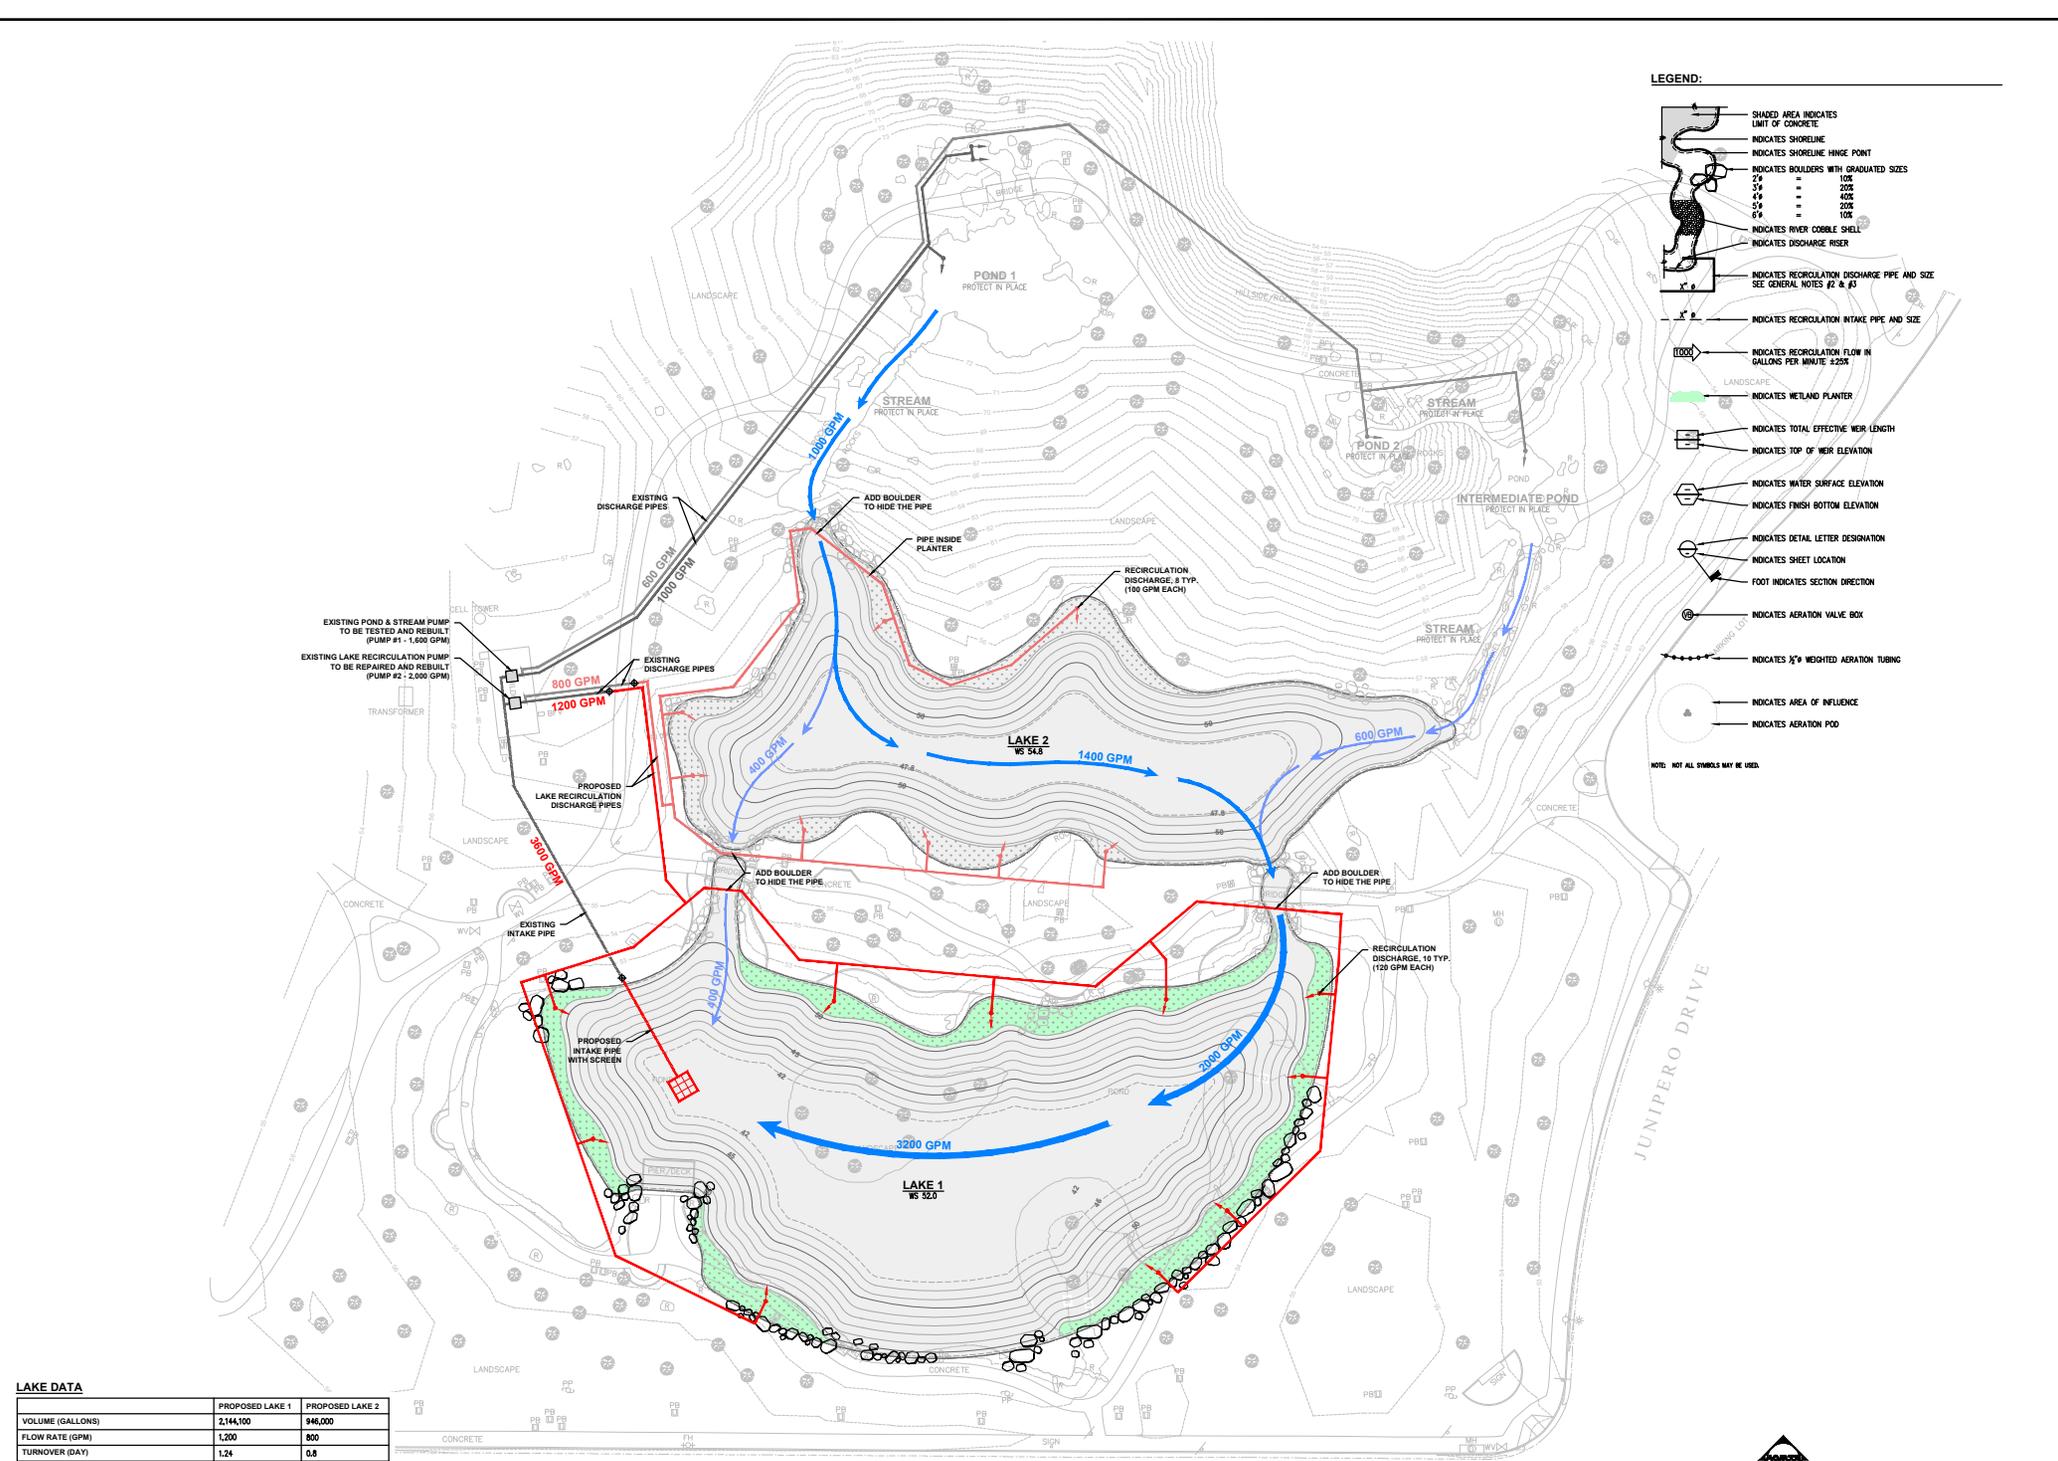
**LAKE DATA**

PROPOSED LAKE 1	PROPOSED LAKE 2
VOLUME (GALLONS)	2,144,100	946,000
FLOW RATE (GPM)	1,200	800
TURNOVER (DAY)	1.24	0.8

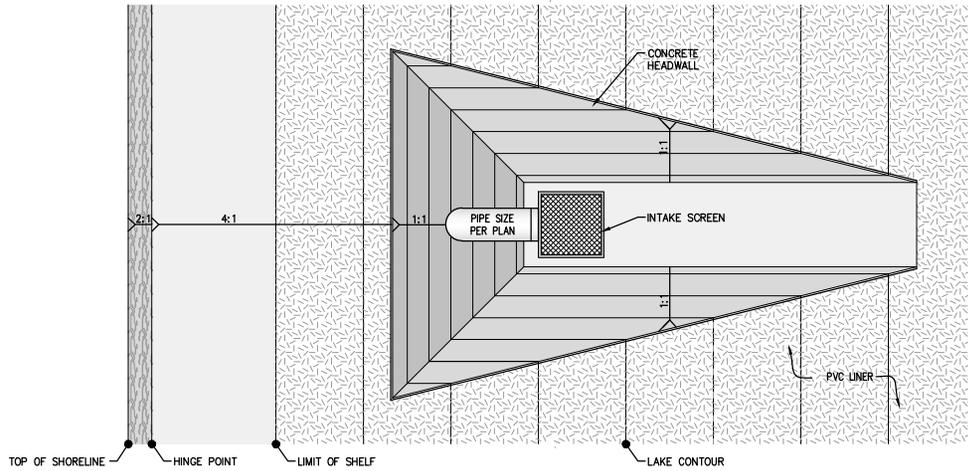
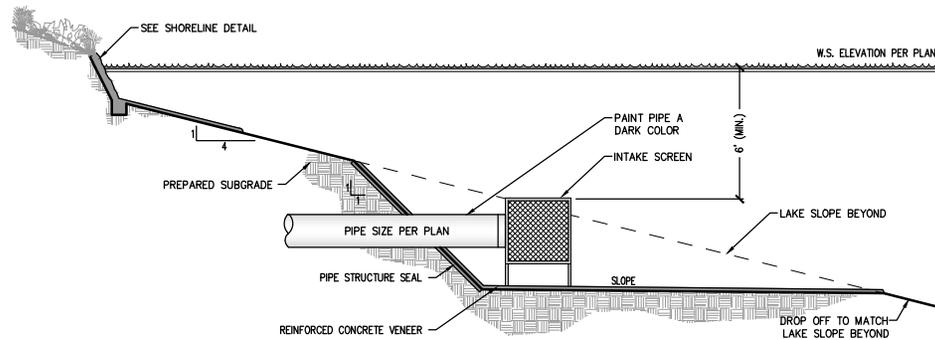
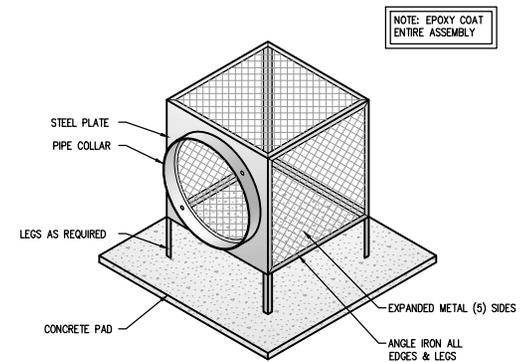
**Exhibit 5.5 - Proposed Screen Intake**

The intake pipe is also part of the recirculation system. The current bio-filter intake pipe at Lake 1 will not work due to clogging and debris buildup. PACE proposes to remove the bio-filter and use a screened intake with a fine screen (1/2" to 3/4" opening). This screen intake can be brushed and cleaned by maintenance staff. See Exhibit 5-5 for the proposed screen intake detail.

PACE recommends removing the bio-filter and using a screened intake pump station intake pipe. See Appendix B for the screen intake detail.

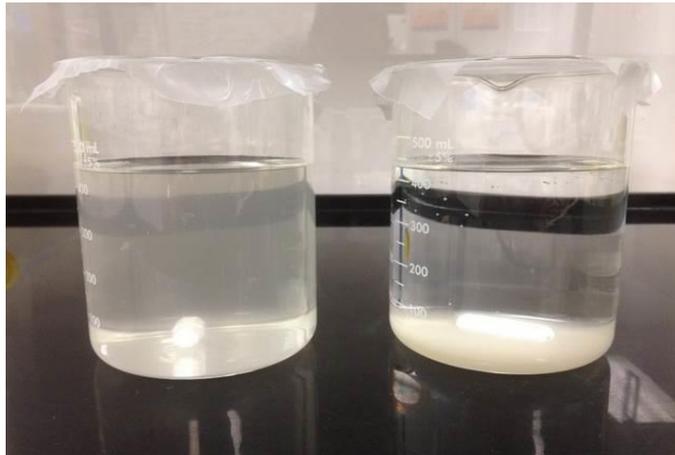
**Exhibit 5-6: Alum Treatment of Turbid Water (Left: Untreated, Right: Treated)**

Aluminum hydroxide has a high capacity for the absorption of phosphorus. The aluminum floc precipitates (Exhibit 5-6) and forms a layer of a reactive barrier that adsorbs soluble phosphorus and prevents re-suspension of particulate phosphorus. Aluminum ions may also react with phosphate ( $\text{PO}_4^{3-}$ ) directly and form water insoluble aluminum phosphate ( $\text{AlPO}_4$ ) that may also precipitate. The reactions between aluminum ion and phosphorous/phosphate in water are very complex and it is known that many competitive reactions occur simultaneously.

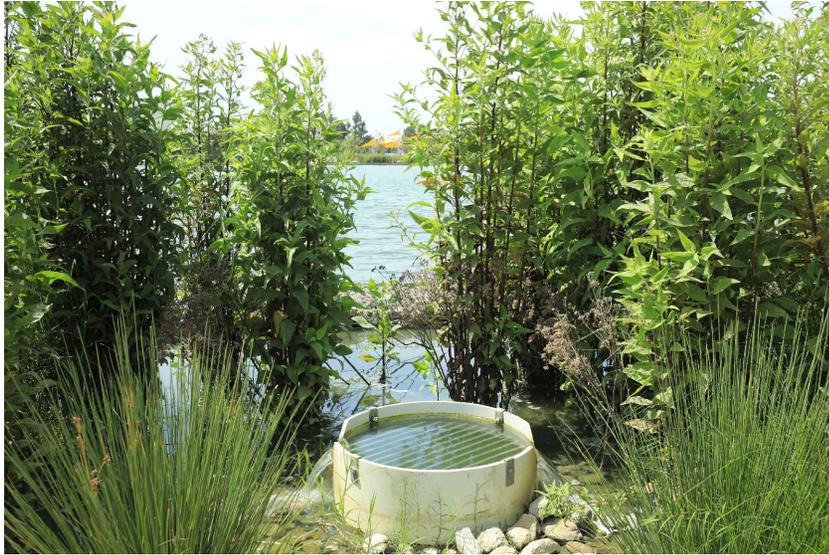
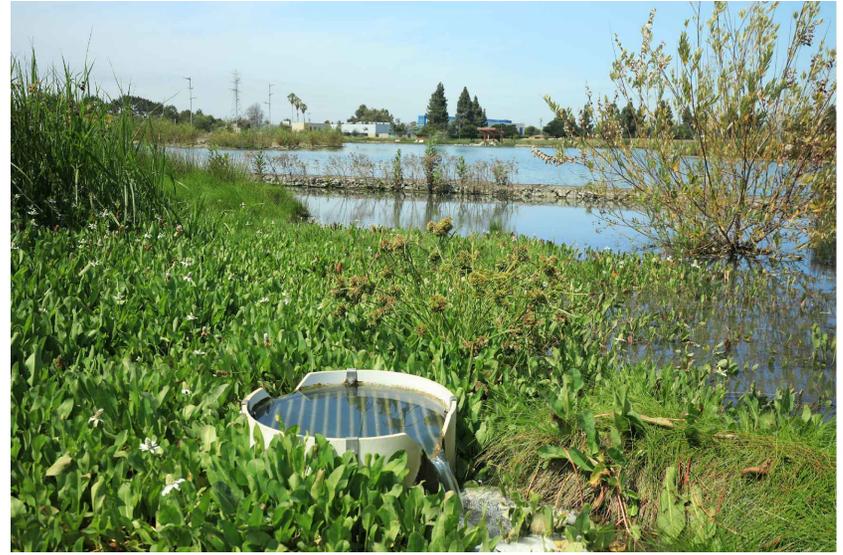
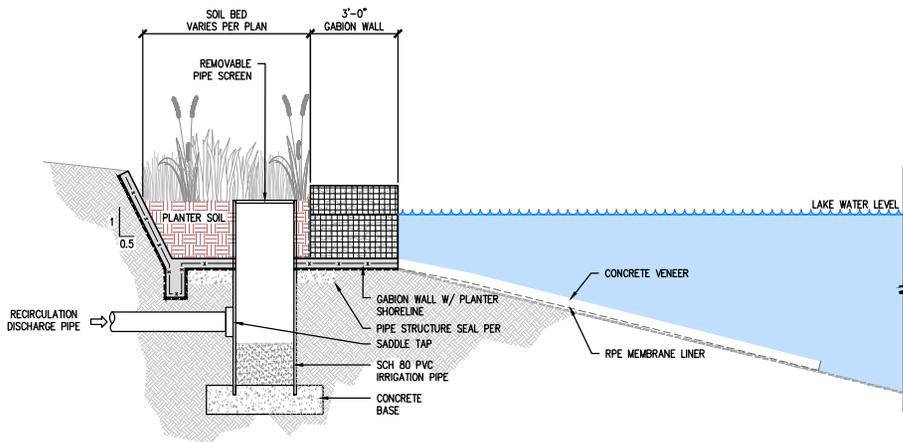
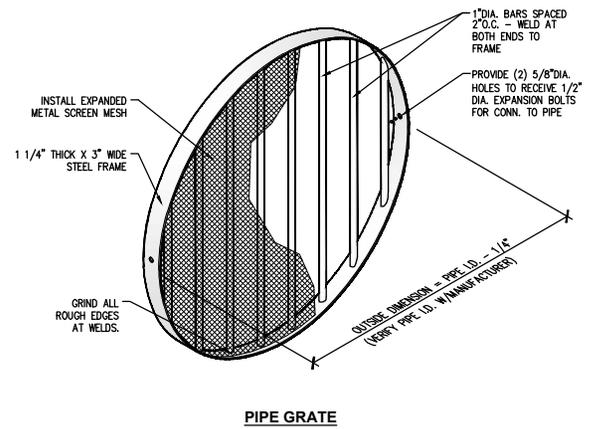
**Exhibit 5.7 - Proposed Alum Discharge Standpipe inside Lake Planter**

NOTE:  
THIS ENTIRE ASSEMBLY SHALL BE HOT-DIP GALVANIZED AFTER ASSEMBLY.

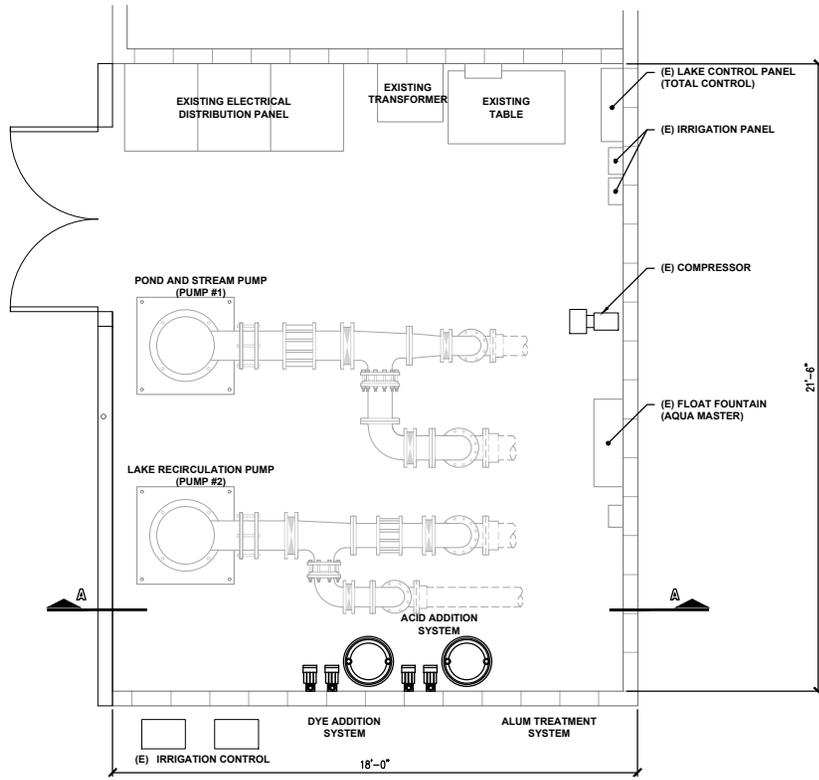
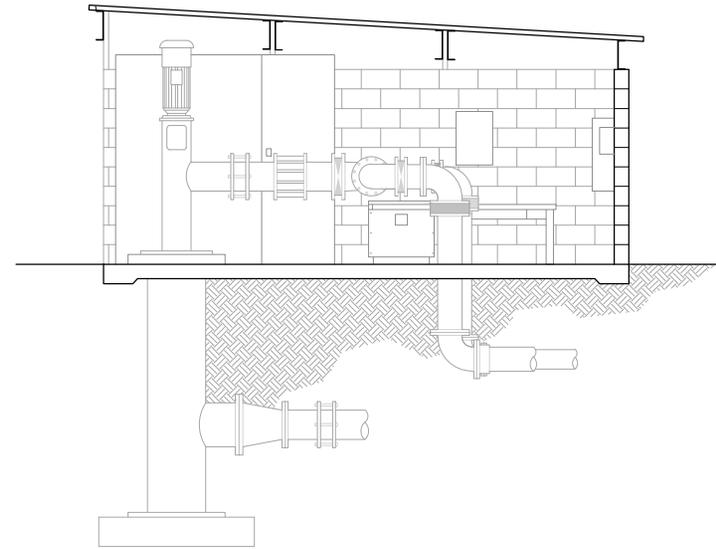
**Exhibit 5.8 - Pump Station with Alum and Acid Treatment System**

For TeWinkle Park Lakes, the existing pump station has available space for the Alum treatment with acid addition system. PACE proposes to have a large tank (150 GAL to 200 GAL) of alum with mixer to supply enough alum for lake treatment, and a small tank (15 GAL) for acid. See Exhibit 5-8 for the proposed location of the alum treatment system.
