## Assessment Report & Recommendations

# TeWinkle Park Lakes

June 2022 – Revised

**Pacific Advanced Civil Engineering, Inc.**  
17520 Newhope Street, Suite 200  
Fountain Valley, CA 92708  
714-481-7300

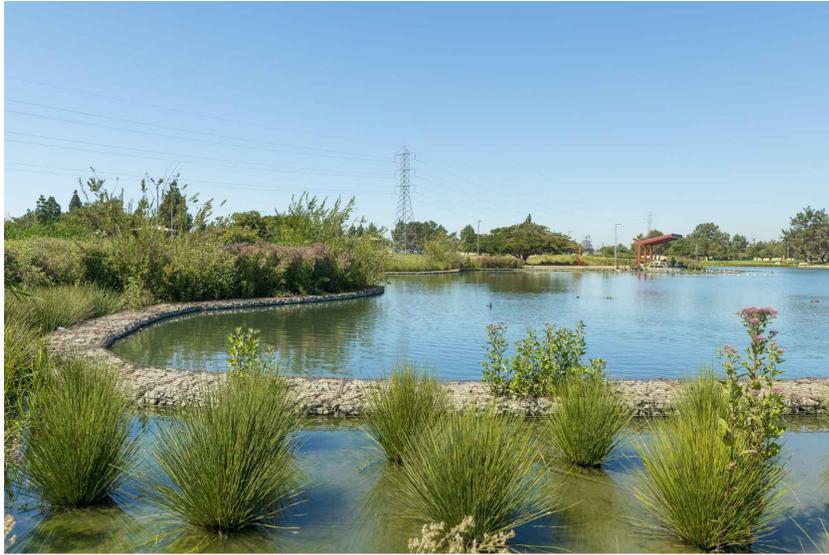
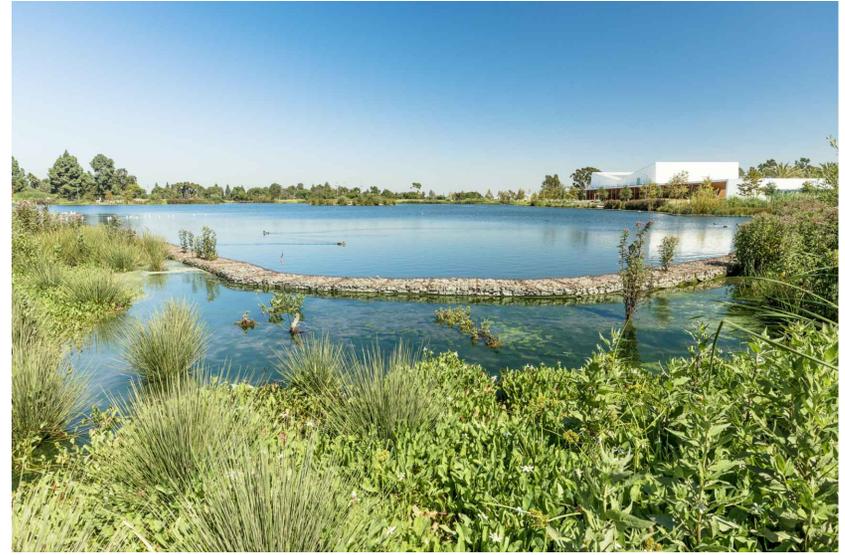
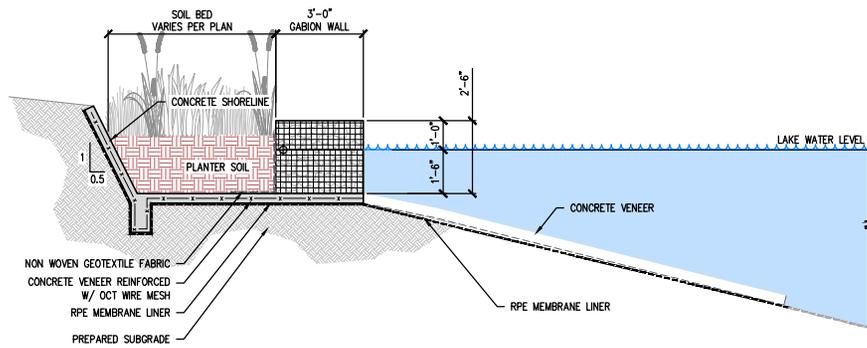
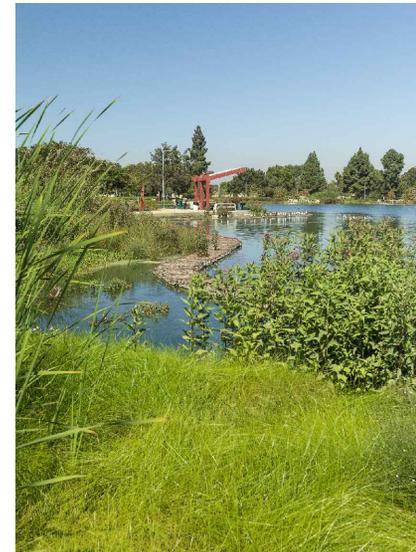
**Exhibit 5.9 - Proposed Lake Planter/ Wetland Shoreline**

For TeWinkle Park Lakes, the original design had no aquatic planter. PACE recommends adding an aquatic planter/wetland along the lake's shoreline with a gabion wall for this project. This shoreline design will keep the waterfowl inside the lakes and away from the walkway to improve the lake trail experience. See Exhibit 5-9 for the shoreline detail.

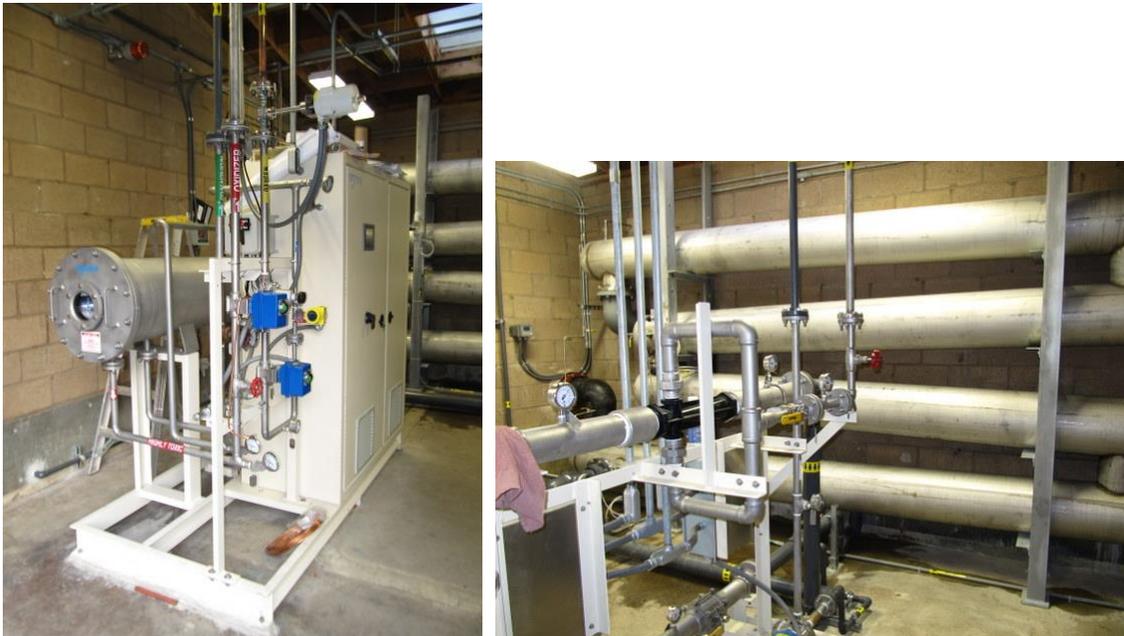
**Photographs 1 and 2: Ozone Generator and Ozone Injection/Contacting System**

This option is significantly more expensive than other treatment options, including filtration, and alum treatment because of its higher capital and operation and maintenance costs. Ozone gas needs to be transferred to the aqueous phase (the water to be treated) using a Venturi injector (Photograph 2). In lake and reservoir water treatment and management, ozone should be injected into a side stream (e.g., recirculation flow, not directly to the lake) and then discharged to the lake to prevent ozone off-gassing from the water surface and any toxicity issues in the lake. Although ozone is extremely short-lived in natural water (last less than a few minutes), it is toxic to fish and other aquatic organisms if they are exposed to ozone directly. These requirements increase the complexity of the treatment system.

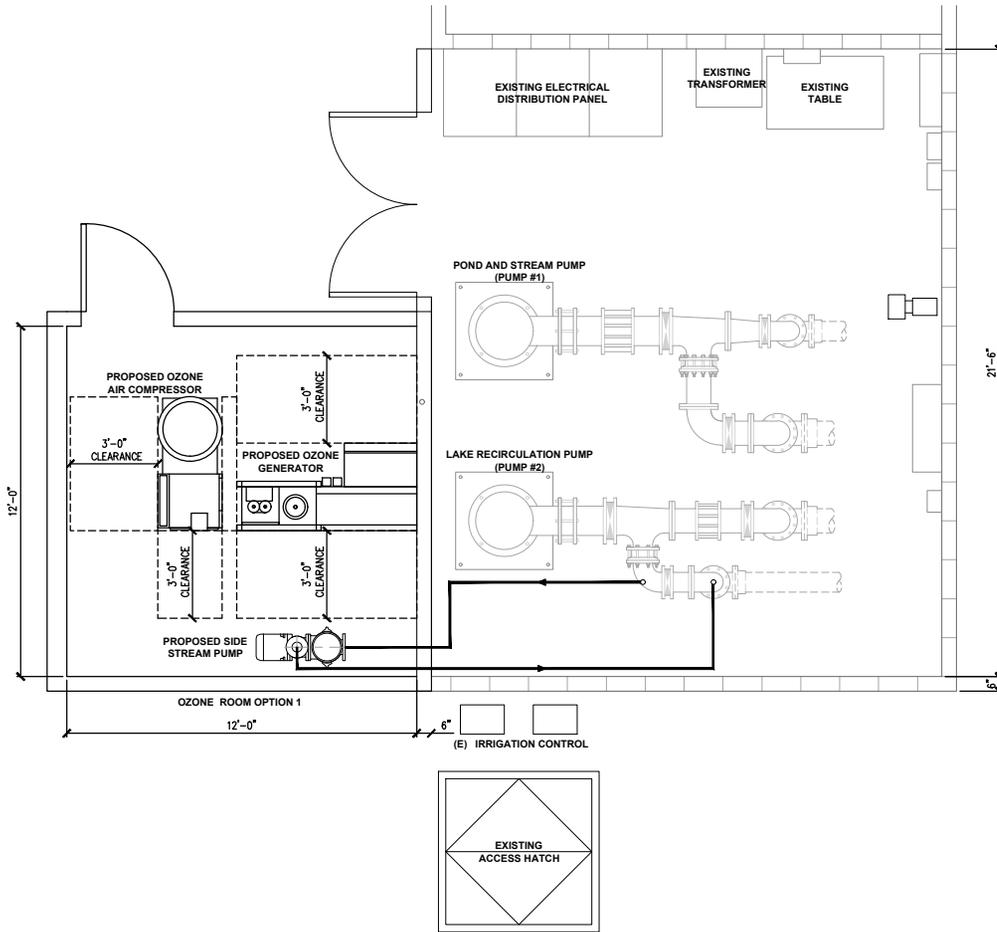
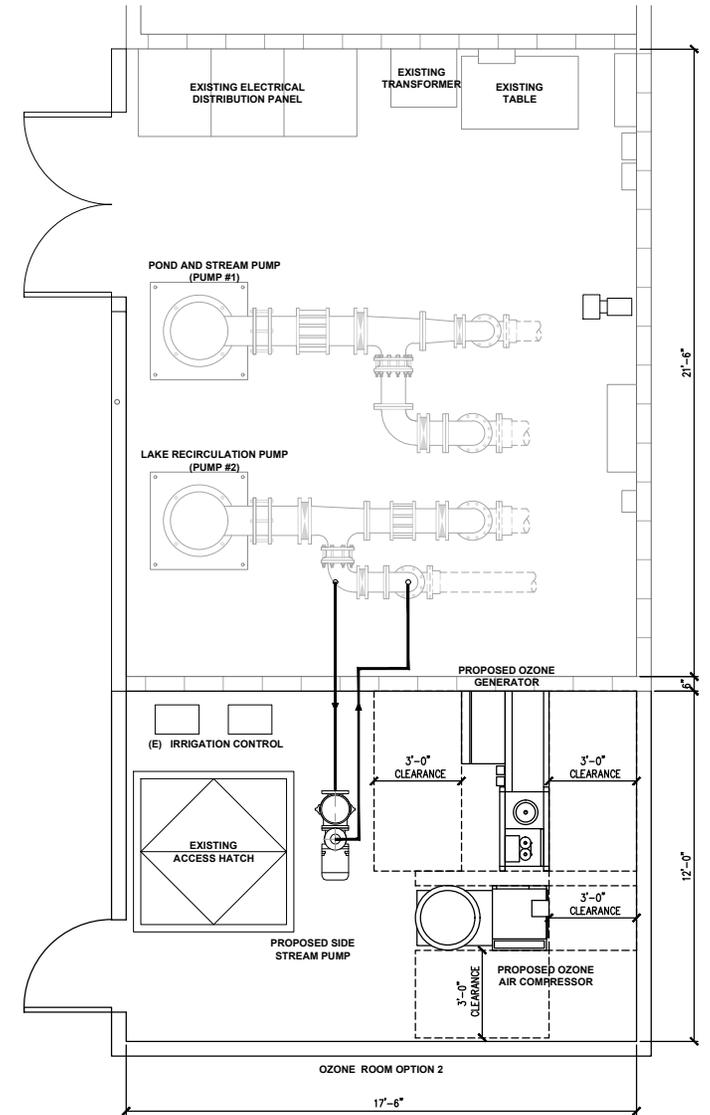
**Exhibit 5.10 - Pump Station with Ozone Room**

For Ozone Room Option 2, the room is added on the Southside of the existing pump station. This room is about 17.5' x 12'. This room will cover the ozone equipment together with irrigation control and an underground vault for water level sensors. See Exhibit 5-10 for both proposed ozone room options at Lake Pump Station.

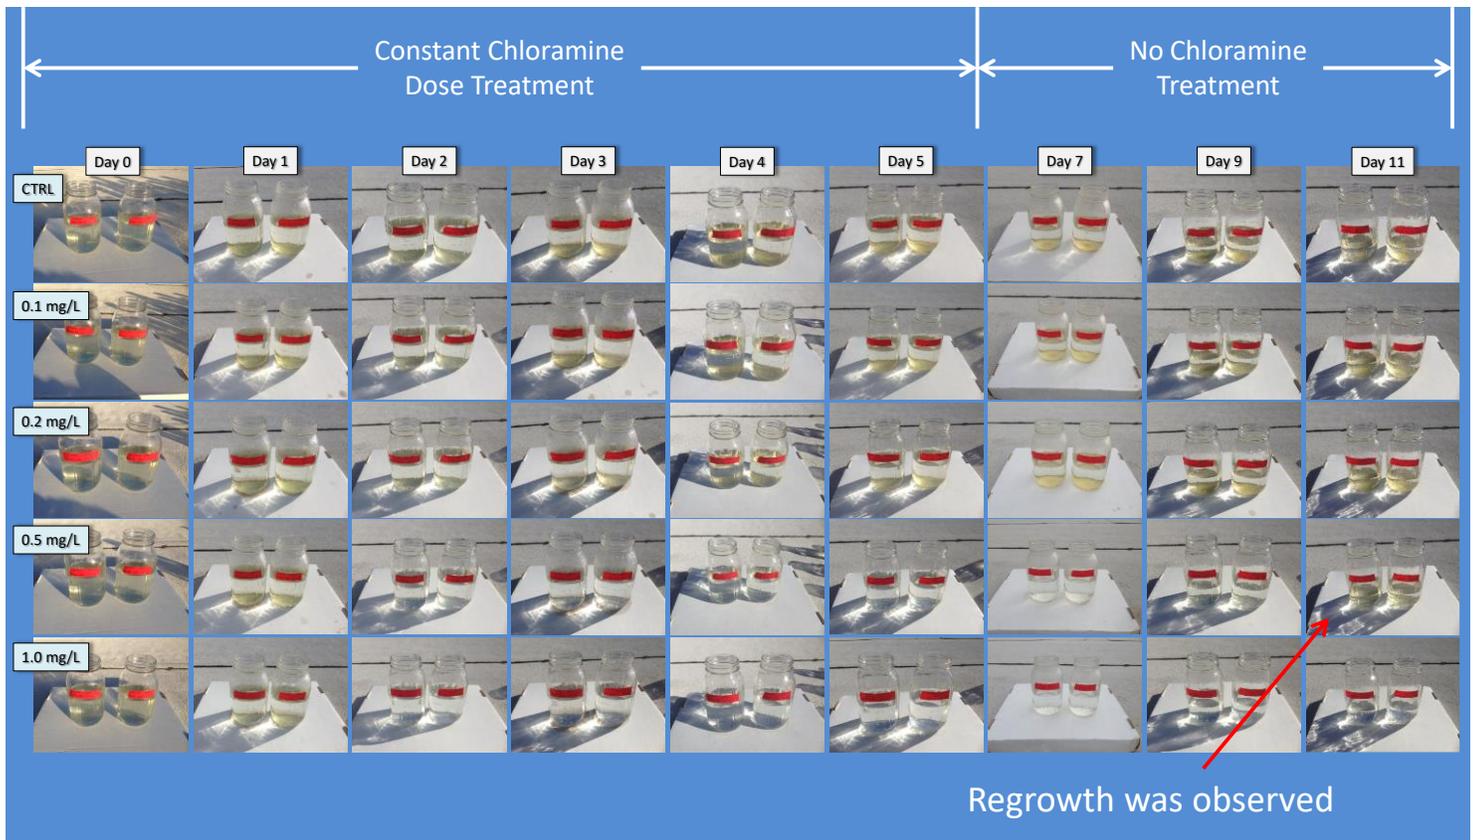
**Photo 3: Impact of the Monochloramine Treatment on the Clarity of a Recycled Water Lake**

If properly used, monochloramine can prevent the growth of harmful and noxious algae (including cyanobacteria) in lake and pond water. PACE’s recent study with water samples from two reclaimed water lakes demonstrated that the daily addition of as low as 0.10 mg/L as Cl<sub>2</sub> of monochloramine could maintain the clarity of the water where the turnover time was 5 to 10 days (Photo 3). Photo 4 shows the algae that could be controlled by 0.10 mg/L of monochloramine.

**Note:** 1/5 of the water was withdrawn from each bottle and replenished with reclaimed water spiked with 0.1 to 1.0 mg/L of monochloramine (which corresponds to final monochloramine doses ranging from 0.02 to 0.2 mg/L) every day. Algae were pre-cultured for three days before the initiation of the chloramine treatment.

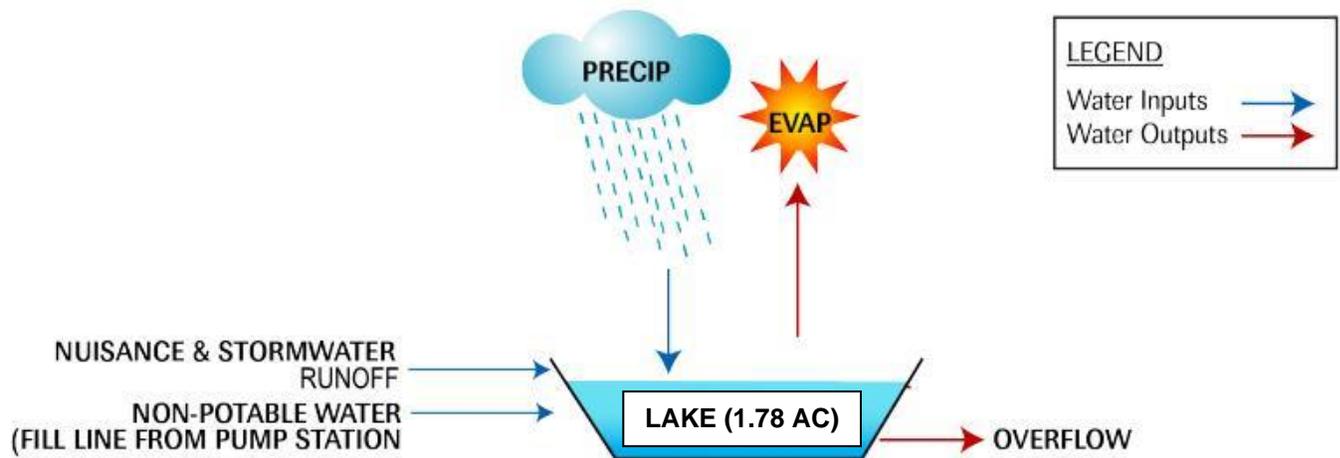
Figure 6-1: TeWinkle Park Lakes Water Balance Schematic

The precipitation and evapotranspiration data is collected from California Irrigation Management Information System (CIMIS) station #75 – Irvine. The “make-up” water to maintain the normal operating lake water level will be through the sources described in “Make-Up Source Water.” A water balance analysis was completed for the lake system that evaluated the water inputs and withdrawals. The inputs include precipitation, stormflow, and estimated nuisance flows (if applicable) while the withdrawals include only evaporation and irrigation since there will be no infiltration loss because of the lake RPE liner. Landscaping irrigation water will be withdrawn from the lake to assist in the overall lake water quality by providing the ability to replace the lake water or turnover. By evaluating the lake inputs and outputs, an evaluation of irrigation demand and lake overflow is presented herein on a monthly basis. Figure 6.1 displays a conceptual water balance schematic for TeWinkle Park Lakes used in the analysis.

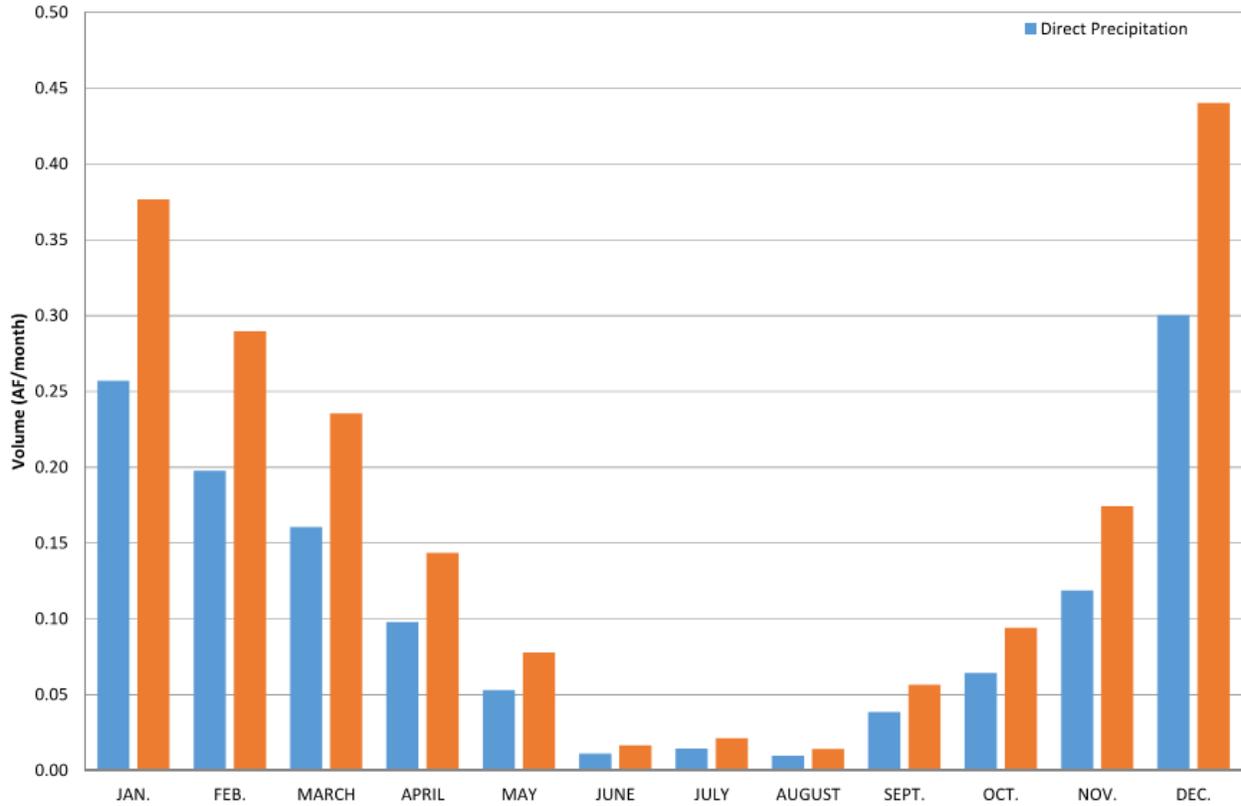
Figure 6-3: Lakes Monthly Input

### Lake Input (AF/mo) versus Time (mo)

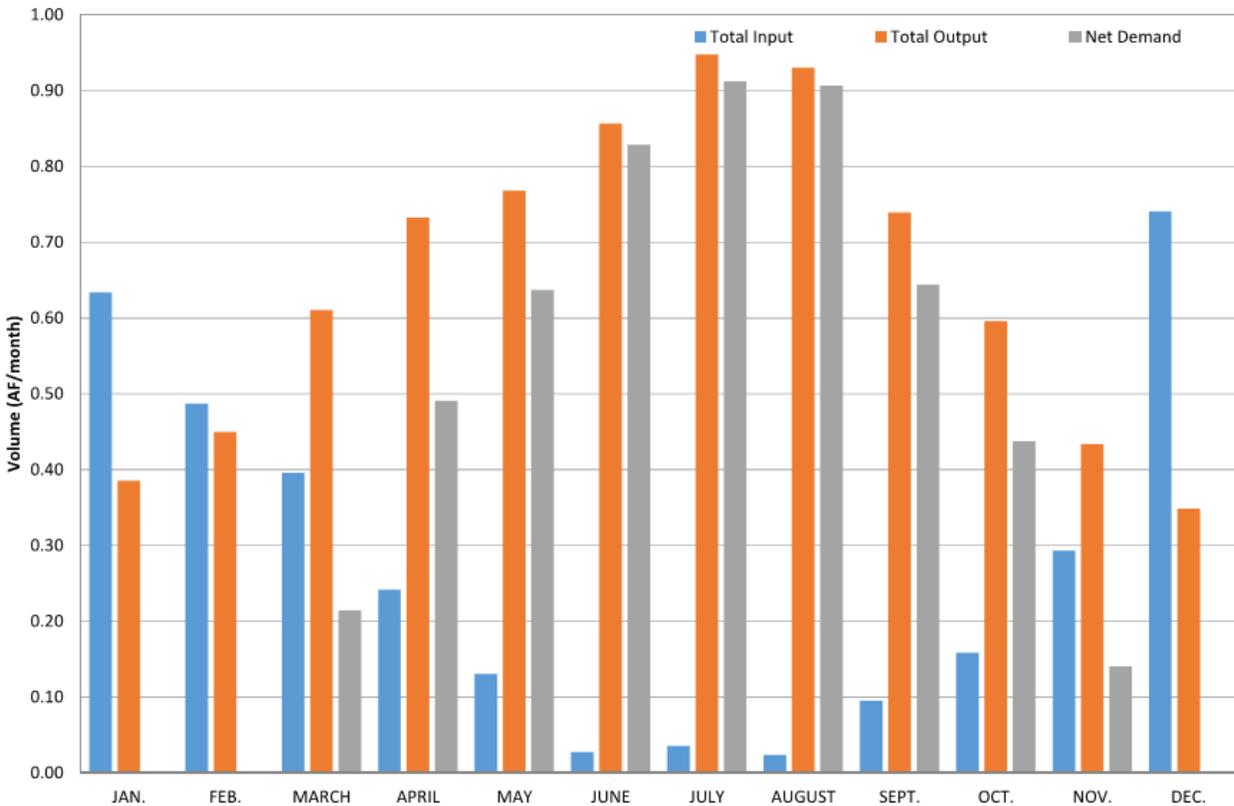
Figure 6-4: Lakes Water Monthly Demand

## Net Demand (AF/mo) versus Time (mo)
