October 31, 2022

Tim Cottage | Project Manager  
Hilco Development Services  
1707 E 28<sup>th</sup> Street, Suite B  
Signal Hill, CA 90755

Re: 200 Baker – Due Diligence Survey  
200 E Baker St, Costa Mesa, CA 92626  
Review of Existing Structure and Site  
RSG Job #22-1-070.00

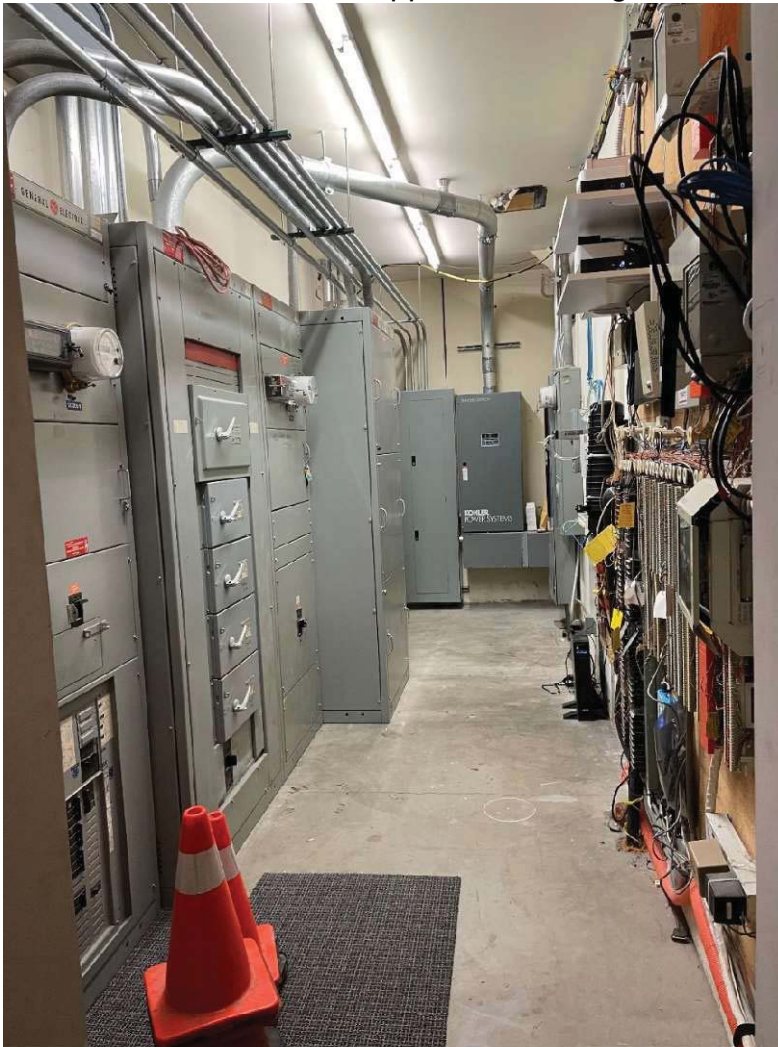
1. The building has (2) electrical rooms. We were able to access the 1st floor one but unable to access the 2<sup>nd</sup> floor due to the passcode lock. In the electrical room on 1<sup>st</sup> floor, all electrical equipment has minimum 3ft clearance in the front and appears to be in good condition.

There are (3) existing metering switchboards (floor mounted on the concrete) and one (1) house metering panel. See the four meters below.

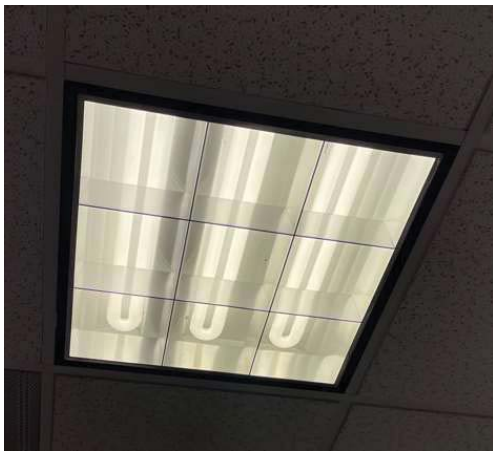
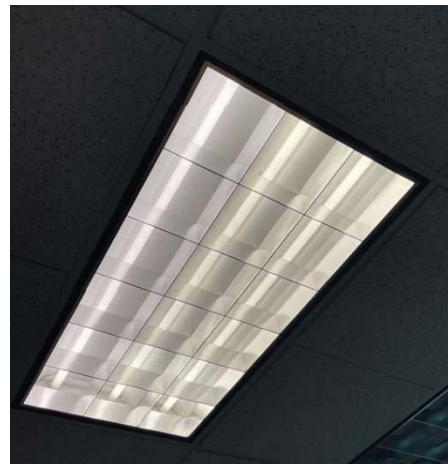
Different type of T8 & LED fixtures (2x2 and 2x4) are installed within open office areas, small offices, and conference rooms. Each fixture includes 3 T8 lamps. It does not appear these fixtures have any daylighting and occupancy controls which are required by current Lighting Title 24 standards.

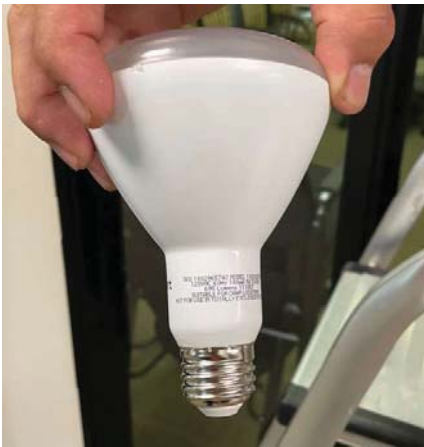
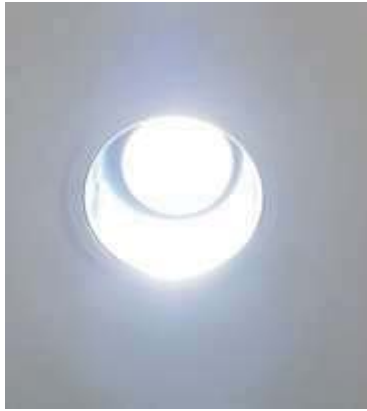
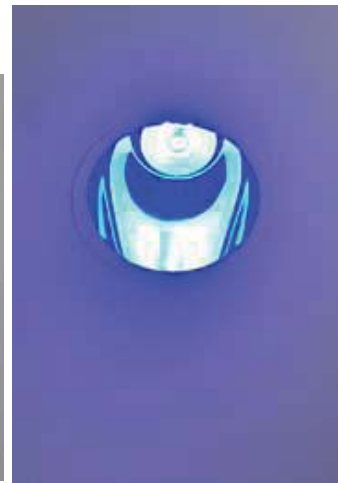
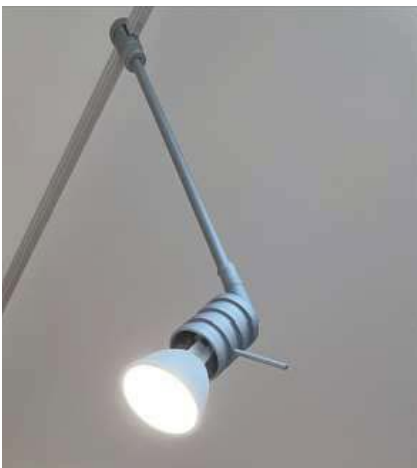
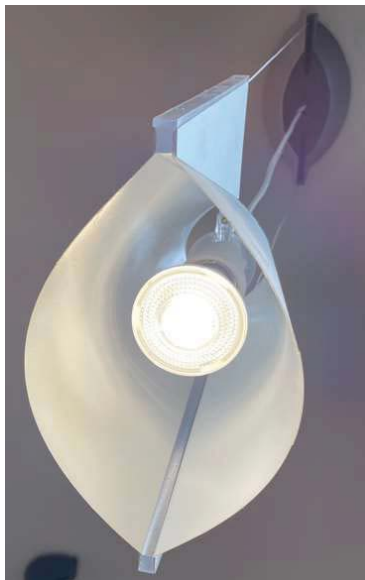
3. Second floor  
a. Light Fixtures

Hallway and lobby areas are equipped with retrofit LED screw-in lamps. Track light with MR16 track heads, pendant MR16, and wall wash are installed at the lobby areas. Color LED retrofit fixtures are also installed.

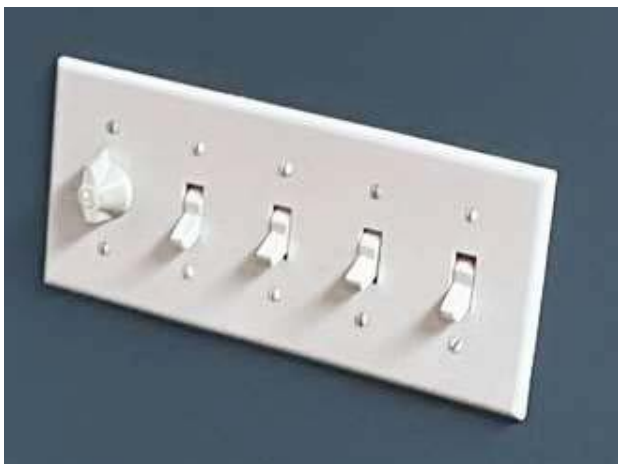
Time clocks are used in the open office area 217 and 221.

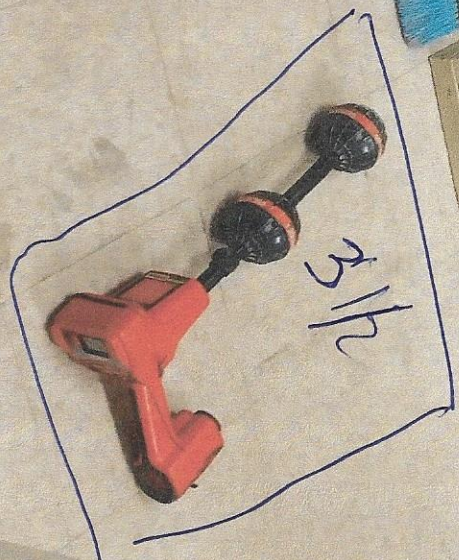
6' DEEP AREA 1 1/2" SHIFT  
SEWER MAIN

NEEDS TO BE CUT TO  
BE ABLE TO DESCALE  
SEWER PIPE BECAUSE  
OF TOO MANY TURNS
