Re: 200 Baker – Due Diligence Survey
200 E Baker St, Costa Mesa, CA 92626
Review of Existing Structure and Site
RSG Job #22-1-070.00

The purpose of this letter is to address our observations of the existing building and site located at 200 East Baker Street in Costa Mesa, CA. Regal Structural Group visited the site on October 18, 2022 and performed a non-destructive observation of the interiors, exteriors, and roof of the building and the site. As-built drawings were not available for our review.

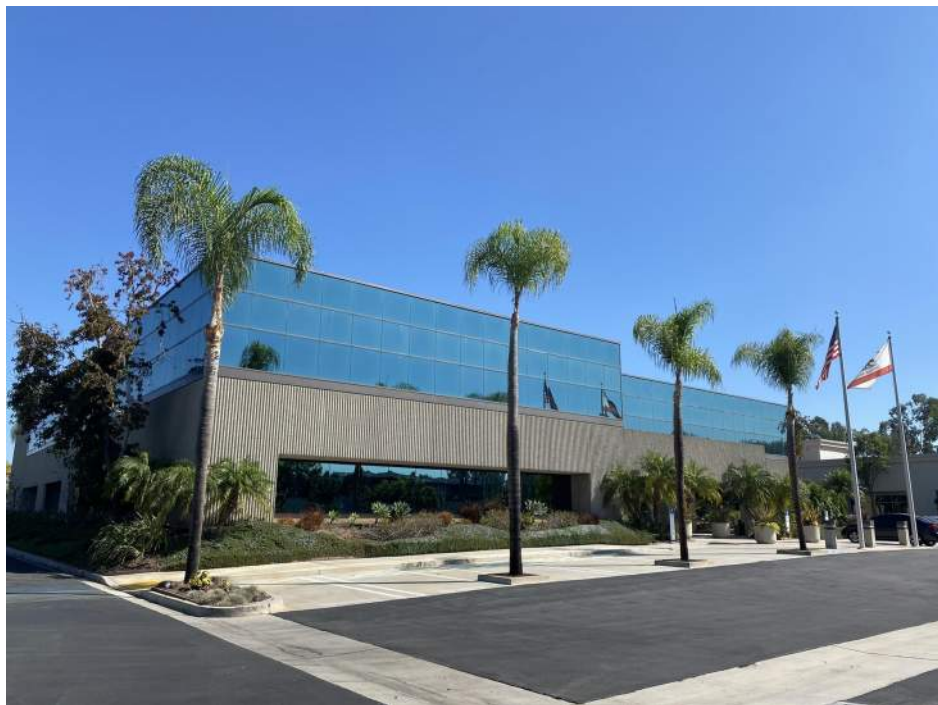
FIG 1: BUILDING EXTERIOR LOOKING FROM WEST

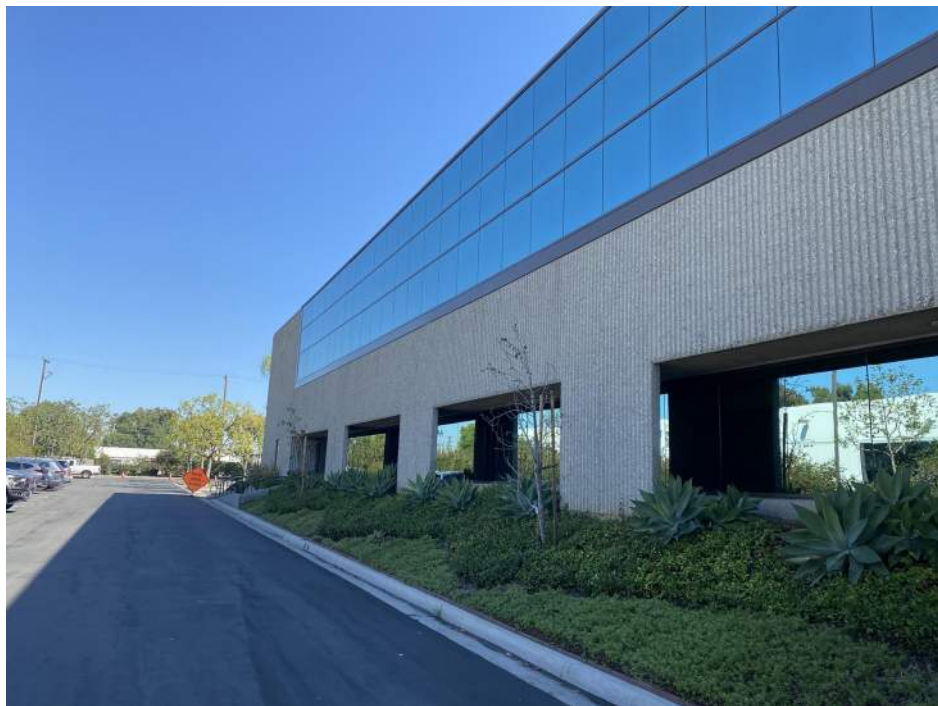
FIG 2: NORTHWEST ELEVATION OF BUILDING

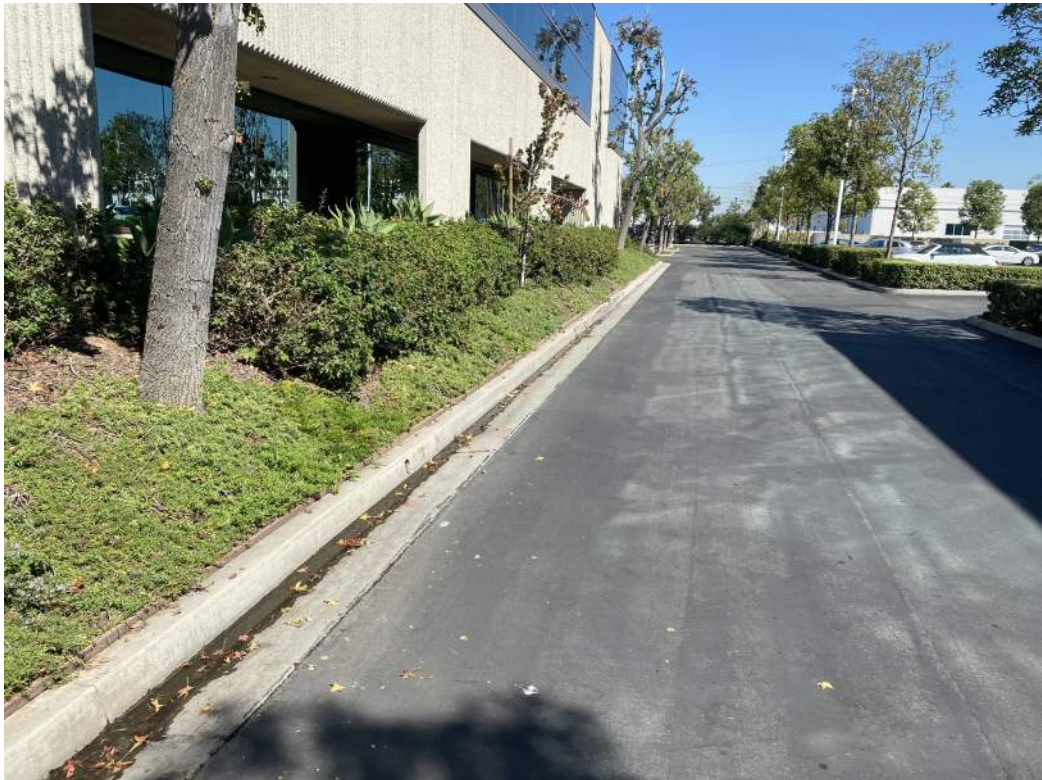
FIG 4: SOUTHEAST ELEVATION OF BUILDING WITH GUTTER

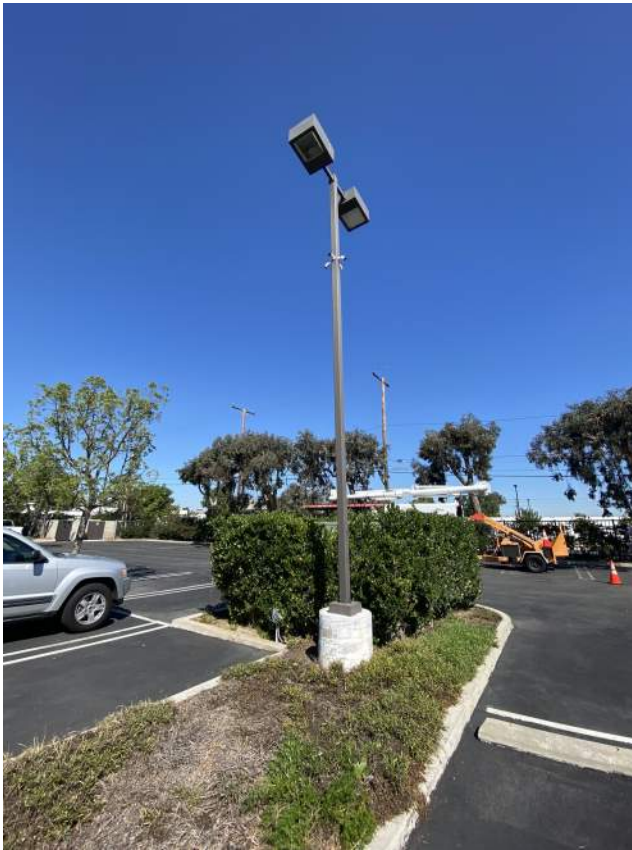
FIG 9: TYPICAL SITE LIGHTING

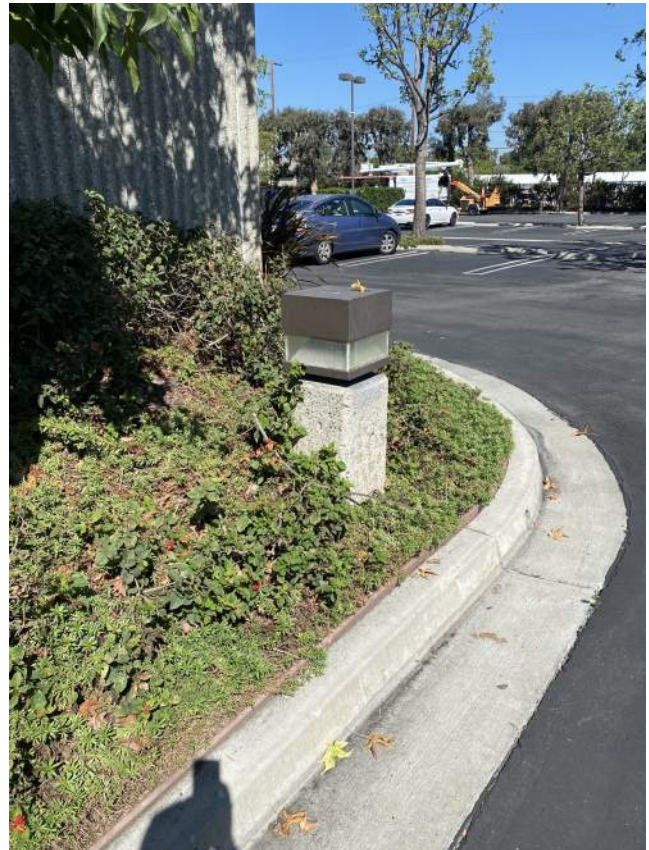
FIG 10: TYPICAL DRIVEWAY / WALKWAY
LIGHTING

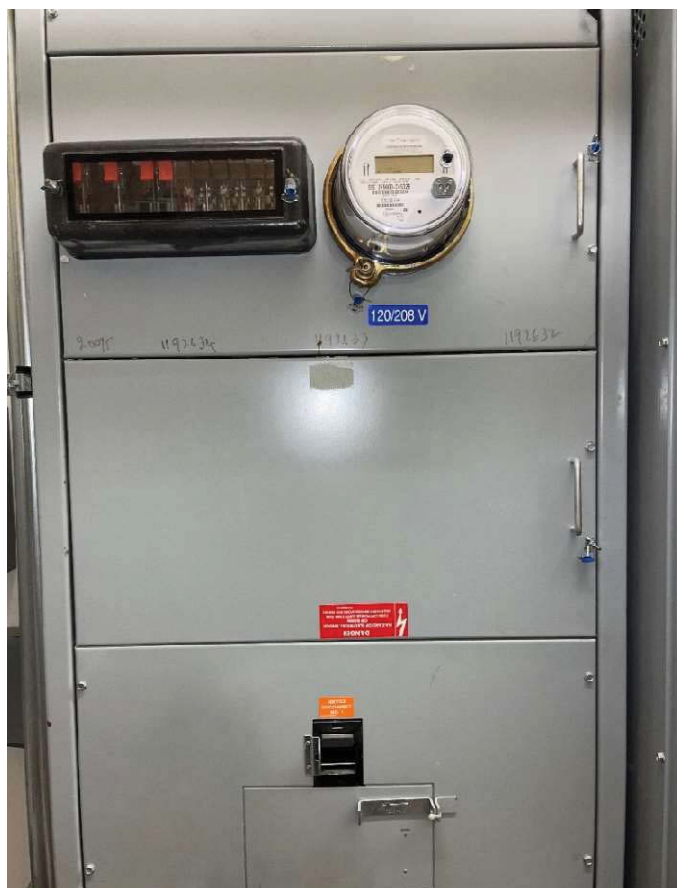
1) 400A 120/208V 3PH 4W 65k AIC with meter.

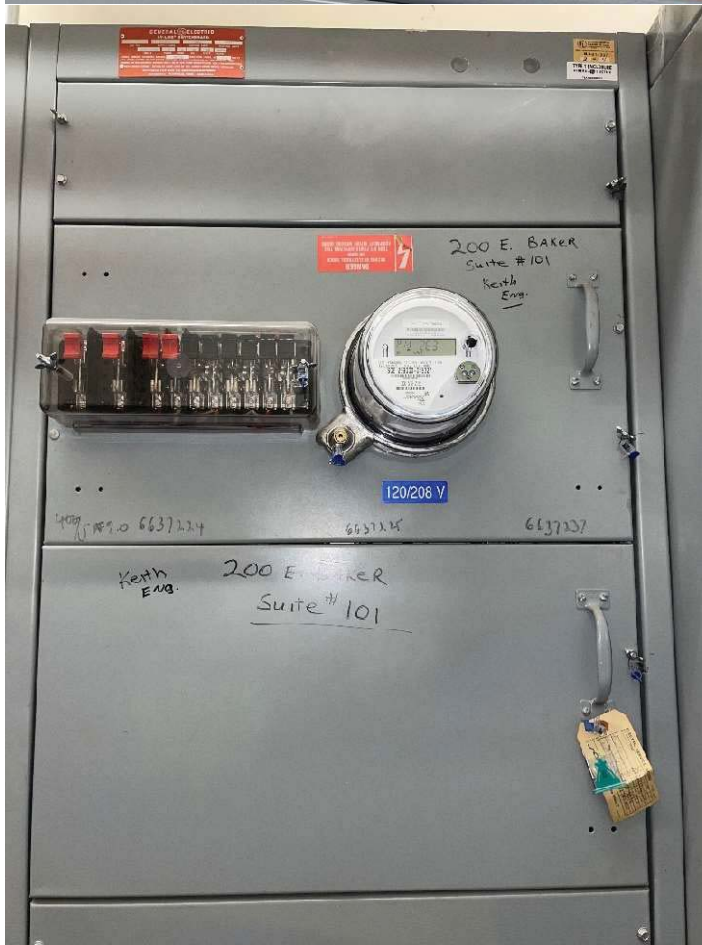
2) 1000A 120/208V 3PH 4W 50k AIC with meter.

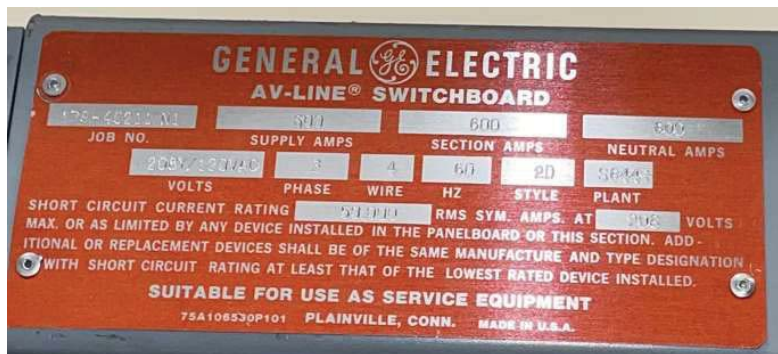
600A 120/208V 3PH 4W 50k AIC with *Electrical report*. A report by a California-registered electrical engineer certifying that all electrical systems comply with the California Electrical Code. The proper measures to remediate the noncompliant system components shall be identified.

3) meter.

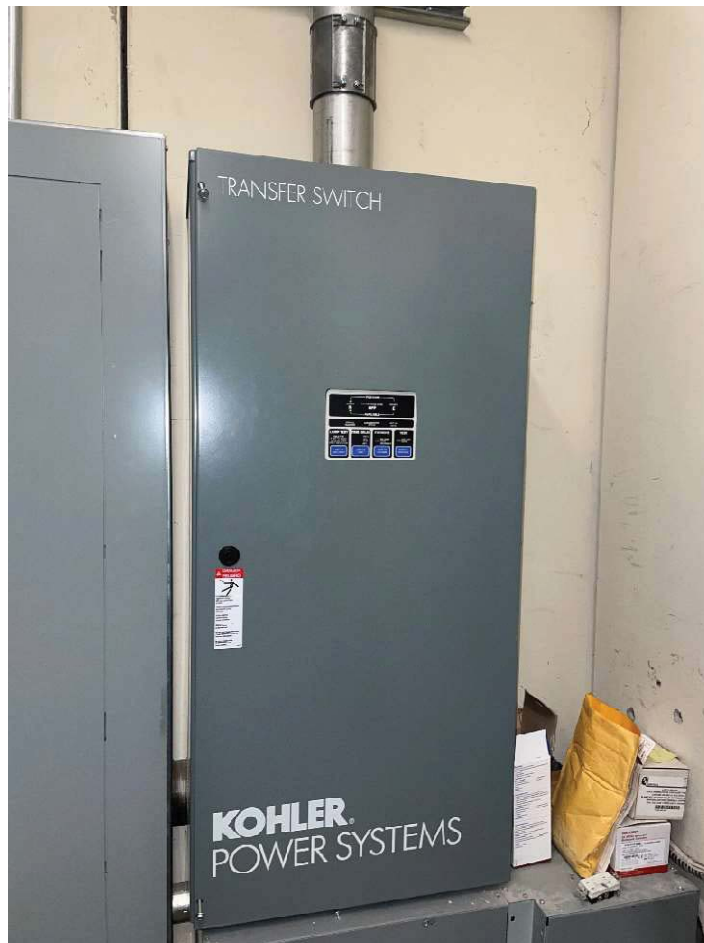
- 5) There is an existing transfer switch inside the first floor electrical room which is powering Panel Gen – 400A, 120/208V, 3PH 4W. Panel Gen is fed from the existing 1000A metering switchboard – Suite 101. Size of the backup generator is unknown. Q3 has not verified the size of the generator.

a. Transfer switch – 400A, 120/208V, 3PH

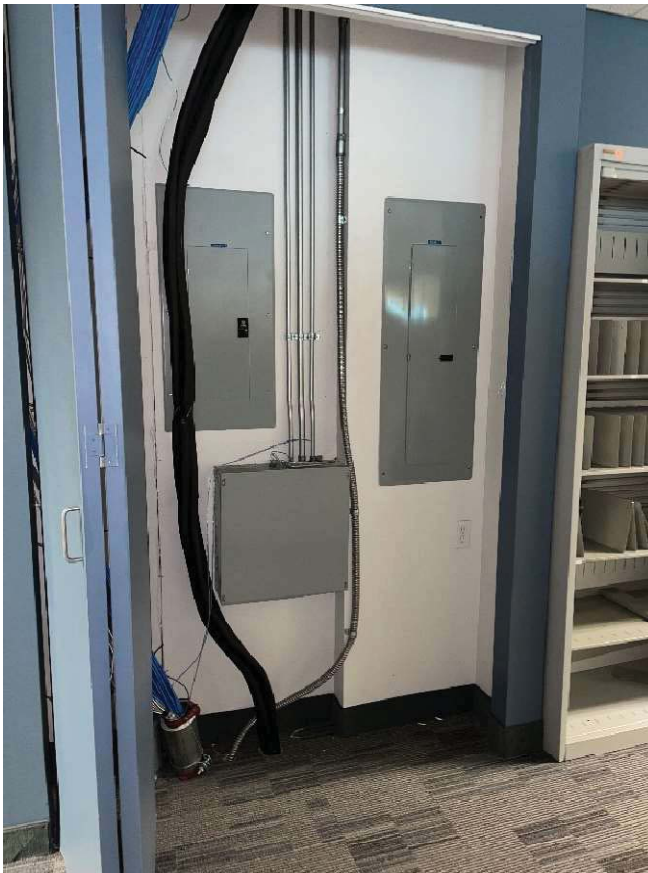
- 8) There are two electrical panels in the open office area of 2nd floor and they do comply with the 3ft clearance requirement. The panels seem to be in good condition.

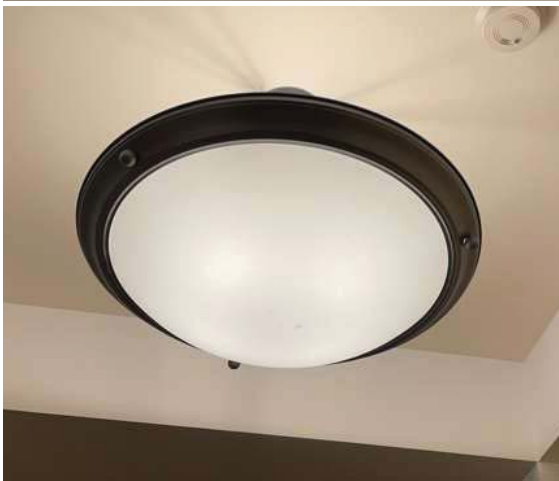
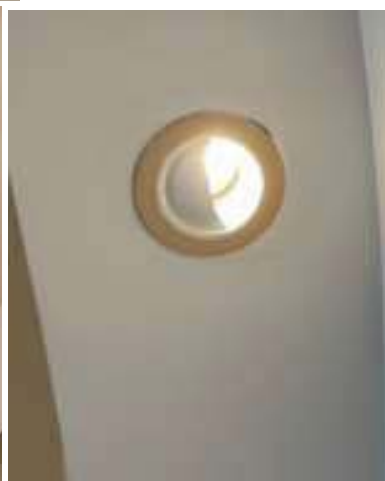
Compact fluorescent fixtures and MR16 can lights are installed in the lobby areas, conference rooms, and hallways. There are no partial-off vacancy sensor controls in the hallway. Our recommendation to bring this facility up to Title 24 Interior lighting compliance is to add in occupancy sensors for additional controls.

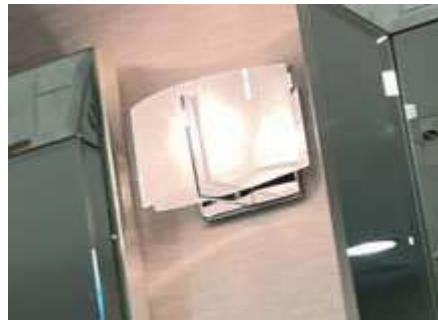
Compact fluorescent fixtures and wall sconces are used in the big restrooms in the middle of the floor.

Overall, most of the fixtures on the 1st floor are equipped with T8 and compact fluorescents lamps. Q3 recommends to upgrade to LED fixtures with daylighting and occupancy sensor controls.

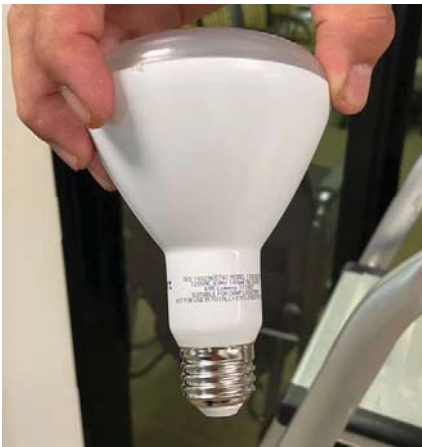
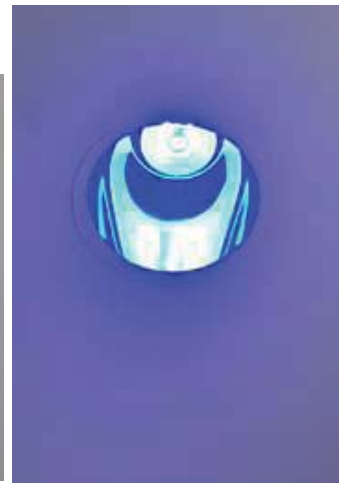
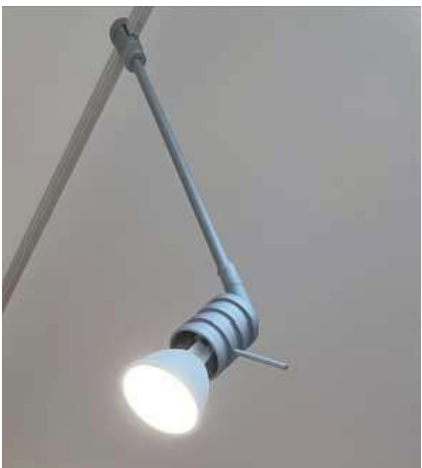
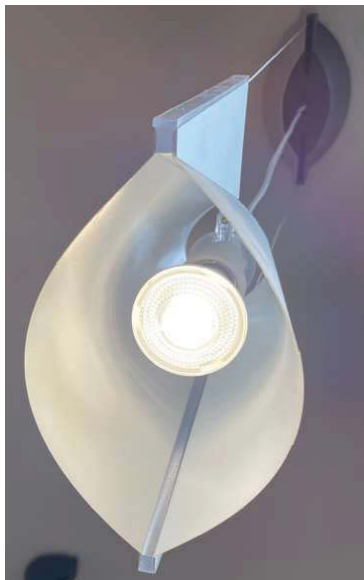
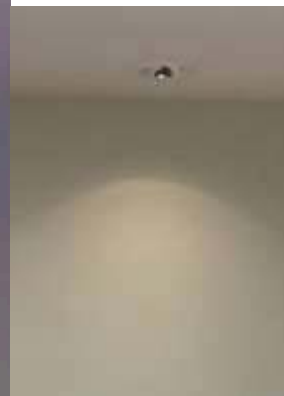
Hallway and lobby areas are equipped with retrofit LED screw-in lamps. Track light with MR16 track heads, pendant MR16, and wall wash are installed at the lobby areas. Color LED retrofit fixtures are also installed.

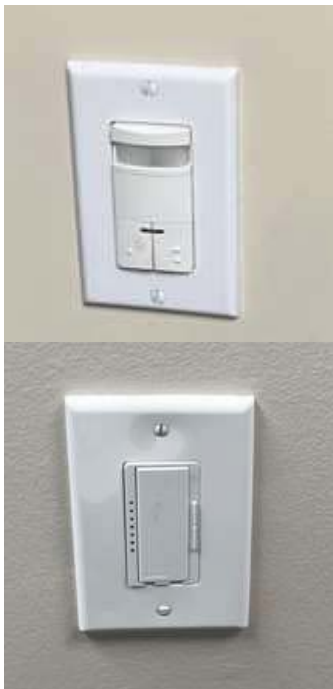
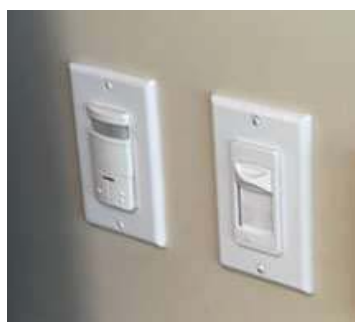
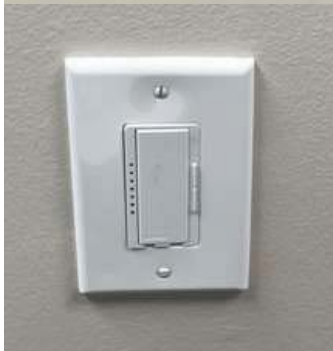
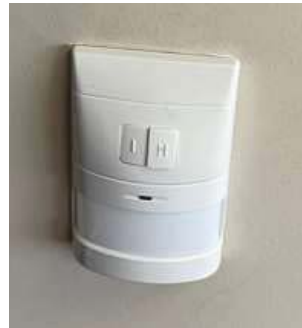
Most of the small offices are equipped with on/off switch with occupancy sensor and step dimmer. Step dimmer is set at 30/60/100%. 7-level step dimmer is found in some corridors. There are no partial-off vacancy sensor in all corridors. Some areas have continuous dimmers. Q3 recommends occupancy and photocell sensors to be installed in order to comply with current Title 24 Standards.

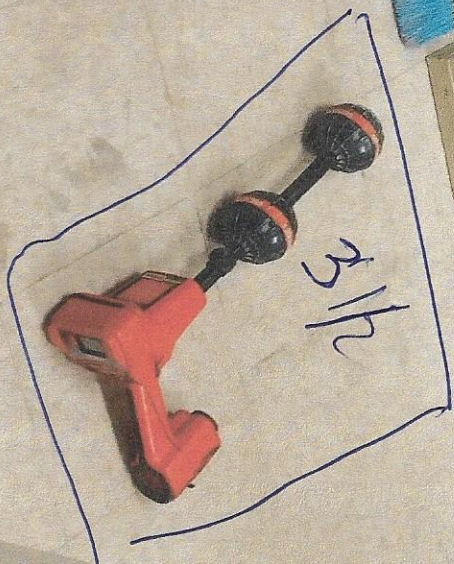
NEEDS TO BE CUT TO
BE ABLE TO DESCALE
SEWER PIPE BECAUSE
OF TOO MANY TURNS

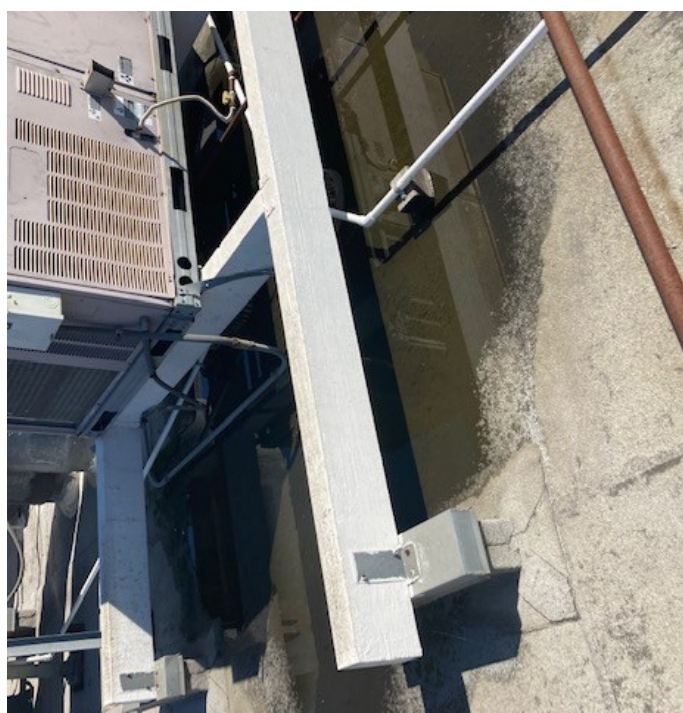
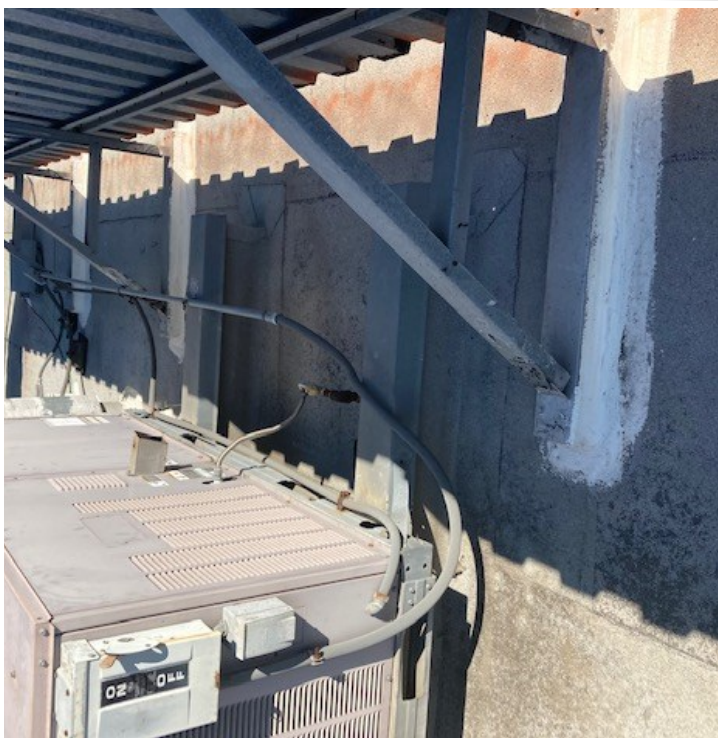
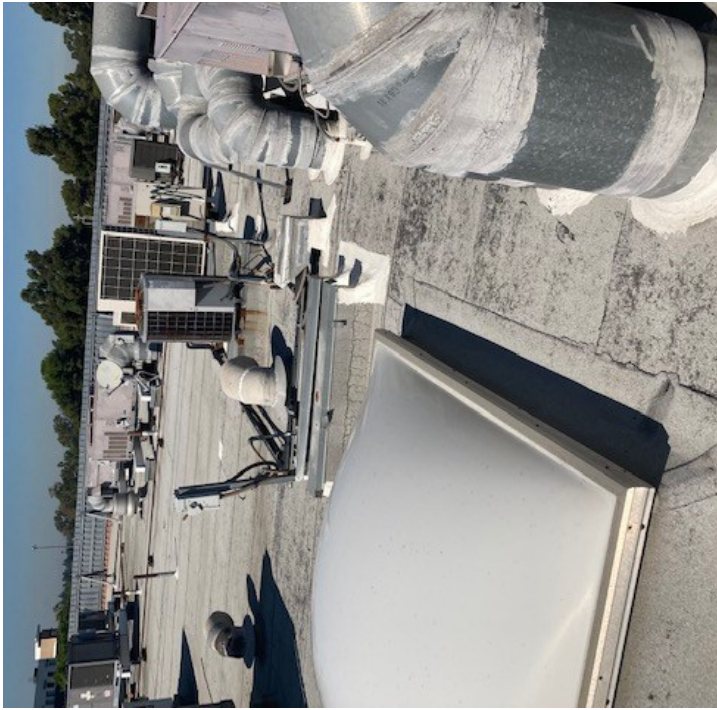
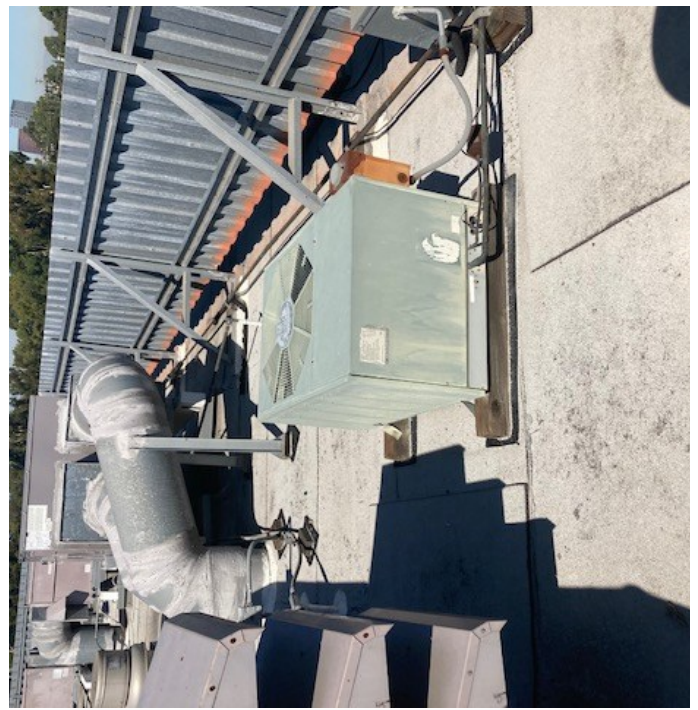
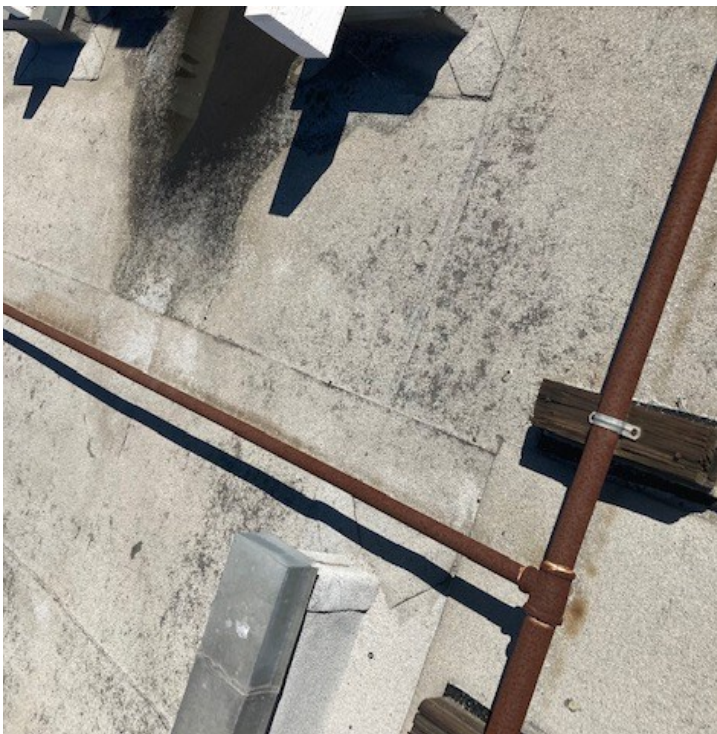
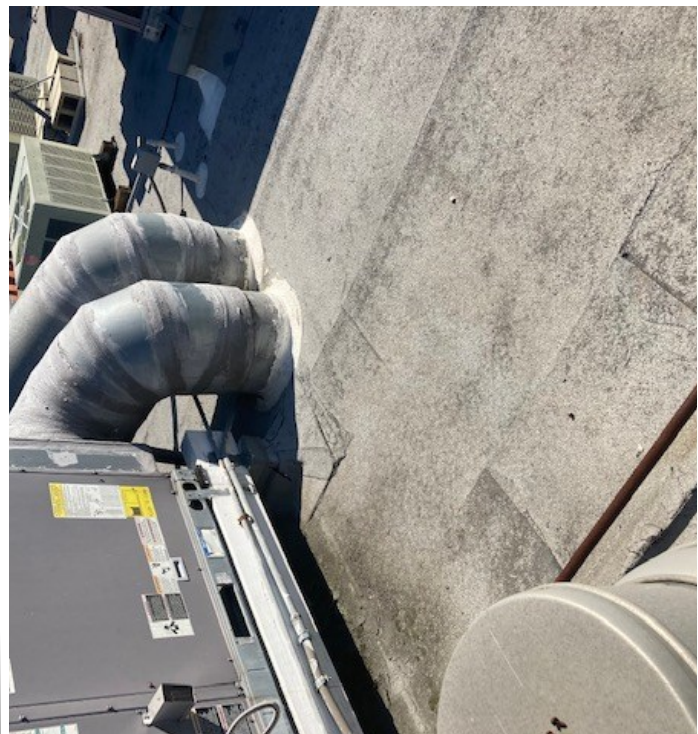
ROOF CONDITION - This roof has been well maintained over the years but has reached it's life expectancy. There is granule loss throughout the cap sheet membrane as well as a few area of ponding water. There are multiple areas experiencing deflection. We believe this is due to damaged plywood decking due to water intrusion. The existing roof membrane is prone to leaks and is in need of replacement.

RECOMMENDATIONS - AMS recommends either replacing the roof membrane or applying a restoration coating to watertight the existing roof.
