June 28, 2024

Re: 660 Baker St – Structural Due Diligence Survey  
660 Baker Street, Costa Mesa, CA 92626  
Review of Existing Structure and Site  
RSG Job #24-1-070.00

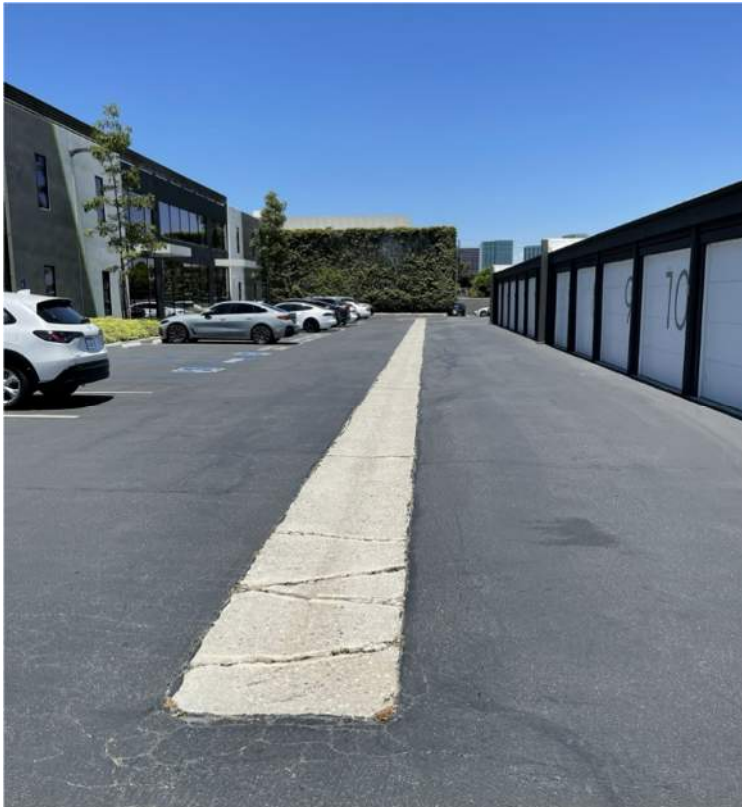
*Image 6 - Eastside of Buildings C & D Looking North*

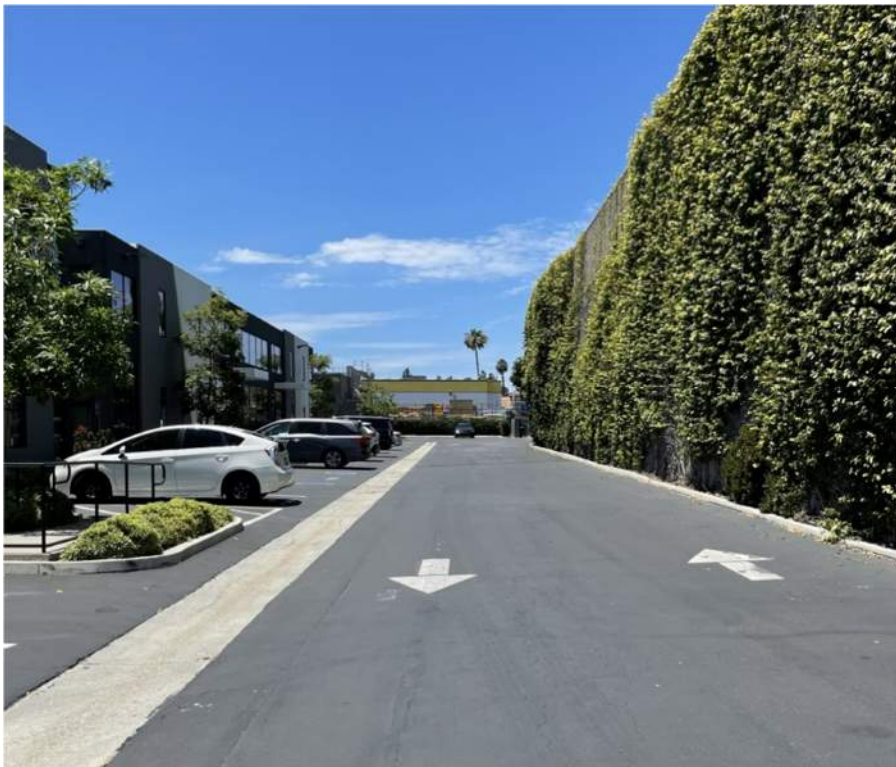
*Image 8 - Parking on North Side of Buildings B&C Looking West*

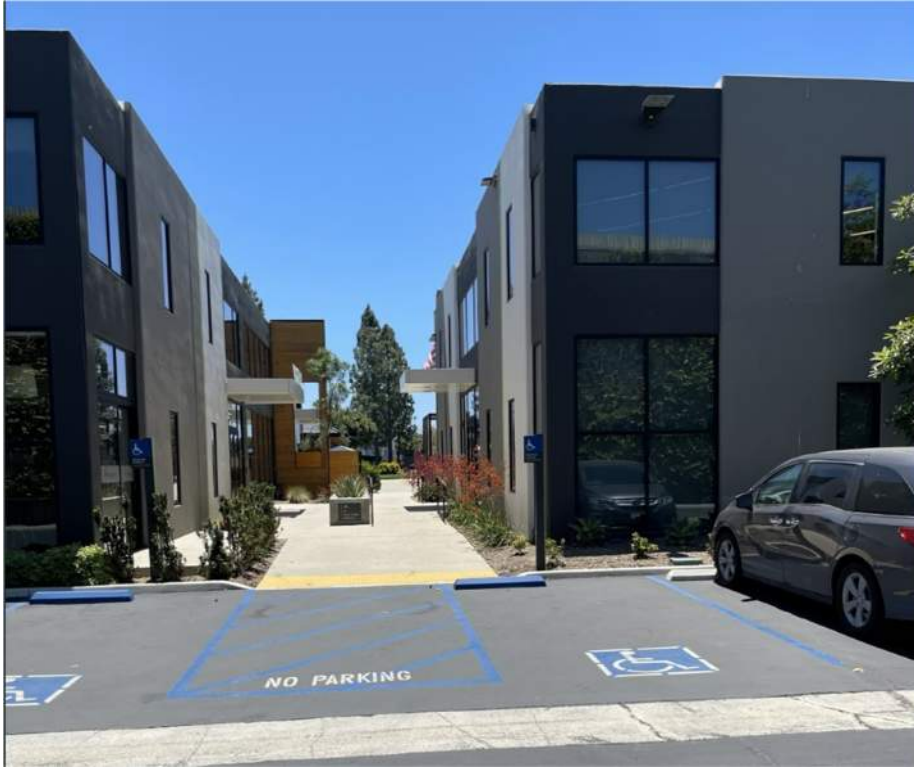
*Image 9 - Breezeway Between Bldg. B&C Looking South*

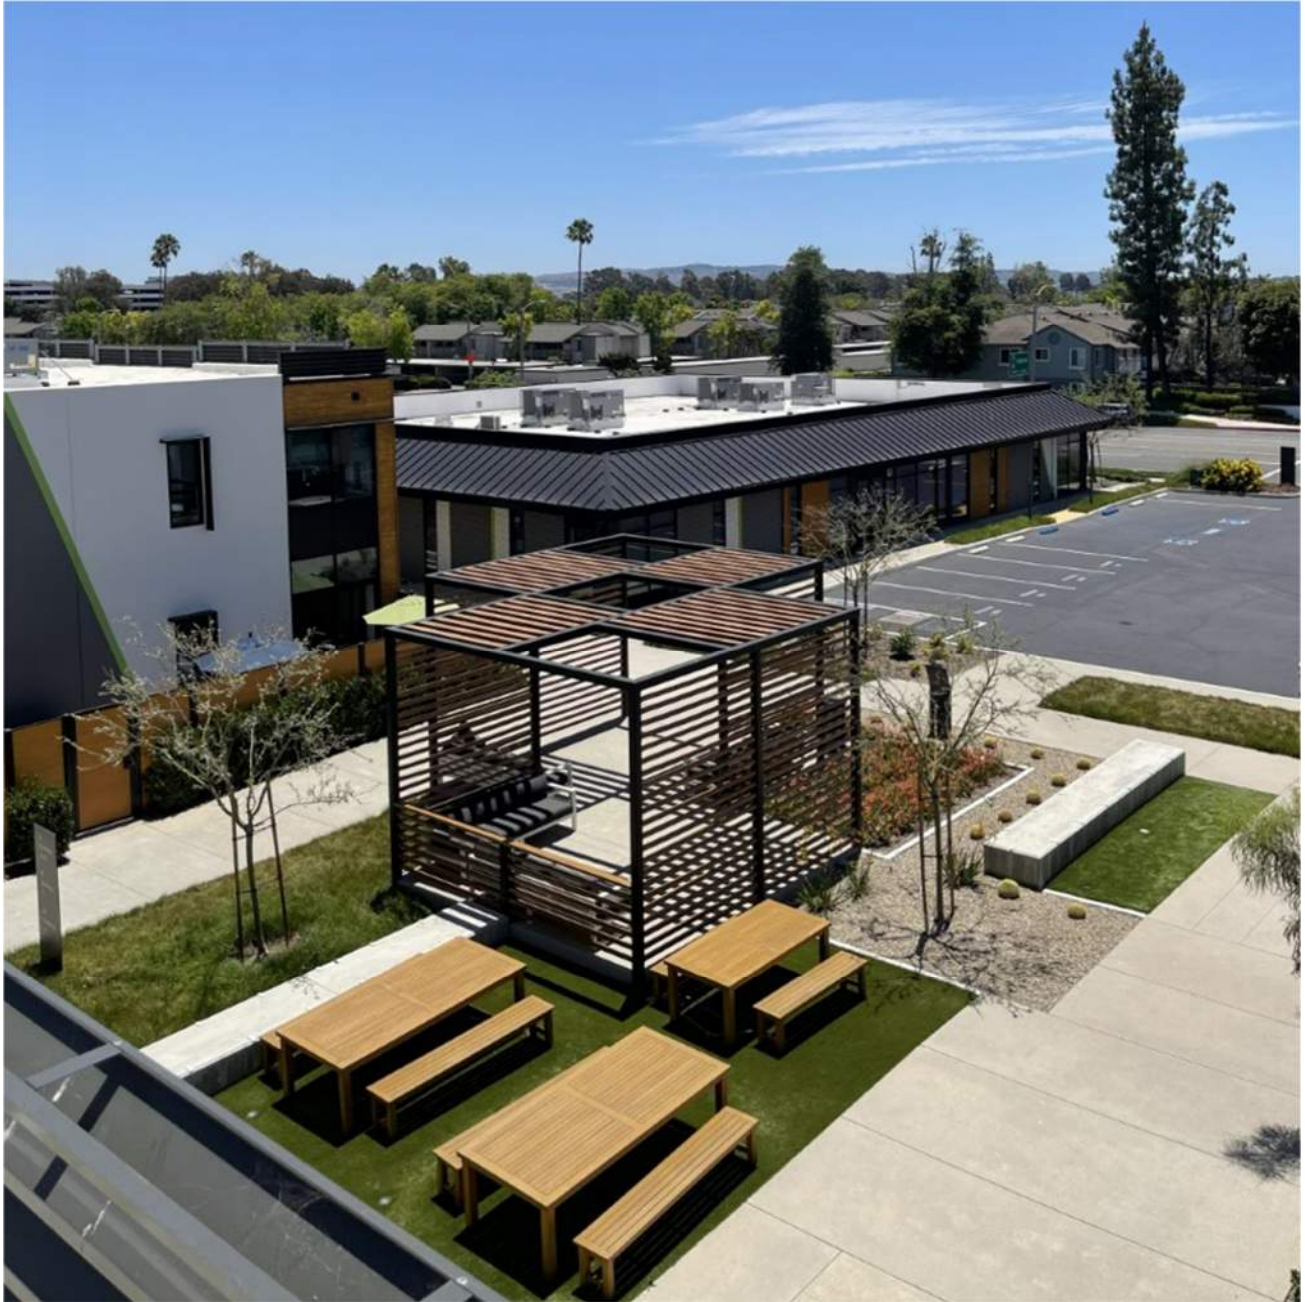
*Image 11 - View Looking South-East Toward Building D*

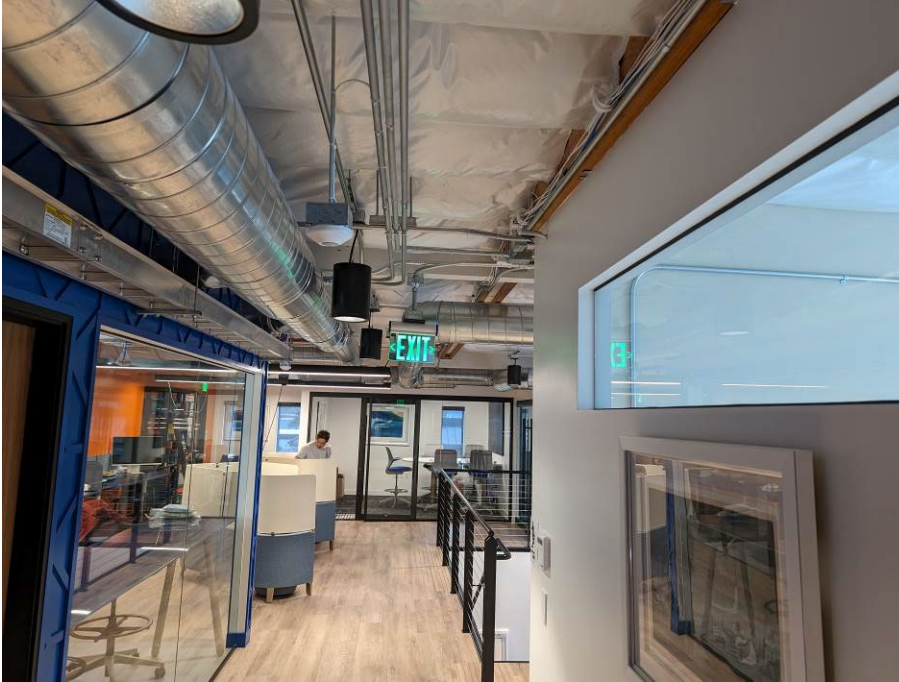
1. View of the interior of Unit A-201 showing non-asbestos sheetrock and joint compound.

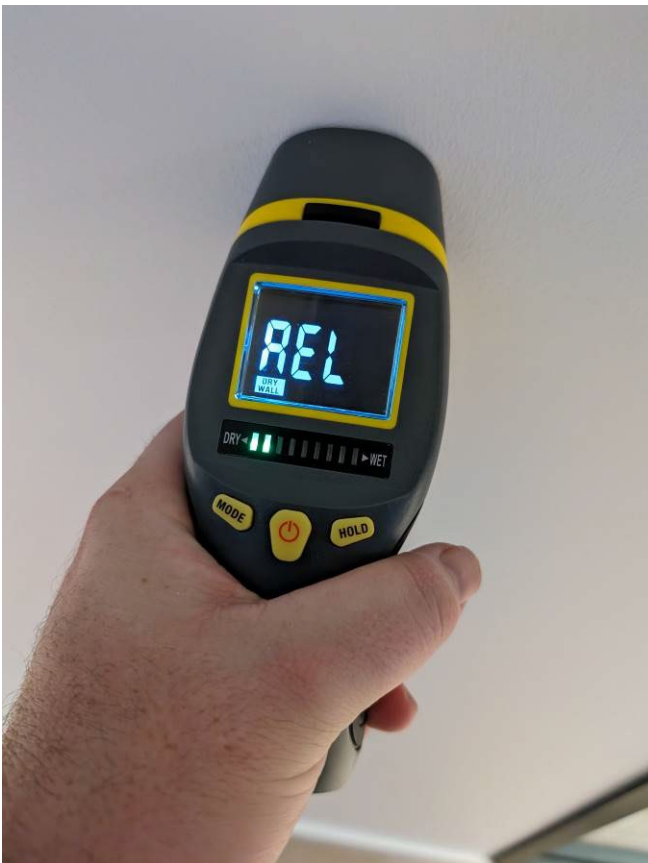
2. View showing dry moisture reading of sheetrock in Unit A-201.

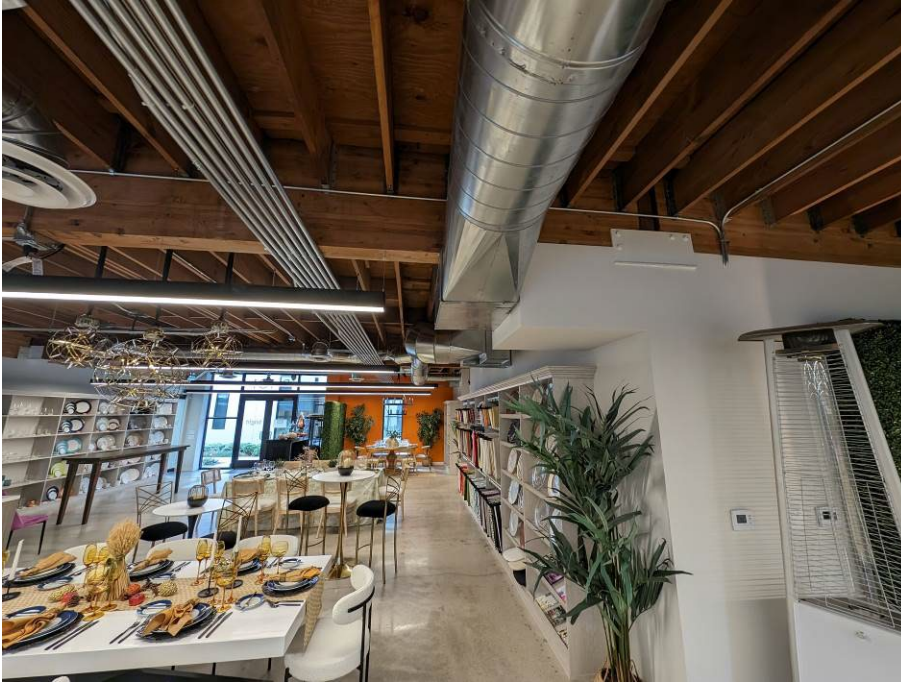
3. View of the interior of Unit B-101 showing non-asbestos sheetrock and joint compound.

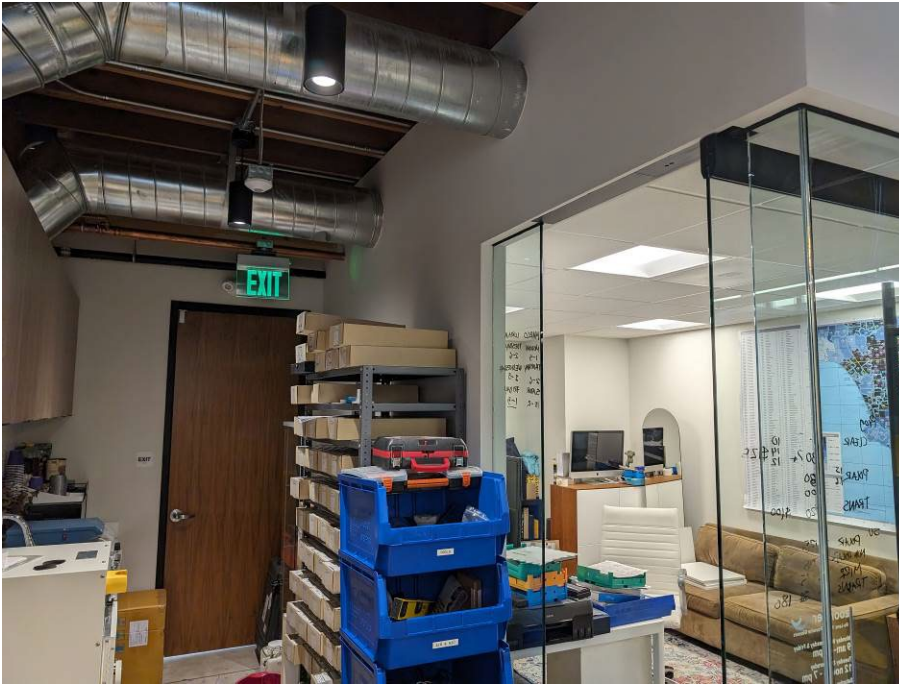
5. View of the interior of Unit B-102 showing non-asbestos sheetrock and joint compound.

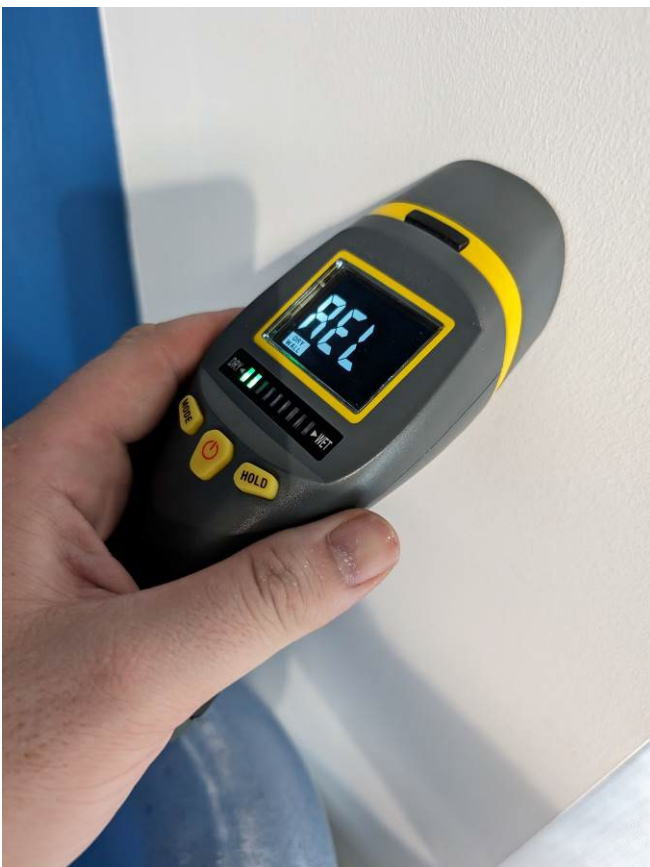
6. View showing dry moisture reading of sheetrock in Unit B-102.

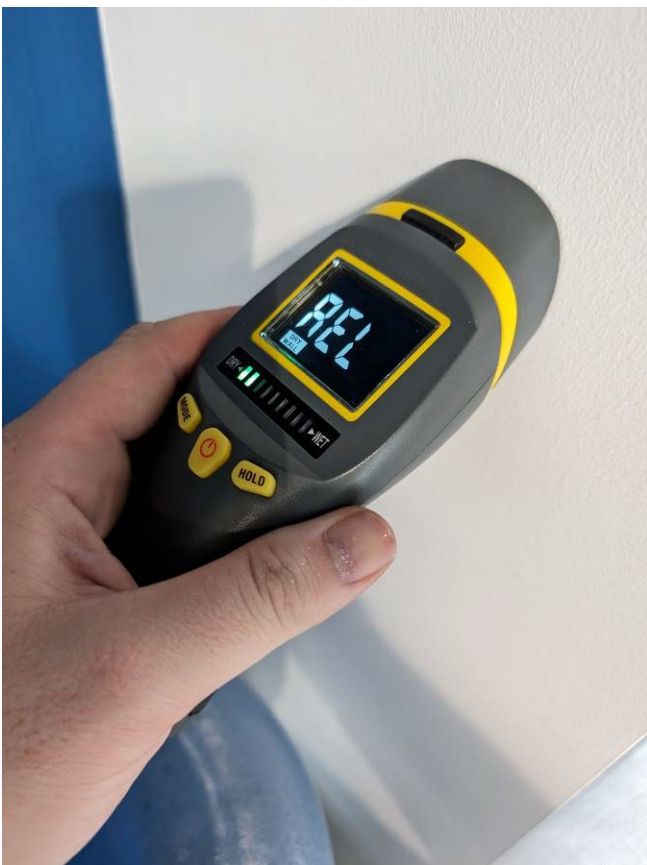
8. View showing dry moisture reading of sheetrock in Unit B-103.

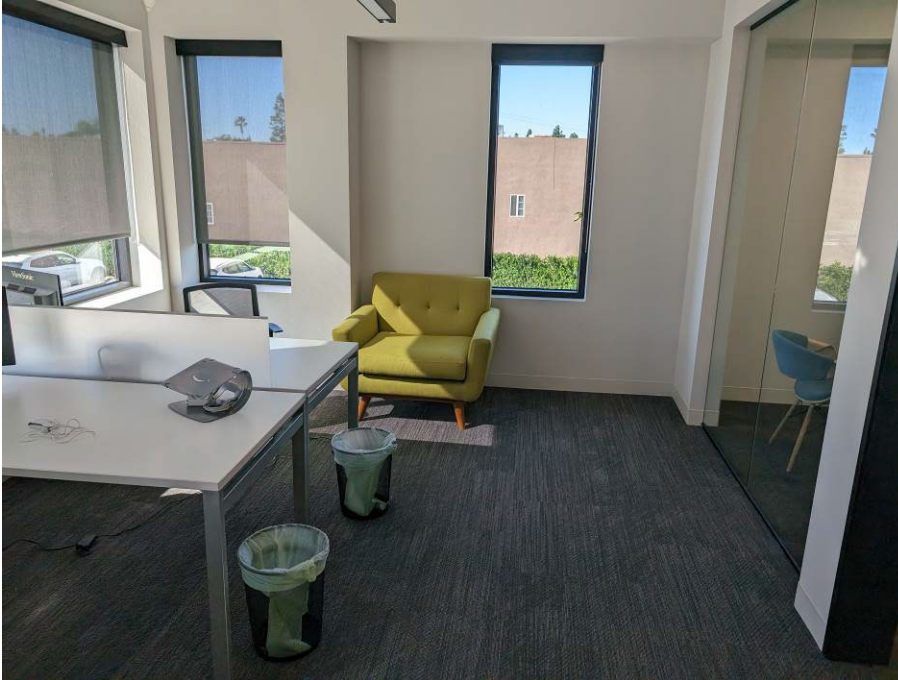
9. View of the interior of Unit B-210 showing non-asbestos sheetrock and joint compound.

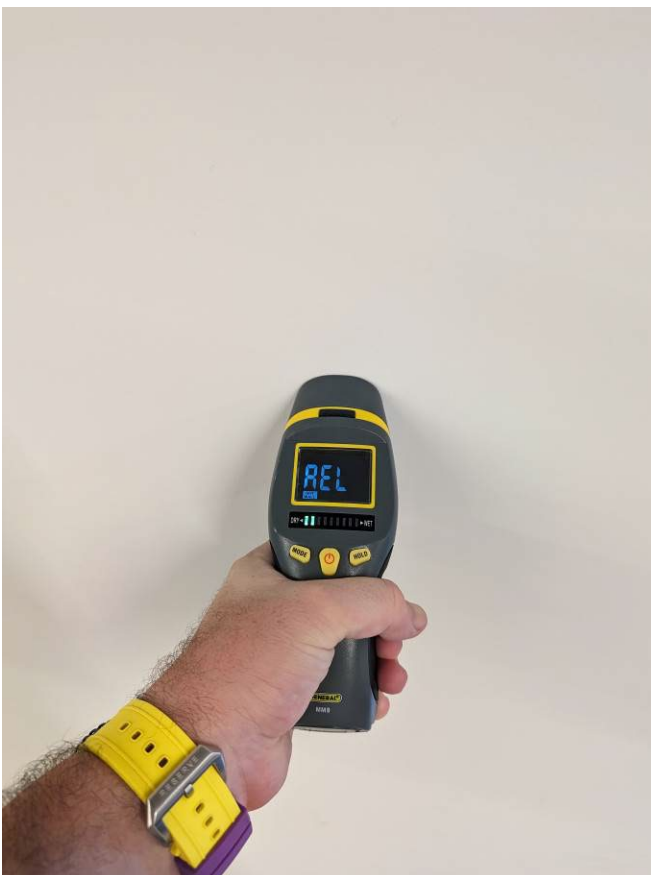
10. View showing dry moisture reading of sheetrock in Unit B-210.

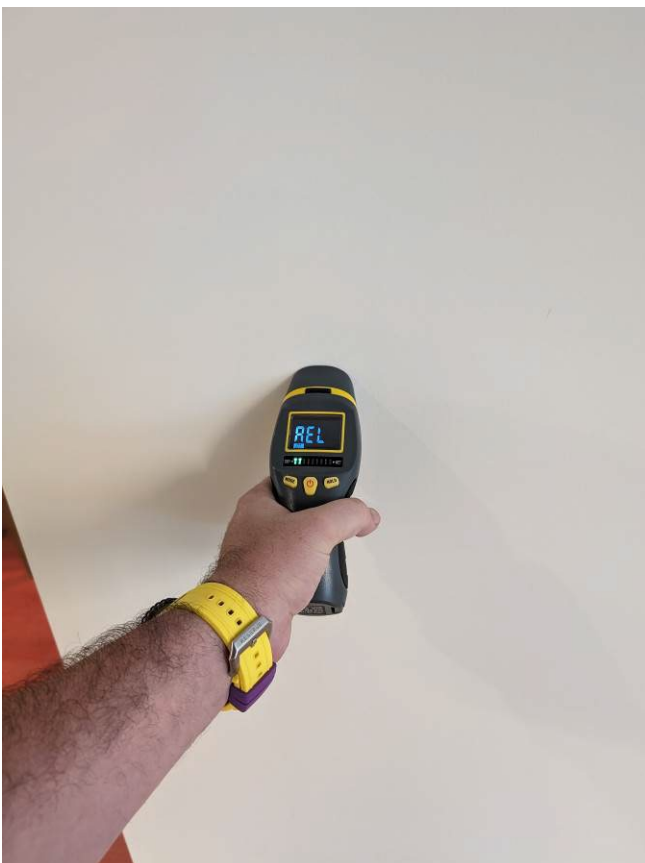
12. View showing dry moisture reading of sheetrock in Unit B-250.

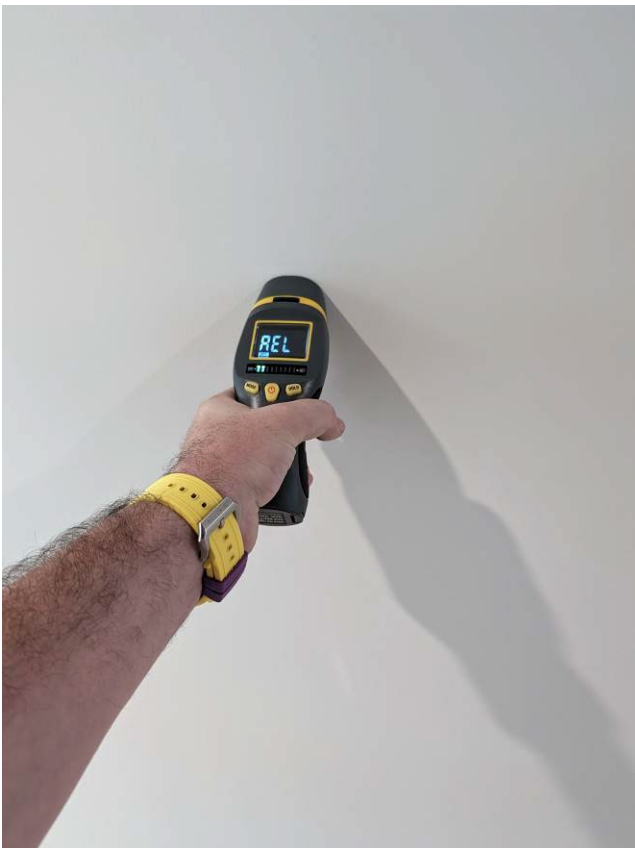
14. View showing dry moisture reading of sheetrock in Unit C-102.

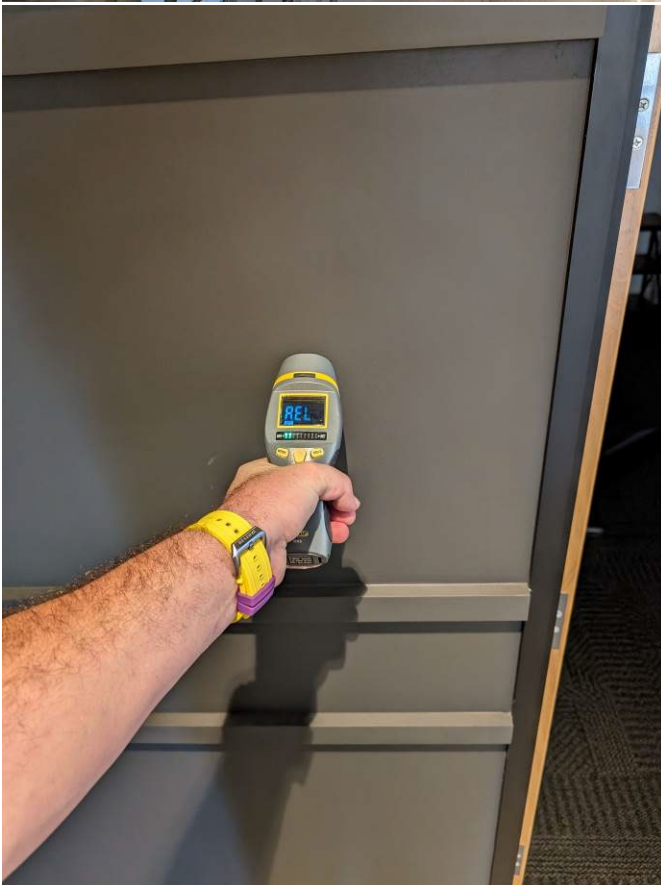
16. View showing dry moisture reading of sheetrock in Unit D-101.

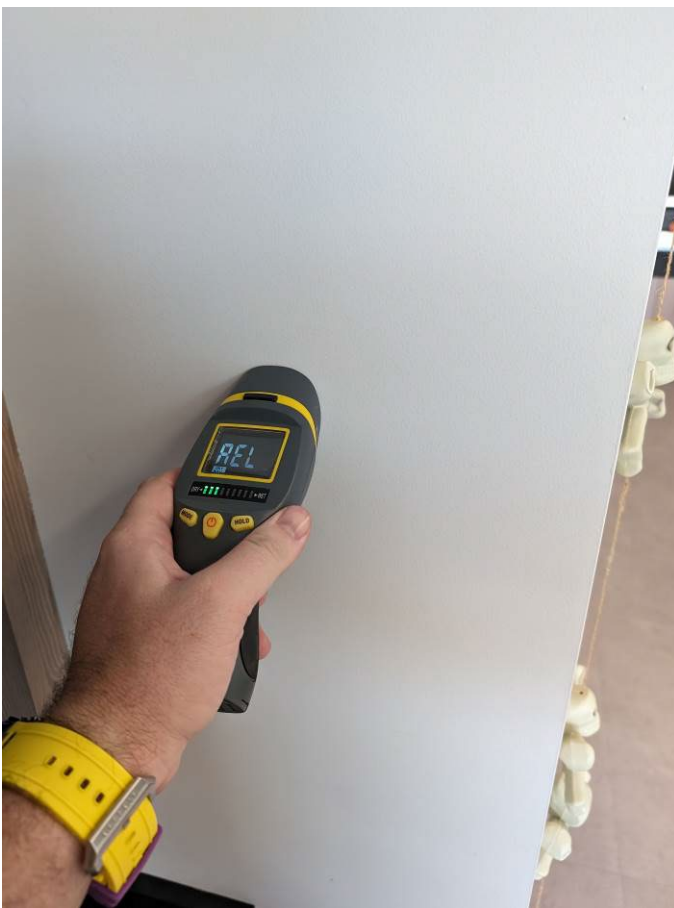
18. View showing dry moisture reading of sheetrock in Unit C-200.

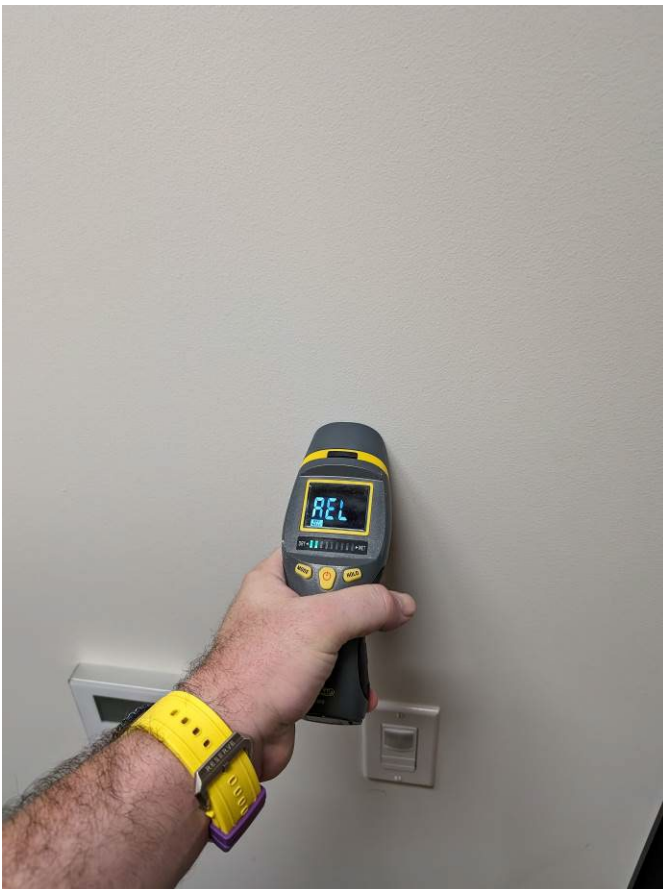
20. View showing dry moisture reading of sheetrock in Unit A-101.

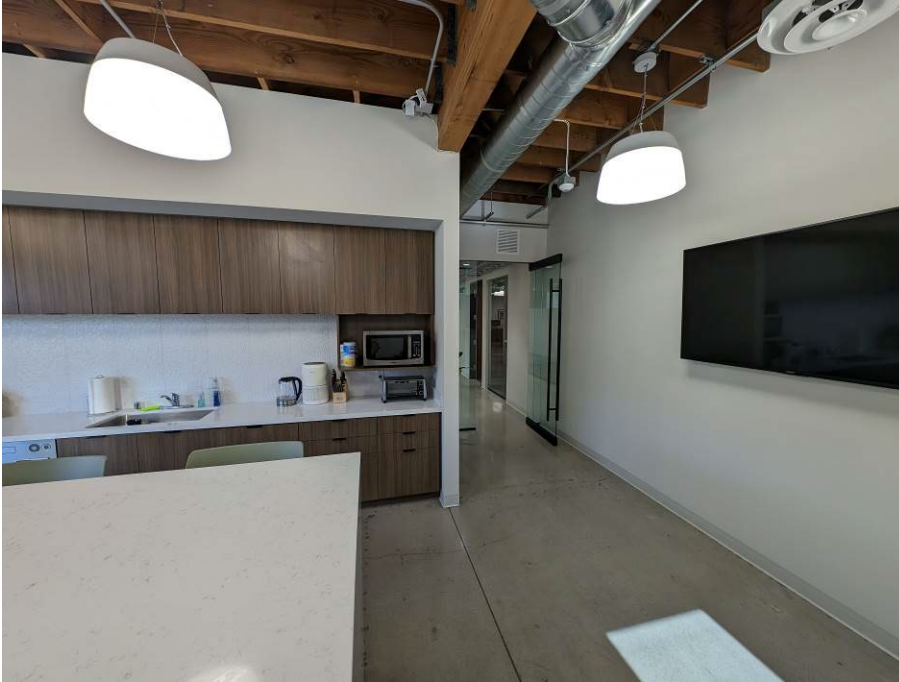
21. View of the interior of Unit C-101 showing non-asbestos sheetrock and joint compound.

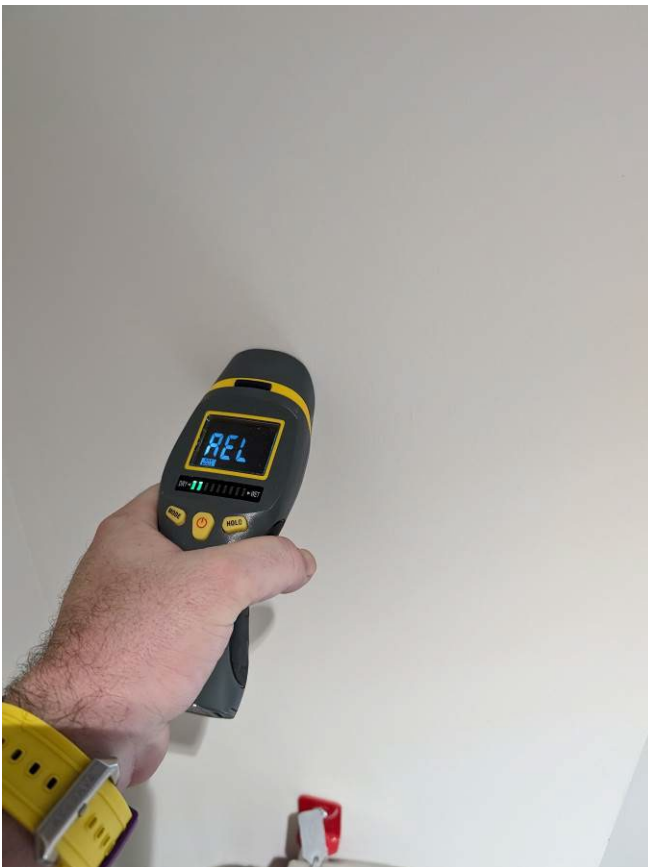
22. View showing dry moisture reading of sheetrock in Unit C-101.

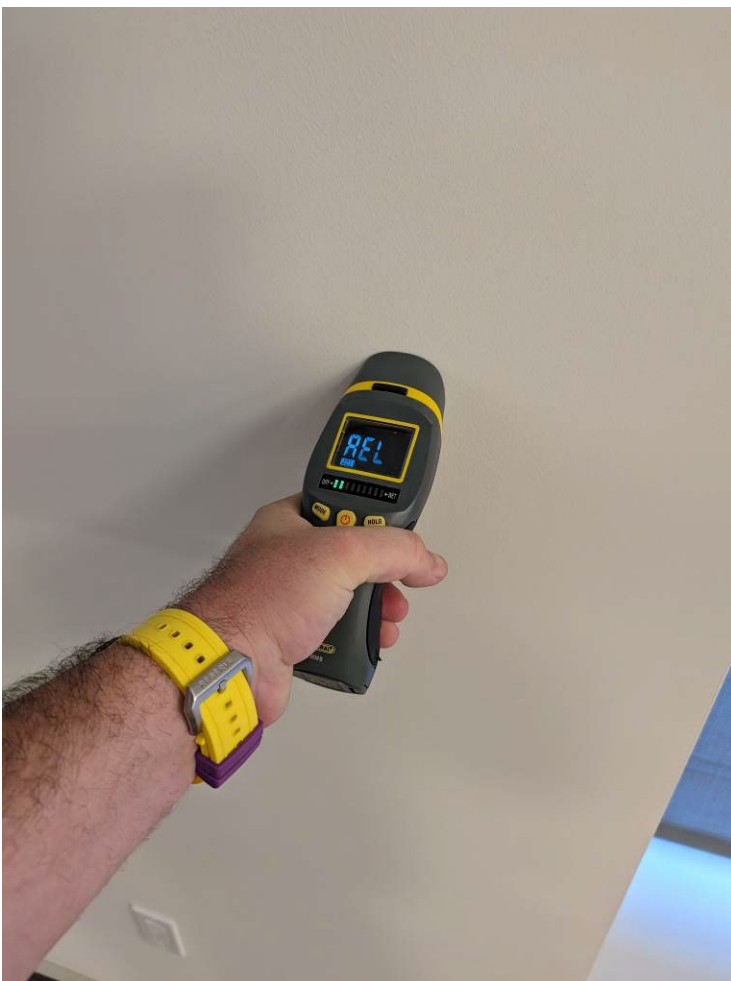
24. View showing dry moisture reading of sheetrock in Unit B-220.
